Countermeasures

Countermeasures are an important and necessary part of bridge maintenance. Not only must the countermeasure restore the safety of the structure, but guard against future assaults. This often has to be completed in a short time and on a shoe string budget.

This document will display some of the different types of countermeasures that have been used both successfully and unsuccessfully in Oklahoma.

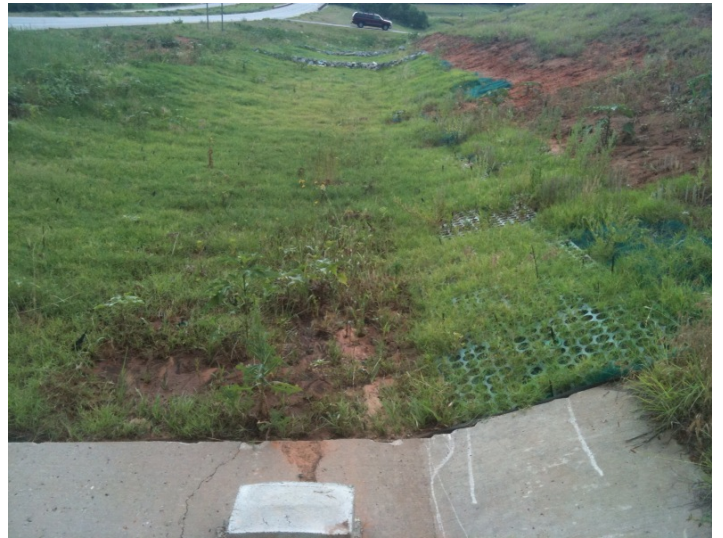
AFTER

Problem Type: Channel Degradation with channel slope greater than 8.8%.

Location: Both upstream and downstream of side drain was degrading

Solution: Scourstop

Notes: The cross drain is located 2 miles north of I-40. Completed in 2009. This solution has performed well.

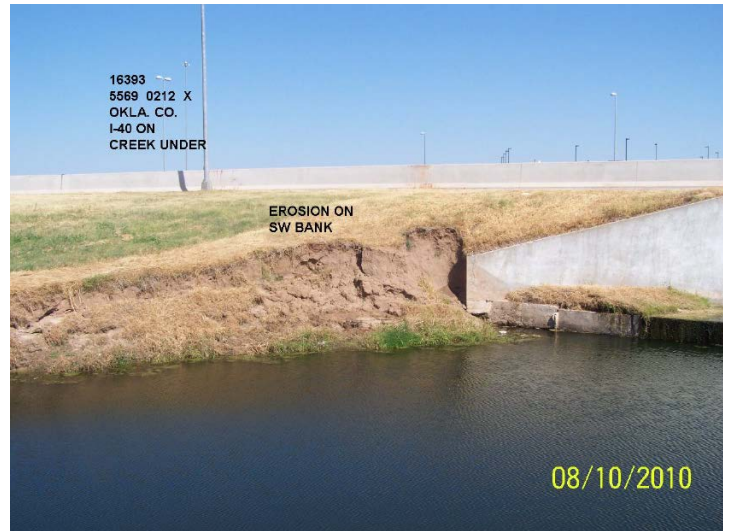
AFTER

Problem Type: Degradation of Channel

Location: Upstream and downstream side of RCB

Solution: New Apron with curtain wall.

Notes: Completed in 1996 along with the fix of the Rockwell RCB.

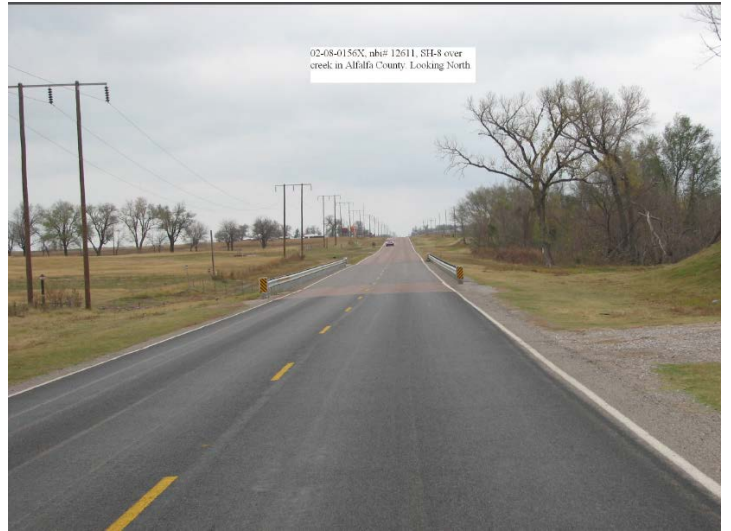
AFTER

Problem Type: Degrading Channel

Location: Upstream and Downstream

Solution: Replace failed RCB.

Notes: Completed in 2009.

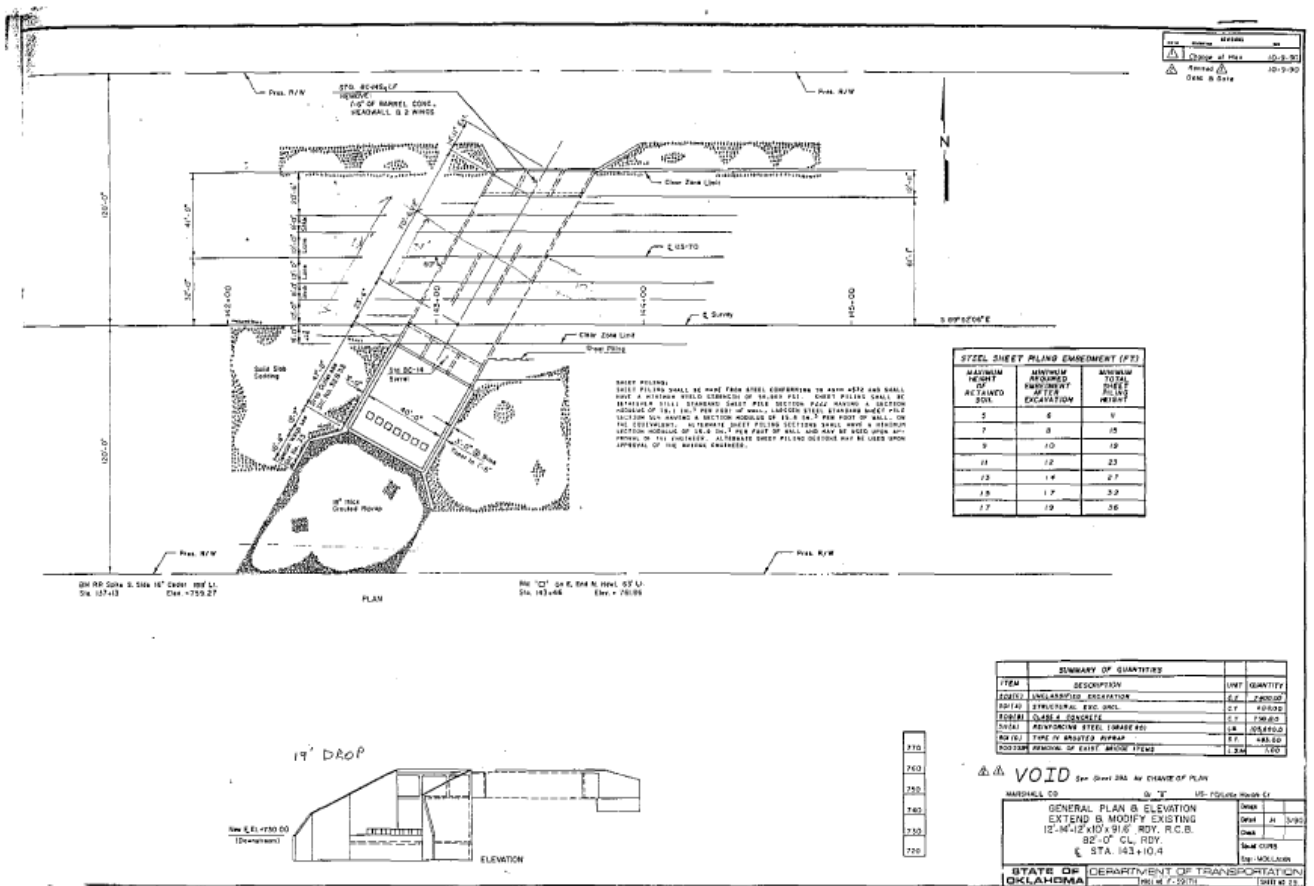
AFTER

Problem Type: Degrading Channel

Location: Degradation of the channel on the downstream side of the RCB.

Solution: Build a drop outlet.

Notes: Completed in 1992.

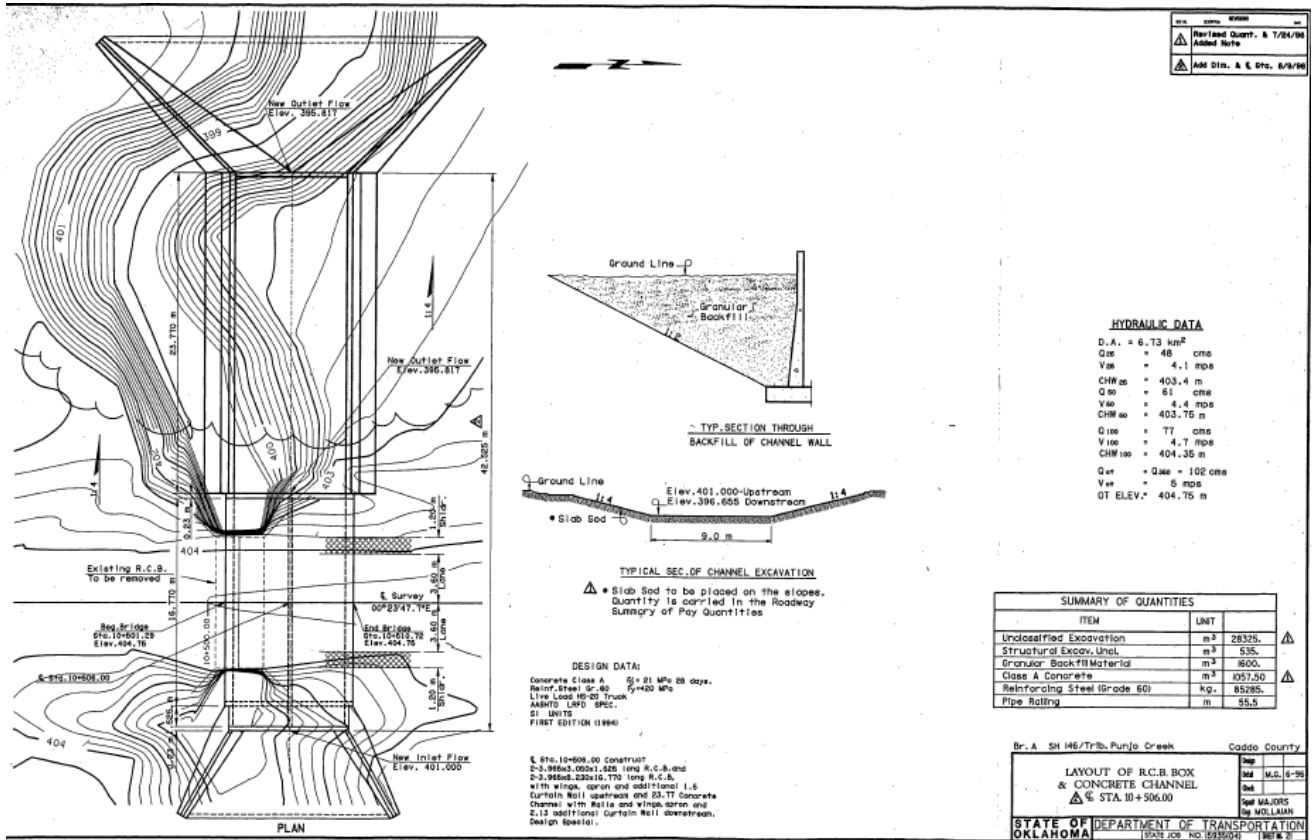
Notes: Completed in 1997. The new structure withstood Tropical Storm Erin which deposited an enormous amount of debris on the upstream side. A well vegetative channel can be seen looking through the 2010 inspection picture.

NB# 25082
 STR. # 0851 0381
 CADDO COUNTY
 FACILITY CARRIED S.H. 146
 FEATURE INTERSECTED PUNJO CREEK
 8-15-10
 LOOKING WEST

Solution: Built a drop outlet.

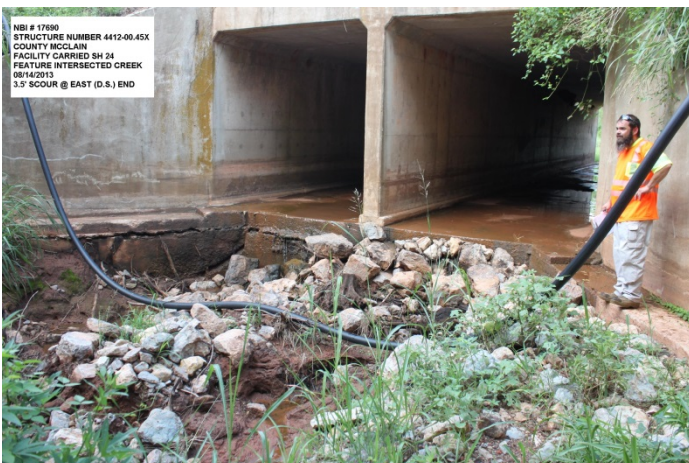
BEFORE

Problem Type: Downstream Degradation

Cost/Outcome: Placed Riprap in Channel before 2013. The downstream wing collapsed in 2015. The solution was not effective.

Solution: Placed Rip Rap at Outlet of RCB and in the channel downstream of RCB

Notes: After the wing was replaced, grouted riprap was also placed in the channel.

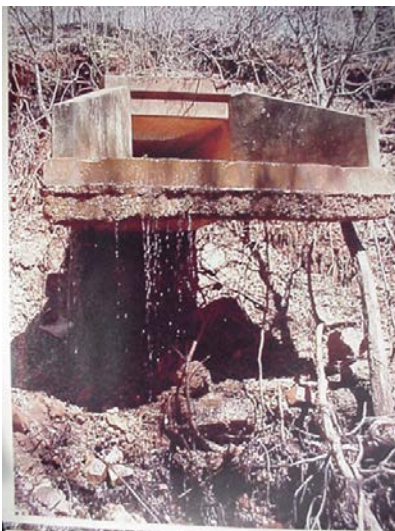
BEFORE

Problem Type: Degradation of the downstream channel with undermining of the RCB.

Notes: The RCB is 4.5 miles east of US 177 in Pottawatomie county. The drainage channel had degraded 11 ft.

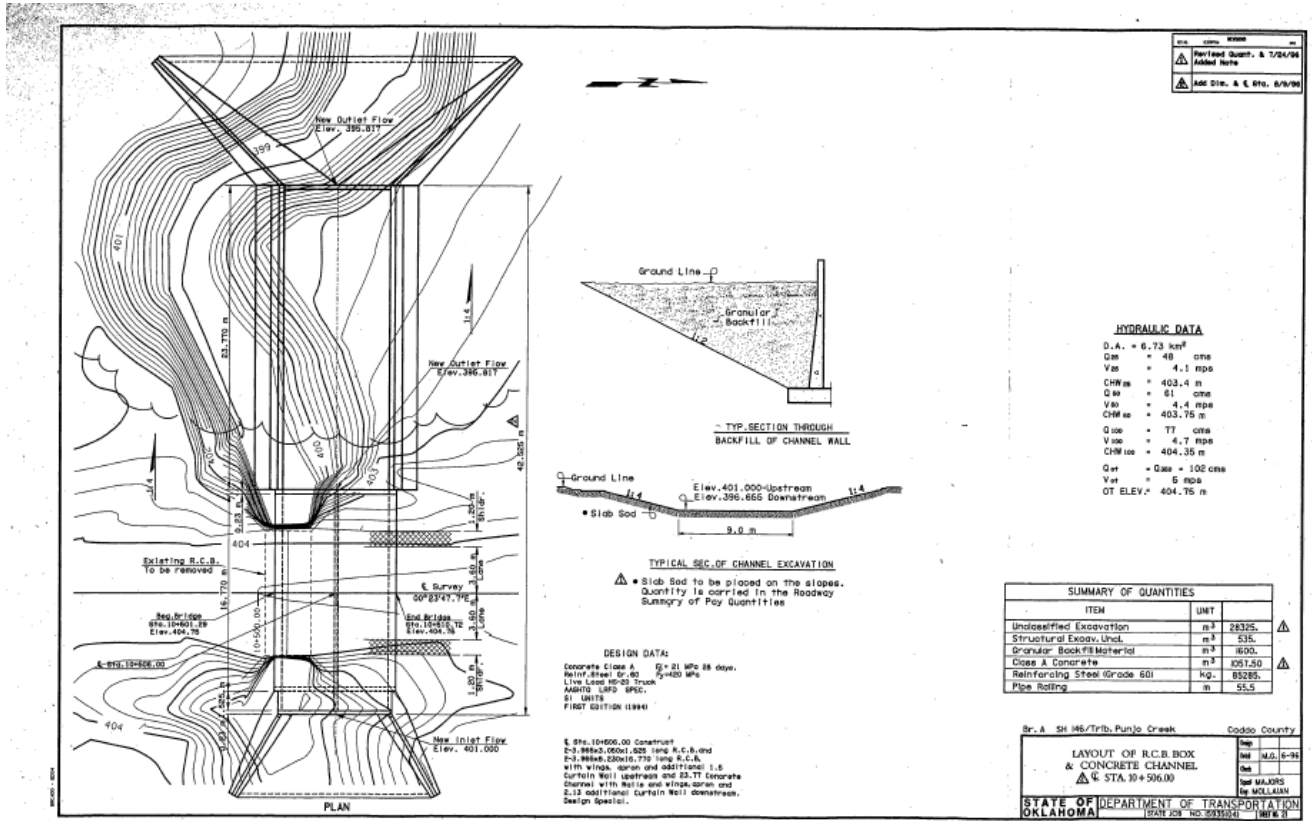
Problem Type: Degradation and Undermining

NBI #: 22082 Str #: 0651 0381 X Caddo County
 Facility Carried: S.H. 148
 Feature Int.: PUNJO CREEK
 24 September, 2011
 Looking W

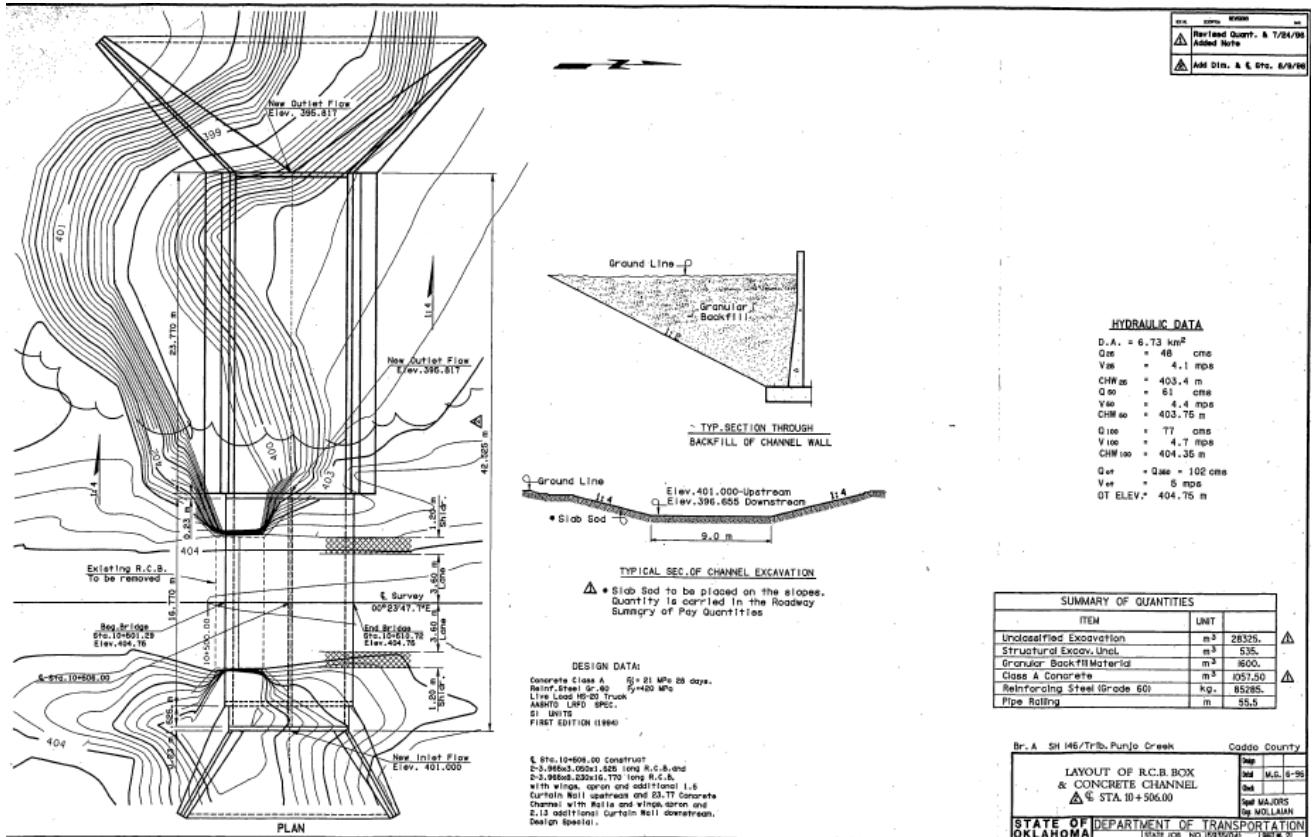
NBI# 25082
 STRUCTURE# 0851 0381 X
 CADDO COUNTY
 FACILITY CARRIED S.H. 146
 FEATURE INTERSECTED PUNJO CREEK TRIB.
 SEPTEMBER 23, 2008
 LOOKING EAST

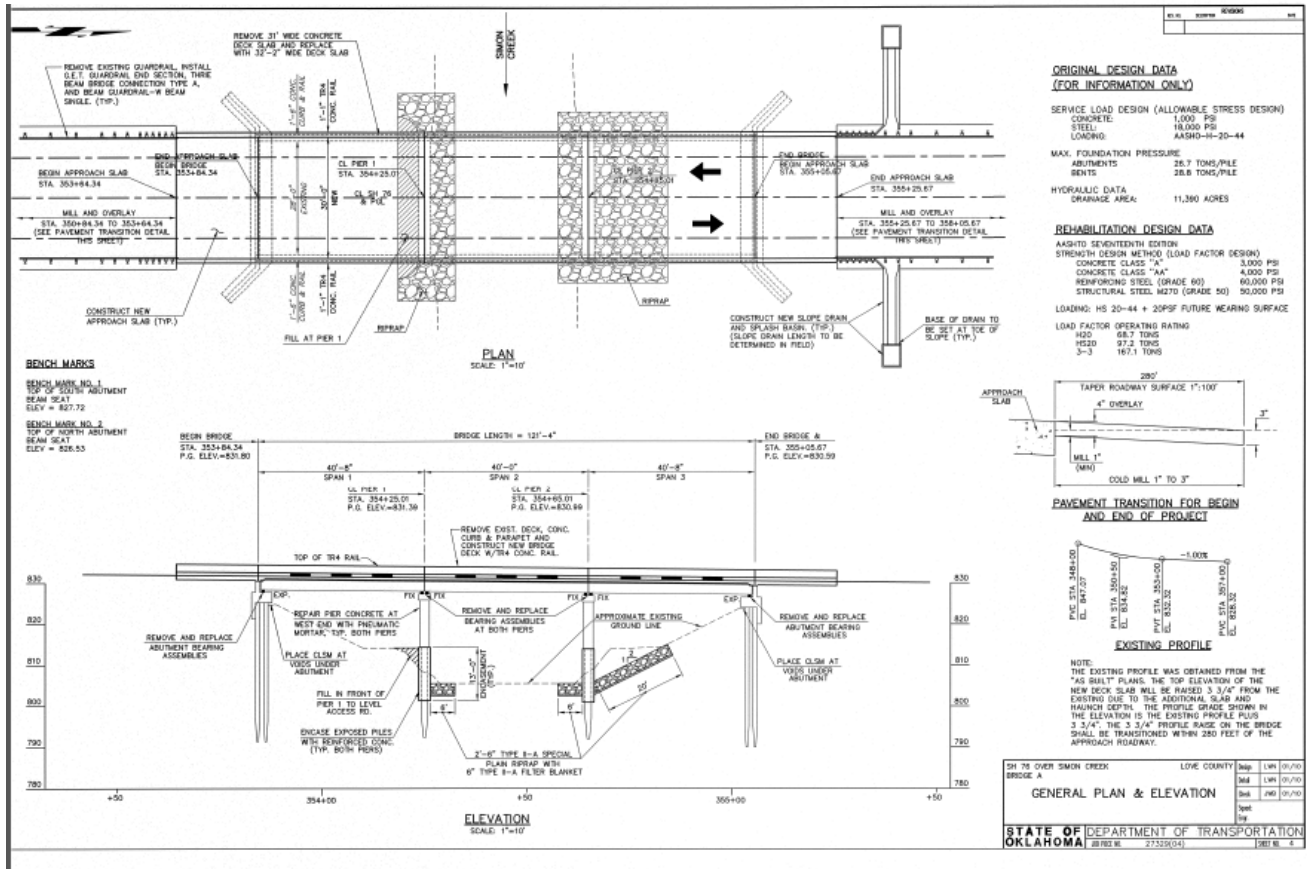
Love Co
 SH 76 over Simon Creek
 NB 1A114 structure # 76-43-16-0666
 Dec 2010

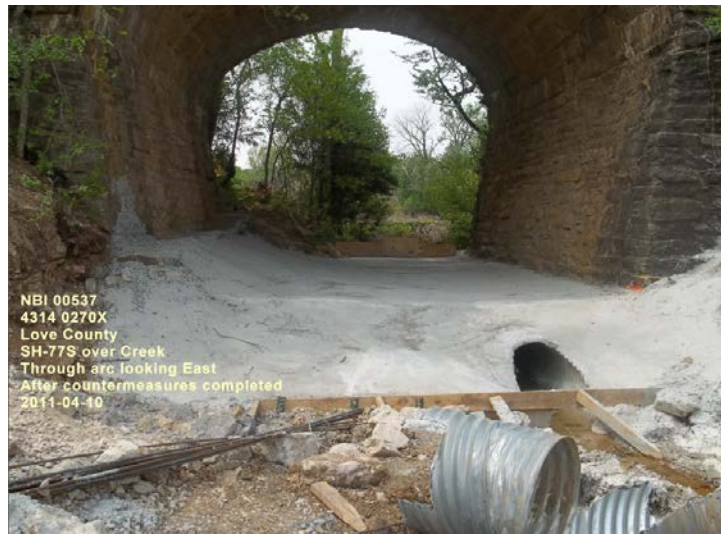
NBI# 00537
STR.# 4314 0270 X
LOVE CO.
S.H. 77 SCENIC @ CREEK
THRU ARCH FLOOR DAMAGE
LOOK - EAST
