OKLAHOMA Transportation TASK ORDER

REPAIR EVALUATIONS OF
DEPRESSED TRANSVERSE
CRACKS IN ASPHALT
PAVEMENTS IN DISTRICT 6

FINAL REPORT ~
ODOT TASK ORDER
2160-20-02

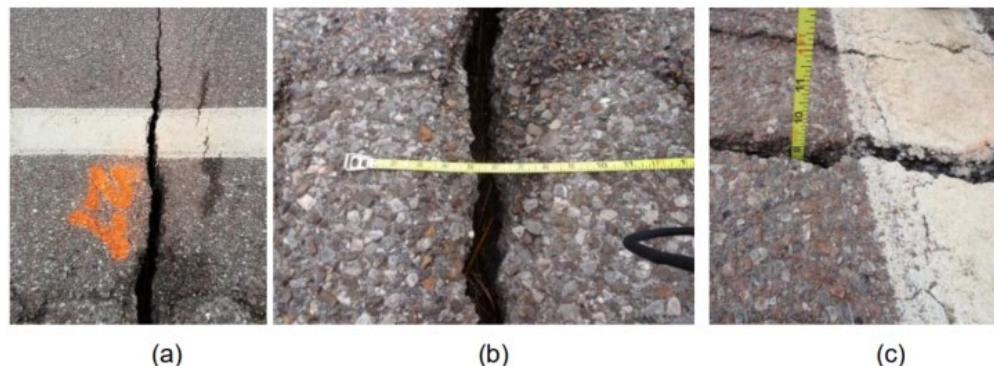
OVERVIEW Transverse cracking is one of the major problems in asphalt pavements in north-western (Panhandle) regions of Oklahoma. The eastbound lane and shoulder of US-270 in Harper County northwest of Woodward, Oklahoma has experienced significant transverse cracking (Figure 1). The extent and probable causes of the transverse cracking at US-270 were documented during Phase 1 of this forensic investigation (ODOT Task Order 2160-18-07). It was evident from the field and laboratory tests that the base supports were still structurally sound. The main issue resided with the cracks in the asphalt layer. The two most probable causes of the surface cracks, identified during Phase 1, were: (1) inability of the asphalt binder to resist low temperature cracking under extreme weather conditions including large thermal cycles with a rapid drop or rise in temperature; and/or (2) brittleness of the asphalt mixes due to aging. This Task Order (2160-20-02) was a follow-up study. It was aimed at evaluating the effectiveness of two transverse crack repair methods, namely (1) trenching and patching using Fibrecrete, and (2) trenching and patching using HMA.

Figure 1 Transverse cracks observed in US-270: (a) view from the top; (b) width of crack; and (c) depth of crack

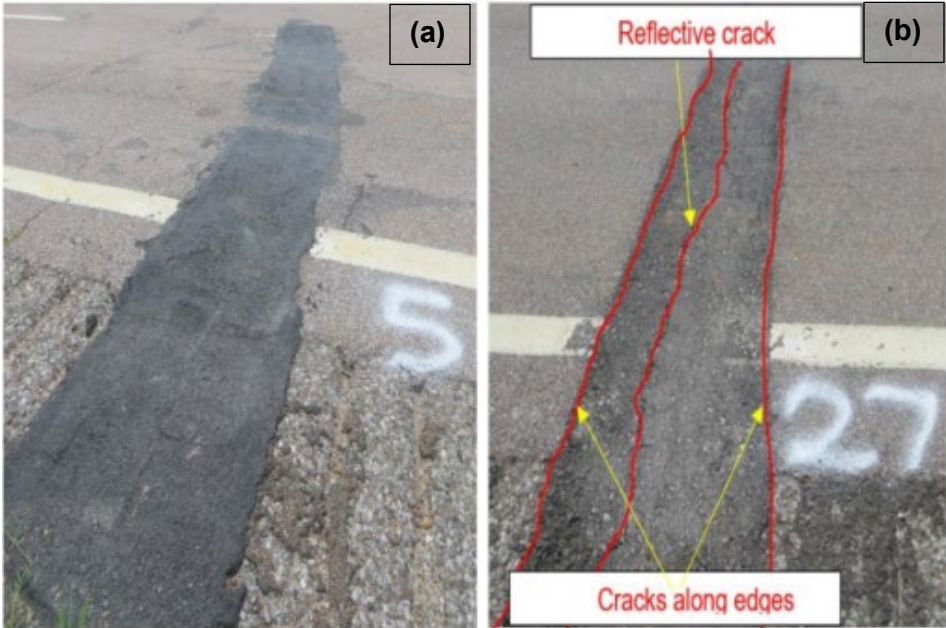
- The physical inspection and GPR results indicated that the propagation of the cracks was fully suppressed by the use of the Fibrecrete layer.
 - Repair with coarse HMA with no tack coat may not produce satisfactory results. Typically, the rate of propagation of reflective cracks in HMA layer is 1-in. per year. However, for the studied sections, reflective cracks were found to propagate 2-in. in one year through the HMA layer. Use of coarse HMA (S3) may be responsible for this faster propagation of cracks. Additional cracks may have occurred due to absence of tack coat (Figure 2).

- Figure 2 Photographs of (a) Fibrecrete-repaired and (b) HMA-repaired cracks during Evaluation #3
- From Face Dipstick and PaveVision3D/Pave 3D 8K evaluations, both HMA and Fibrecrete were found to exhibit increased rut depths after repair. This was due to the initial compaction of the HMA and Fibrecrete which happened in the early stage of opening to traffic. However, the IRI of the Fibrecrete- and HMA-repaired sections were found to be comparable.

- Based on the life cycle cost analysis results and the results from the three evaluations, Fibrecrete repair method was recommended when pavement performance degrades due to similar transverse cracking and rutting.
