PROJECT TITLE
I-35/SH-7 SUBSURFACE
INVESTIGATION

FINAL REPORT ~
ODOT TASK ORDER
2160-20-06

I-35/SH-7 SUBSURFACE INVESTIGATION

November 2022

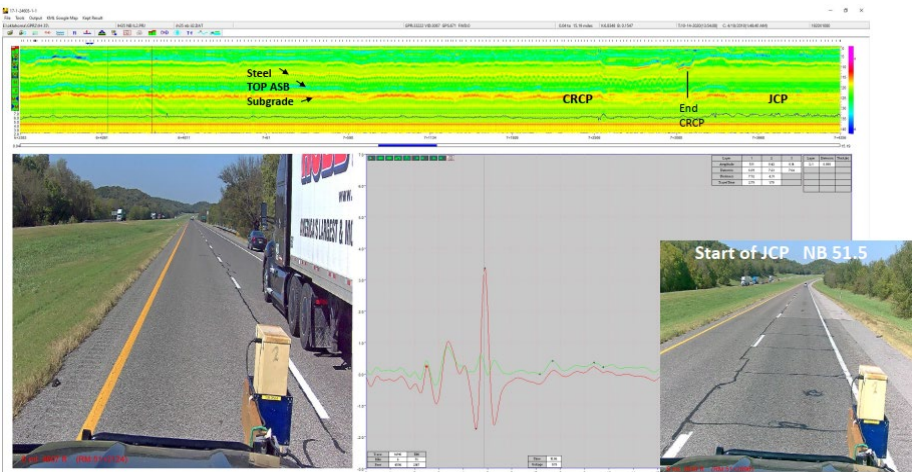
Figure 2 GPR and video images from north-bound I-35 section near Mile Post 51.5

- The GPR images showed two different types of pavements in the studied section of I-35, namely Jointed Concrete Pavement (JCP) and Continuously Reinforced Concrete Pavement (CRCP). The JCP section showed severe reflection cracking. Excessive truck loading and change in pavement section between shoulders and driving lanes are likely causes of edge failures.
