Oklahoma Dept. of Transportation - Bridge Inspection Report

| NBI No.: 17051 | Structure No.: 6822 0000 X | Local ID: -1 | Suff. Rating: 82.90 | ND |

| NBI # | Structure # | County | Fac. Carried | Fac. Intersected | Insp. Date |
|---|---|---|---|---|---|
| 17051 | 6822 0000 X | Sequoyah | I-40 | ARKANSAS RIVER | 7/19/2024 |

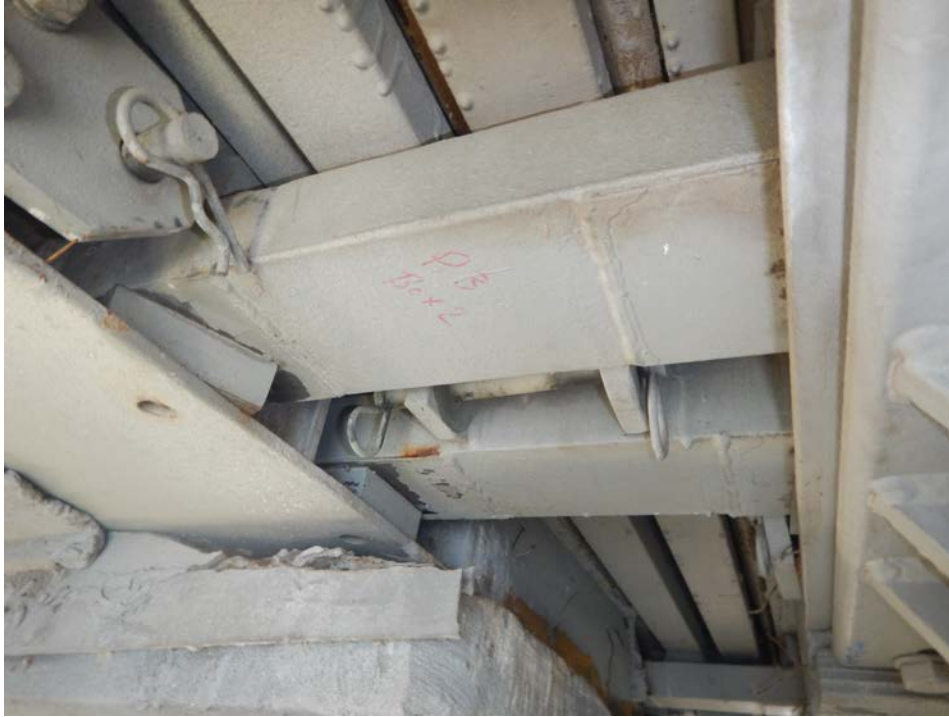
| NBI No.: | | Structure No.: | | Local ID: | | Suff. Rating: | | ND | | | | |
|--|---|---|---|---|---|---|---|---|---|---|---|--|
| PX – Modular joints have fractured or missing components, joint seals bulging/torn, joints closed: Joint 3 Box 2 – W box unsupported. Box 3 – Both box bottom plates fractured and missing under W end of support bar 1. Bearing blocks dislodged. Support bar 2 partially unsupported. Box 4 – Both box bottom plates fractured. Boxes 5 and 6 – E bearing block for support bar 1 missing. Box 7 – W box bottom plate fractured under support bar 1. Box 8 – W box supported by 6 3/4in over 22 1/4in length. Box 15 – W box bottom plate fractured under support bar 1. Composite reinforcing above beam 10 exposed and box unsupported. Box 16 – W box bottom plate fractured away, support bar 1 unsupported. E box bottom plate fractured. Box 17 – W box not fully supported. Joint 6 – equidistant bars broken/dislodged/missing, transverse separation beam sagging. Box 2 – Transverse separation beam and repair plate fractured, sagging 1in. Longitudinal support bar broken free from transverse beam, dislodged. Box 3 – Longitudinal support bar broken free from transverse beam, dislodged. Joint 10 – equidistant bars broken/dislodged/missing. Box 3 – Longitudinal support bar broken free from transverse beam, dislodged. | | | | | | | | | | | | |

Photograph 3 - Looking northwest at the underside of the pier 3 modular joint at support box 2. Note: bottom plate of the support box is unsupported along the end of span 3. Equidistant spring between support bars is missing (typical).

- Patch spalls in driving surface.
- Repair cracks in bearing boxes at modular joint supports at pier 3. Also, install shim plates or additional support below bearing blocks to prevent future cracking.

- Replace modular joints at pier 3, 6 and 10.
- Replace pourable joint seals at west abutments and fixed joints and deck control joints.
- Replace strip seal expansion joint at east abutment.

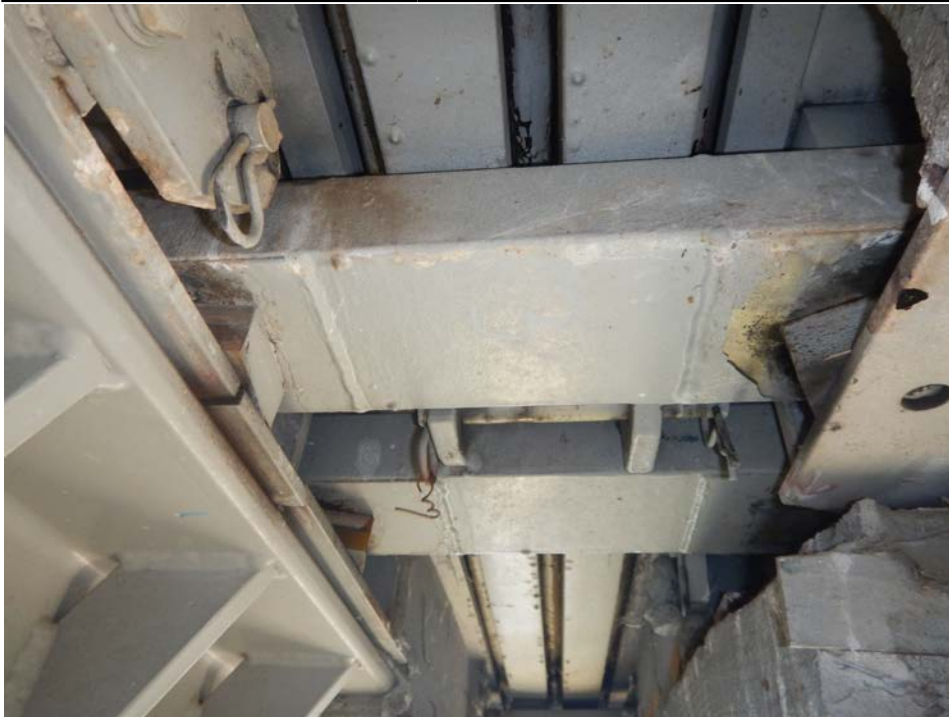
Photograph 4 - Looking south at the underside of the pier 3 modular joint at support box 3. Note: bottom plate of support box has fractured and west end of support bar 1 is unsupported. Bearing block for support bar 2 is dislodged. Stainless steel sliding surface is painted.

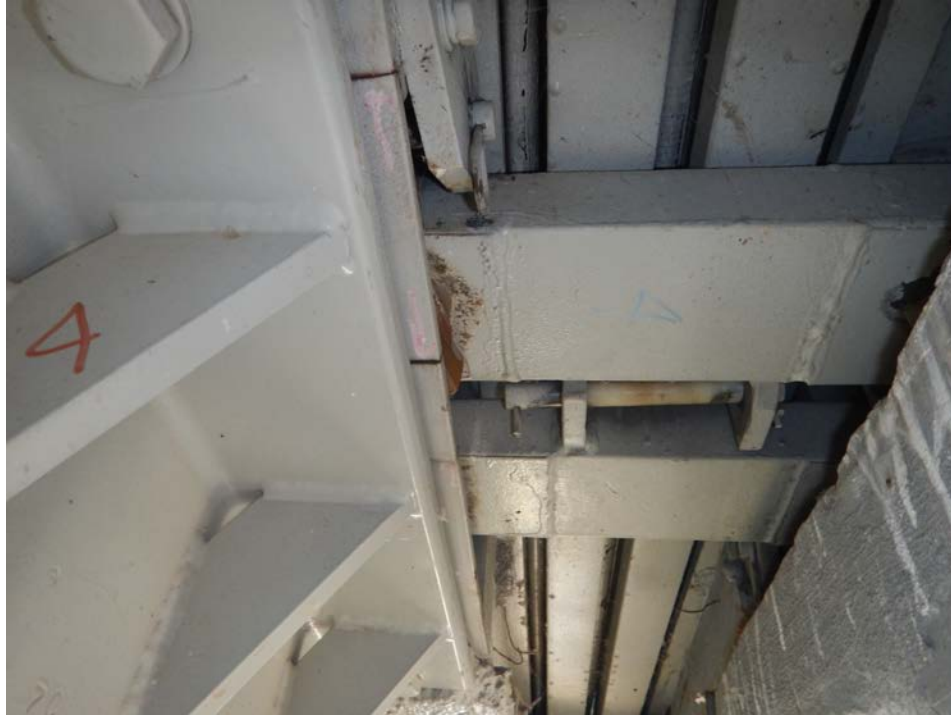
Photograph 5 - Looking south at the underside of the pier 3 modular joint at support box 4. Note: the bottom plate of support box has fractured and support bar 2 is unsupported.

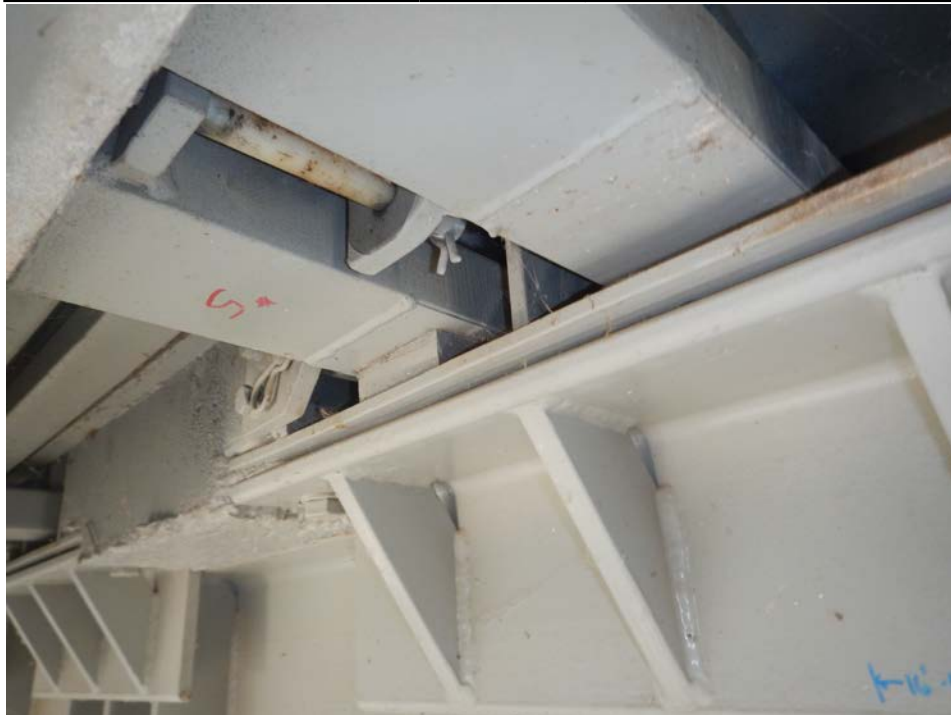
Photograph 6 - Looking east at the underside of the pier 3 modular joint at support box 5. Note: bearing block for support bar 1 is missing at the east support box. Stainless steel sliding surface is painted (typical).

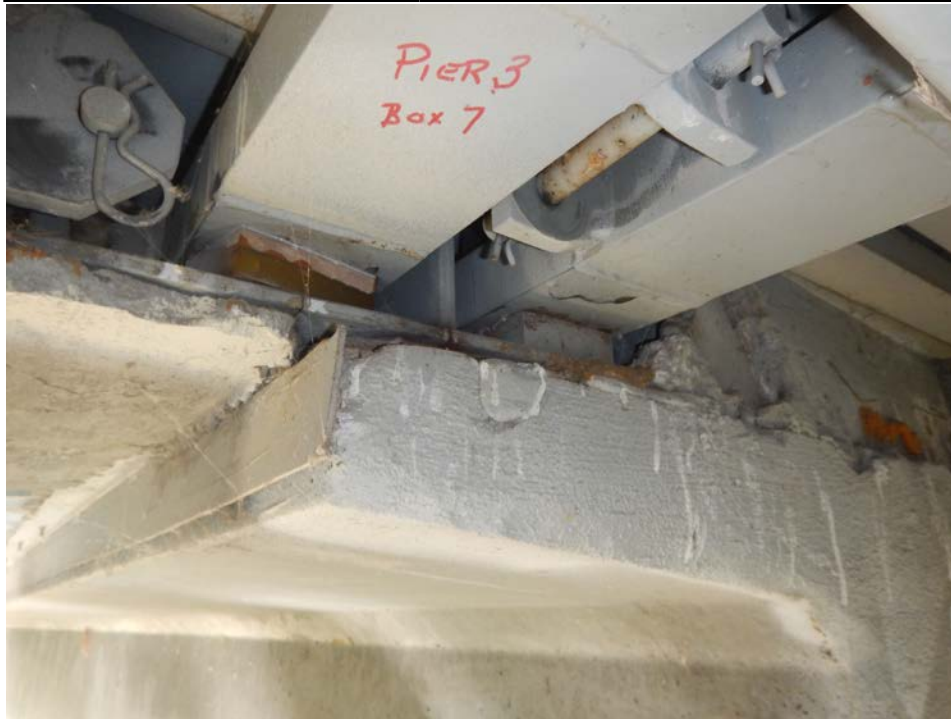
Photograph 7 - Looking west at the underside of the pier 3 modular joint at support box 7. Note: bottom plate of bearing support box is fractured adjacent to vertical plate.

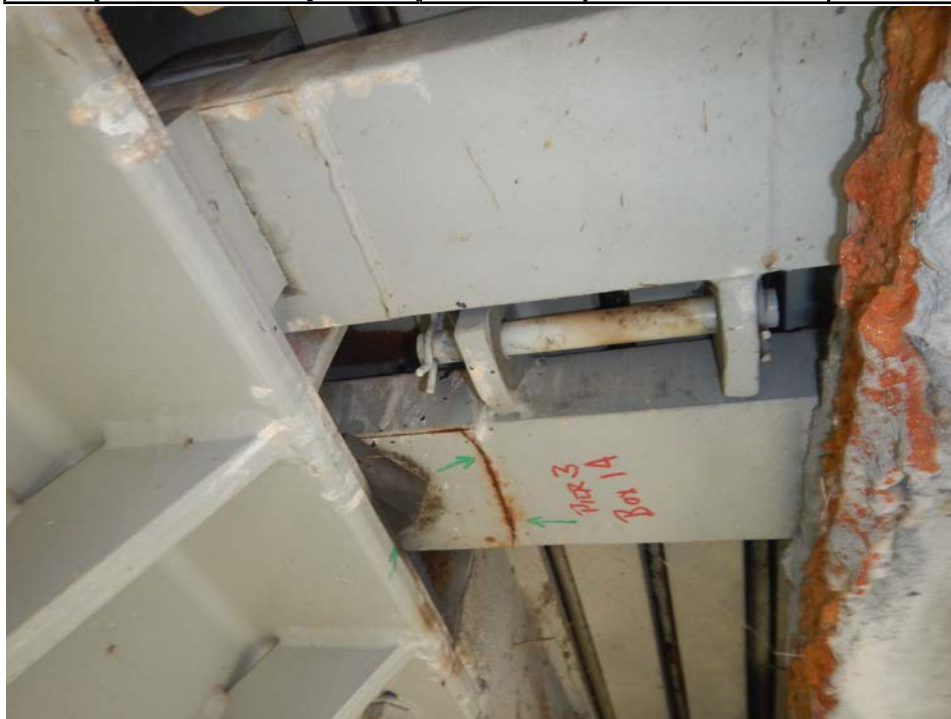
Photograph 8 - Looking south at the underside of the pier 3 modular joint at support box 14. Note: stainless steel plate welded to support bar 1 at the east bearing box has fractured near the west weld.

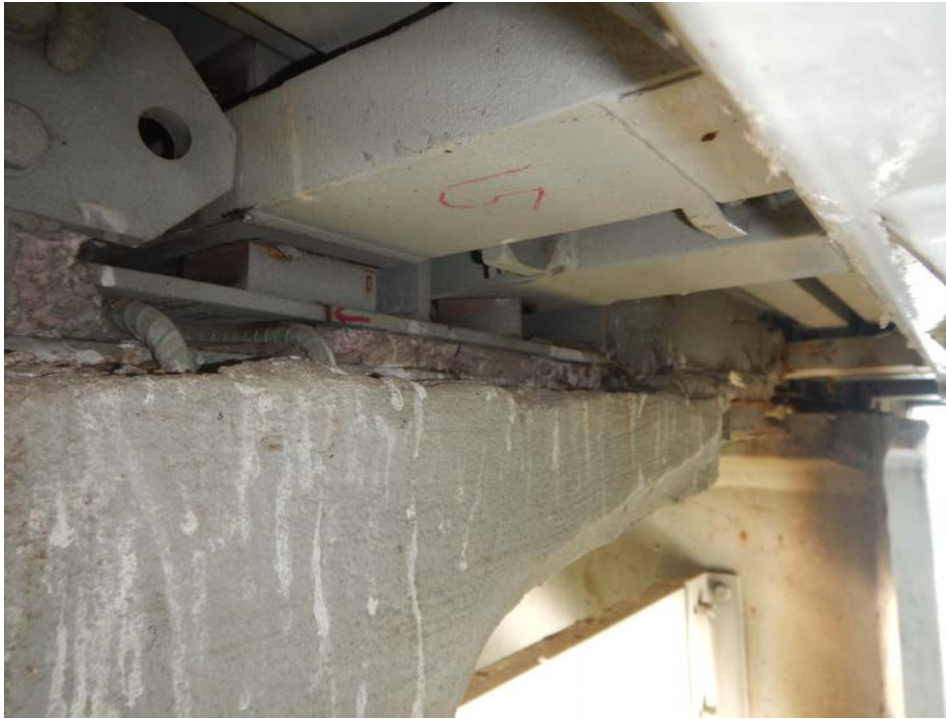
Photograph 9 - Looking west at the underside of the pier 3 modular joint at support box 15. Note: bottom plate of the west support box is fractured beneath the bearing block for support bar 1. Composite reinforcing extending up from beam 10 is exposed with no concrete under support box.

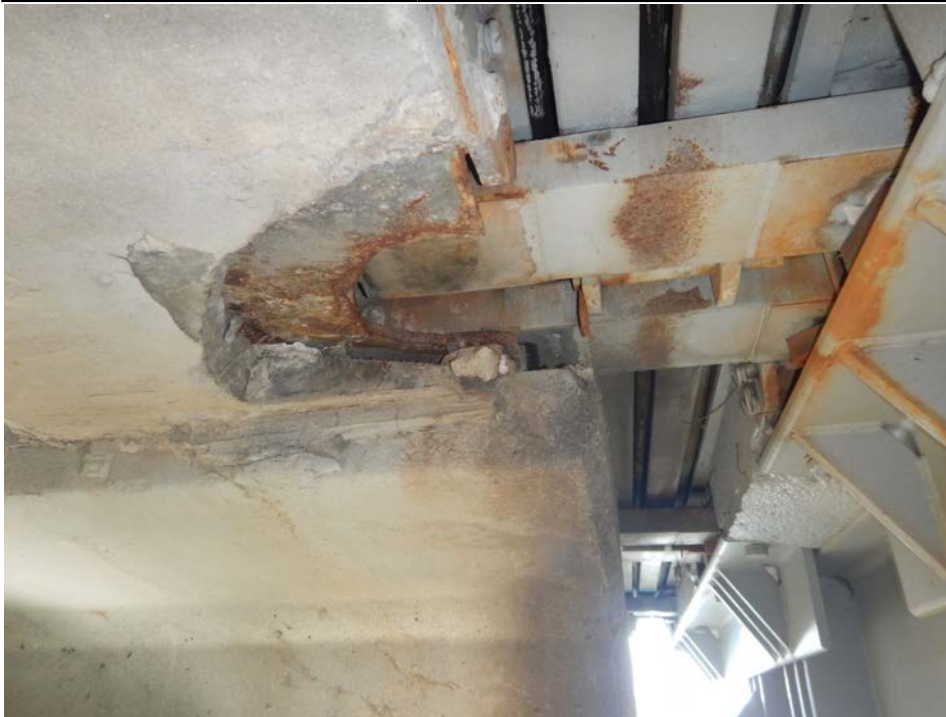
Photograph 10 - Looking north at the underside of the pier 3 modular joint at support box 16. Note: bottom plate of the west support box has fractured away and the west end of support bar 1 is unsupported.

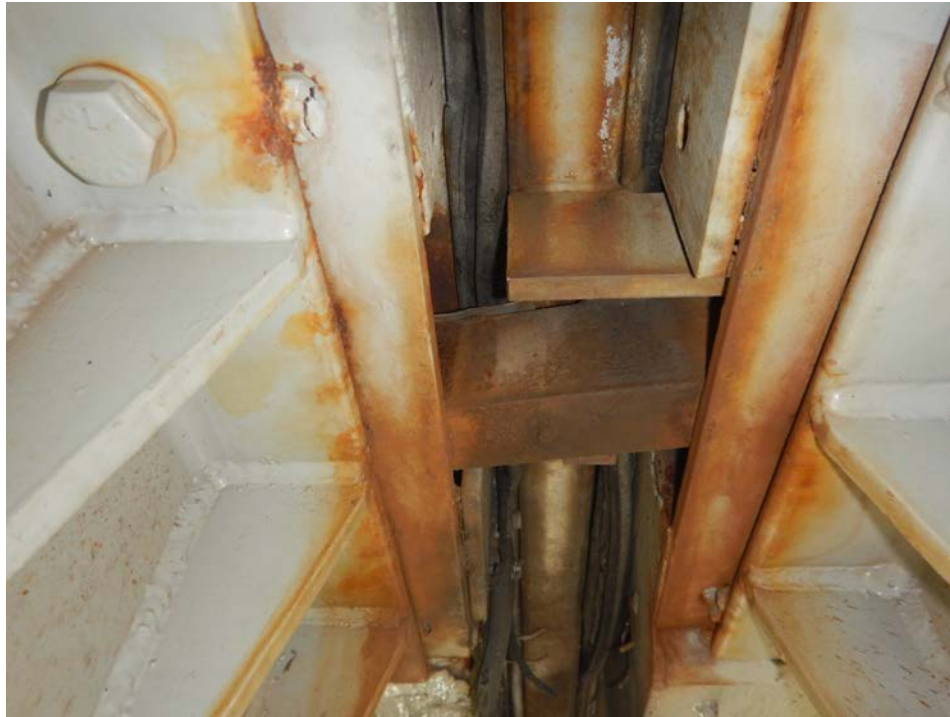
Photograph 11 - Looking south at the underside of the pier 6 modular joint at support box 3. Note: support bar has broken away from the transverse separation beam.

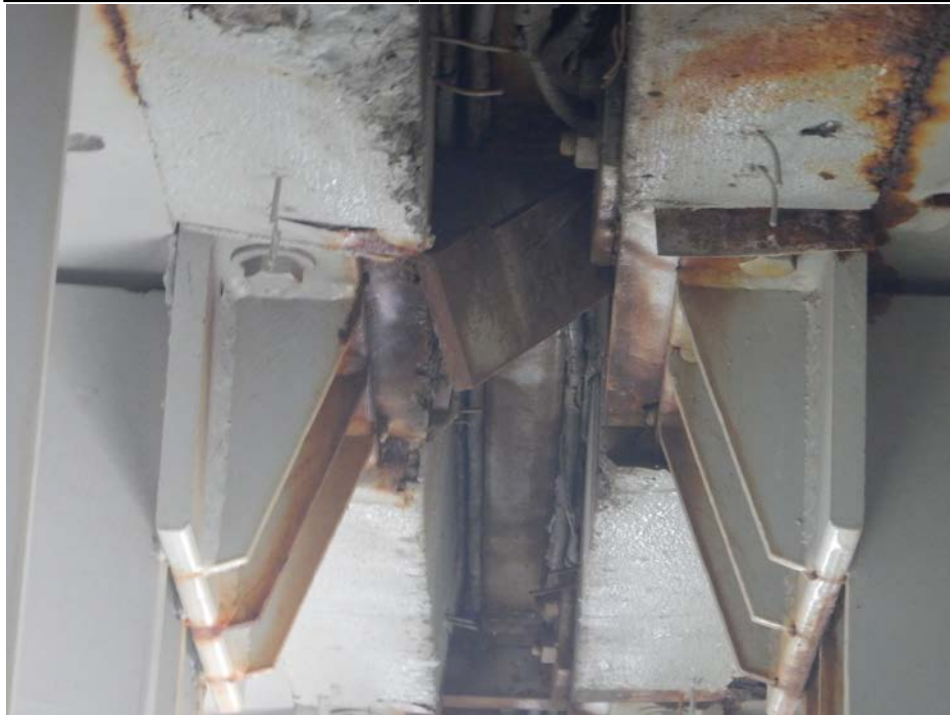
Photograph 12 - Looking north at the underside of the pier 6 modular joint at support box 10. Note: support bar has broken away from the transverse separation beam.

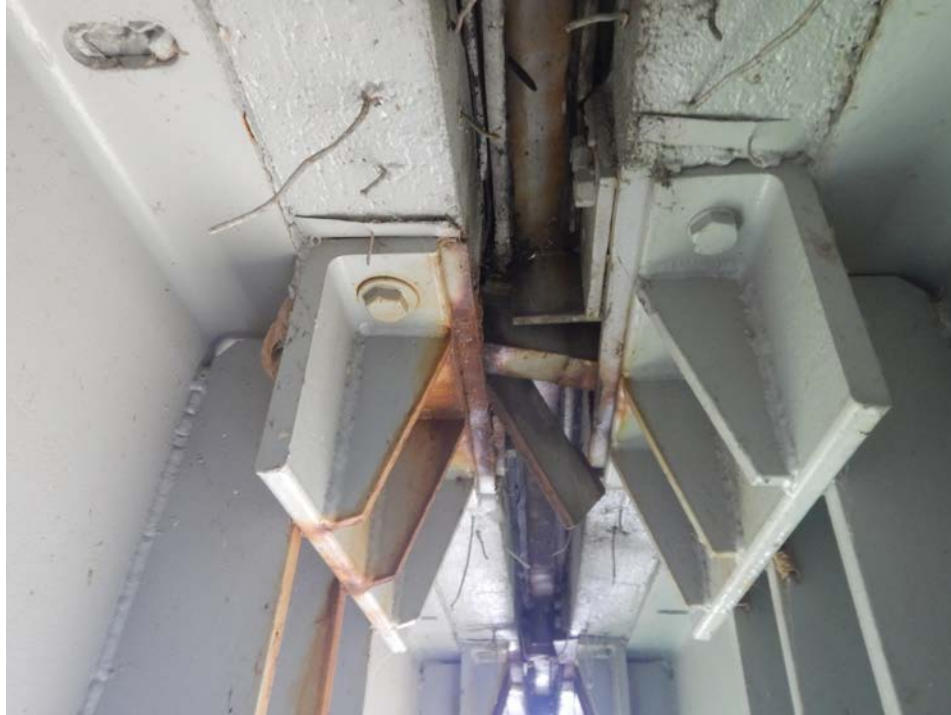
Photograph 13 - Looking south at the underside of the pier 10 modular joint at support box 4. Note: support beam is no longer attached to the transverse support beam and has slid east. South equidistant bar has broken and is wedged in place.

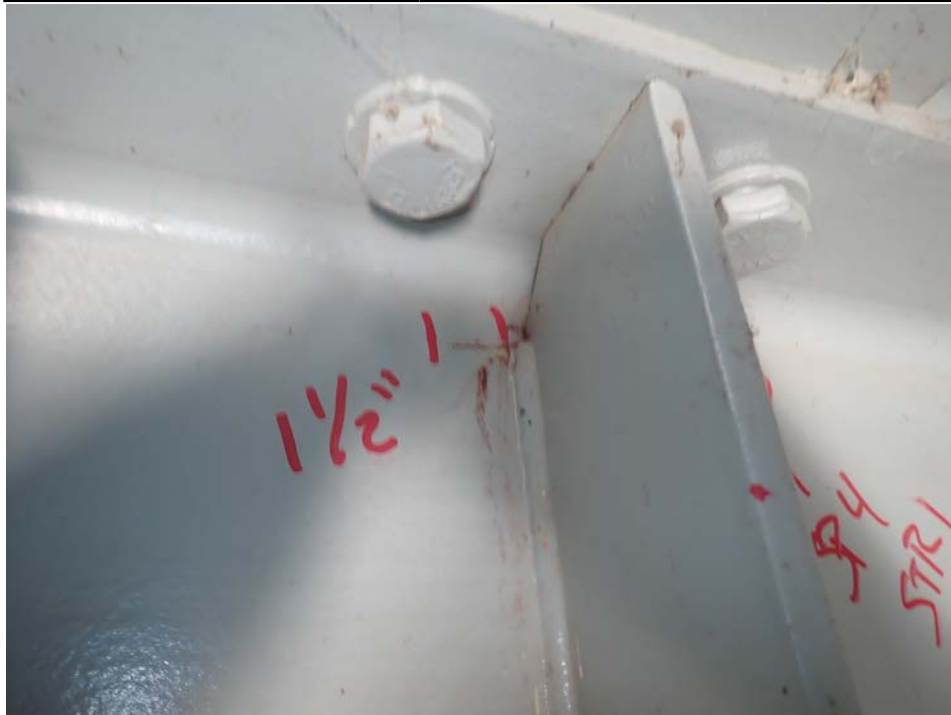
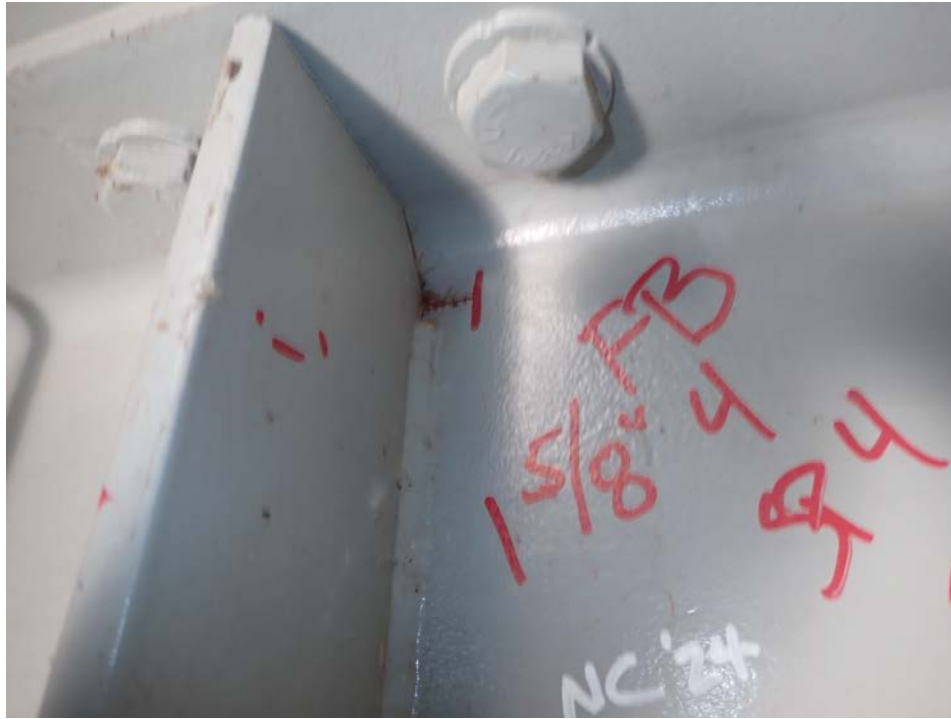
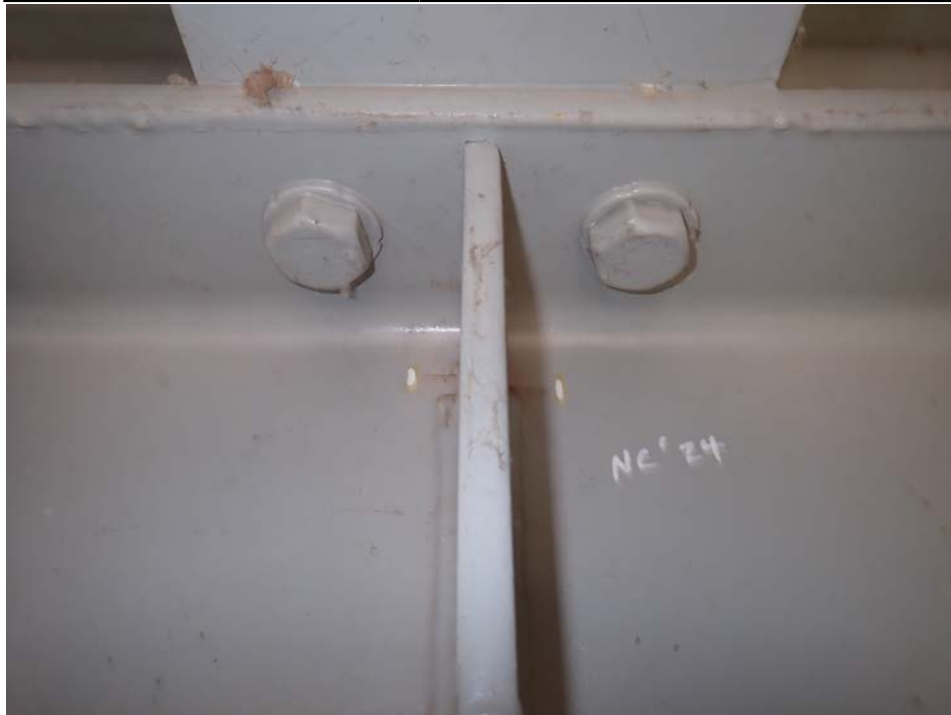
| NBI No.: | | Structure No.: | | Local ID: | | Suff. Rating: | | ND | | | | |
|--|---|---|---|---|---|---|---|---|---|---|---|--|
| PX – Span 4 FB 4 has cracks in web at top of vertical stiffener below stringer 1 (1 5/8in and 1 1/2in) and below stringer 3 (2 3/8in) Member Alignment – Span 6 FB 4 has 1/4in sweep between girders 1 and 2. Span 6 FB 2 between G3 and G4 has 11/16in local kink in lower strut. Span 9 FB 0 at G4 has slight bow in lower gusset plate. Painted over pack rust between FB components below deck control and expansion joints. Loose bolts or oversized bolt holes at FB to girder connections at span 5 FB 8 G3, span 7 FB 3 G2, span 9 FB4 G2, span 11 FB 3 at G2 and Span 12 FB 2 at G2. | | | | | | | | | | | | |

Photograph 14 - Looking northwest at span 4, floor beam 4, stringer 1. Note: no change to 1 1/2-inch-long horizontal crack.

Photograph 15 - Looking southwest at span 4, floor beam 4, stringer 1. Note: no change to 1 5/8-inch-long horizontal crack.

Photograph 16 - Looking east at span 4, floor beam 4, stringer 1. Note: cracks have now daylighted through to west face of web.

- Replace missing or loose bolts at stringer connections.
- Arrest ends of cracks at:
 - o Floor beam 4, span 4 under stringer 1.
 - o Floor beam 4, span 4 under stringer 3.

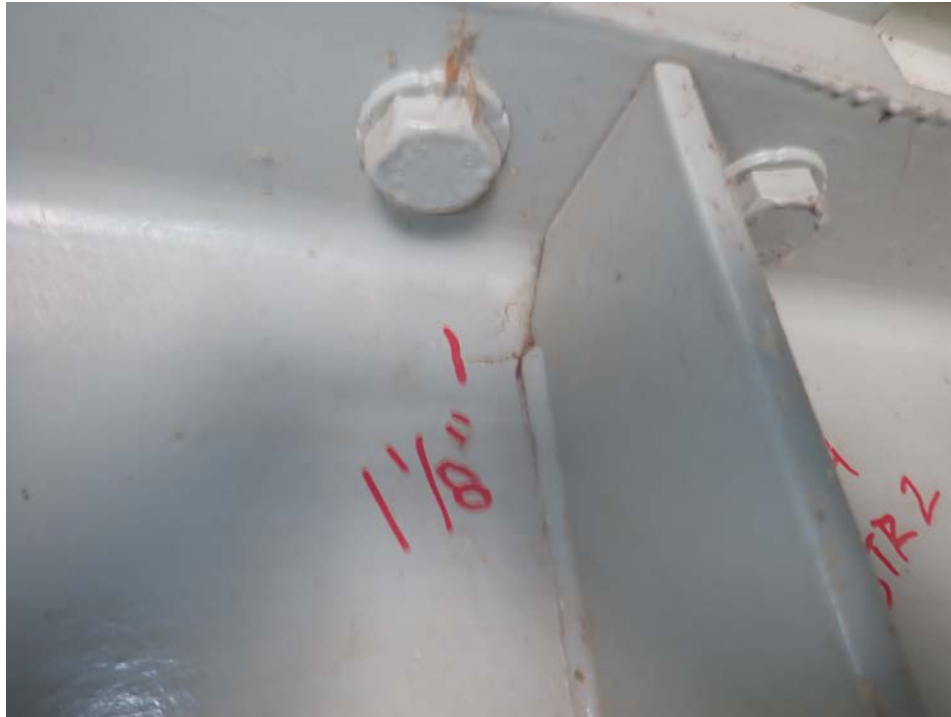
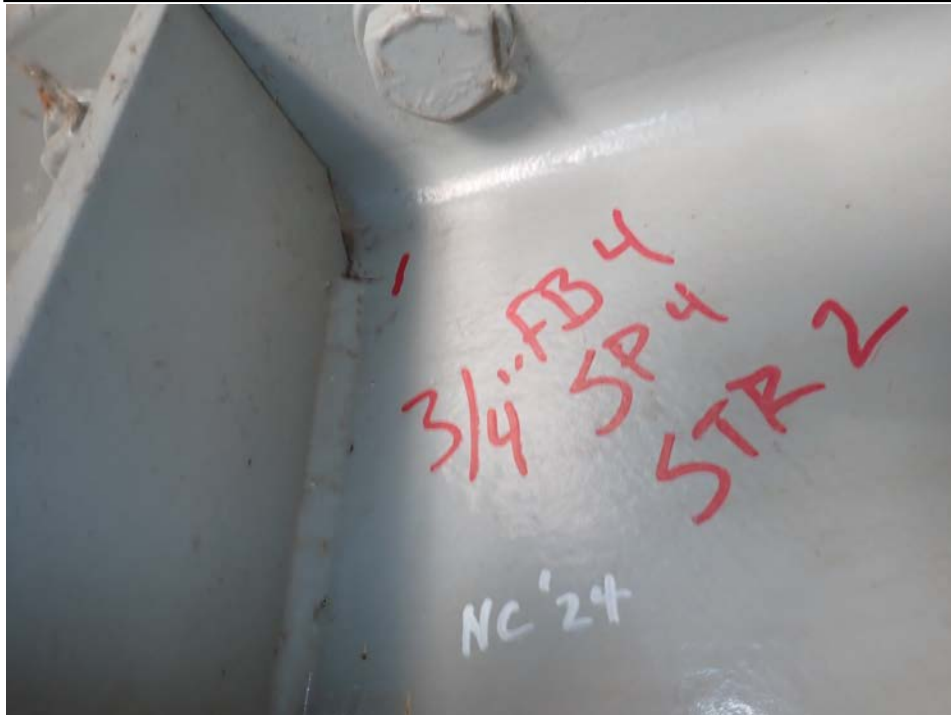
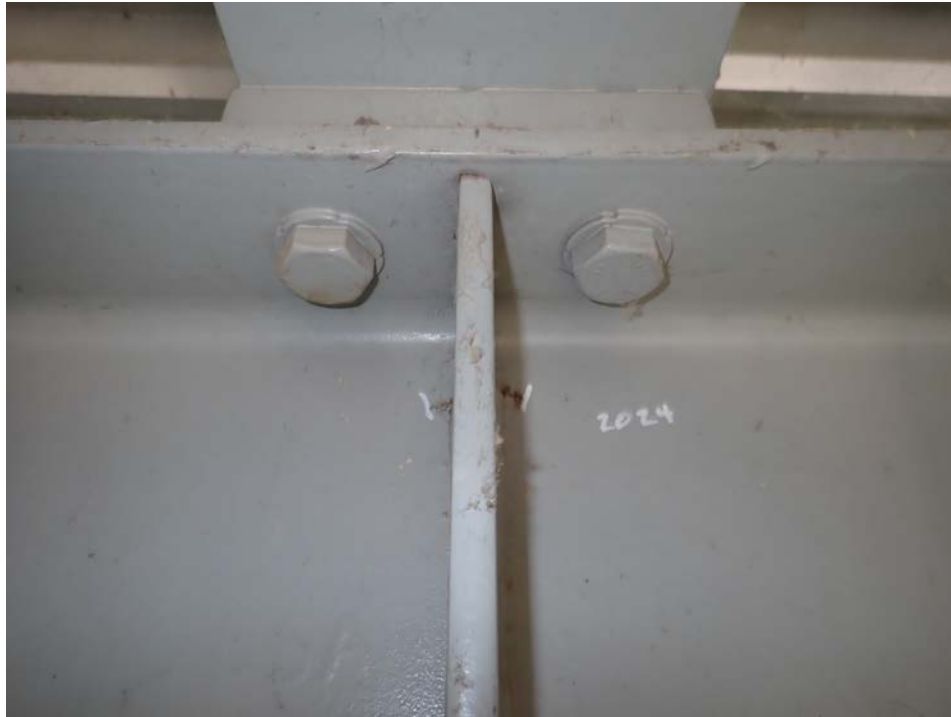
Photograph 17 - Looking northwest at span 4, floor beam 4, stringer 2. Note: no change to 1 1/8-inch-long horizontal crack.

Photograph 18 - Looking southwest at span 4, floor beam 4, stringer 2. Note: no change to 3/4-inch-long horizontal crack.

Photograph 19 - Looking east at span 4, floor beam 4, stringer 2. Note: cracks have now daylighted through to west face of web.

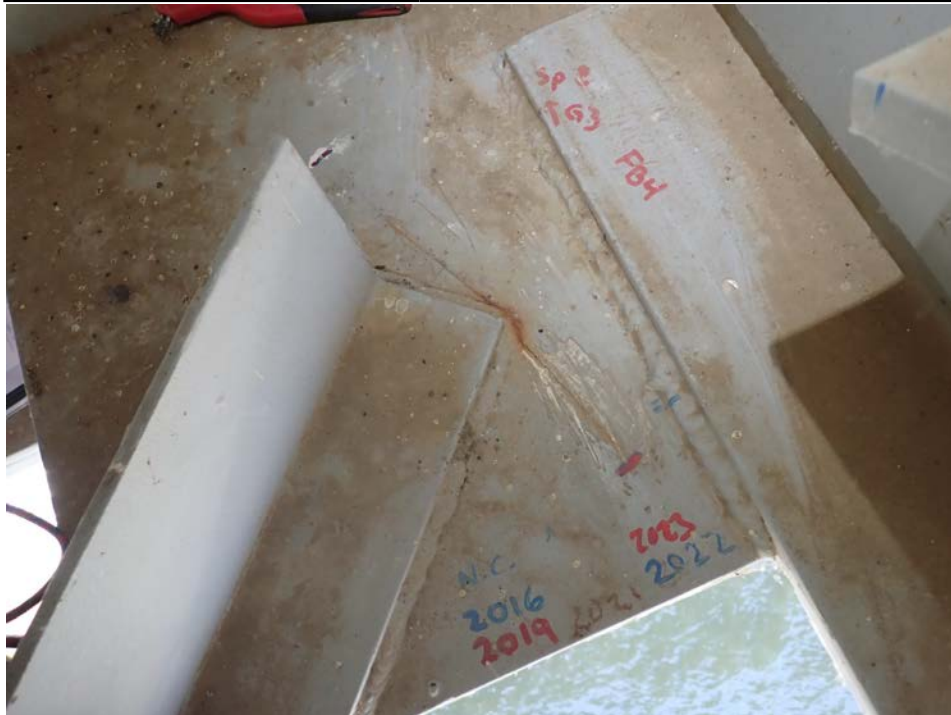
- Cracks in lateral bracing gusset plates:
 - o Span 8, girder 3 at floor beam 4 (8 1/2-inch-long crack in gusset plate).
 - o Span 10, girder 2 at floor beam 2 (18-inch-long crack in gusset plate weld).

Photograph 20 - Looking southwest at span 8, girder 3 at floor beam 4. Note: no change to 8 1/2-inch-long crack in gusset plate.

- o Stringer diaphragm over floor beam 5, span 6, between stringers 3 and 4.
- Repair cracks in lateral bracing gusset plates:
 - o Span 8, girder 3 at floor beam 4 – 8 1/2-inch-long crack in gusset plate.

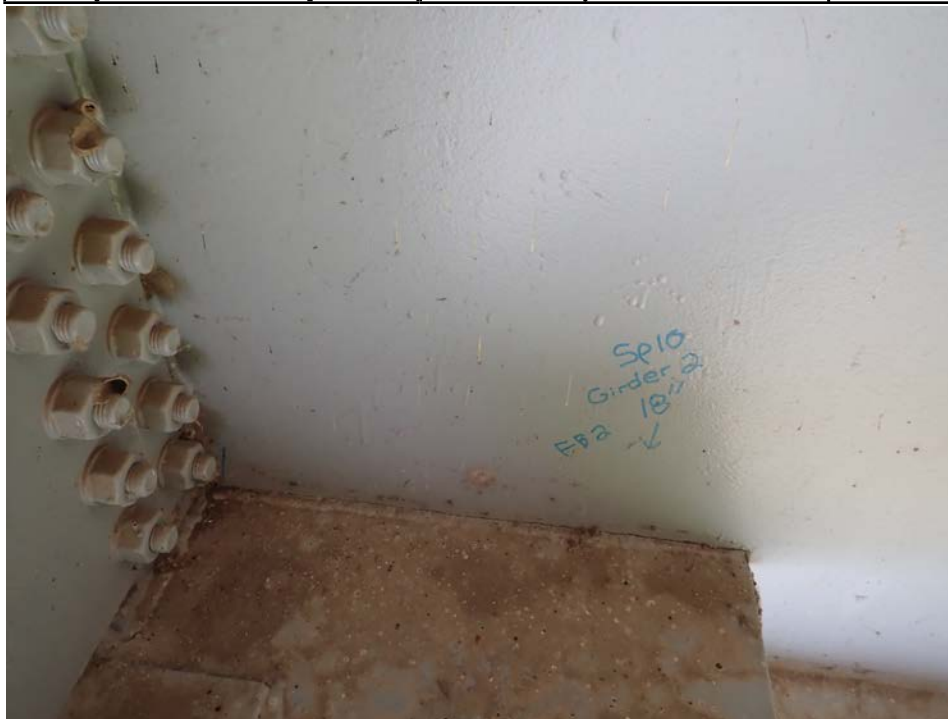
Photograph 21 - Looking north at span 10, girder 2 at floor beam 2. Note: no change to 18-inch-long crack in gusset plate weld.

- o Span 10, girder 2 at floor beam 2 – 18-inch-long crack in gusset plate weld.
 - o Span 11, girder 2 at floor beam 1 – 8-inch-long and 6-inch-long cracks in gusset plate weld.

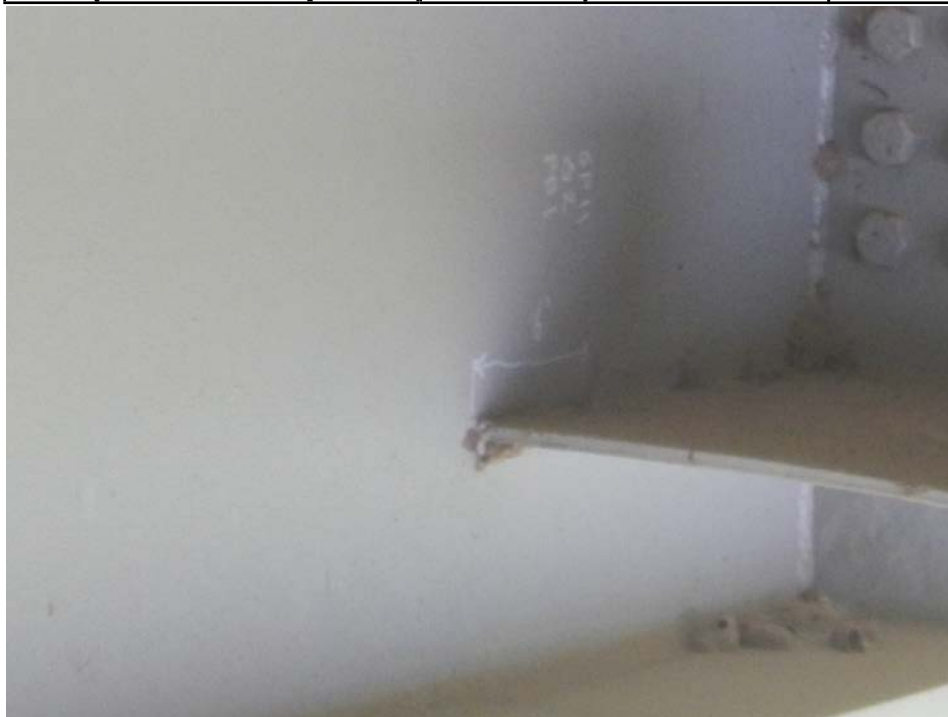
- o Span 11, girder 2 at floor beam 1 (8-inch-long and 6-inch-long cracks in gusset plate weld).
- Horizontal web splice terminations in spans 4 near floor beam 5, span 5 near floor beams 3 and 11, and span 6 near floor beam 3. Cracks or cored hole noted at:

Photograph 22 - Looking east at span 11, girder 2 at floor beam 1. Note: no change to 6-inch-long crack at the lower lateral bracing gusset plate.

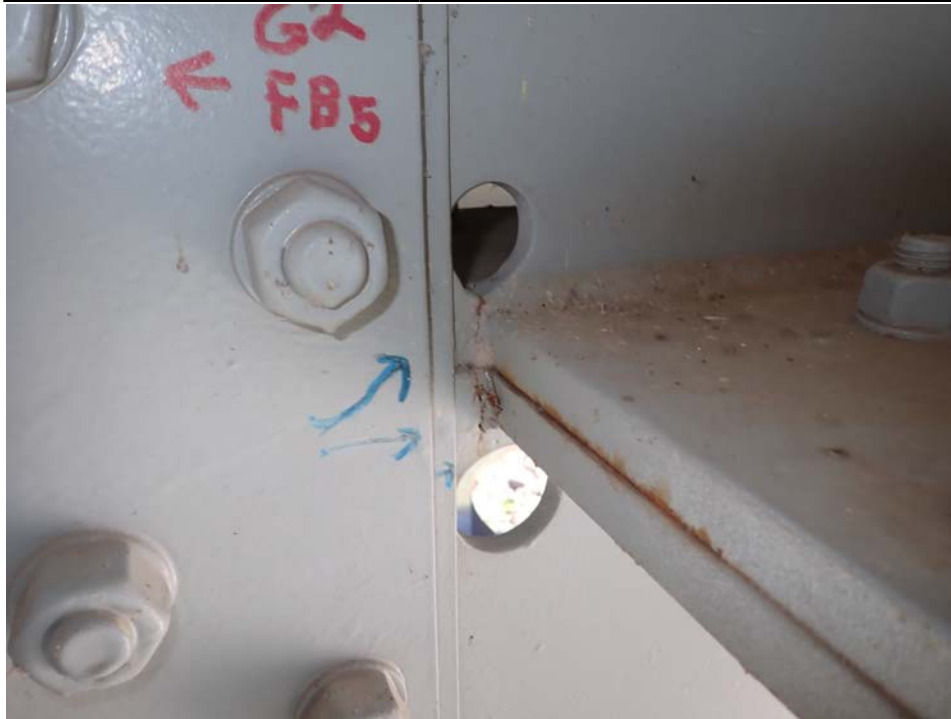
- o Span 4, girder 2, near floor beam 5 (1-inch-long crack arrested by cored hole, 1 1/2-inch-long crack arrested by cored hole).
 - o Span 4, girder 4, near floor beam 5 (7/16-inch-long crack arrested by a cored hole).

Photograph 23 - Looking northeast at span 4, girder 2, near floor beam 5 at end of longitudinal bolted web splice. Note: no change to upper web 1-inch-long crack or 1 1/2-inch-long crack.

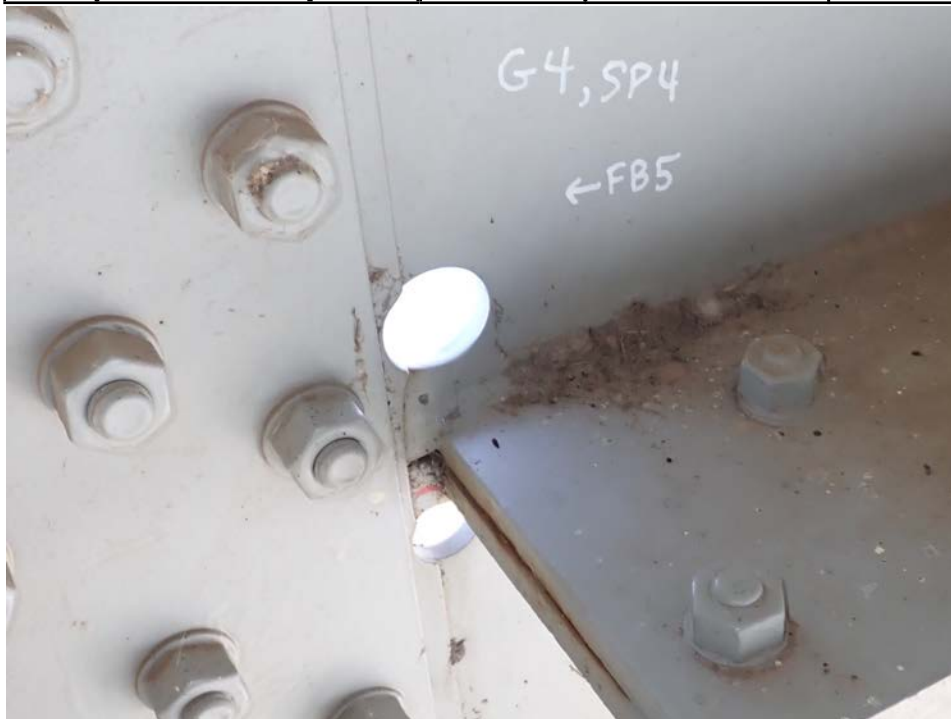
Photograph 24 - Looking northeast at span 4, girder 4, near floor beam 5. Note: no change to 7/16-inch-long crack. No crack apparent in upper web, preventative arrestor hole drilled.

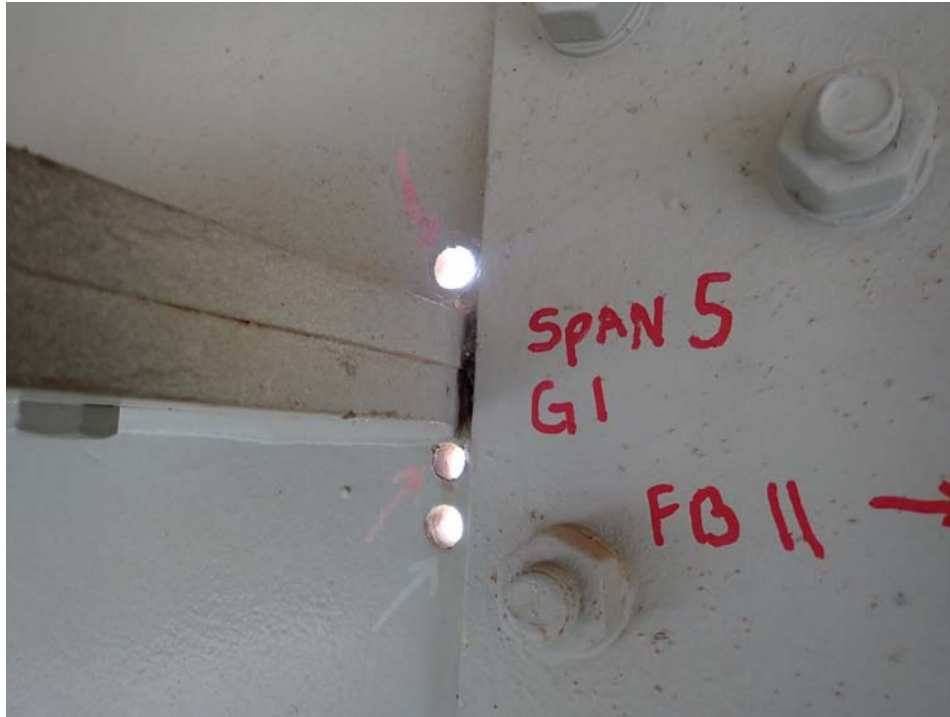
- o Span 5, girder 1, near floor beam 11 (3/4-inch-long crack stopping short of cored hole, 1 1/4-inch-long crack arrested by two cored holes).
 - o Span 5, girder 2, near floor beam 11 (2-inch-long crack arrested by a cored hole).

Photograph 25 - Looking south at span 5, girder 1, near floor beam 11. Note: no change to 3/4-inch-long crack or 1 1/4-inch-long crack.

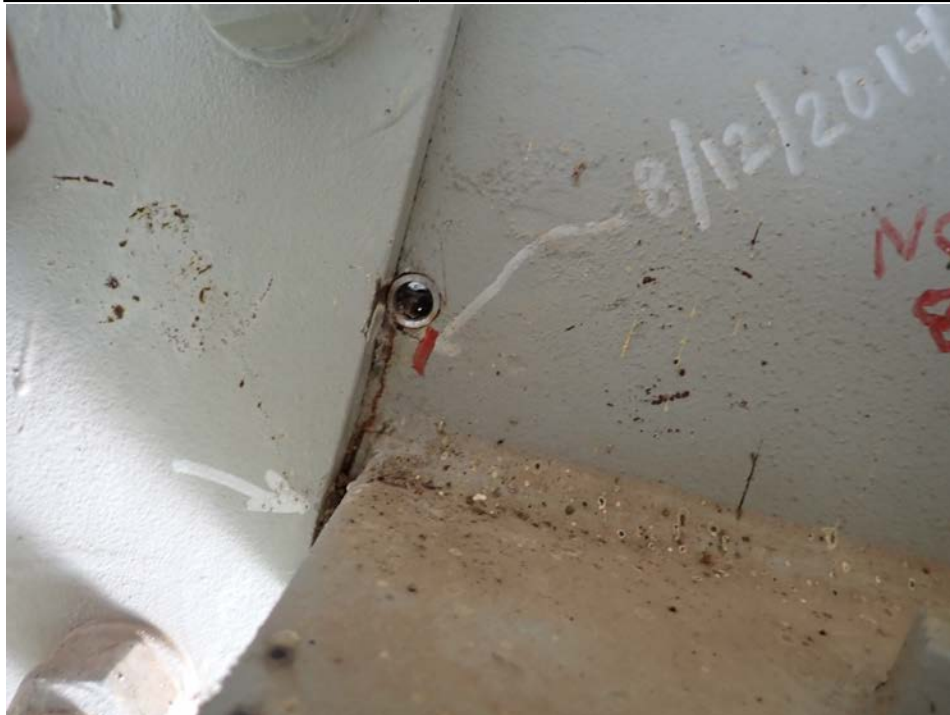
Photograph 26 - Looking north at span 5, girder 2, near floor beam 11. Note: no change to 2-inch-long crack.

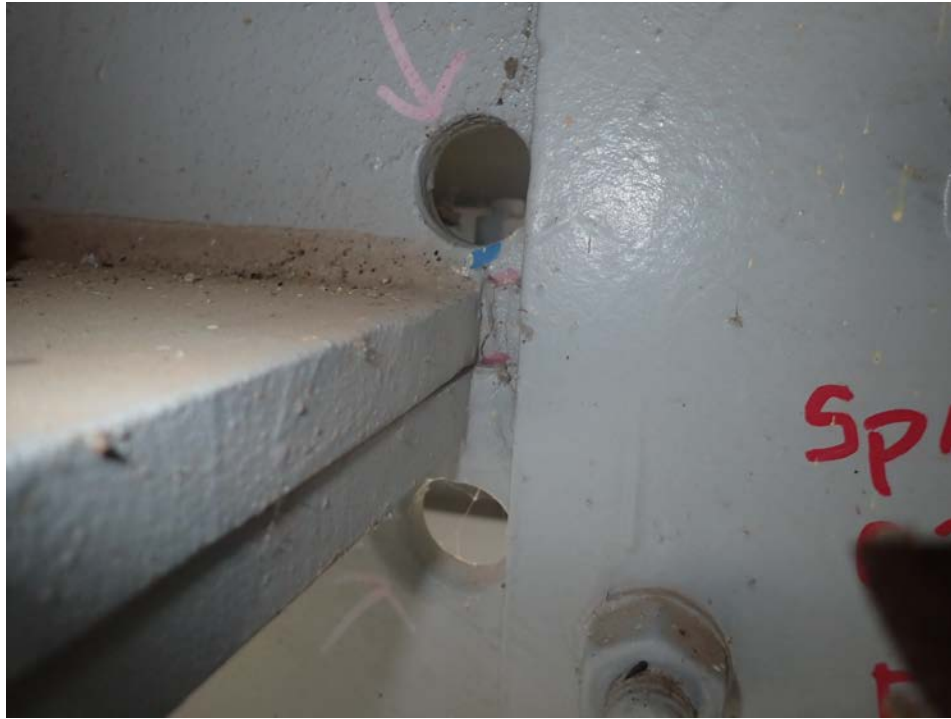
- o Span 5, girder 3, near floor beam 11 (7/8-inch-long crack stopping short of cored hole).
 - o Span 5, girder 4, near floor beam 3 (1 1/8-inch-long crack arrested by a cored hole, 1-inch-long crack arrested by a cored hole).

Photograph 27 - Looking south at span 5, girder 3, near floor beam 11. Note: no change to 7/8-inch-long crack.

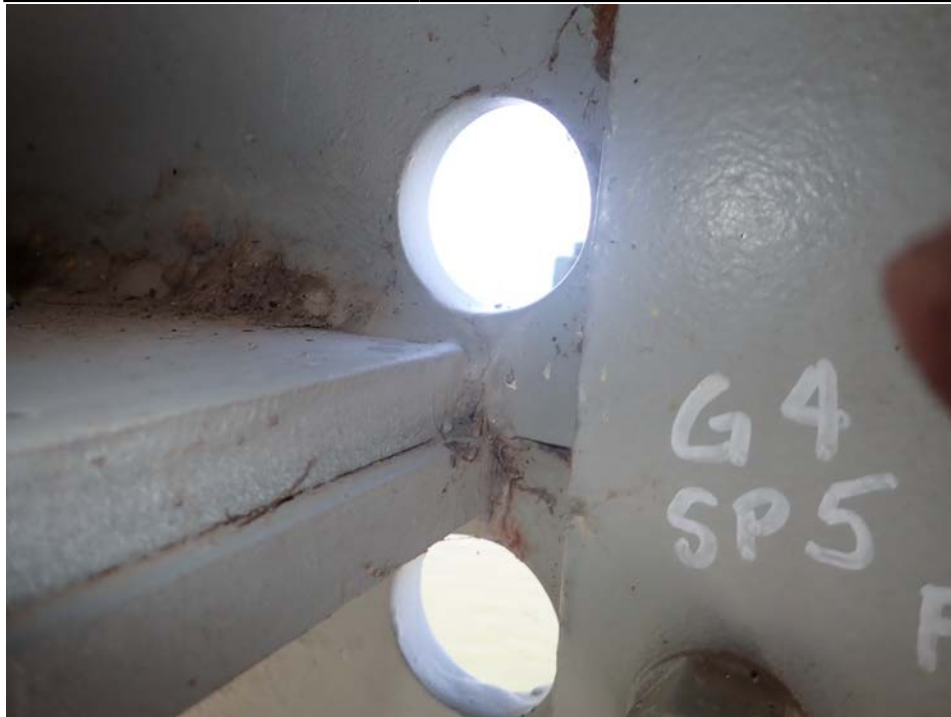
Photograph 28 - Looking north at span 5, girder 4, near floor beam 3. Note: no change to 1 1/8-inch-long crack or 1-inch-long crack.

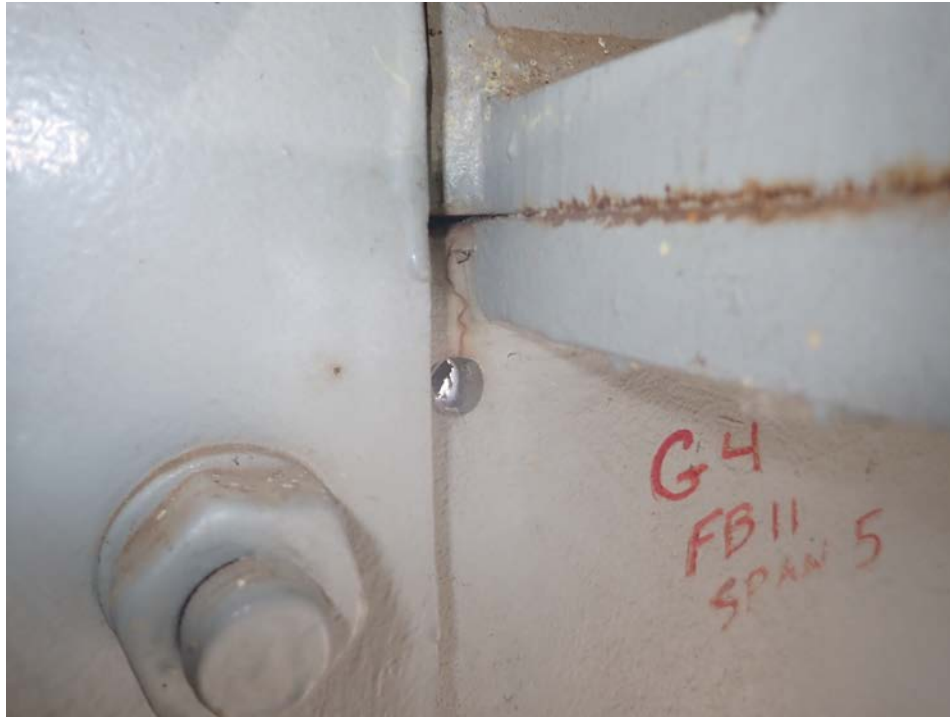
- o Span 5, girder 4, near floor beam 11 (1-inch-long crack arrested by a cored hole).
 - o Span 6, girder 1, near floor beam 3 (both cracks arrested by a cored hole).

Photograph 29 - Looking northeast at span 5, girder 4, near floor beam 11. Note: no change to 1-inch-long crack.

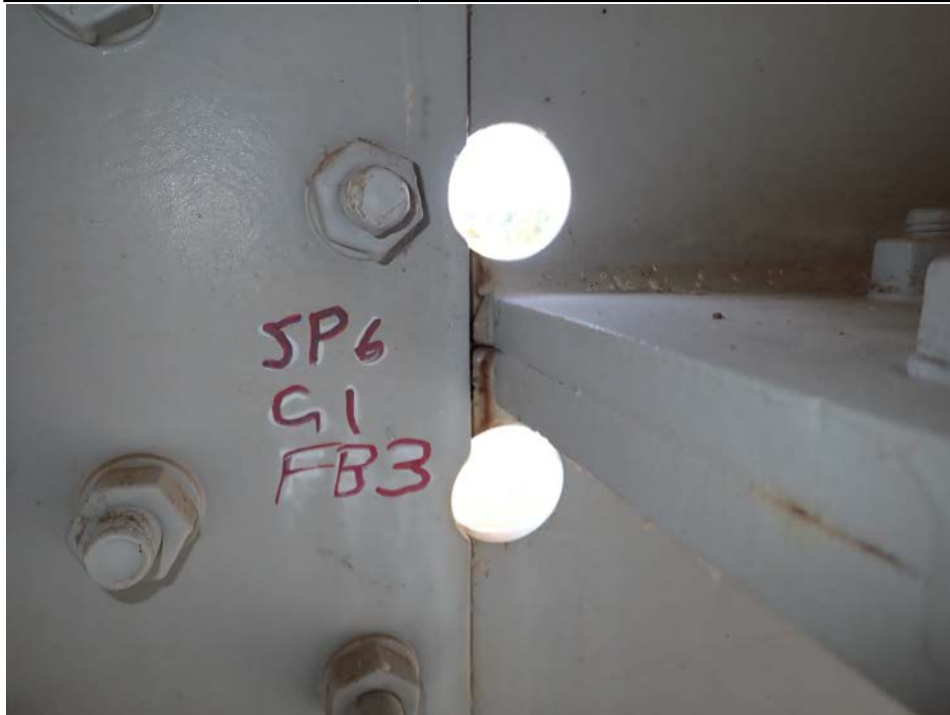
Photograph 30 - Looking south at span 6, girder 1, near floor beam 3. Note: no change to both cracks arrested by a cored hole.

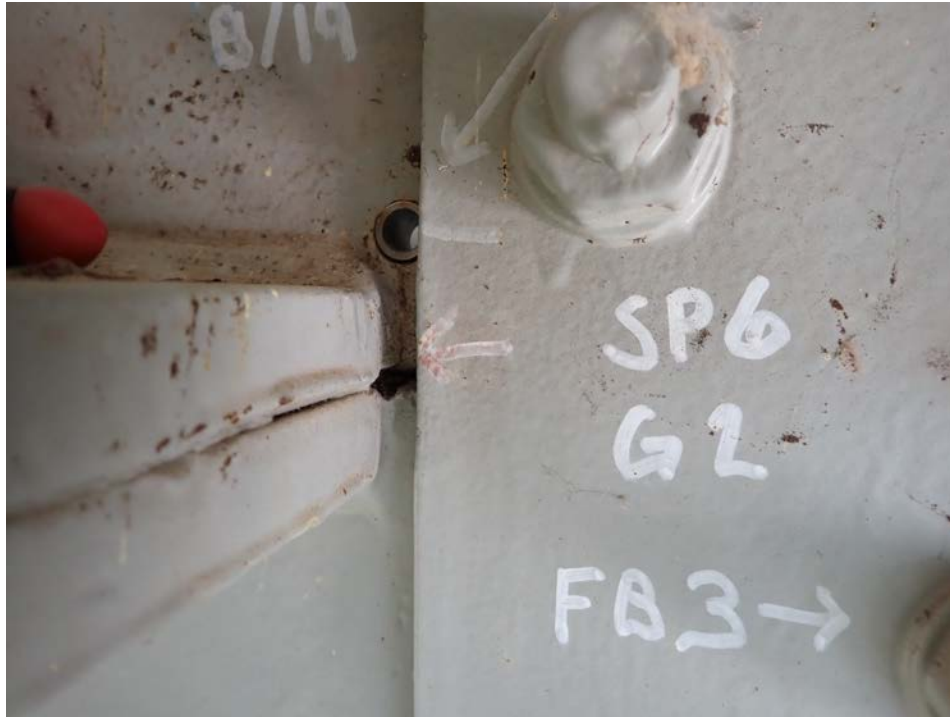
- o Span 6, girder 2, near floor beam 3 (1-inch-long crack arrested by a cored hole).
 - o Span 6, girder 3, near floor beam 3 (Paint crack originally noted, no cracks found during 2024 OS ins).

Photograph 31 - Looking north at span 6, girder 2, near floor beam 3. Note: no change to 1-inch-long crack.
