Oklahoma Dept. of Transportation - Bridge Inspection Report

| NBI No.: 17051 | Structure No.: 6822 0000 X | Local ID: -1 | Suff. Rating: 82.90 | ND |

| NBI # | Structure # | County | Fac. Carried | Fac. Intersected | Insp. Date |
|---|---|---|---|---|---|
| 17051 | 6822 0000 X | Sequoyah | I-40 | ARKANSAS RIVER | 7/19/2024 |

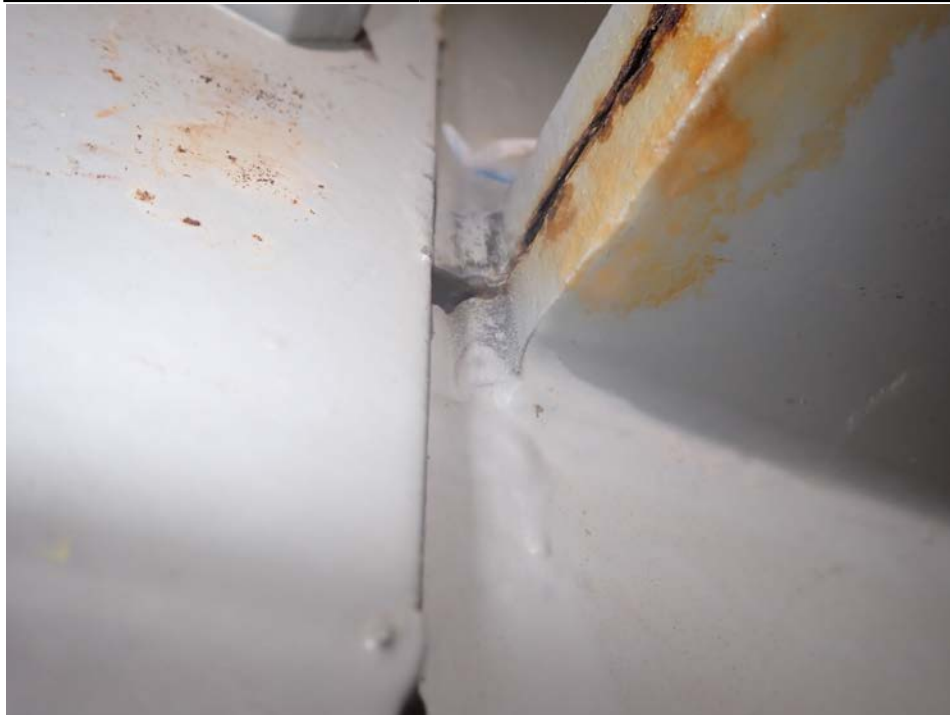
- o Span 6, girder 2, near floor beam 3 (1-inch-long crack arrested by a cored hole).
 - o Span 6, girder 3, near floor beam 3 (Paint crack originally noted, no cracks found during 2024 OS ins).

Photograph 32 - Looking south at span 6, girder 3 near floor beam 3. Note: paint cracks previously noted, no cracks found.

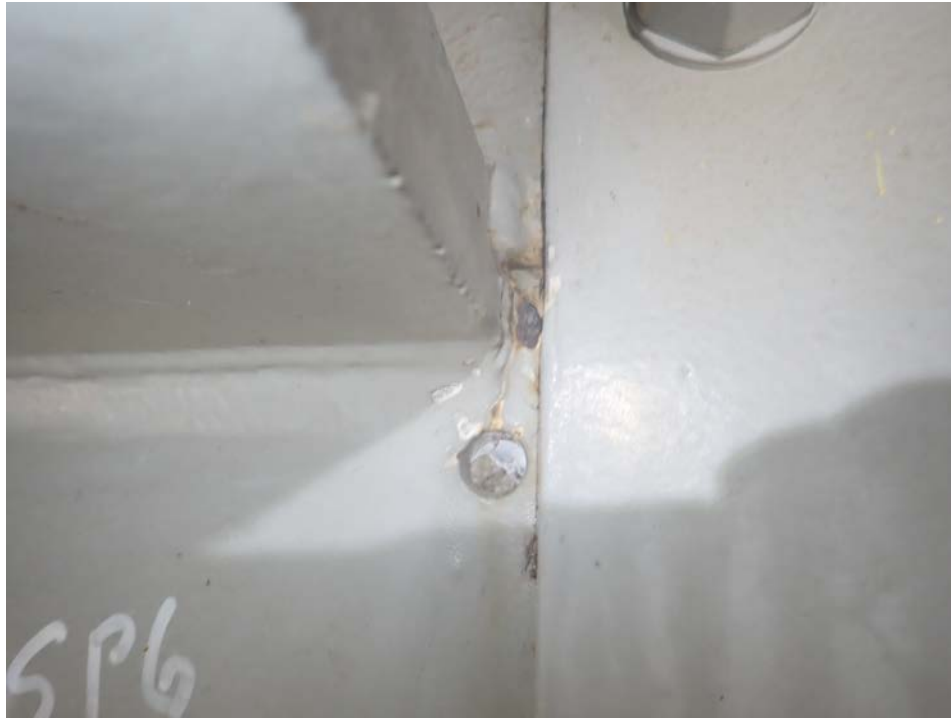
- o Span 6, girder 4, near floor beam 3 (1 1/4-inch-long crack arrested by a cored hole).

Photograph 33 - Looking north at span 6, girder 4, near floor beam 3. Note: no change to the 1 1/4-inch-long crack.

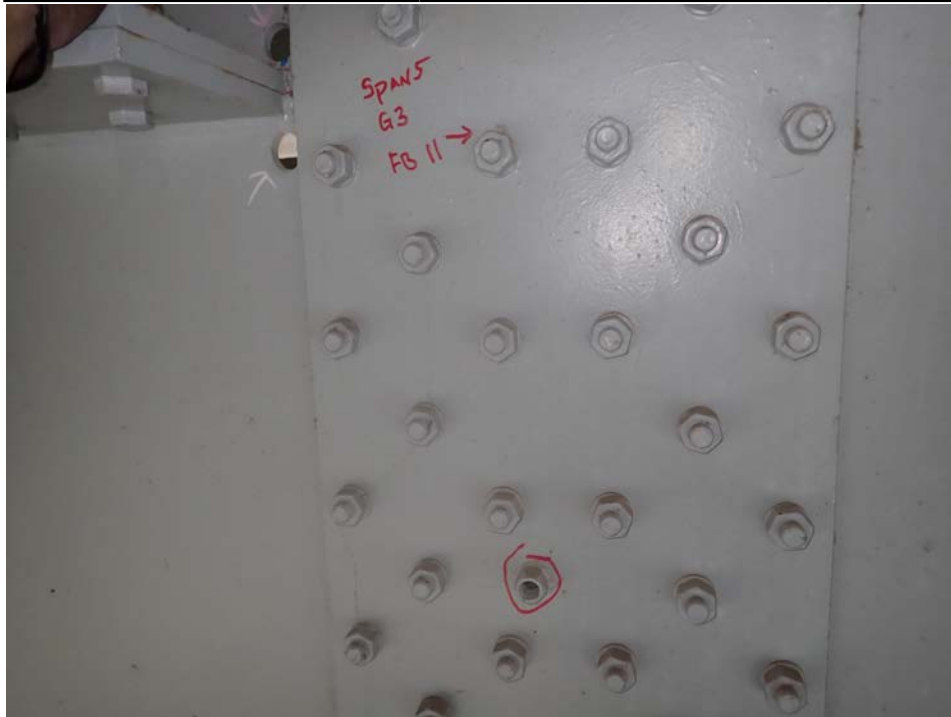
Photograph 34 - Looking south at span 6, girder 3 field splice near floor beam 11. Note: missing bolt.

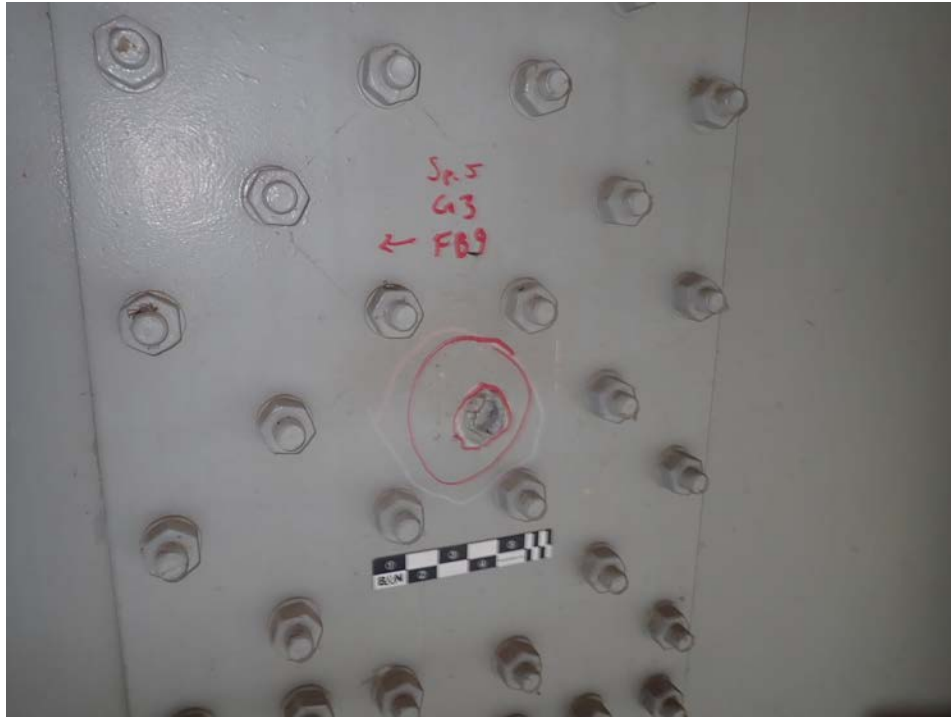
Photograph 35 - Looking south at span 5, girder 3 field splice near floor beam 9. Note: missing bolt with localized deformation.

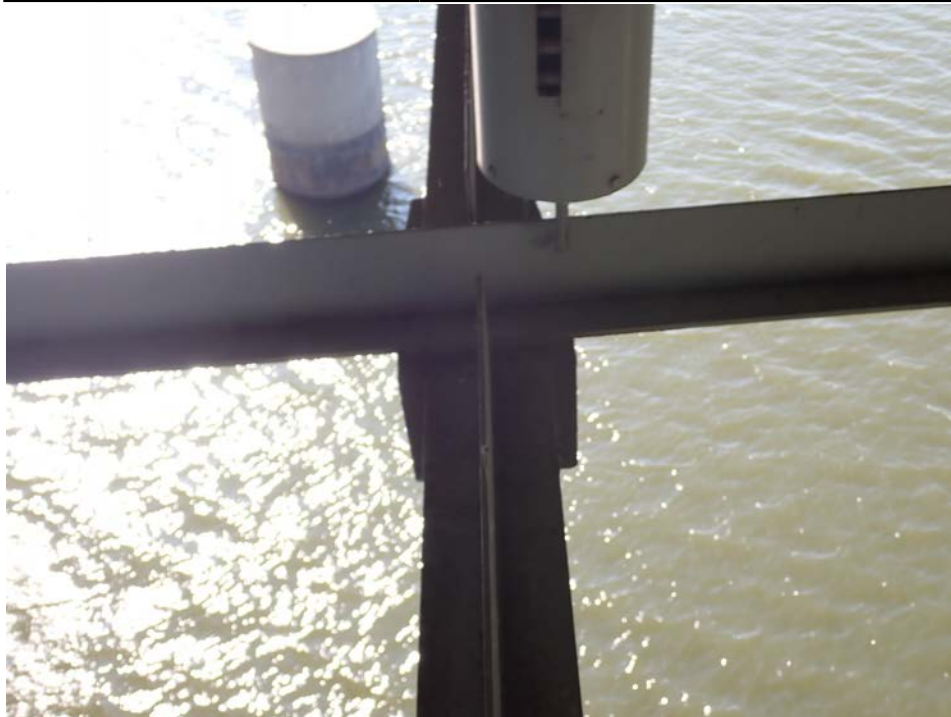
Photograph 36 - Looking southeast at span 4, girder bay 1-2 and floor beam bay 5-6. Note: fractured connection bolt at bottom of anti-vibration dampener (typical).

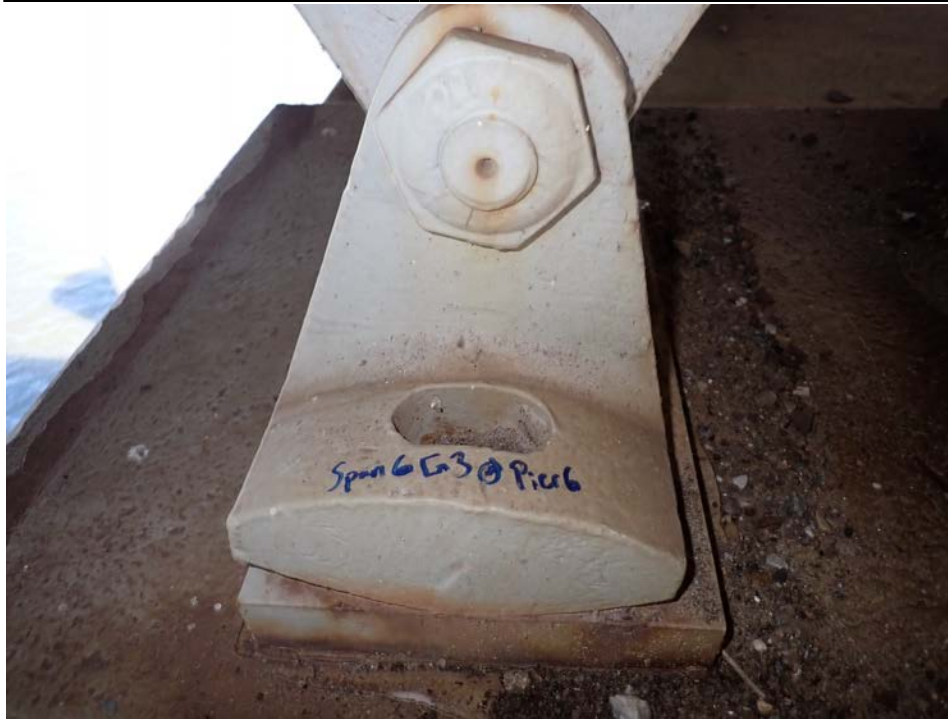
| NBI No.: | | Structure No.: | | Local ID: | | Suff. Rating: | | ND | | | |
|---|---|---|---|---|---|---|---|---|---|---|---|
| <p>Bearings at piers 4, 6, 10 and E abutment have pack rust between rocker and masonry plate. Several bearing bolts broken/missing, pier 6 and E abutment worst.</p> <p>E abutment bearings have corrosion with 1/16in painted over pitting, anchor bolts bent/broken from over expansion.</p> <p>E abutment G1 and G2 bearings shifted 1in N, G3 and G4 bearings shifted 1in S.</p> <p>Span 6, pier 6 bearings rocked up to 14 degree in expansion at 91F, bearings at pier 10 rocked up to 9 degrees expansion. Pier 4 G3 rocked more than other girders.</p> | | | | | | | | | | | |

Photograph 37 - Looking north at span 6, girder 3 rocker bearing at pier 6. Note: outboard anchor rod is missing.

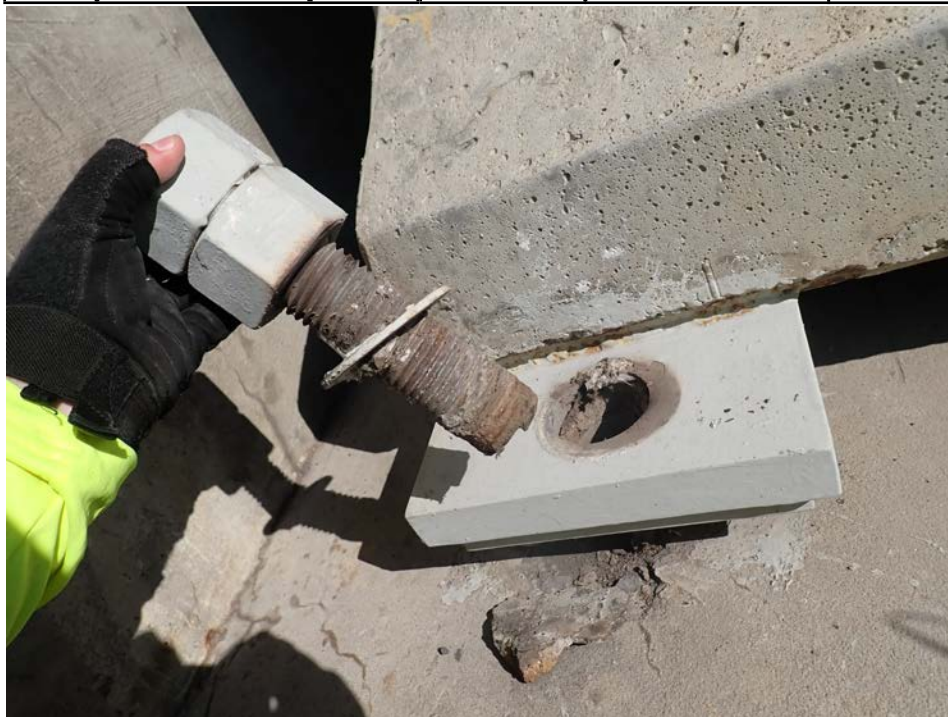
Photograph 38 - Looking north at beam 1 at the west abutment. Note: southern bolt is separated from abutment.

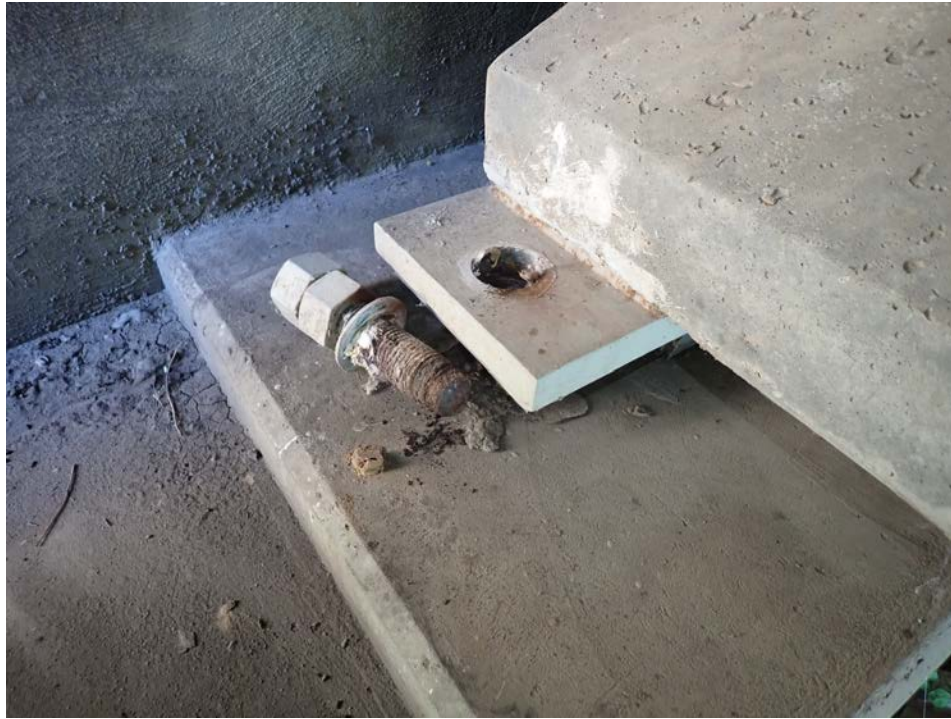
Photograph 39 - Looking northwest at beam 2 at the west abutment. Note: southern bolt is separated from abutment.

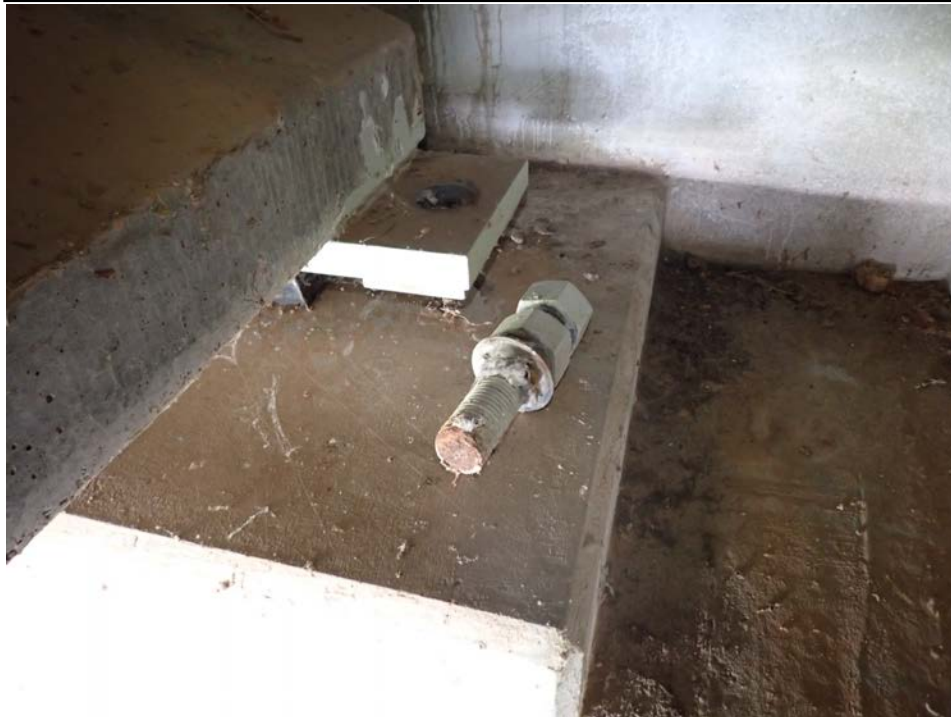
Photograph 40 - Looking west at beam 4 at the west abutment. Note: both bolts separated from abutment.

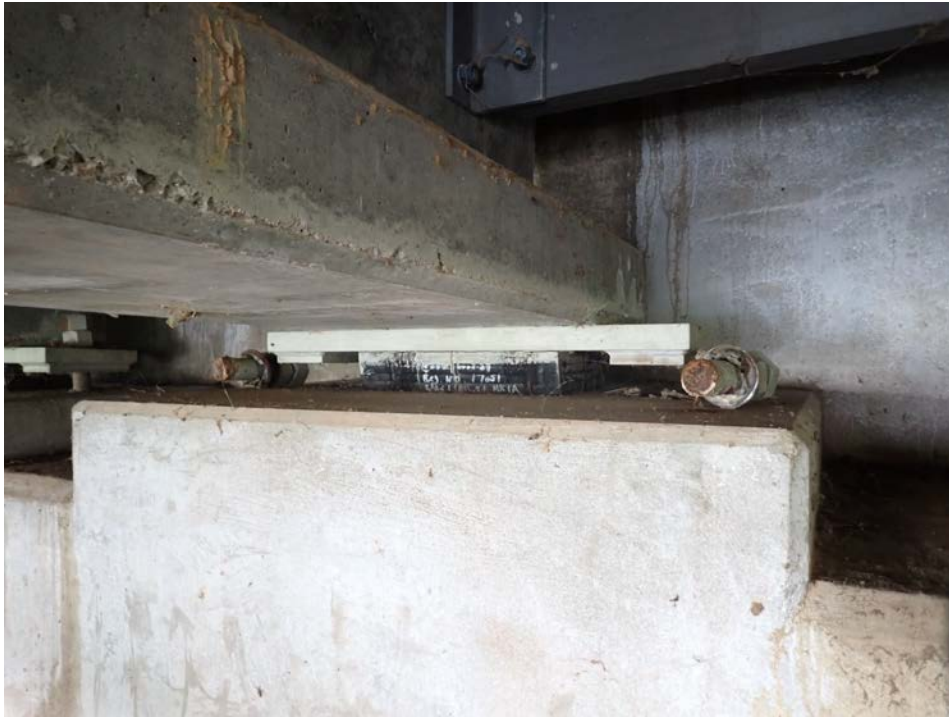
Photograph 41 - Looking west at beam 9 at the west abutment Note: both bolts disconnected from abutment.

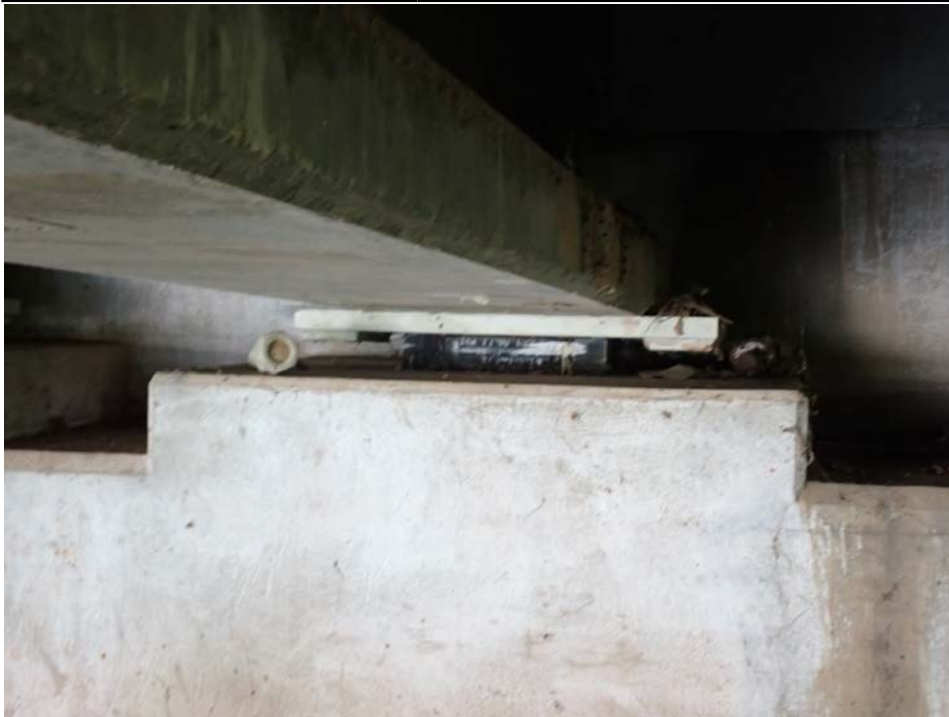
Photograph 42 - Looking west at beam 12 at the west abutment. Note: both nuts separated from abutment.

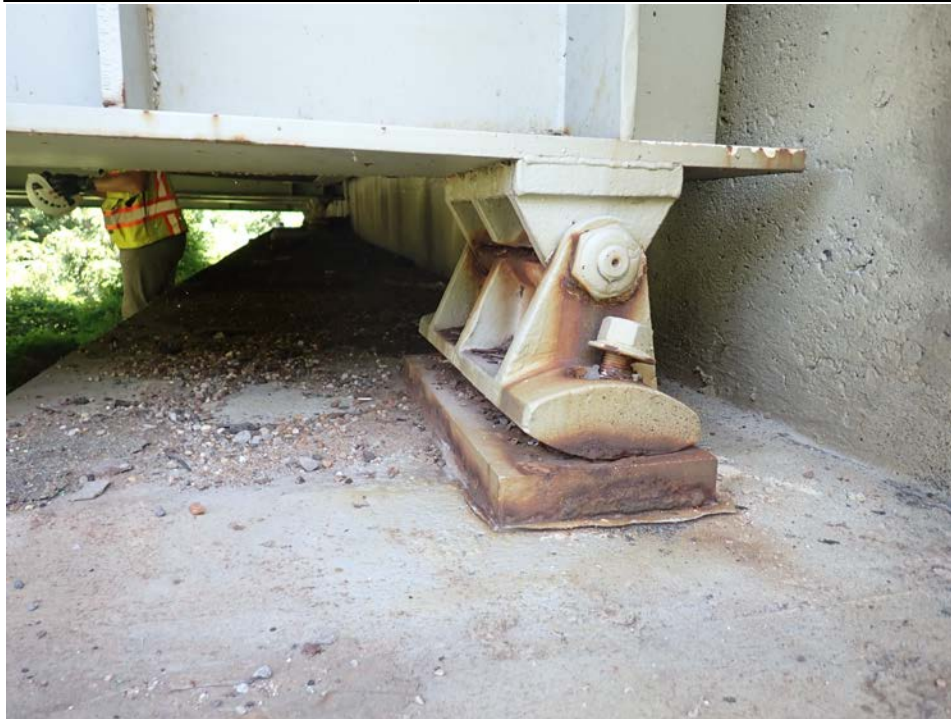
Photograph 43 - Looking north at beam 1 bearing at the east abutment. Note: bolts are disconnected at beam 1 bearing north, beam 2 both sides, beam 4 bearing south side.

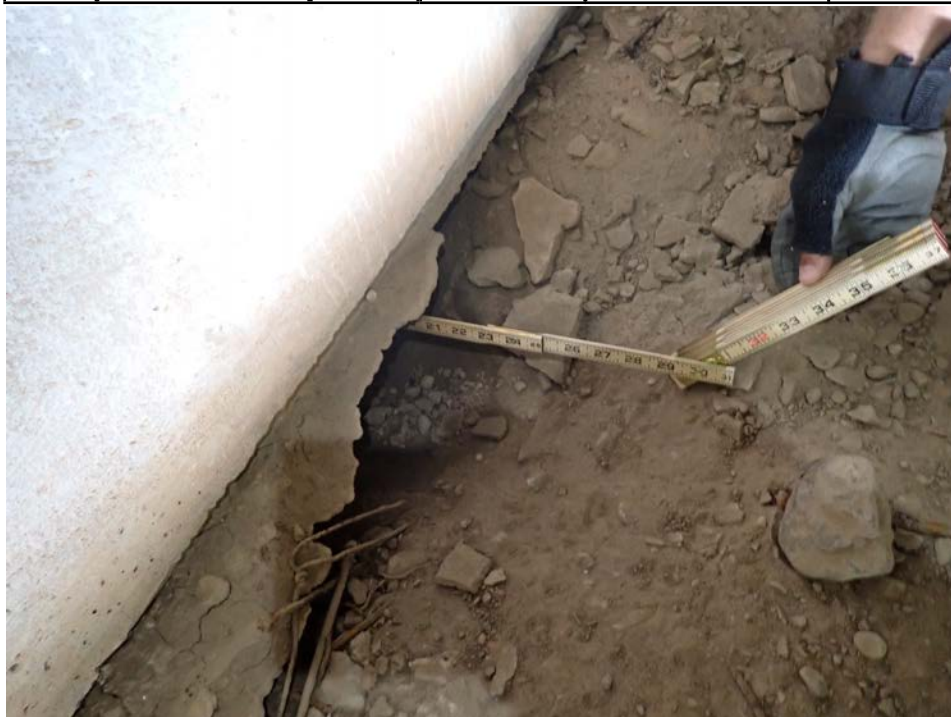
Photograph 44 - Looking west at the west abutment beneath beam 5. Note: undermining up to 20 inches.
