Oklahoma Dept. of Transportation - Bridge Inspection Report

NBI No.: 17611	Structure No.: 5159 0300 X	Local ID: -1	Suff. Rating: 66.70	ND
--------------------------	--------------------------------------	------------------------	-------------------------------	-----------

INSPECTION NOTES: 7/18/24

NBI #	Structure #	County	Fac. Carried	Fac. Intersected	Insp. Date
17611	5159 0300 X	Muskogee	S.H. 100	ARKANSAS RIVER	7/18/2024

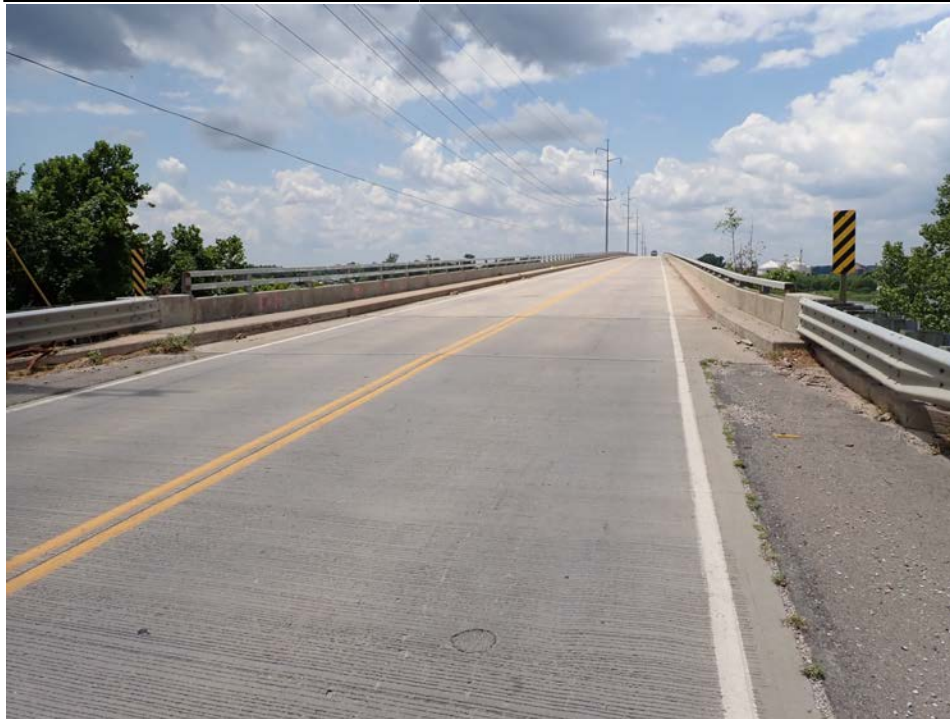
Photograph 1 - Looking west at the bridge end view.

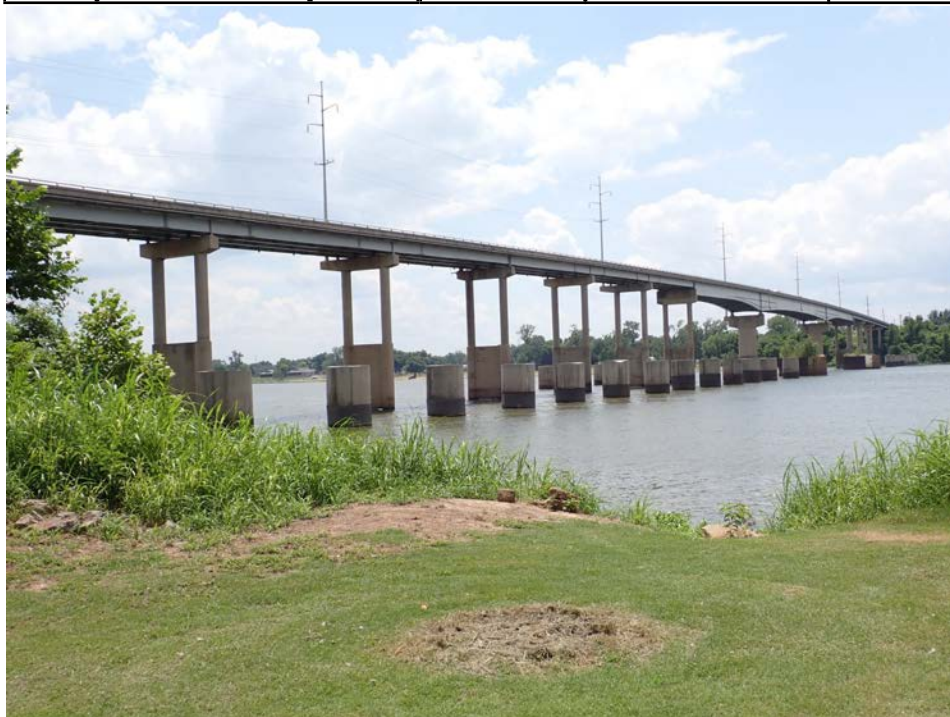
Photograph 2 - Looking southwest at the bridge elevation.

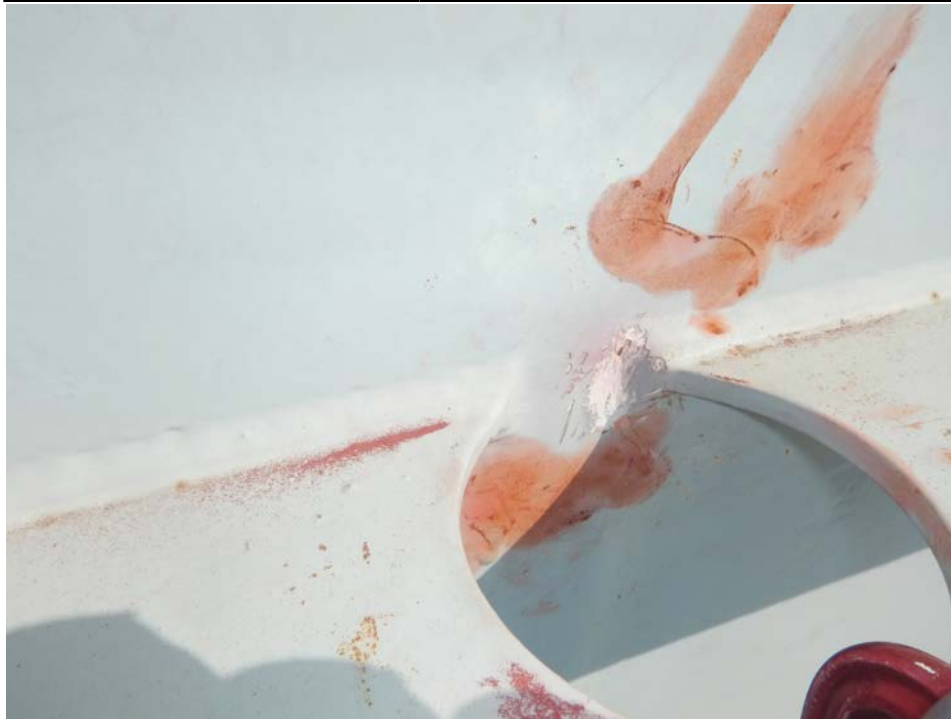
- Girder web cracks at:
 - o Span 5, G 1 (south face) between FBs 4 and 5 – 1 1/4-inch paint crack in web at the longitudinal stiffener cored hole (perform Magnetic Particle Testing during 2022 O/S inspection)

Photograph 3 - Looking north at span 5, girder 1 outboard between floor beams 4 and 5. Note: No MT indication.

- Monitor 1 1/4-inch long paint crack in span 5, G 1 web at longitudinal stiffener cored hole between FBs 4 and 5 (Magnetic Particle Testing to be performed during 2022 O/S inspection).

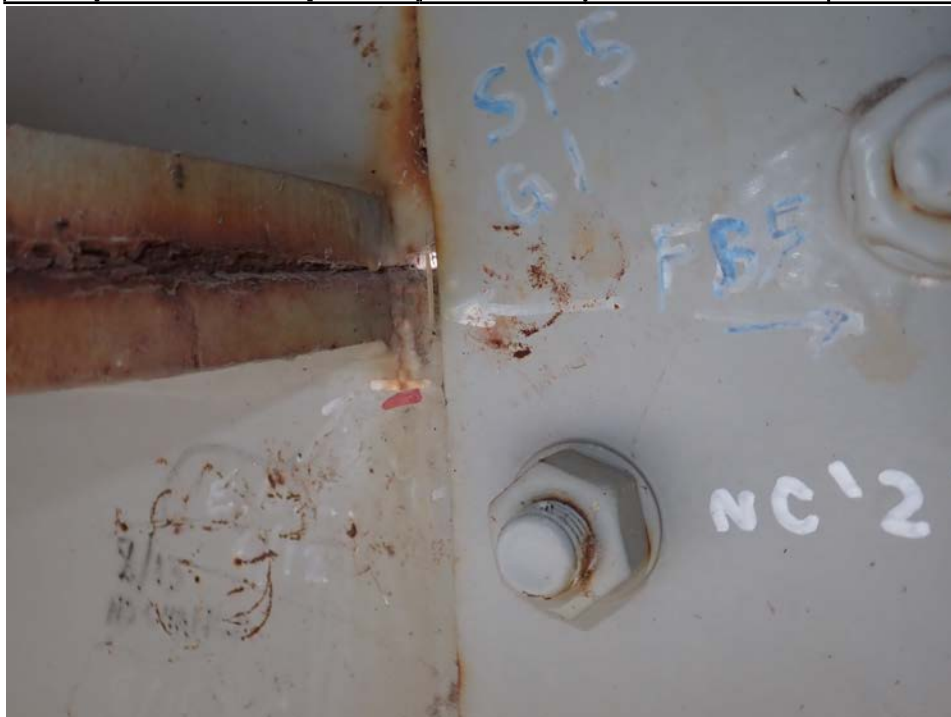
- o Span 5, G 1 at the field splice near FB 5 – 5/8-inch crack with no arrestor hole.
 - o Span 5, G 2 at the field splice near FB 5 – paint crack.
 - o Span 6, G 1 at the field splice near FB 3 – arrested crack.

Photograph 4 - Looking southeast at span 5, girder 1 at the field splice near floor beam 5. Note: 5/8 inch-long crack in the inboard face at the horizontal web splice termination, no change.

- Replace N railing post anchor bolts missing at eastern most railing post.
- Unclog deck scuppers.
- Reseal fixed poured joint seal at both abutments.
- Arrest girder web cracks at horizontal splice termination at:
 - Span 5, G 1 at field splice near FB 5 – 5/8 inch.
 - Span 6, G 2 near FB 11 – 3/16-inch-long vertical crack in lower web plate.
- Replace missing bolts and tighten loose bolts at
 - Girder splice locations
 - FB connection to girders in spans 5, 6 and 7.
 - Stringer connection to FBs in spans 5, 6 and 7.
- Repair cracked web connection plate weld for FB 6 in span 5 at G 1.
- Reattach FB 0 lower connection to G 2 in span 6.
- Repair cracks in lower lateral bracing in span 5, FB 7, G 2 and span 6, FB 12, G 2, and other similar locations.
- Tighten loose anchor bolts and replace missing or bent anchor bolts.

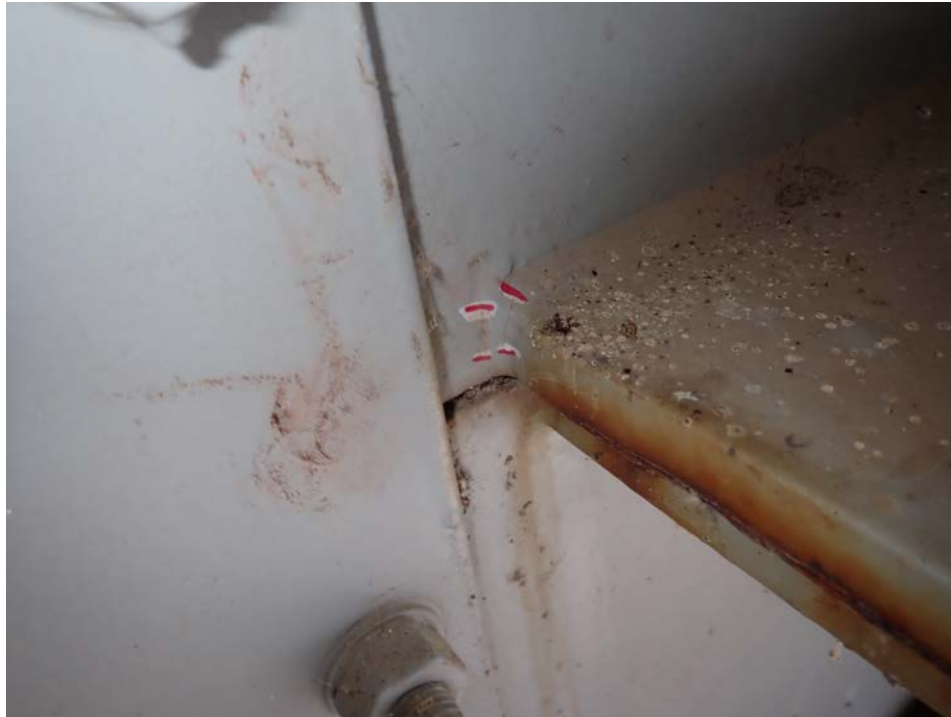
Photograph 5 - Looking northeast at span 5, girder 2 at the field splice near floor beam 5. Note: Two 3/8 inch-long paint cracks in the inboard face at the horizontal web splice termination, no change.

- Monitor locations of girder web cracks having drilled hole retrofits or paint cracks at horizontal splice termination at:
 - Span 5, G 2 at field splice near FB 5 – paint crack.

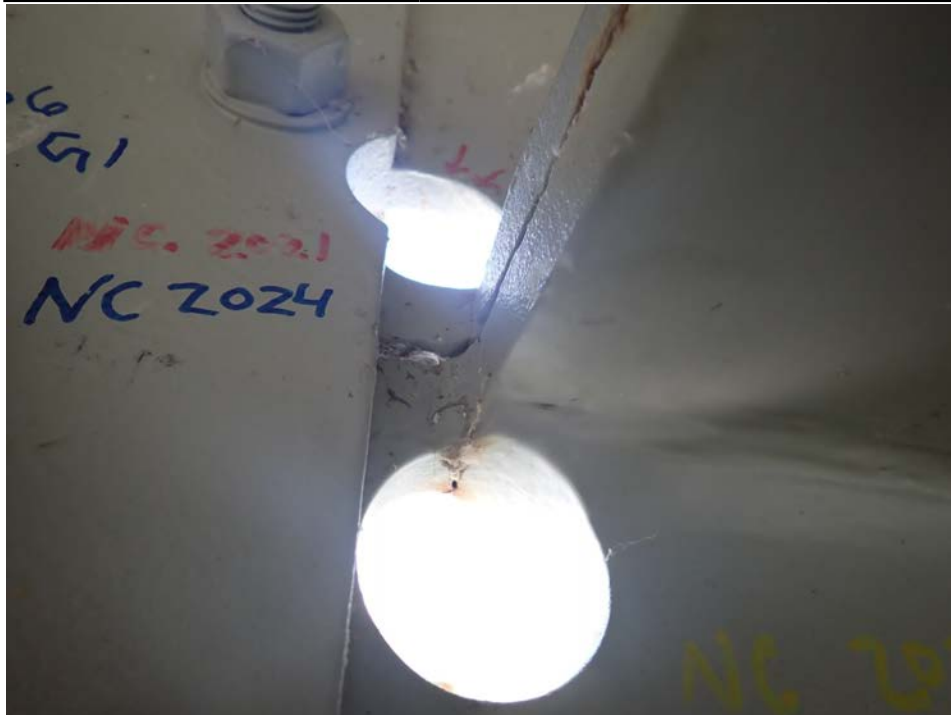
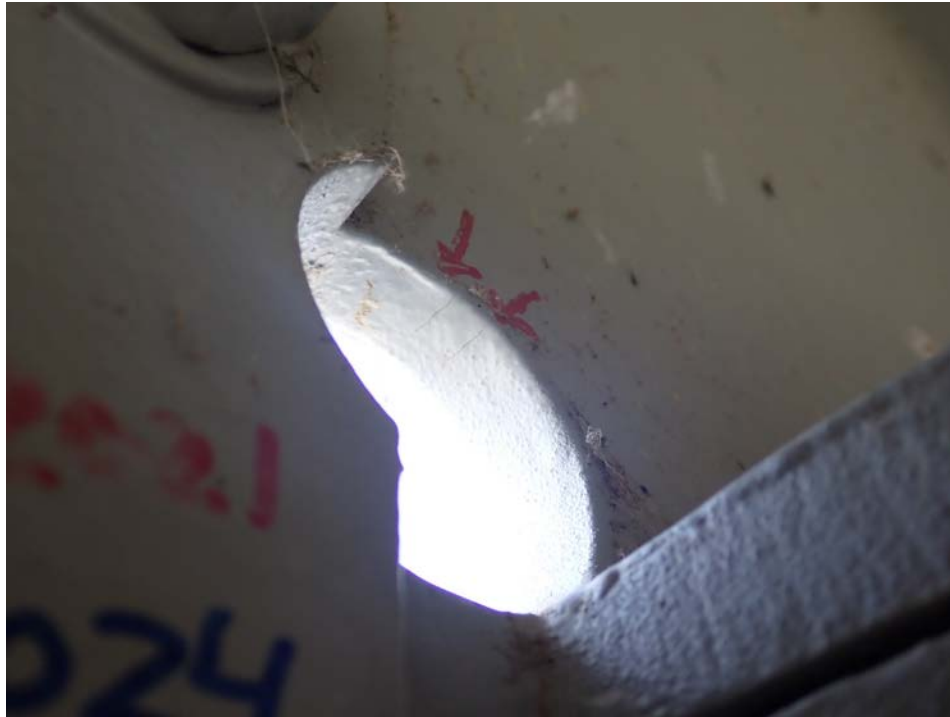
Photograph 6 - Looking south at span 6 girder 1, end of horizontal filed splice near floor beam 3. Note: 3/4-inch-long crack in the inboard face at the horizontal web splice termination has not propagated past the arrestor holes. Also note, 1/2-inch-long paint cracks along the top of the upper arrestor hole.

Photograph 7 - Looking southwest at span 6 girder 1, end of horizontal filed splice near floor beam 3. Note: 3/4-inch-long crack in the inboard face at the horizontal web splice termination has not propagated past the arrester holes. 1/2-inch-long paint cracks along the top of the upper arrester

- Span 6, G 1 at field splice near FB 3 – arrested crack.
 - Span 7, G 1 at field splice near FB 4 – paint crack.
 - Span 7, G 2 at field splice near FB 4 – arrested crack.

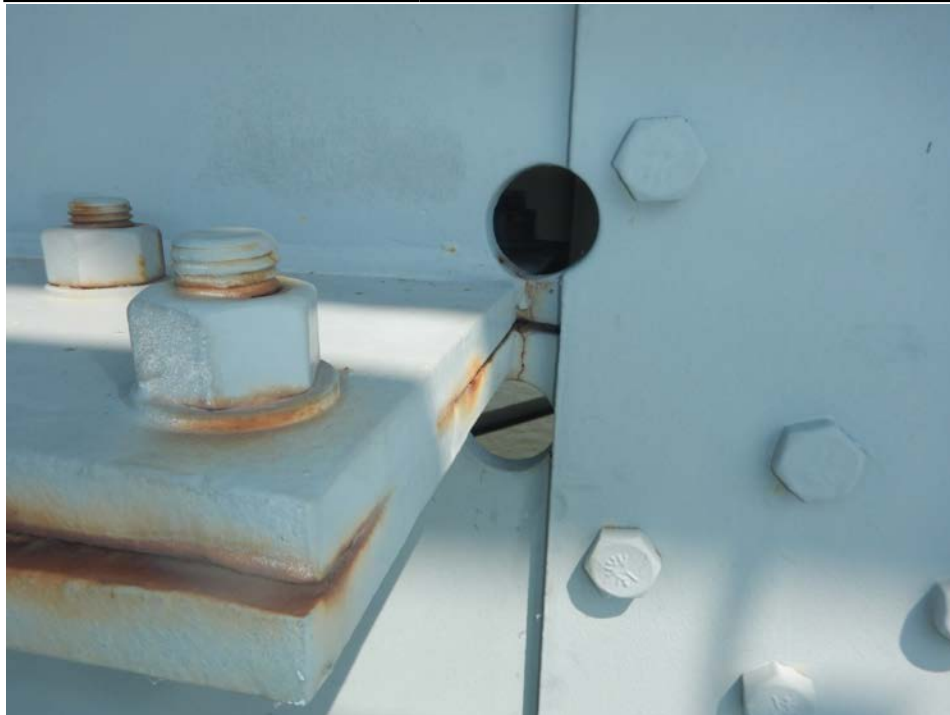
Photograph 8 - Looking north at span 6, girder 1 outboard near floor beam 3 at field splice. Note: crack with arrester holes.

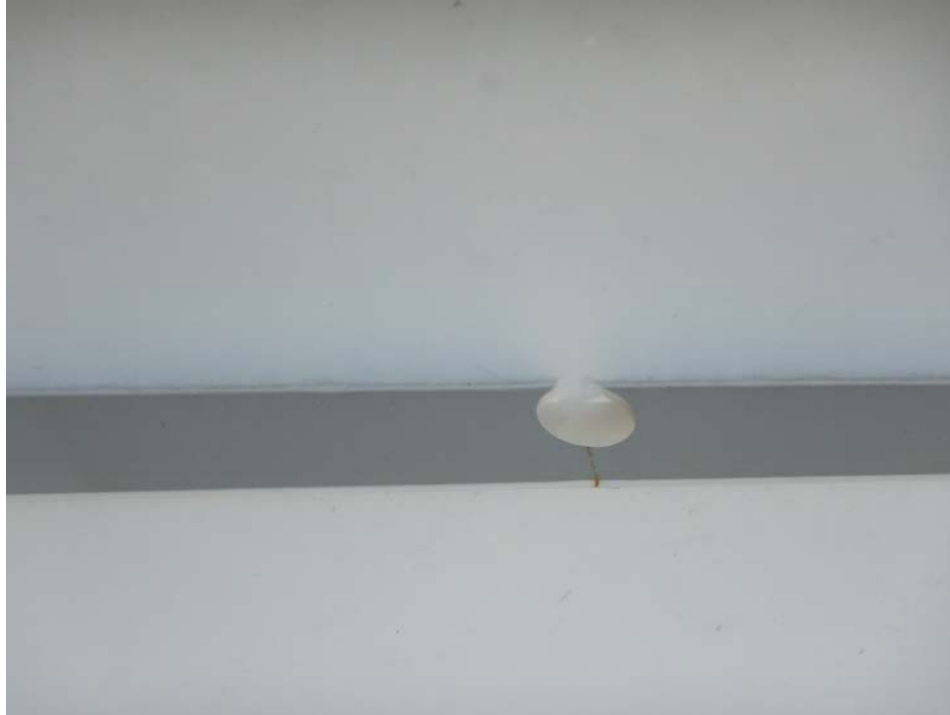
Photograph 9 - Looking north at span 6, girder 1 outboard near floor beam 7 at center channel light.
Note: Crack in horizontal stiffener with arrestor hole.

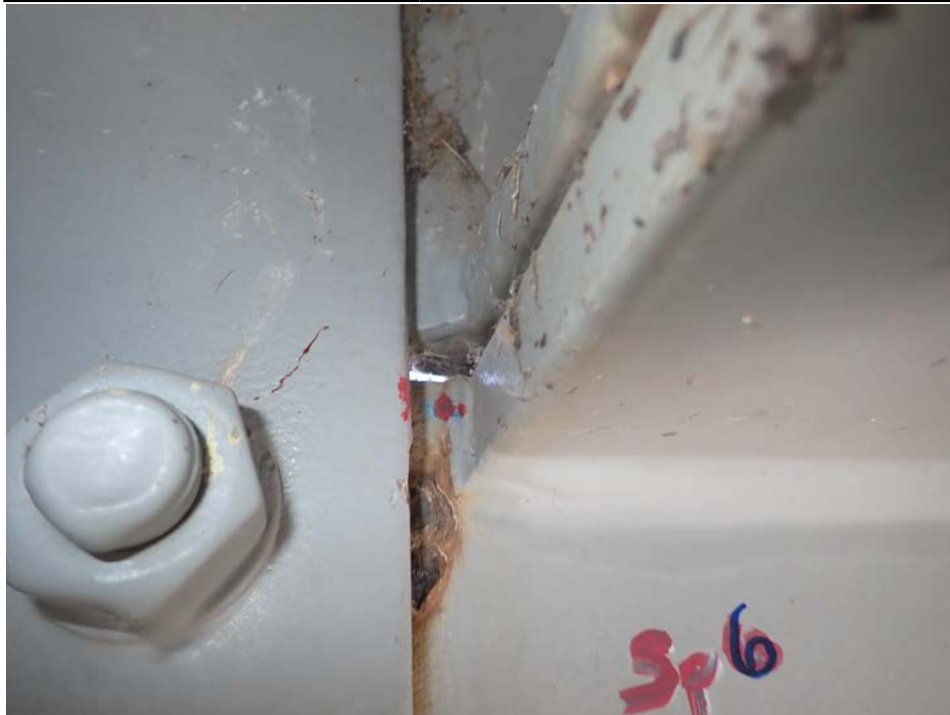
- o Span 6, G 2 at the horizontal field splice termination near FB 11 – 3/16-inch crack.
 - o Span 7, G 1 at the field splice near FB 4 – paint crack.
 - o Span 7, G 2 at the field splice near FB 4 – arrested crack.

Photograph 10 - Looking northwest at span 6, girder 2 at the field splice near floor beam 11. Note:
No change to 3/16-inch-long crack in the inboard face at the horizontal web splice termination.

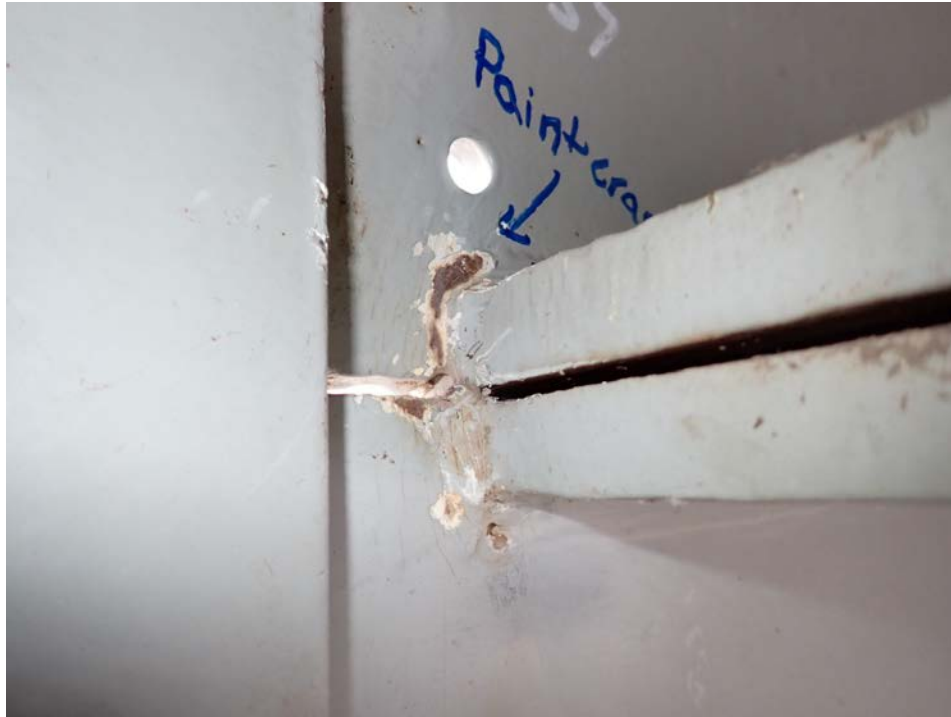
Photograph 11 - Looking south at span 7, girder 1 at the field splice near floor beam 4. Note: 1 inch-long paint crack in the upper web with an arrestor hole, and a 1 1/8-inch-long paint crack in the lower web without an arrestor hole in the inboard face at the horizontal web splice termination.

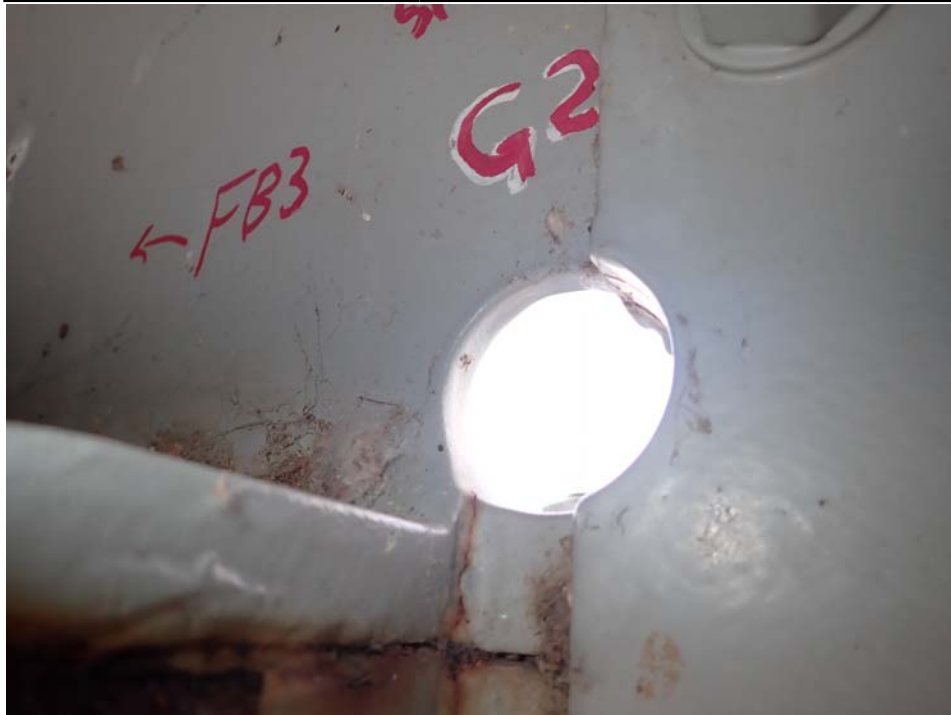
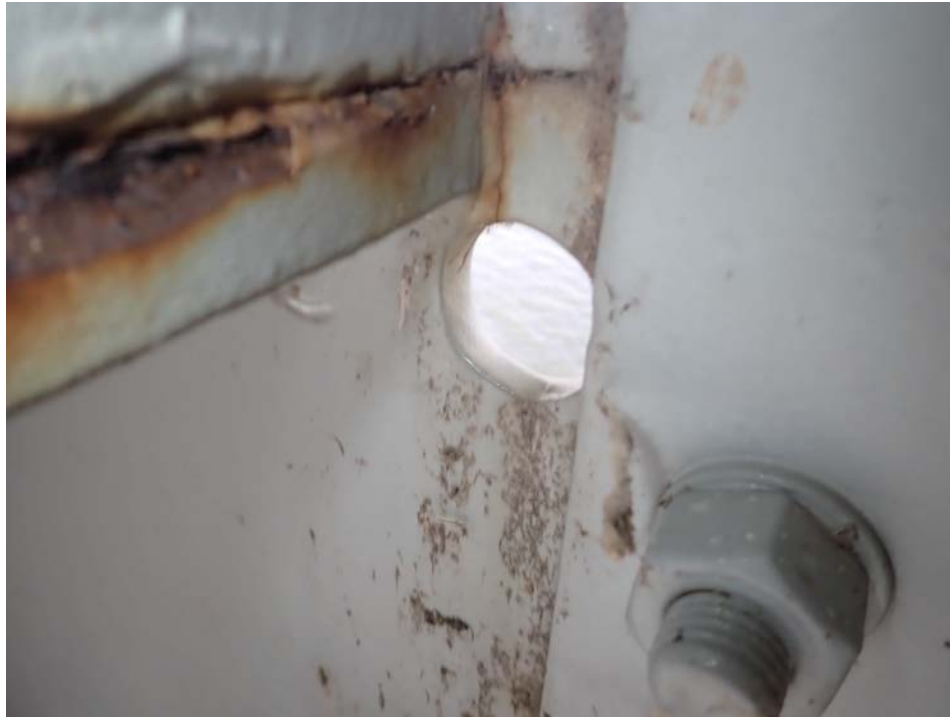
Photograph 12 - Looking north at span 7, girder 2 at the field splice near floor beam 4. Note: 2 arrested cracks, no propagation across the hole.

Photograph 13 - Looking north at span 7, girder 2 at the field splice near floor beam 4. Note: 2 arrested cracks, no propagation across the hole.

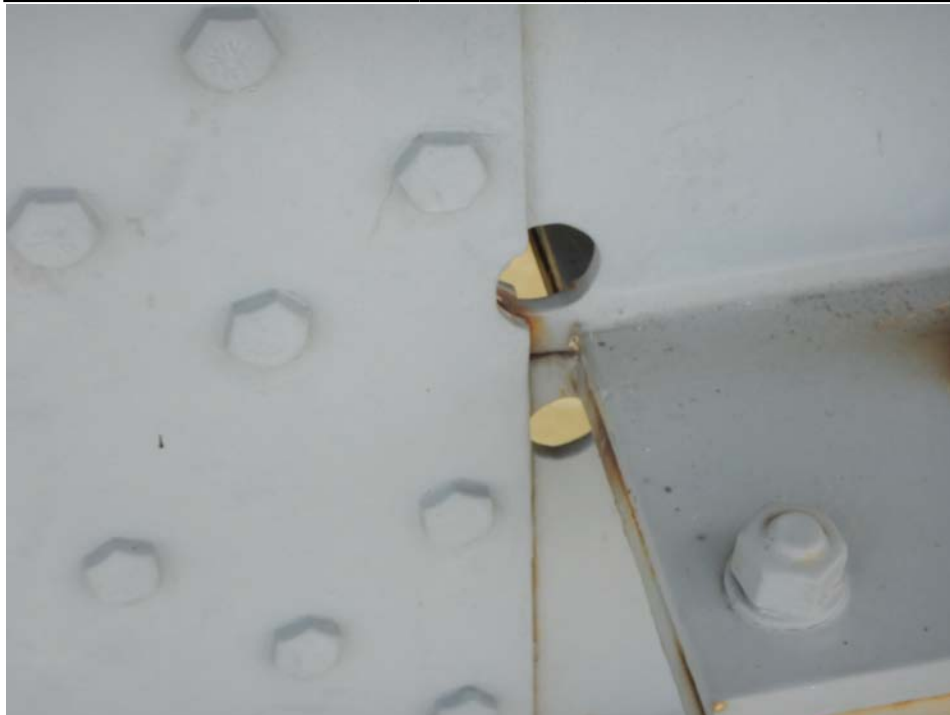
Photograph 14 - Looking south at span 7, girder 2 outboard near floor beam 4 at field splice. Note: Crack with arrestor holes.

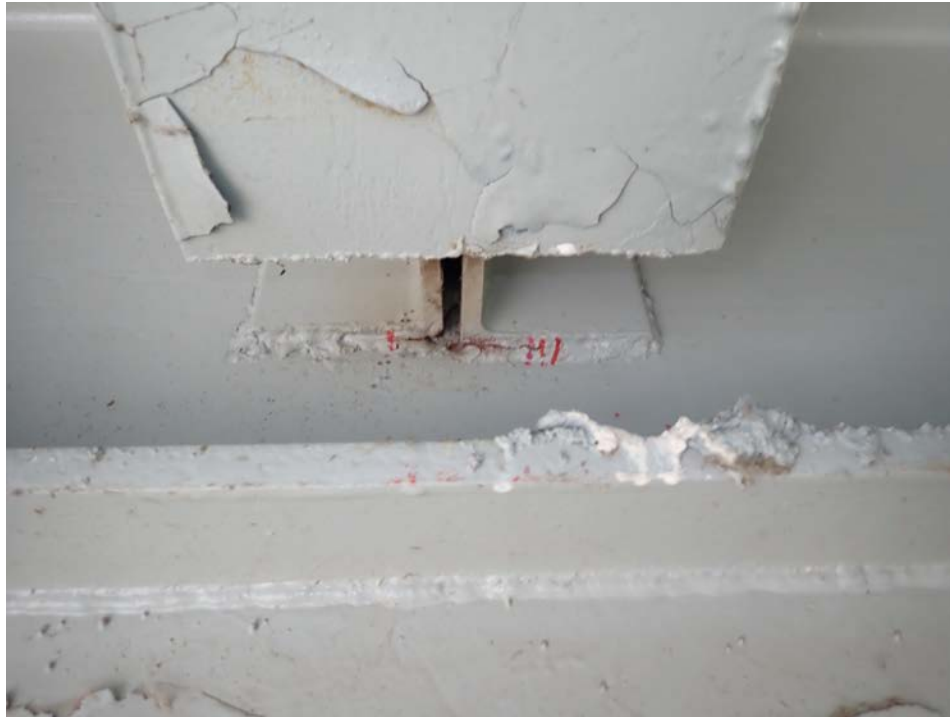
Photograph 15 - Looking west at span 5, stringer 3 connection to floor beam 3 (east face), span 5.
Note: 3 1/2-inch long crack along weld on the underside of the stringer connection angles, no change.

- Monitor cracked welds at cross frame connection to girders due to pack rust.
- Monitor cracks at stringer connection angles at:
 - Span 5, stringer 3 connection to FB 3

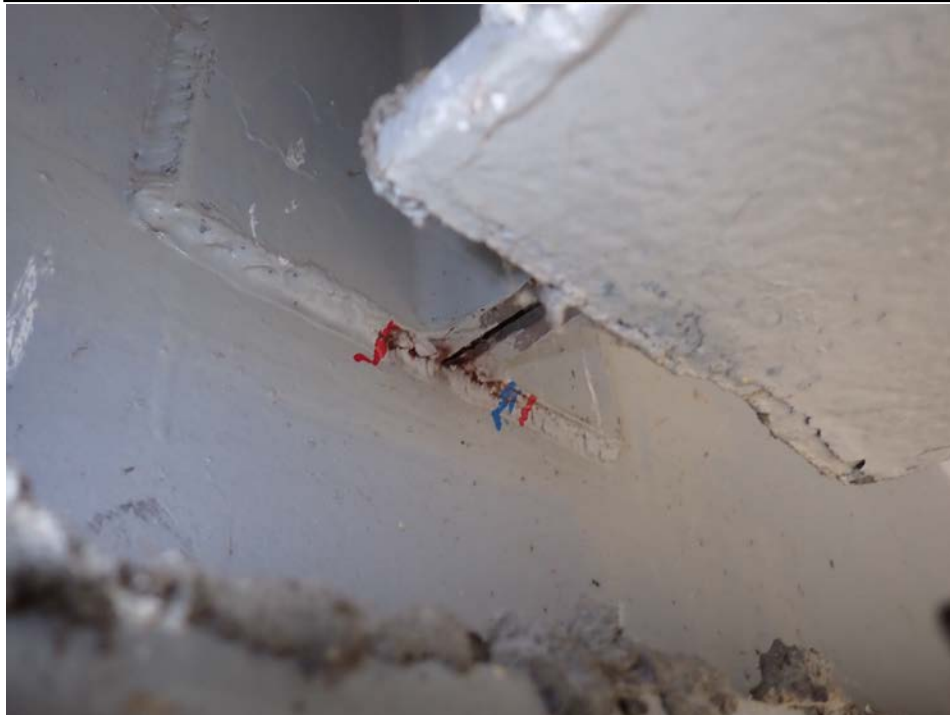
Photograph 16 - Looking west at span 7, stringer 1 connection to floor beam 0. Note: No change to the 3 1/2-inch-long crack along weld on the bottom of the stringer connection angles.

- Span 7, stringer 1 connection to FB 0
 - Span 7, stringer 3 connection to FB 0
- Monitor welded connections at recently replaced FBs.

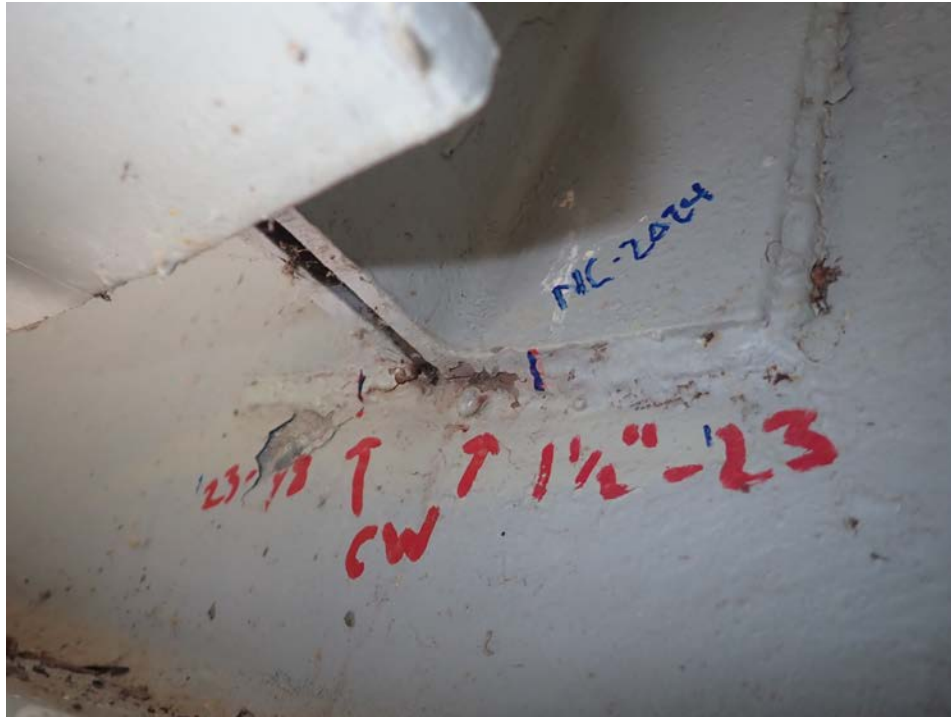
Photograph 17 - Looking west at span 7, stringer 3 connection to floor beam 0. Note: No change to the 1/2-inch and 7/8-inch-long cracks in the weld on the bottom of the stringer connection angles.

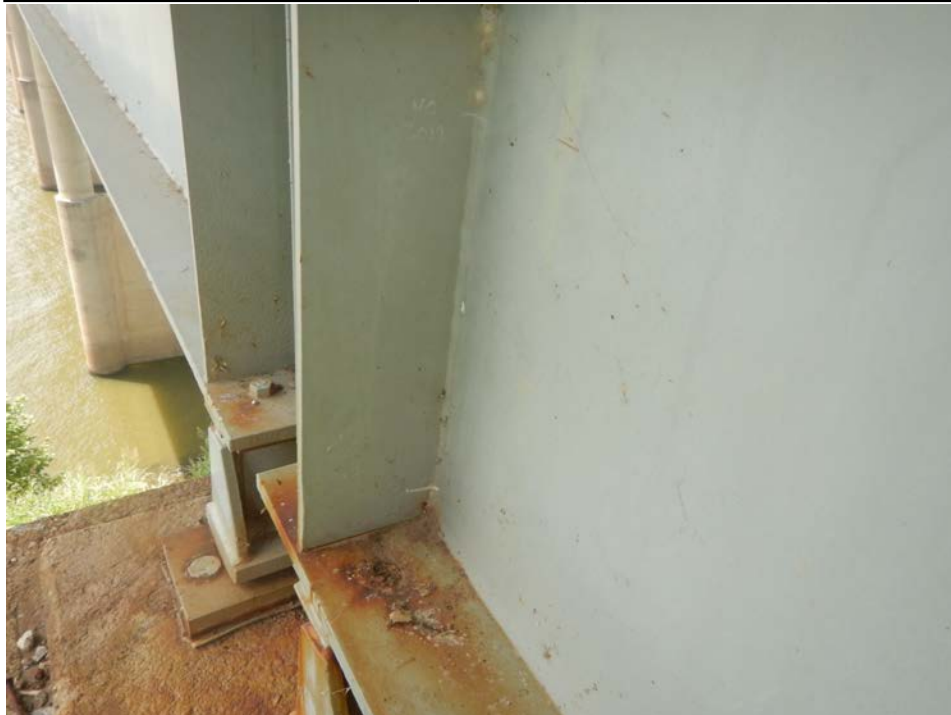
Photograph 18 - Looking northwest at span 15, girder 1 outboard at pier 14. Note: Crack in weld for vertical stiffener.

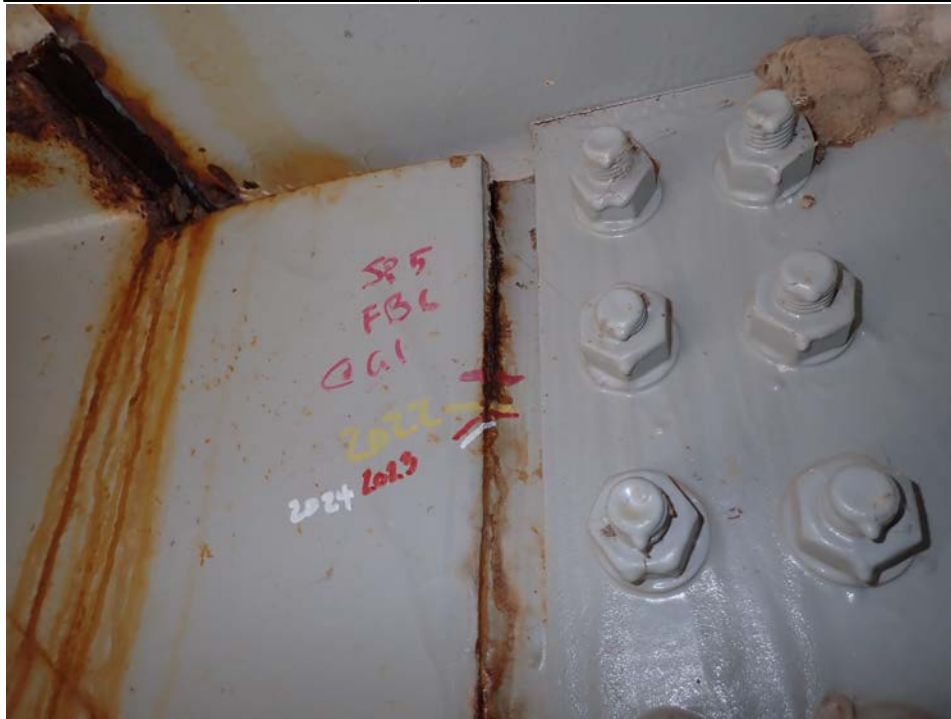
- Cracked FB to girder connection welds:
 - Span 5, FB 6 upper connection to G 1 – 5 1/2-inch crack in connection plate weld (3/8-inch growth).

Photograph 19 - Looking east at span 5, floor beam 6 upper connection to girder 1. Note: 5 1/2-inch-long crack in connection plate weld, 3/8-in growth.

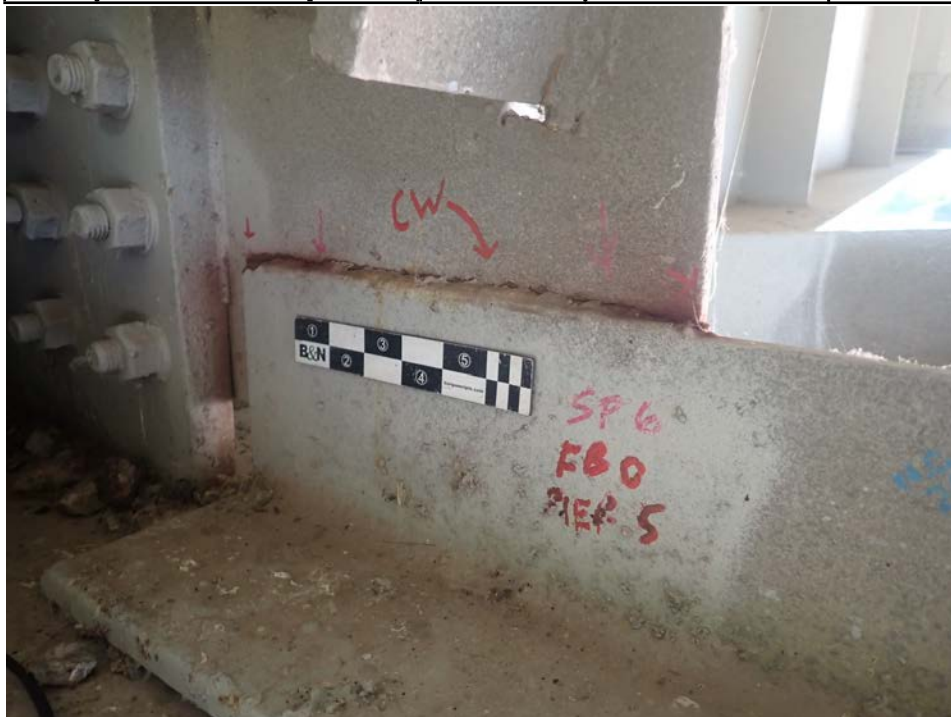
- o Span 6, FB 0 lower connection to G 2 – horizontal weld cracked full length.
 - o Span 7, FB 0 lower connection to G 2 – 1 1/8-inch and 1/2-inch cracks in welded repair.

Photograph 20 - Looking northeast at span 6, floor beam 0 lower strut connection to girder 2 at pier 5. Note: Full-length horizontal crack in the weld.

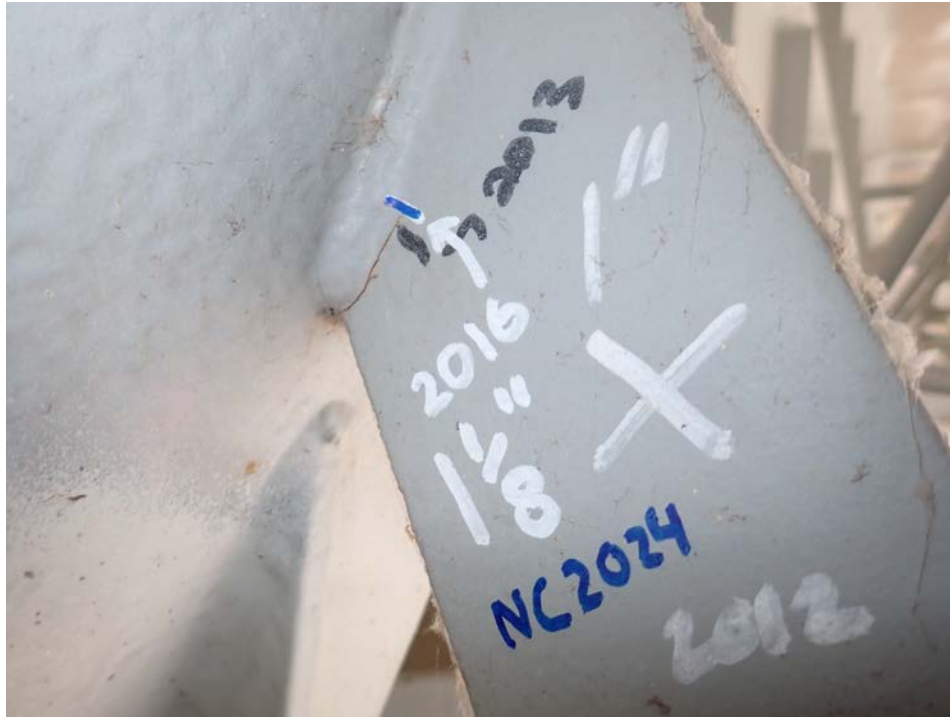
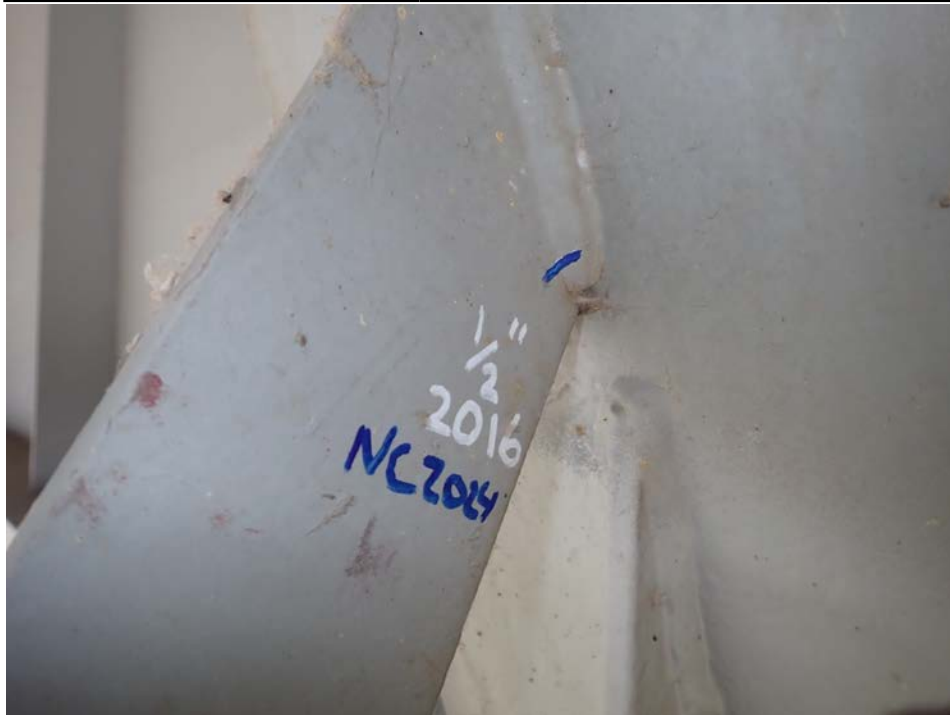
Photograph 21 - Looking east at the span 7, floor beam 0 lower strut connection to girder 2 at pier 6.
Note: No change to 1 1/8-inch-long crack in repair plate weld on the west face and no change to the 1/2-inch-long crack on the east face.

Photograph 22 - Looking west at the span 7, floor beam 0 lower strut connection to girder 2 at pier 6.
Note: No change to 1 1/8-inch-long crack in repair plate weld on the west face and no change to the 1/2-inch-long crack on the east face.
