Fracture Critical Bridge Inspection Report

NBI Bridge No.: 17611

Route S.H. 100 over ARKANSAS RIVER
Muskogee County

7/14/2023

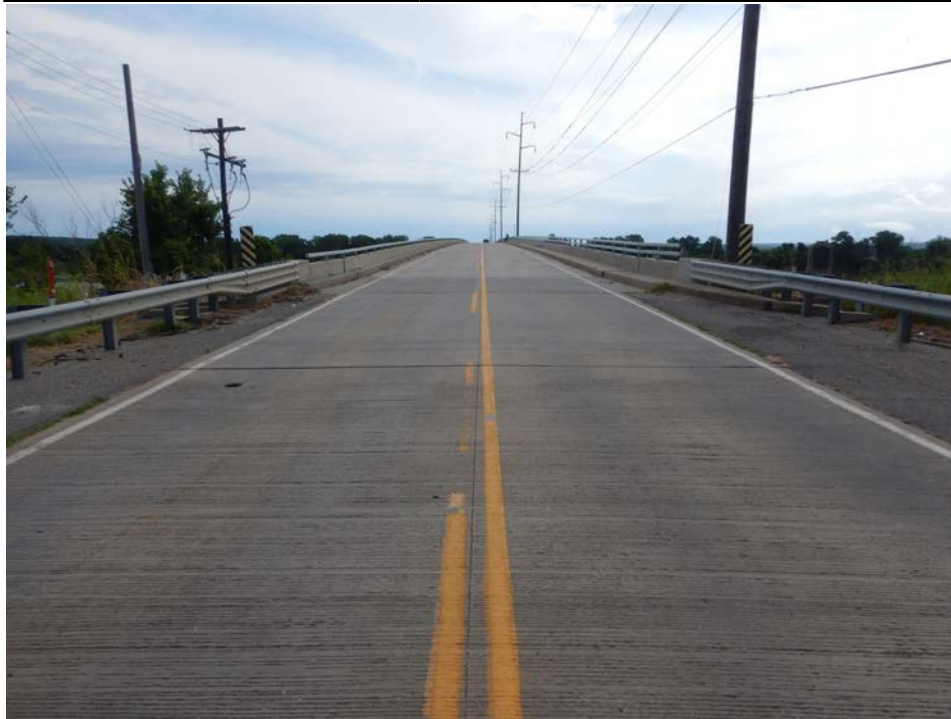
Photograph 1 - Looking east at the bridge end view.

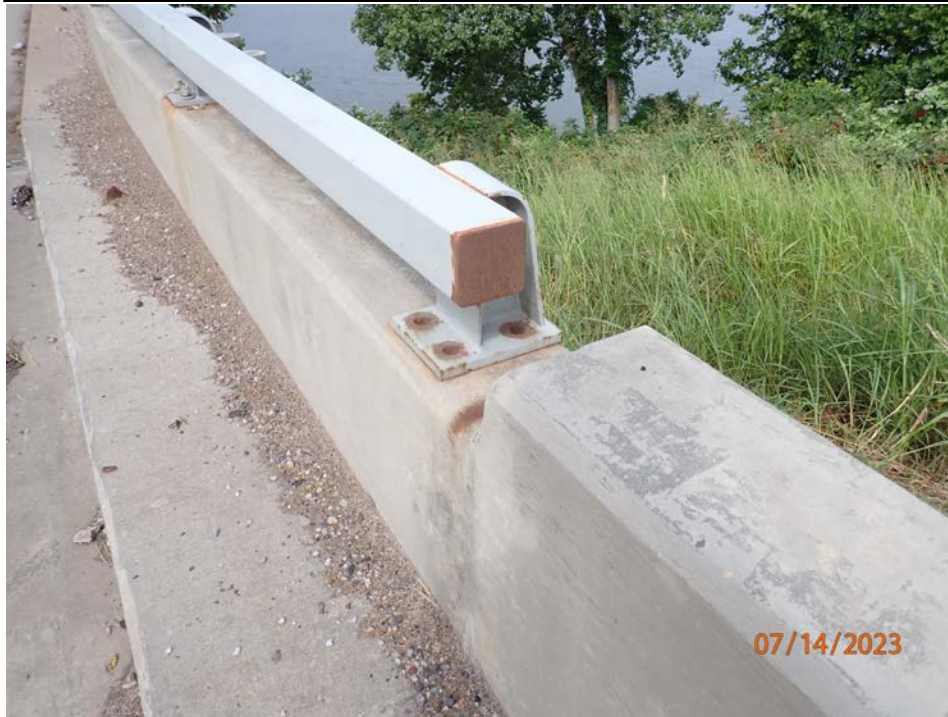
- **PX** – The easternmost rail post along the north barrier at the end of the east approach slab is missing all four anchor bolts **(photo 3)**.
- Span 5 sidewalk near piers 4 and 5 exhibits spalling. These are not significant and have not changed since the prior inspection.

Photograph 3 - Looking northwest at the north rail east end post. Note: rail post is missing all four anchor bolts.

- Replace north railing post anchor bolts missing from the eastern most railing post.
- Unclog the deck scuppers.
- Reseal the fixed poured joint seal at both abutments.

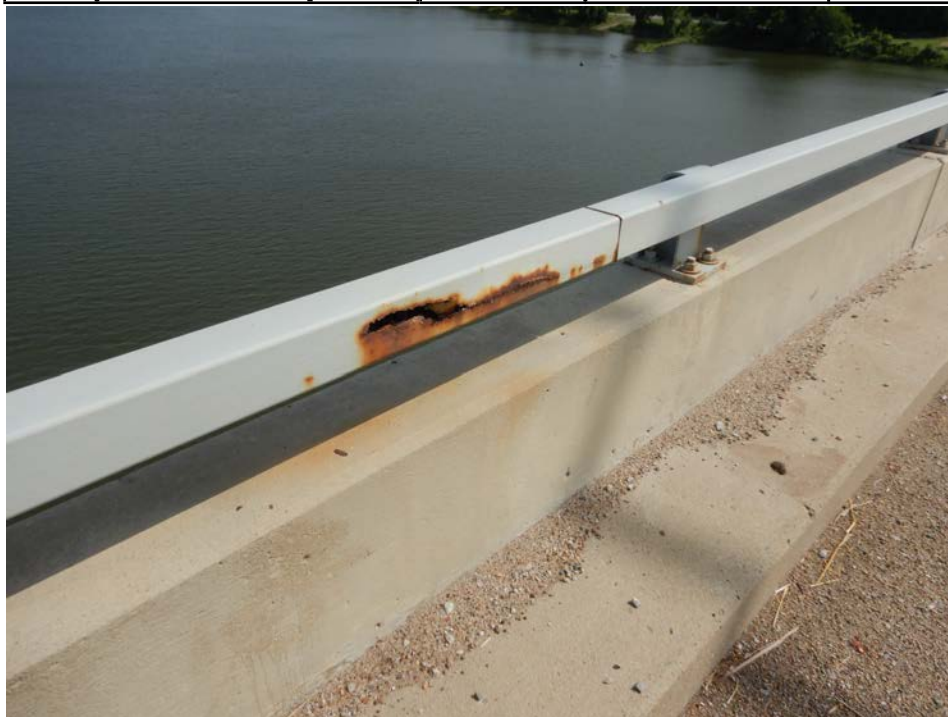
- East sidewalk in span 3 exhibits a 15-square-foot delamination.
- Corrosion holes through the steel tube were observed through the south bridge rail near floor beam 7, span 7, and in the north bridge railing in span 6, near pier 6 **(photo 4)**.

Photograph 4 - Looking northeast at the north bridge railing in span 6 near pier 6. Note: corrosion hole through rail.

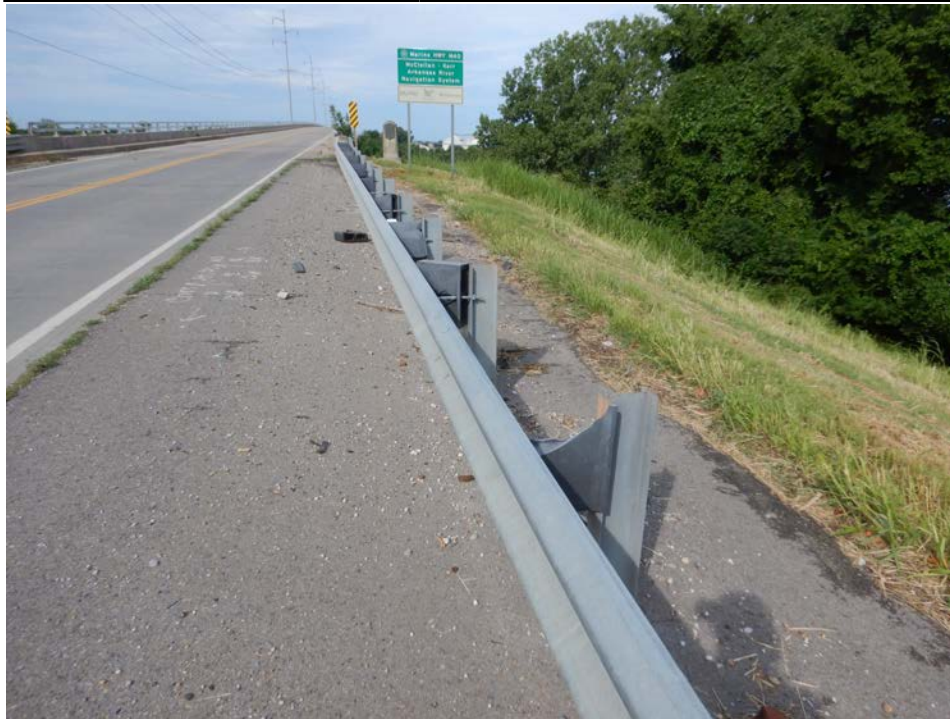
- The west termination of the north bridge railing is missing one rail post.
- The northeast approach railing exhibits multiple twisted/damaged blockouts **(photo 5)**. The southeast approach railing near the east end of the bridge exhibits collision damage to the approach rail and post for 60 feet from the end of the bridge.

Photograph 5 - Looking west along the northeast approach railing. Note: the blockouts have been damaged for 60 feet near the transition.

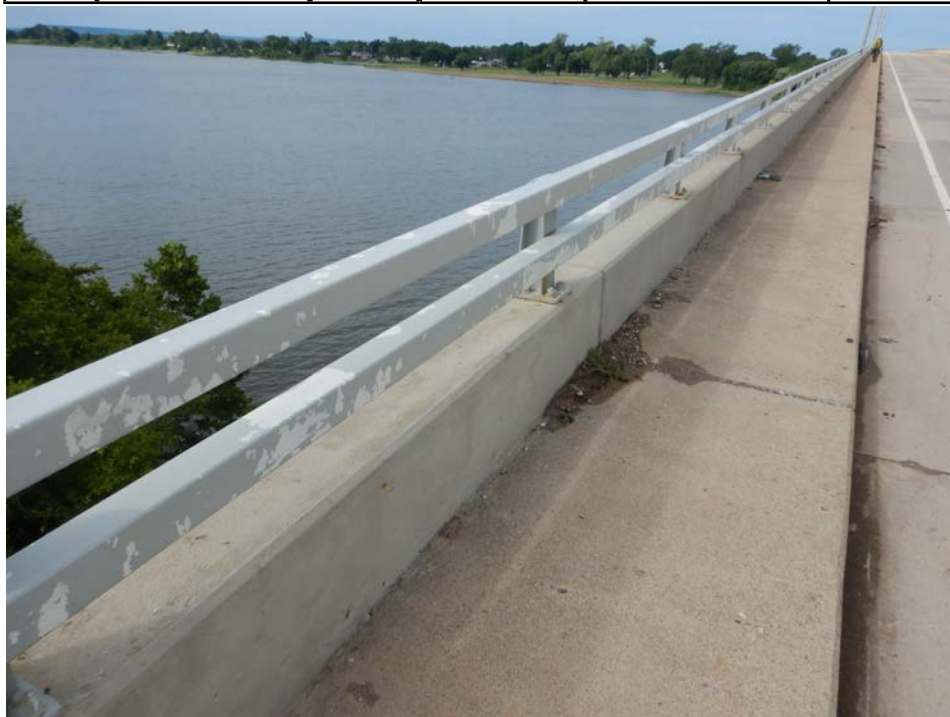
- The south metal rail near floor beam 3, span 10 exhibits minor impact damage.
- Isolated areas of the steel railing painted coating exhibit peeling paint due to adhesion failure between the top and intermediate coats **(photo 6)**. Areas of corrosion are beginning to bleed through. Isolated areas of the concrete rail skim coat exhibit minor cracking.

Photograph 6 - Looking southwest at the south bridge railing in span 14. Note: top coat of paint is peeling due to adhesion failure.

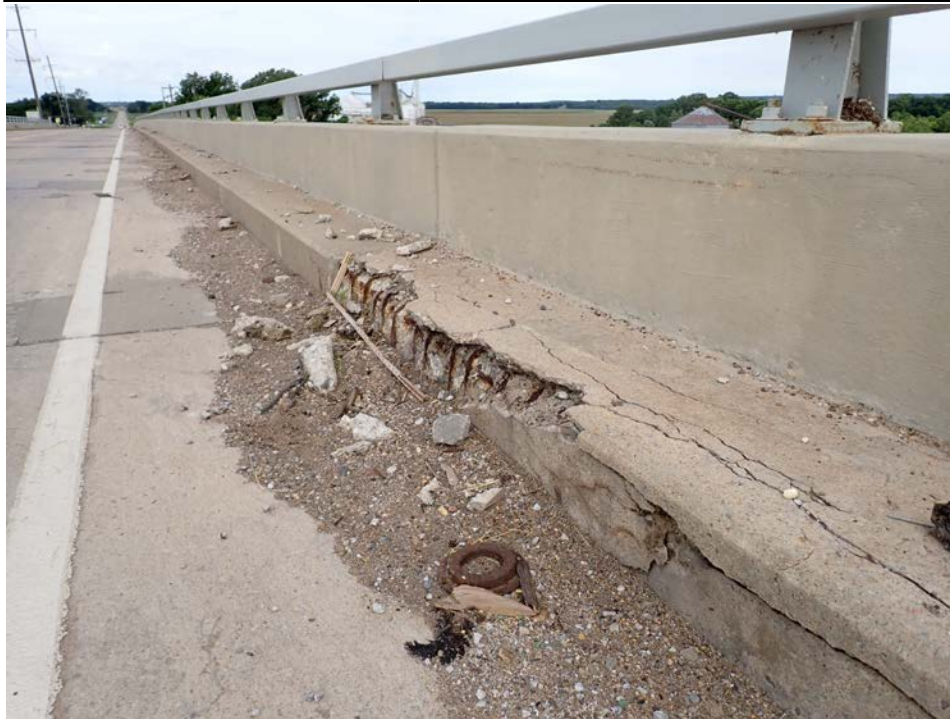
- Minor debris exists along the toe of both the north and south barriers.
- The curbs exhibit active vertical cracks and small spalls with exposed reinforcing due to insufficient cover **(photo 7)**. These are not currently problematic.

Photograph 7 - Looking northwest at the north concrete curb at mid span of span 3. Note: 7-foot-long by full curb height spall with exposed and corroded reinforcing steel.

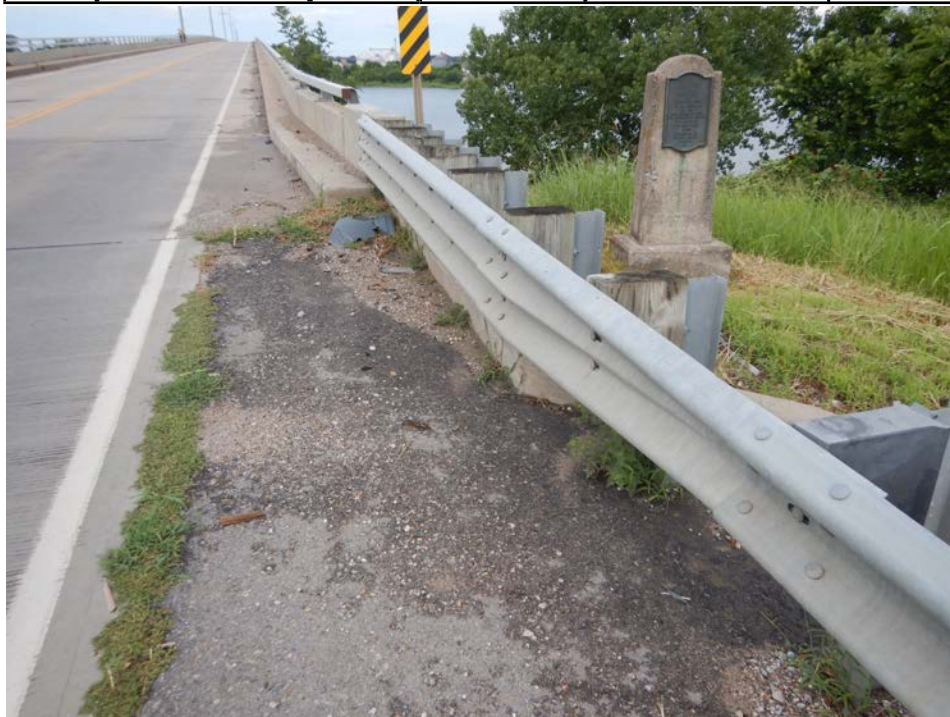
Photograph 8 - Looking west at the northeast approach railing transition. Note: transition meets current standards; however, safety curb extends 14 inches from face of railing and is unprotected.

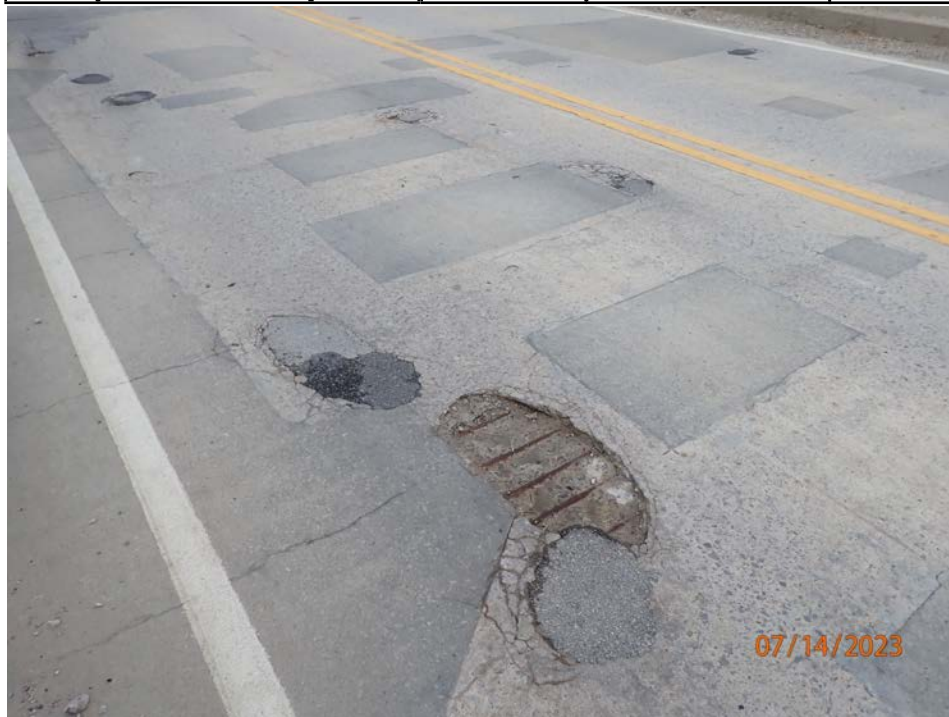
Photograph 10 - Looking northwest at span 7 deck top eastbound lane. Note: 2-foot-long by 1-foot-wide by up to 3-inch deep pothole with 5 exposed and corroded transverse reinforcement.

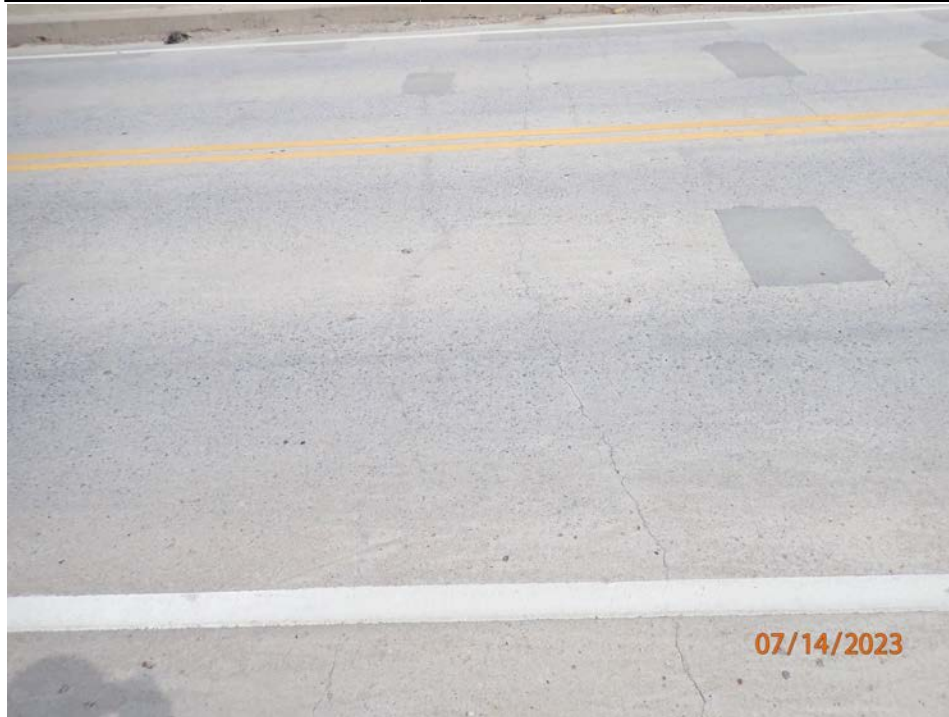
Photograph 11 - Looking north at span 5 top of deck. Note: transverse cracking spaced 1 to 3 feet apart.

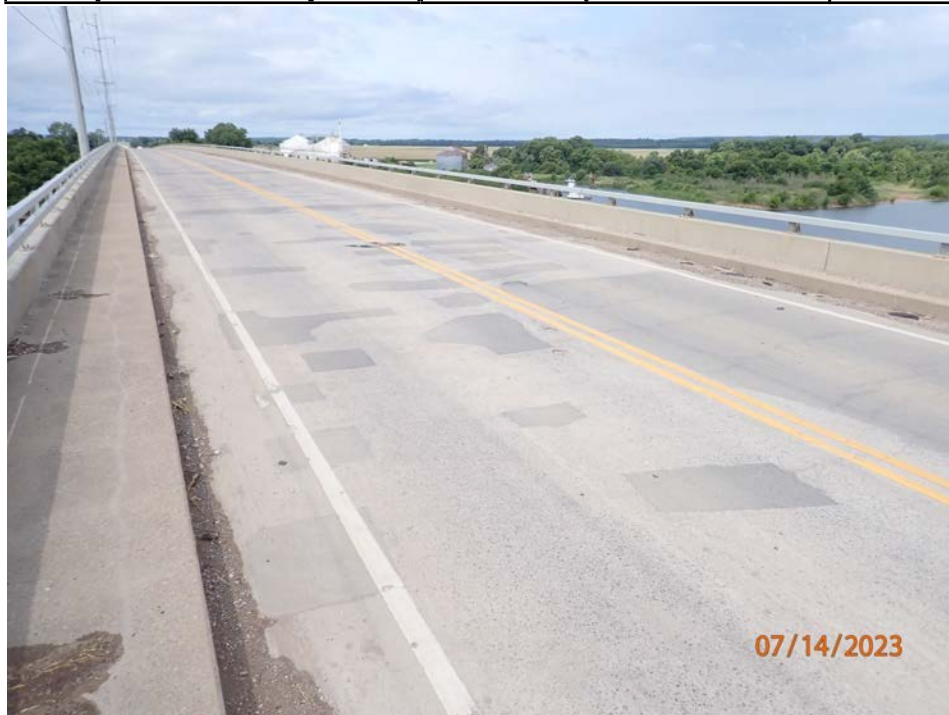
Photograph 12 - Looking northwest at span 7 deck top. Note: typical patching in good condition throughout the bridge.

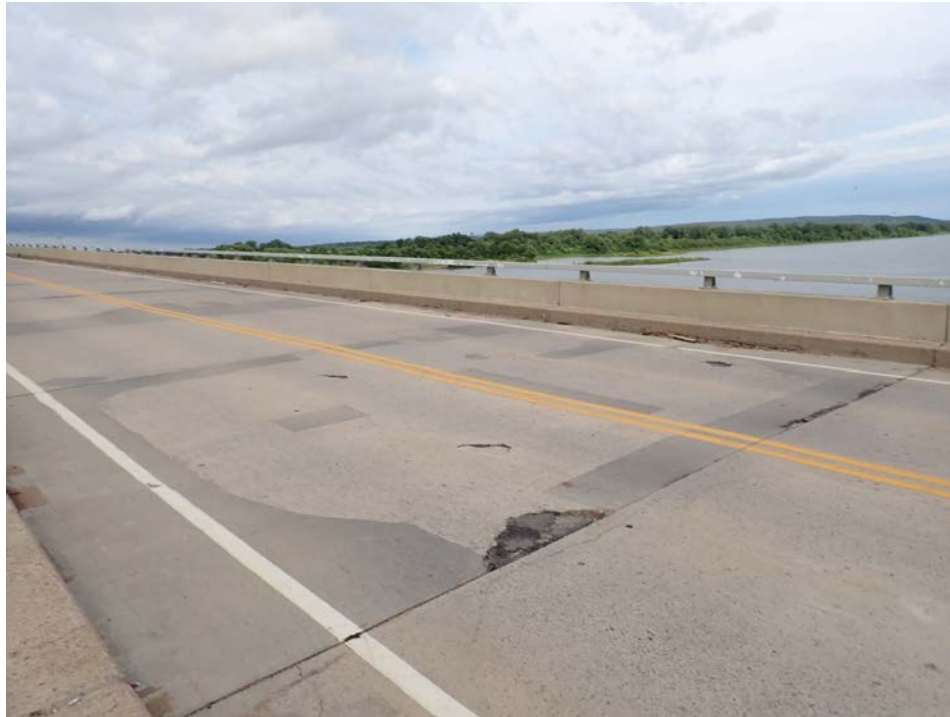
Photograph 13 - Looking northwest at the deck near mid span of span 14. Note: concrete patches throughout with isolated asphalt patches and spalling.

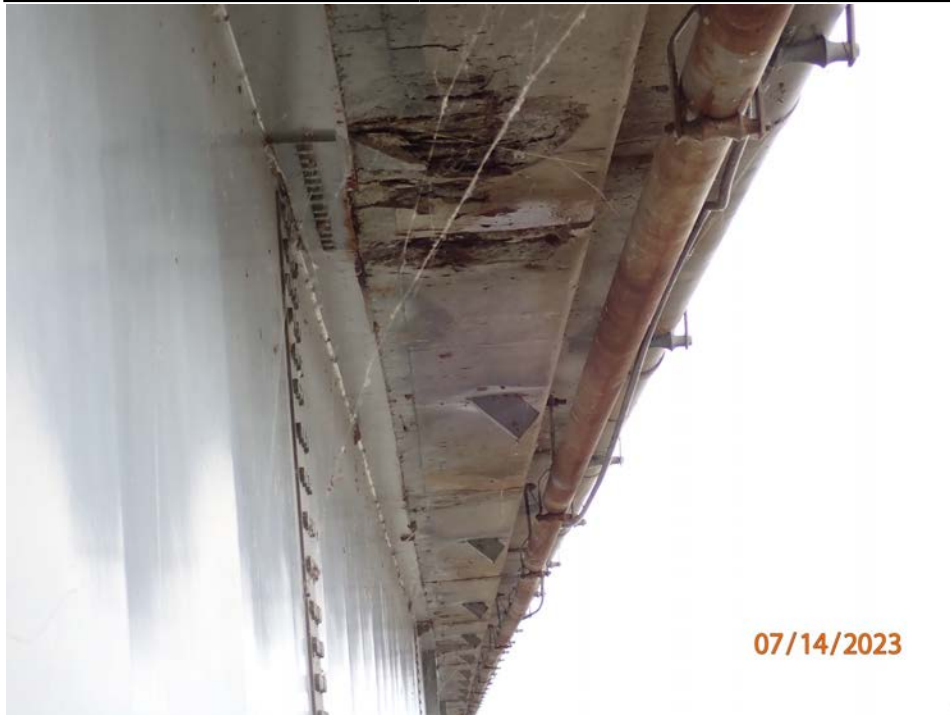
- **FX** – Isolated spalls typically 4 to 6 square feet and up to 3/4 inch deep with exposed reinforcing steel exist on the soffit (**photo 14**). These spalls are not currently problematic.

Photograph 14 - Looking west at span 12 north soffit overhang near pier 12. Note: typical spalling with exposed and corroded reinforcement.

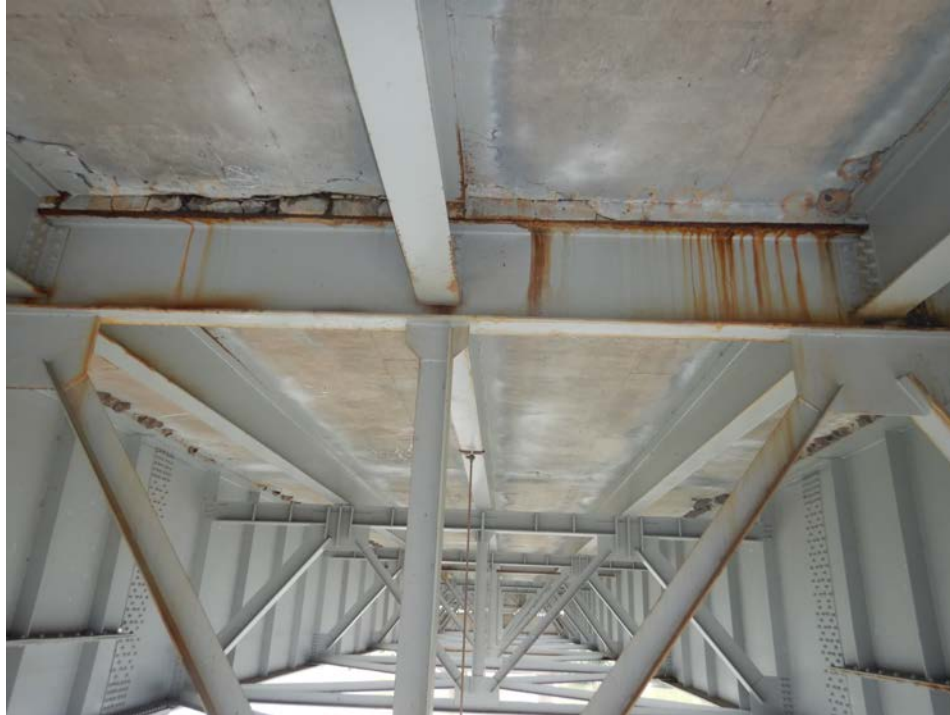
- **FX** – Shallow spalls are common along the top flange of girders, floor beams, and stringers. Isolated locations have larger spalls up to 1-foot-wide with exposed corroding reinforcing steel (**photo 15**). This spalling is most likely due to pack rust between the superstructure and the deck.

Photograph 15 - Looking east at floor beam 3, span 7. Note: pack rust and section loss exists along the top flange of the floor beam. Spalls are typical in the deck soffit adjacent to the floor beam.

- Monitor the deck soffit along the girders, floor beams and stringers for further spalls falling into the channel.
- Monitor the vertical offset of the finger joints for changes in height at piers 4 and 7.

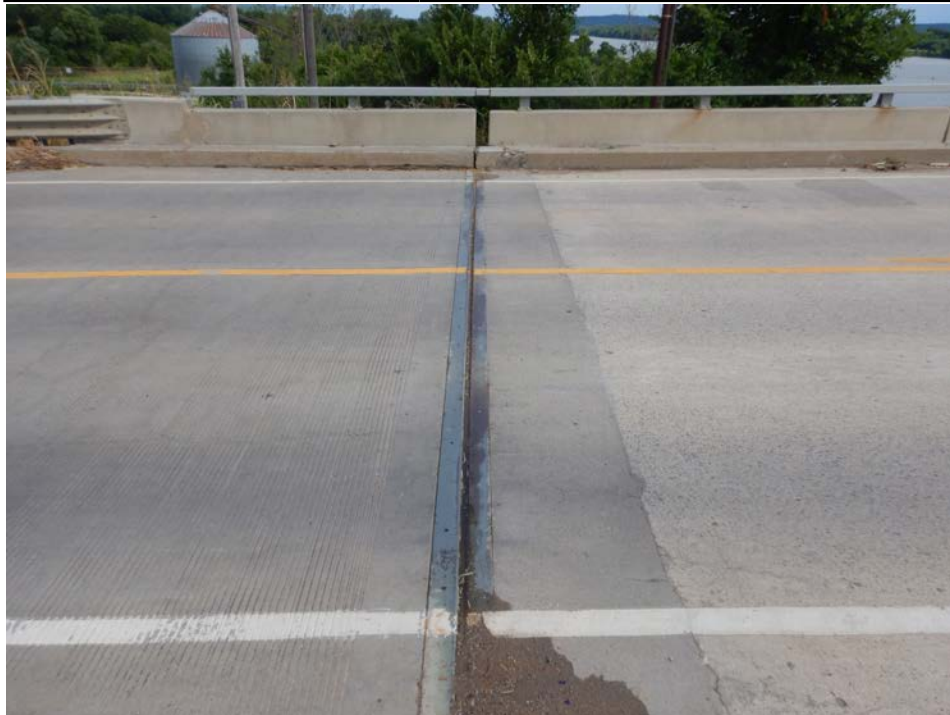
- **PX** – The poured fixed joint at the abutments exhibits minor to moderate debris impaction, debonded seals, and a few shallow spalls and patches in the headers (**photo 16**).

Photograph 16 - Looking north along the sealed expansion joint at the west abutment. Note: moderate debris impactation throughout.

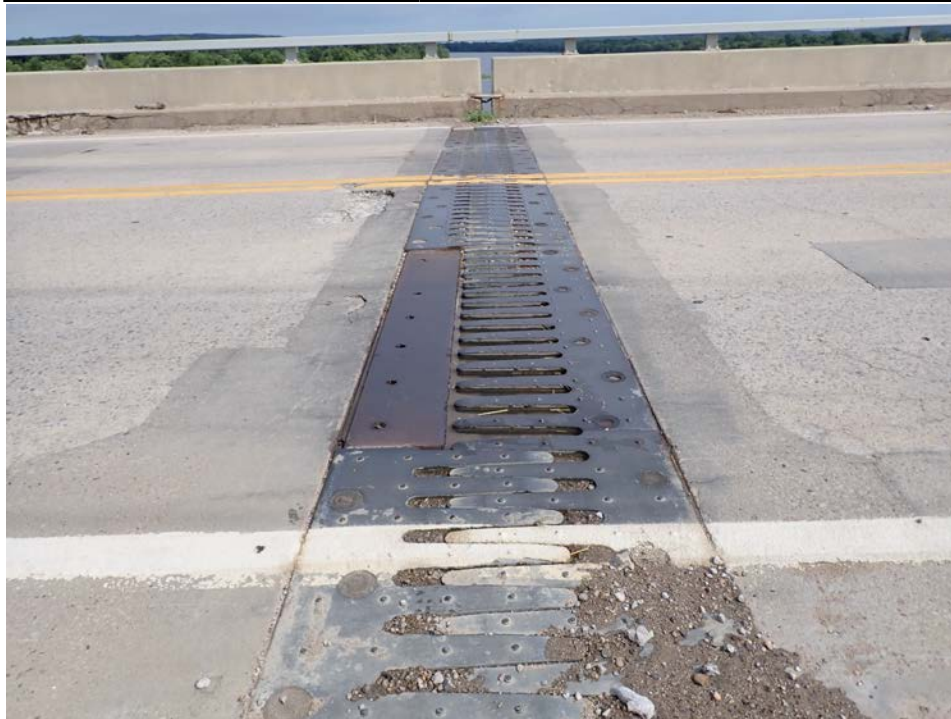
- **FX** – The poured fixed joint armor at the west abutment exhibits a 1-inch vertical offset with the deck armor lower than the approach armor.
- The finger joints at piers 4 and 7 have an elastomeric trough under the joints. Debris has filled the trough causing debris impaction with most severe conditions observed at the shoulders (**photo 17**). The seal is torn at pier 7 (**photo 18**).

- Two 5-foot-long sections of the pier 4 finger joint have been replaced with a welded steel plate (**photo 17**). Both finger joints have a slight vertical offset of 1/8 to 3/8 inch.

Photograph 17 - Looking north along the finger joint over pier 4. Note: 5 feet of missing fingers on span 4 side in east travel lane, 4 feet missing in span 4 side near the north shoulder. Heavy debris compaction for the full length inhibits expansion of joint.

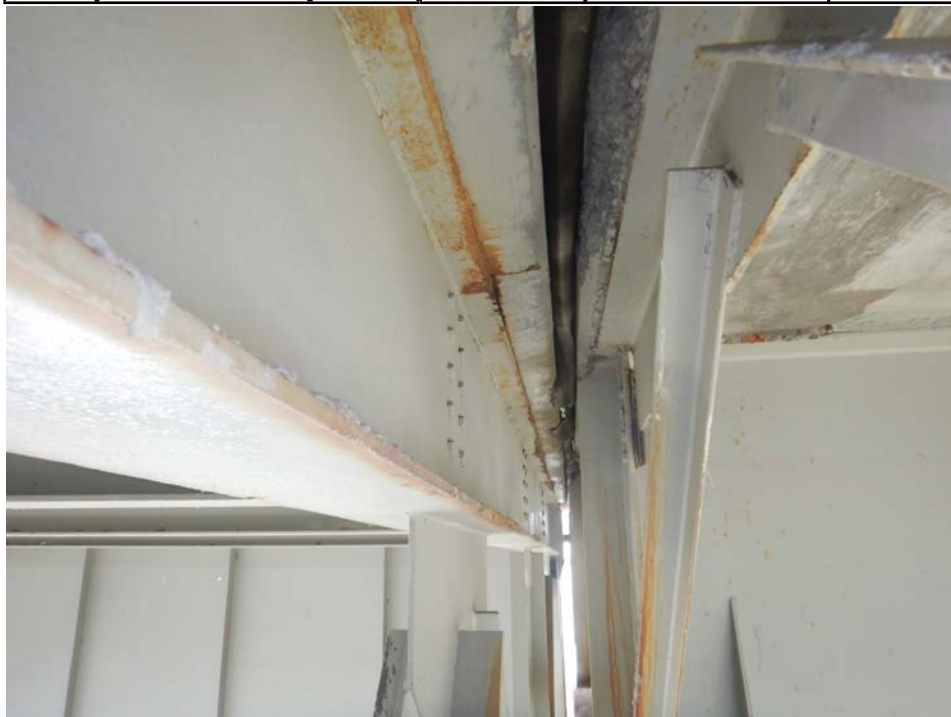
Photograph 18 - Looking north along the underside of the finger joint over pier 7. Note: trough torn and falling through along the underside.

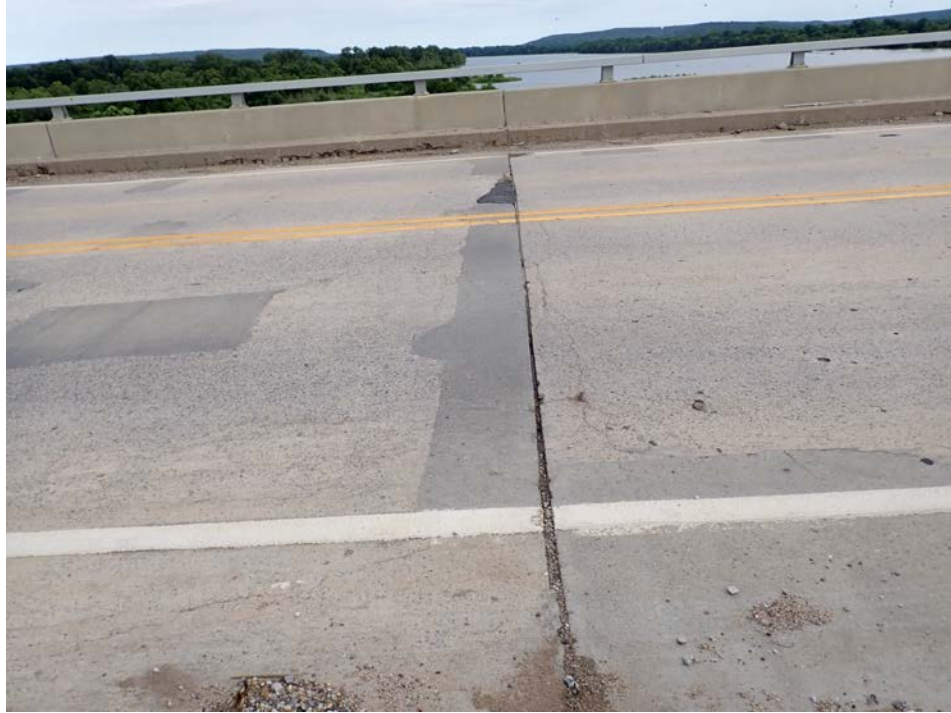
- Poured seal deck control joints are typically spaced at 18 feet in the approach spans and at 50 to 75 feet in the main spans. Joint seals exhibit areas of failure and the joint headers exhibit cracking and/or spalling up to 2 feet long and 2 inches wide, some with exposed reinforcement. Isolated areas have been patched with asphalt since the previous inspection (**photo 19**).

Photograph 19 - Looking north along the construction joint over floor beam 2 in span 3. Note: typical condition, isolated spalls/delaminations with concrete and AC patches.

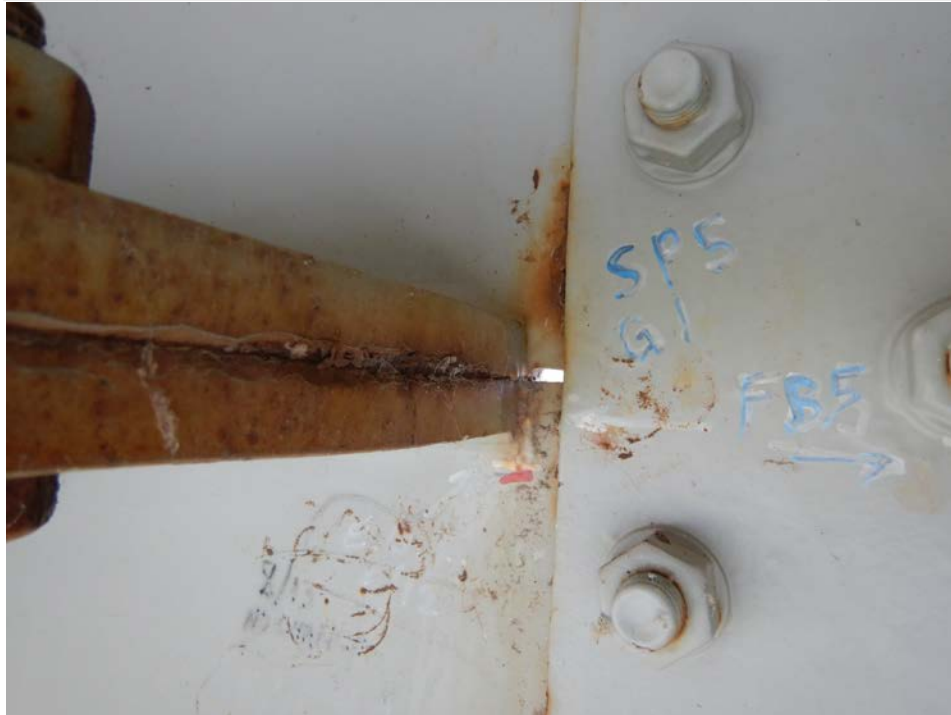
- Span 5, girder 1 at the field splice near floor beam 5 – 5/8-inch-long crack with no arrestor hole.
 - Span 5, girder 2 at the field splice near floor beam 5 – paint crack.

Photograph 20 - Looking southeast at girder 1, span 5 at the field splice near floor beam 5. Note: 5/8-inch-long crack in the inboard face at the horizontal web splice termination.

- Arrest girder web cracks at the horizontal splice termination at:
 - Span 5, girder 1 at the field splice near floor beam 5 – 5/8-inch-long crack with no arrestor hole.

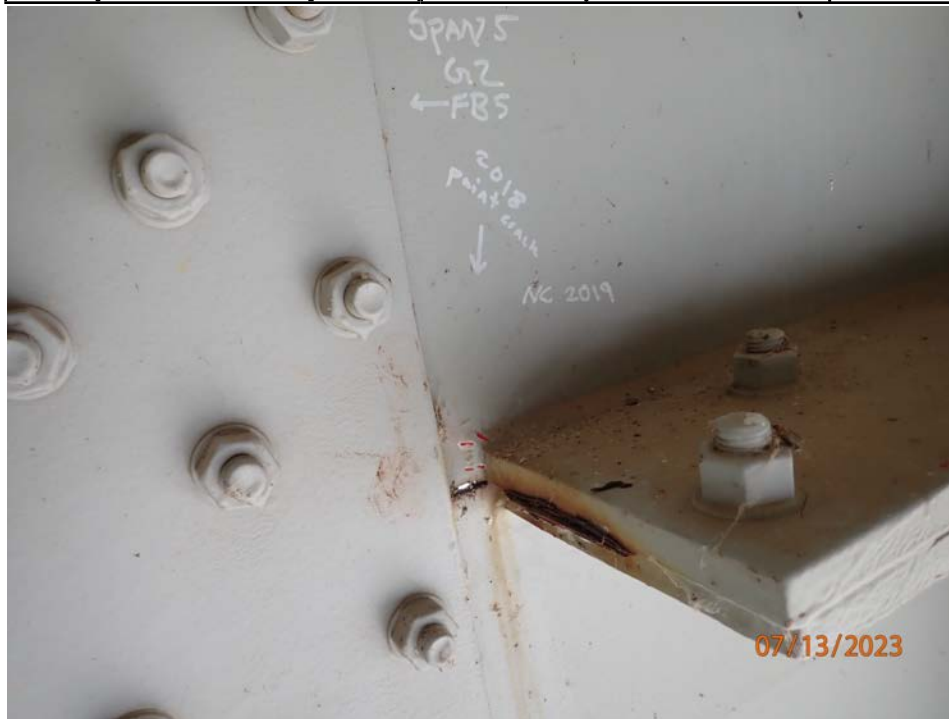
Photograph 21 - Looking northeast at girder 2, span 5 at the field splice near floor beam 5. Note: 3/8-inch-long paint crack in the inboard face at the horizontal web splice termination.

- Monitor locations of girder web cracks having drilled hole retrofits or paint cracks at the horizontal splice termination at:
 - Span 5, girder 2 at the field splice near floor beam 5 – paint crack.

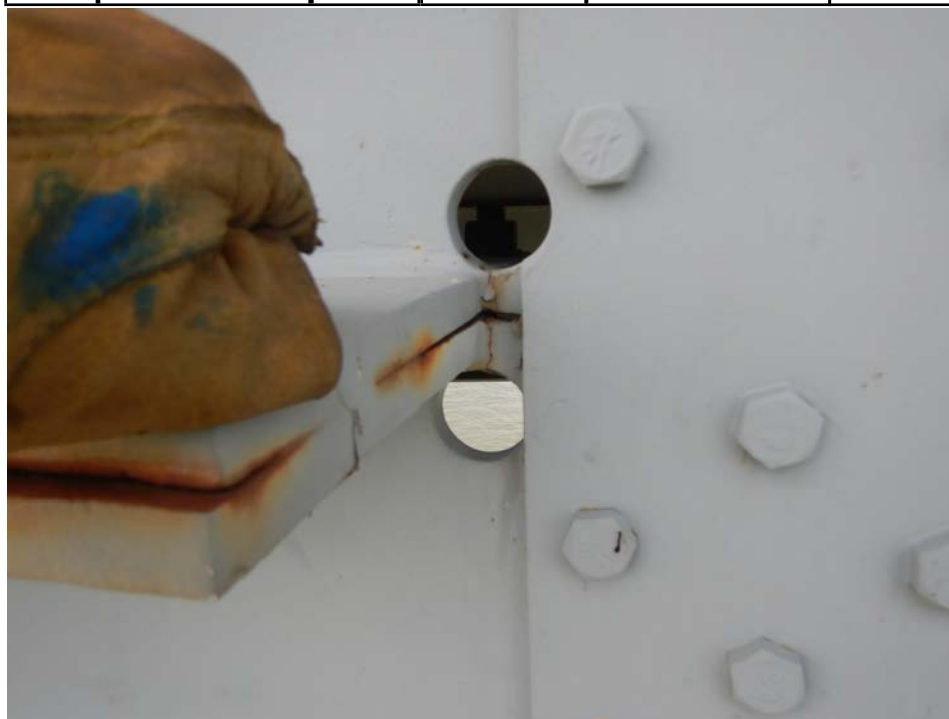
Photograph 22 - Looking north at girder 1, span 6 at the field splice near floor beam 3. Note: 3/4-inch-long crack in the inboard face at the horizontal web splice termination has not propagated past the arrestor holes.

- Span 6, girder 1 at the field splice near floor beam 3 – arrested crack.
 - Span 7, girder 1 at the field splice near floor beam 4 – paint crack.
 - Span 7, girder 2 at the field splice near floor beam 4 – arrested crack.

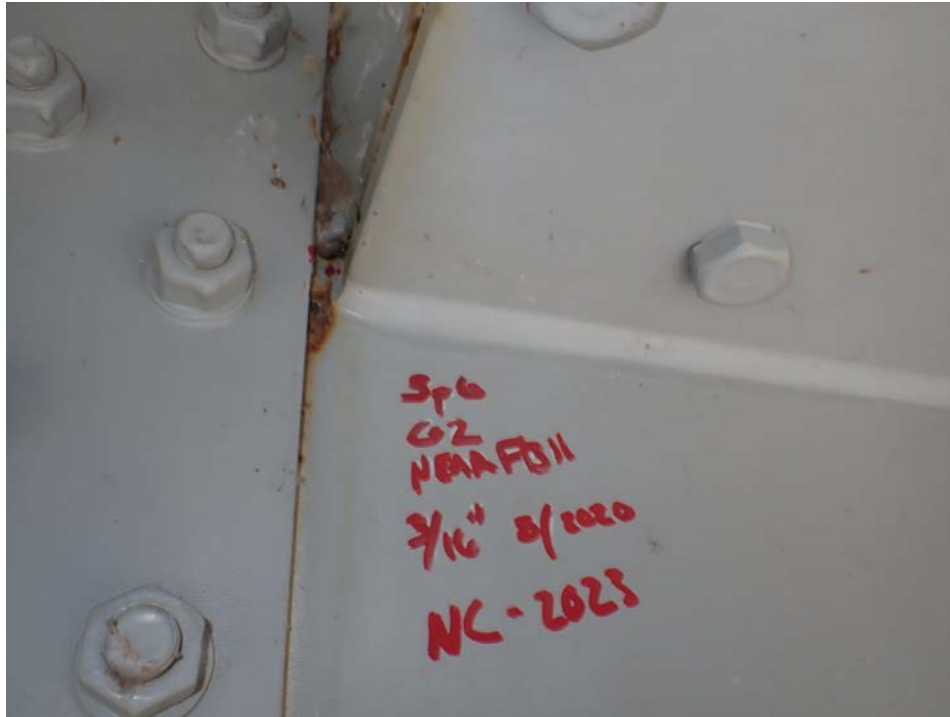
Photograph 23 - Looking north at girder 2, span 6 at the field splice near floor beam 11. Note: 3/16-inch-long crack in the inboard face at the horizontal web splice termination.

- Span 6, girder 2 near floor beam 11 – 3/16-inch-long vertical crack in the lower web plate.
- Replace missing bolts and tighten loose bolts at
 - Girder splice locations

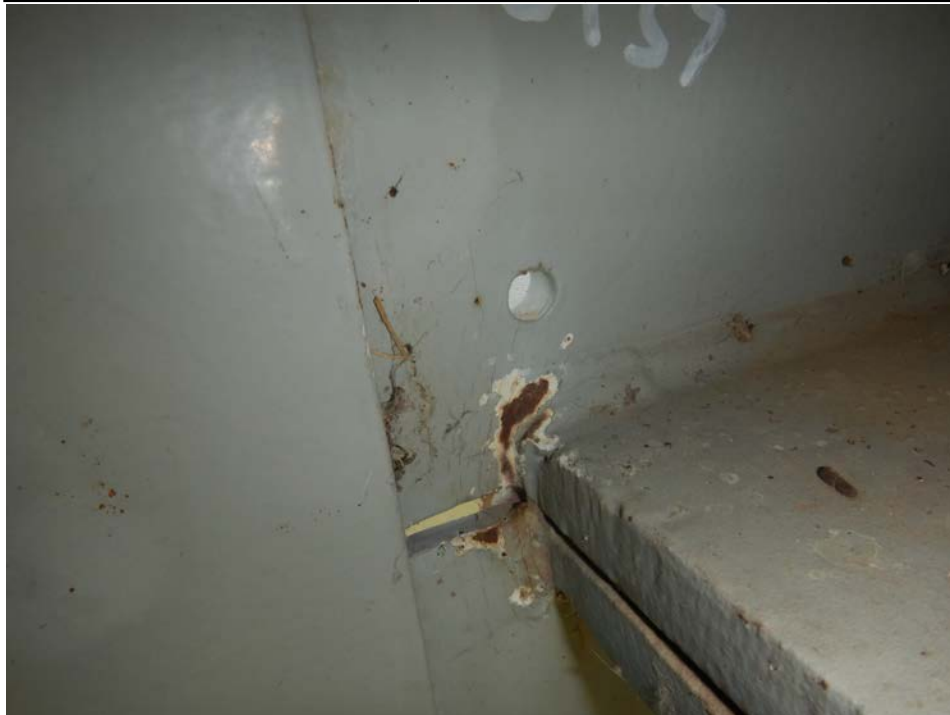
Photograph 24 - Looking southwest at girder 1, span 7 at the field splice near floor beam 4. Note: 1-inch-long paint crack in the upper web with an arrestor hole, and a 1 1/8-inch-long paint crack in the lower web without an arrestor hole in the inboard face at the horizontal web splice termination.

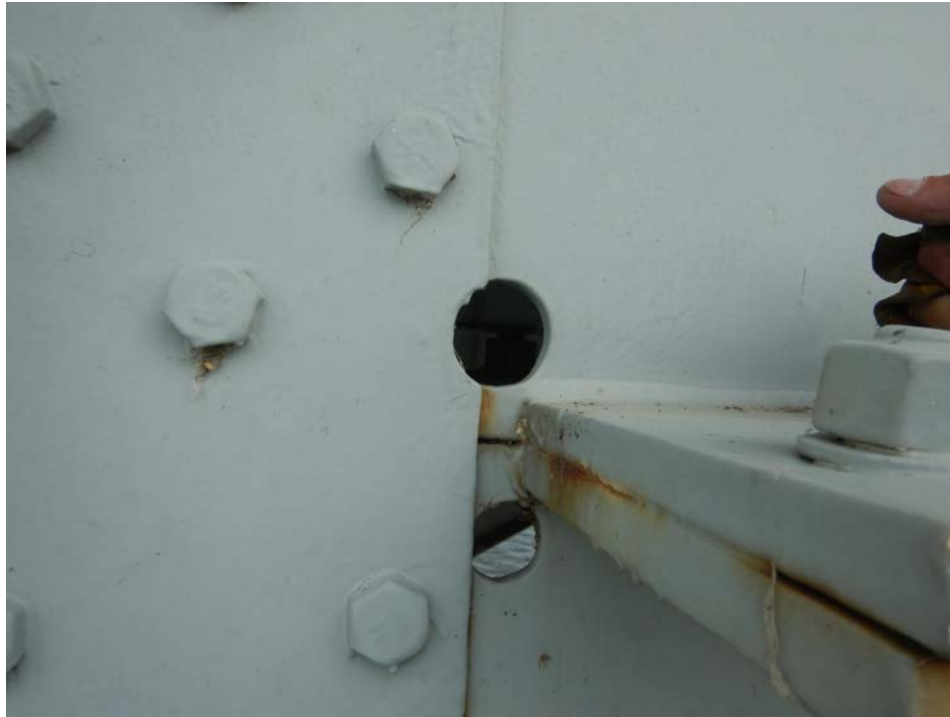
Photograph 25 - Looking south at girder 2, span 7 at the field splice near floor beam 4. Note: no cracks in outboard face of girder web

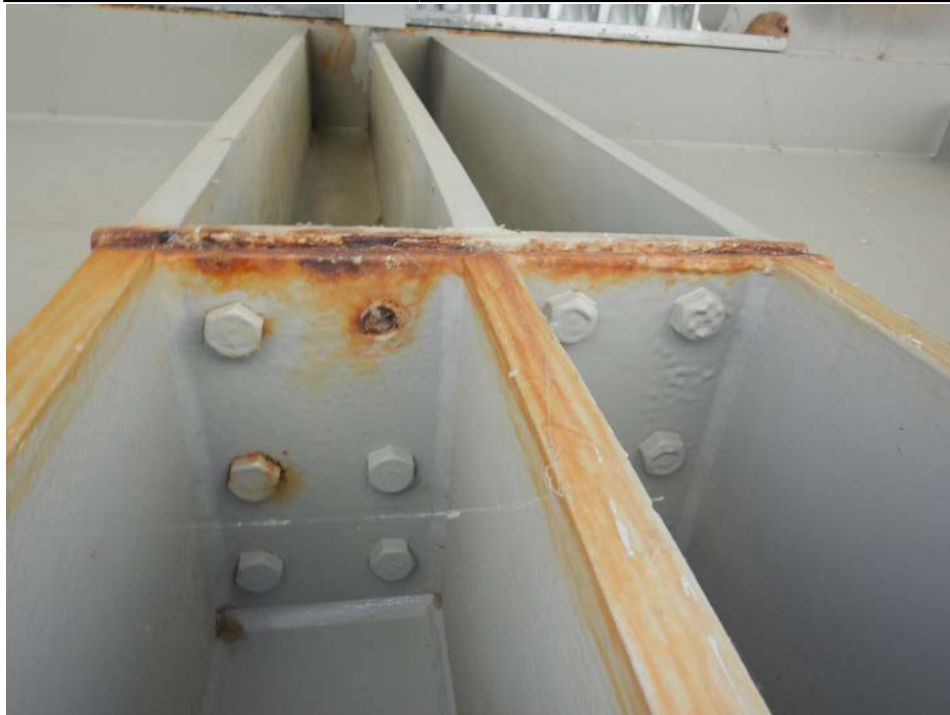
Photograph 26 - Looking up along the outboard face of the bearing stiffener for girder 1 at pier 6. Note: 1 missing bolt in horizontal splice. Corrosion and pitting exist at the splice interface.

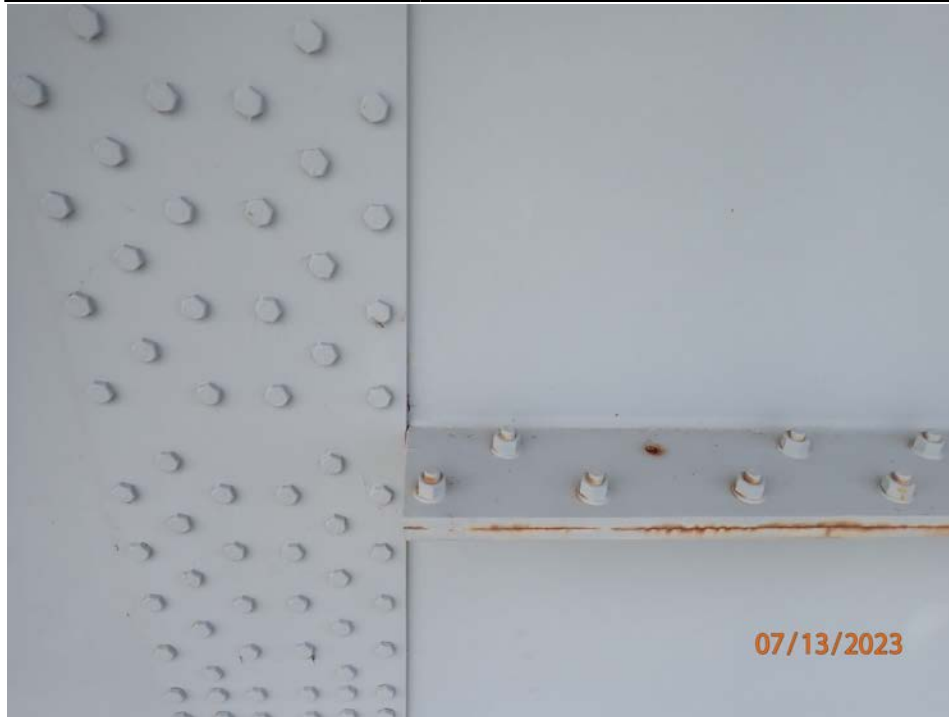
Photograph 27 - Looking north at the span 6, girder 2 field splice near floor beam 12. Note: 1 missing bolt in the horizontal splice.

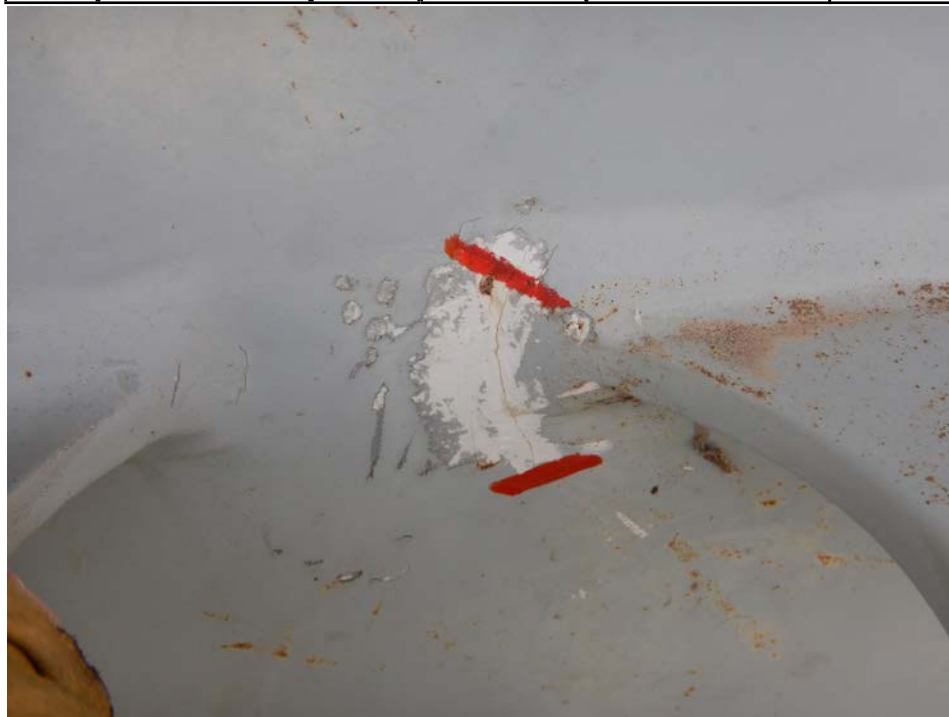
- Girder web cracks at:
 - Span 5, girder 1 (south face) between floor beams 4 and 5 – 1 1/4-inch-long paint crack in web at the longitudinal stiffener cored hole (perform Magnetic Particle Testing during 2022 Other/Special inspection)

Photograph 28 - Looking north at girder 1, span 5 at the lower longitudinal stiffener splice between floor beams 4 and 5. Note: 1 1/4-inch long vertical paint crack in the girder web.

- Monitor the 1 1/4-inch long paint crack in the span 5, girder 1 web at the longitudinal stiffener cored hole between floor beams 4 and 5 (perform Magnetic Particle Testing during 2022 Other/Special inspection).

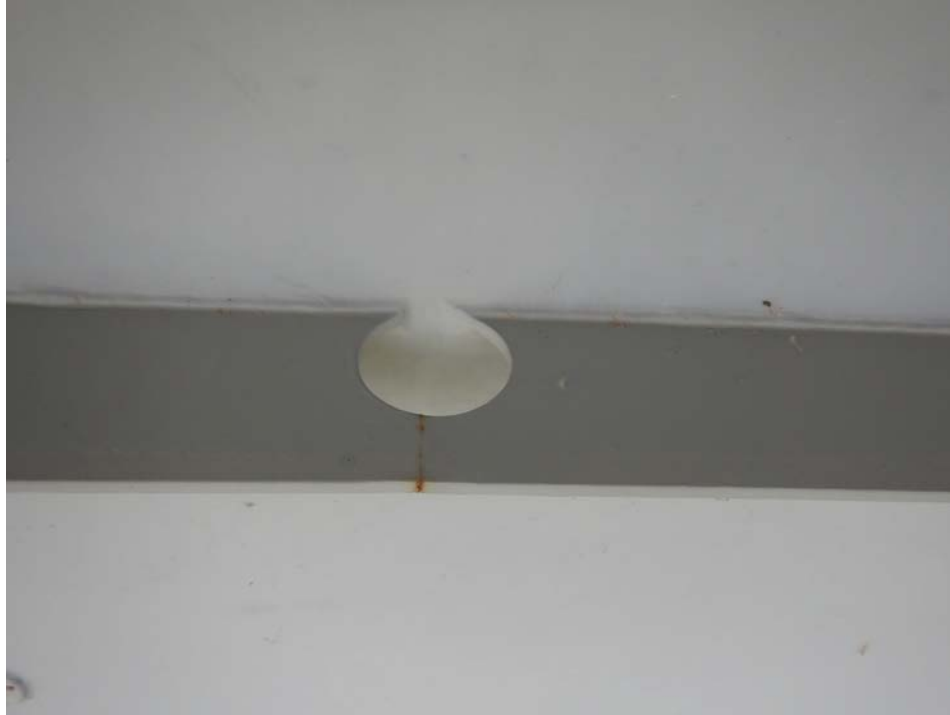
Photograph 29 - Looking north at girder 1, span 6 at the upper longitudinal stiffener splice near floor beam 7. Note: crack in splice on free edge side of cored hole.

- Monitor cored hole locations in the longitudinal stiffeners for crack development in the girder web.
- Monitor bow in the web of girder 1, span 7 at the field splice between floor beams 3 and 4.

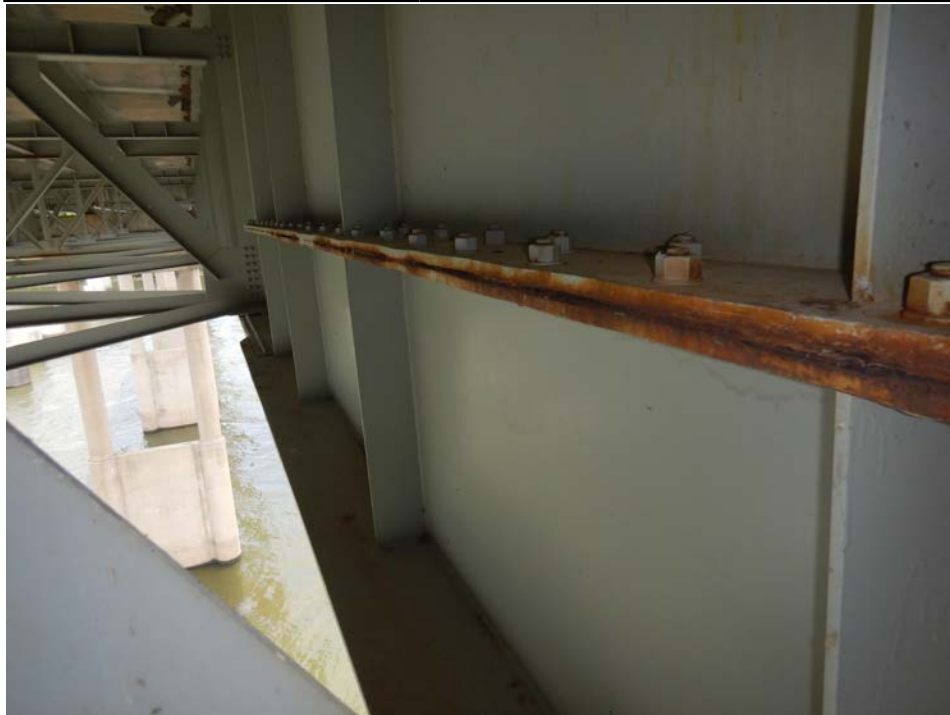
Photograph 30 - Looking south along the girder 1, span 7 horizontal splice. Note: 1/4-inch-thick pack rust exists between the splice plates.

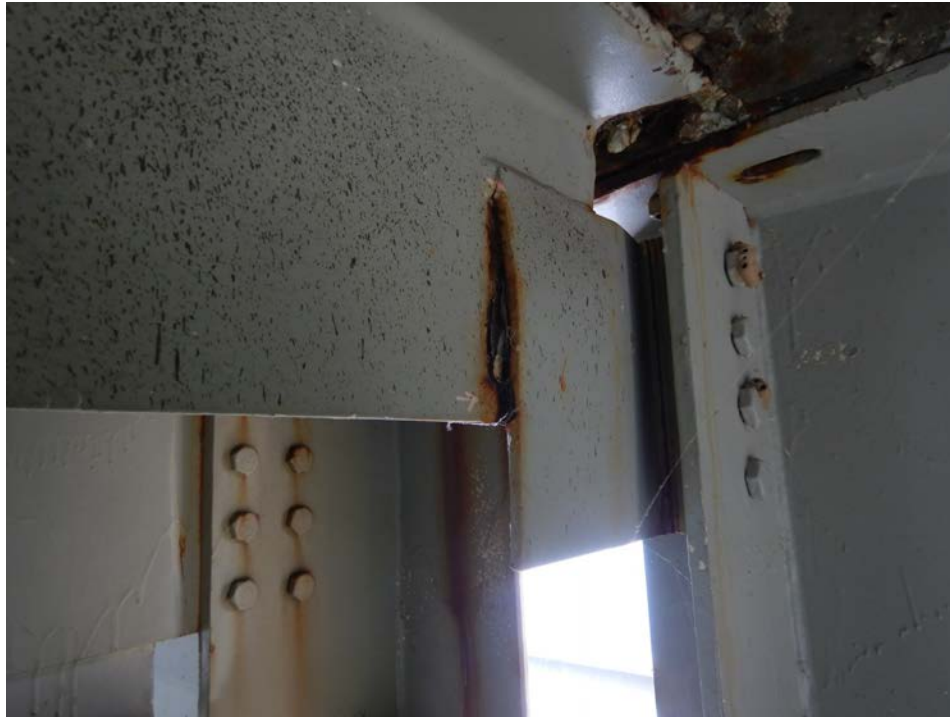
Photograph 31 - Looking southeast at the end diaphragm connection to girder 1, span 4 at pier 4.
Note: pack rust has broken the bottom and vertical welds.

- Monitor cracked welds at cross frame connection to girders due to pack rust.
- Monitor cracks at the stringer connection angles at:
 - Span 5, stringer 3 connection to floor beam 3
