Fracture Critical Bridge Inspection Report

NBI Bridge No.: 17611

Route S.H. 100 over ARKANSAS RIVER
Muskogee County

7/14/2023

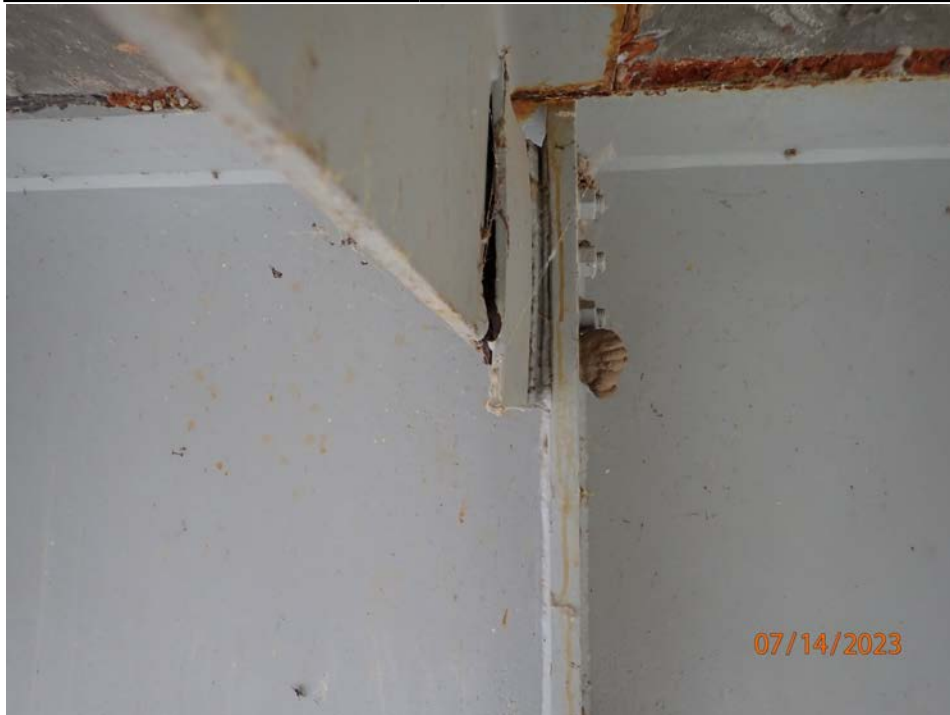
Photograph 32 - Looking north at cross frame connection to girder 2 over pier 12. Note: full-length crack in gusset plate to cross frame connection due to pack rust.

- Monitor cracked welds at cross frame connection to girders due to pack rust.
- Monitor cracks at the stringer connection angles at:
 - Span 5, stringer 3 connection to floor beam 3

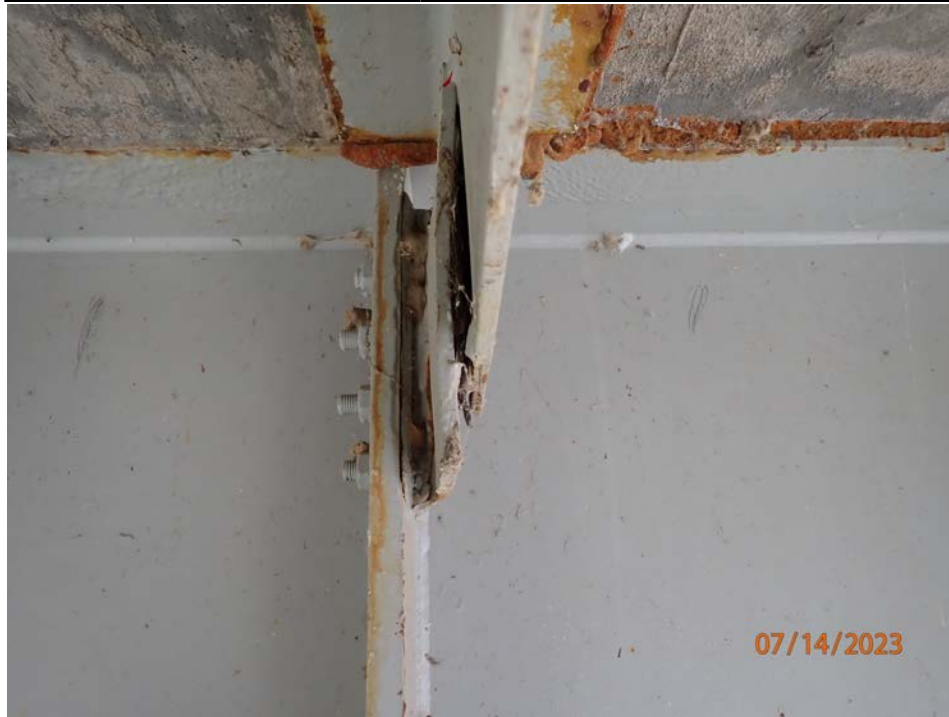
Photograph 33 - Looking south at cross frame connection to girder 3 over pier 12. Note: crack in gusset plate to cross frame connection due to pack rust.

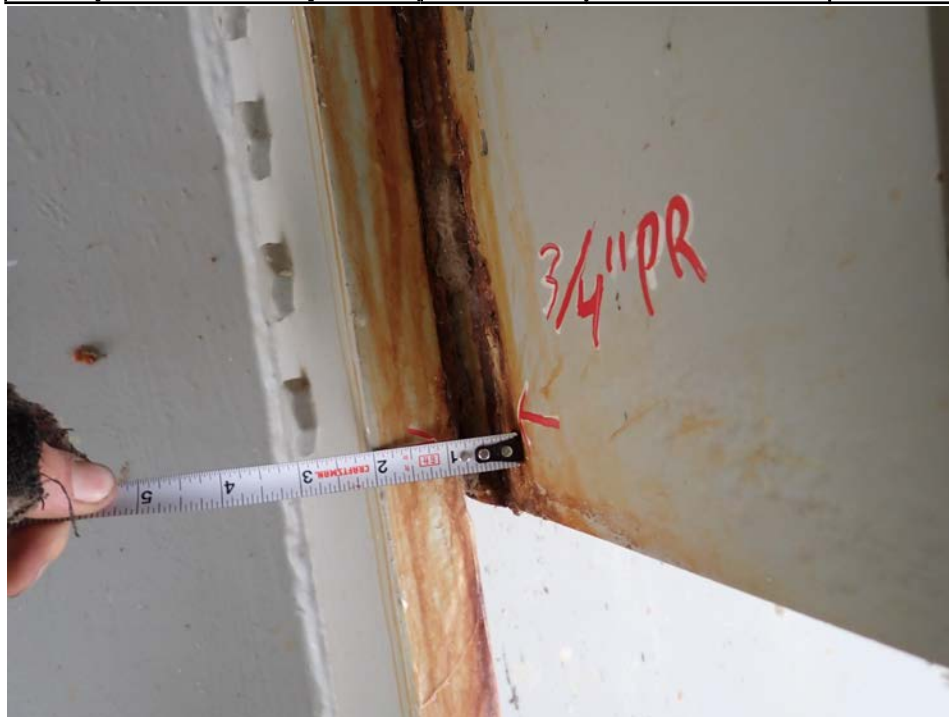
Photograph 34 - Looking southwest at the diaphragm connection to girder 1 over pier 9. Note: typical pack rust between bearing stiffener and diaphragm interface up to 3/4 inch thick.

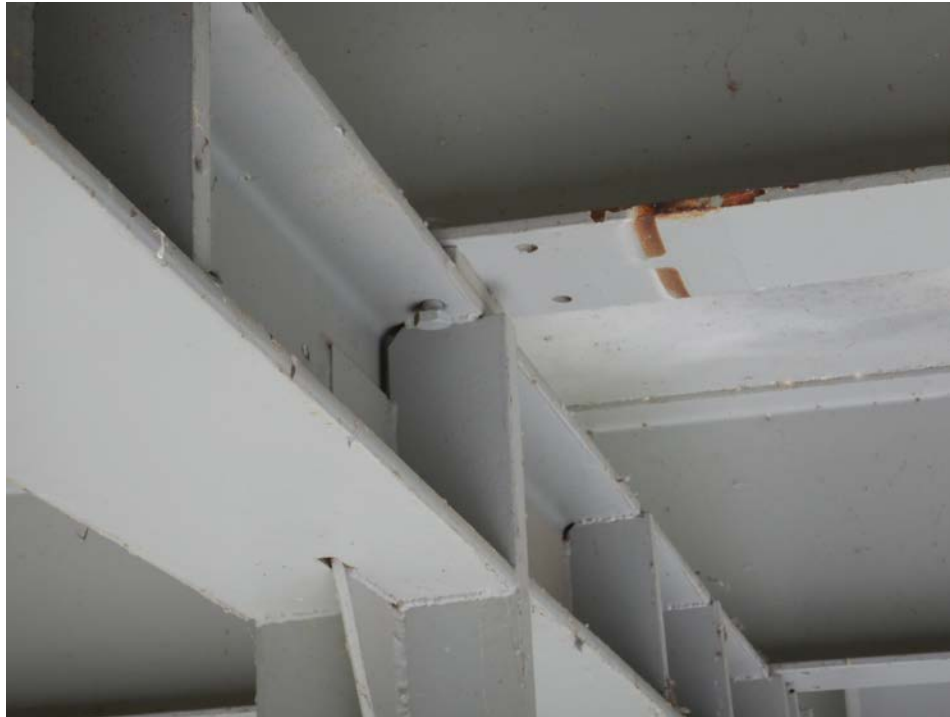
Photograph 35 - Looking north at the stringer 2 connection to floor beam 4, span 5. Note: bolt on east face is loose and bolt holes punched in wrong location.

- Floor beam connection to the girders in spans 5, 6 and 7.
 - Stringer connection to floor beams in spans 5, 6 and 7.
- Repair cracked web connection plate weld for floor beam 6 in span 5 at girder 1.

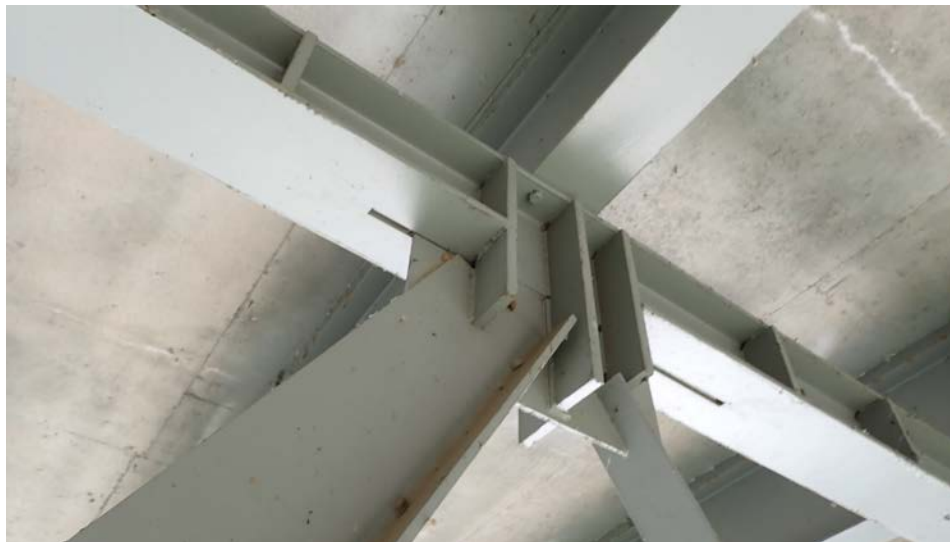
Photograph 36 - Looking southeast at the stringer 3 connection to floor beam 4, span 6. Note: loose bolt stringer connection bolt.

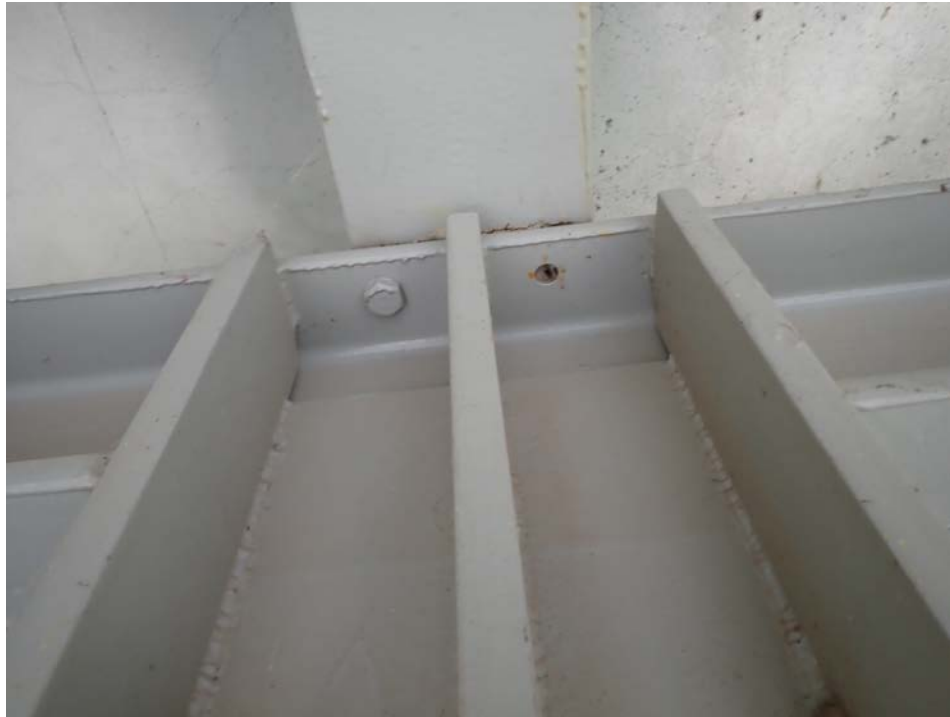
Photograph 37 - Looking east at the stringer 3 connection to floor beam 4, span 7. Note: one missing stringer connection bolt.

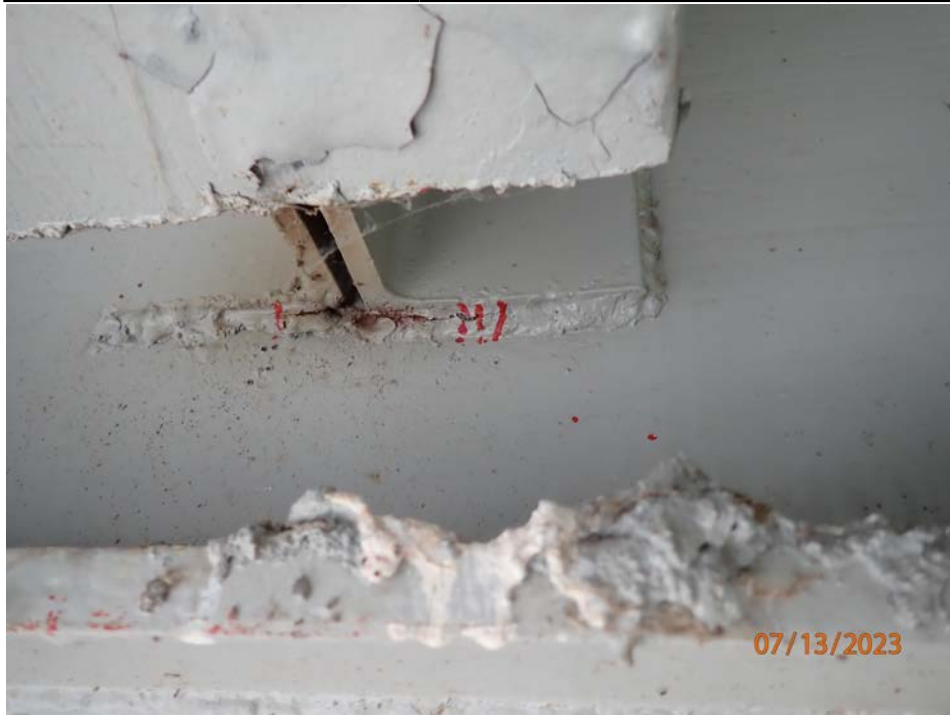
Photograph 38 - Looking west at the stringer 3 connection to floor beam 3, span 5. Note: 3 1/2-inch-long crack along weld on the underside of the stringer connection angles.

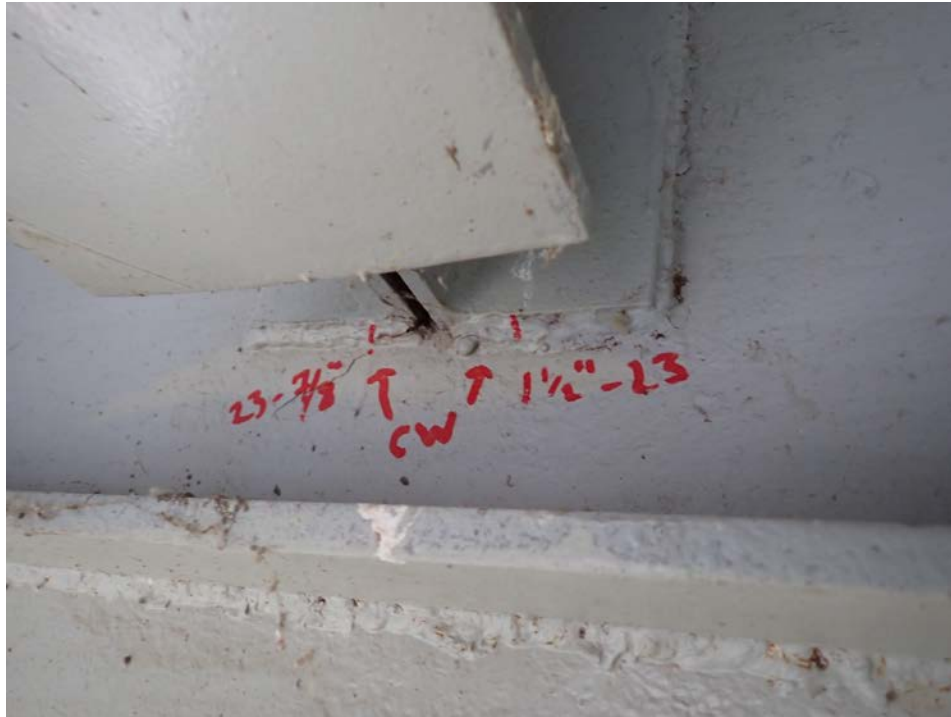
Photograph 39 - Looking west at the stringer 3 connection to floor beam 3, span 7. Note: 1 1/2-inch and 7/8-inch-long cracks in weld on the underside of the stringer connection angles.

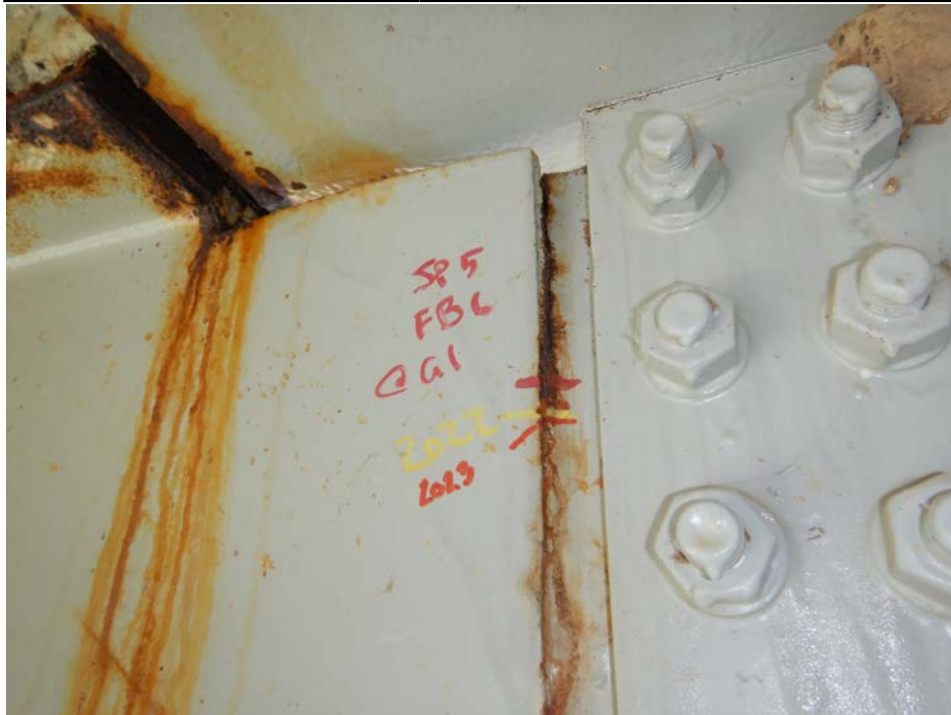
- Cracked floor beam to girder connection welds:
 - Span 5, floor beam 6 upper connection to girder 1 – 5 1/8-inch-long crack in connection plate weld.
 - Span 6, floor beam 0 lower connection to girder 2 – horizontal weld cracked full length.
 - Span 7, floor beam 0 lower connection to girder 2 – 1 1/8-inch-long and 1/2-inch-long cracks in welded repair.

Photograph 40 - Looking east at floor beam 6 connection to girder 1, span 5. Note: 5 1/8-inch vertical crack in connection weld.

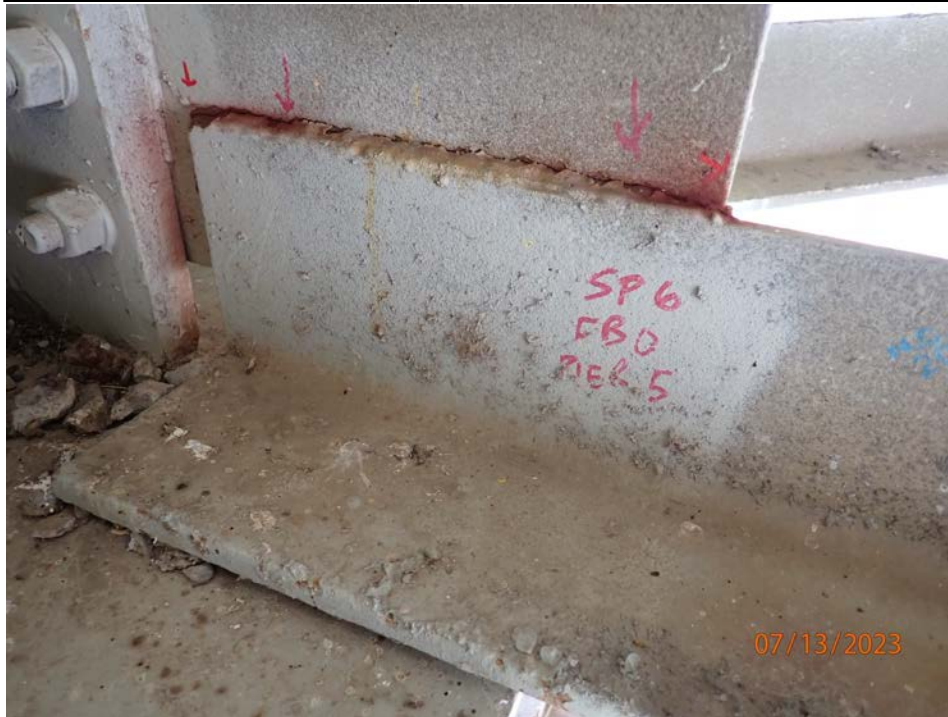
Photograph 41 - Looking east at floor beam 0 lower connection to girder 2 over pier 5. Note: full width crack along the floor beam to gusset plate weld on both faces.

- Reattach floor beam 0 lower connection to girder 2 in span 6. Consider bolting the previously welded connection.
- Repair cracks in the lower lateral bracing in span 5, floor beam 7, girder 2 and span 6, floor beam 12, girder 2.

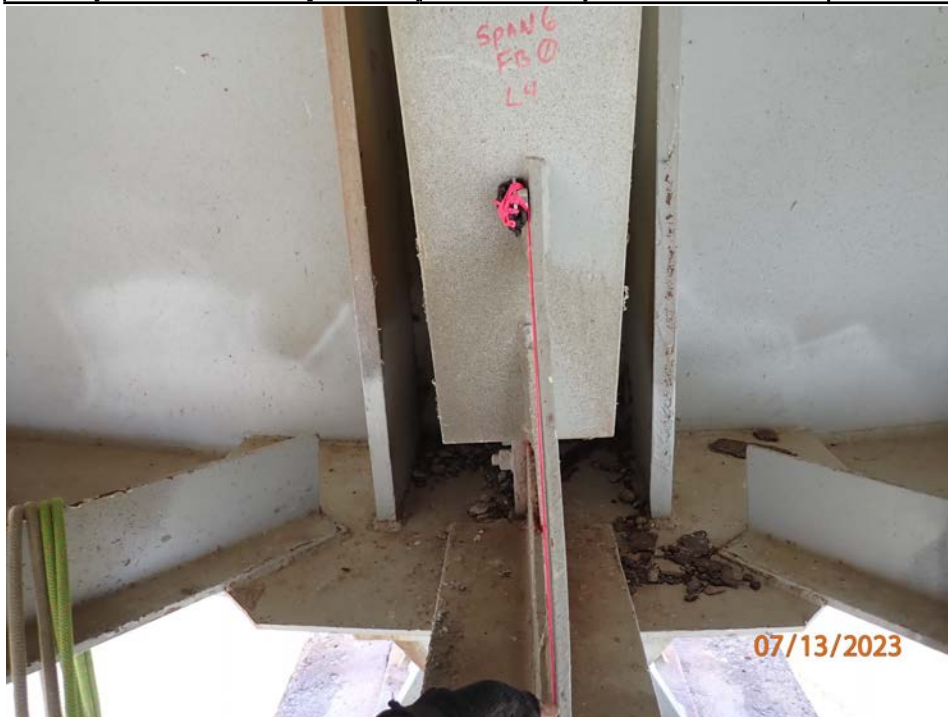
Photograph 42 - Looking north at floor beam 0 lower connection to girder 2 over pier 5. Note: gusset plate has been reinforced with a diagonal bar, which is now bowing out of plane 1/16 inch.

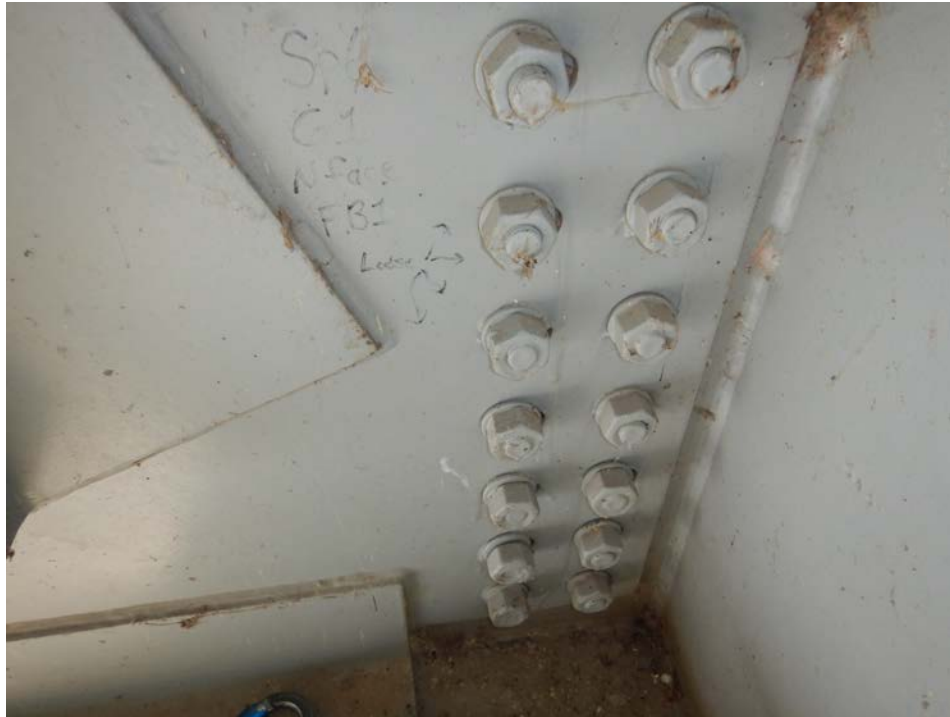
Photograph 43 - Looking east at floor beam 1, span 6 connection to girder 1. Note: loose bolts exist in the bottom strut connection to the girder. Several misdrilled holes exist in the connection.

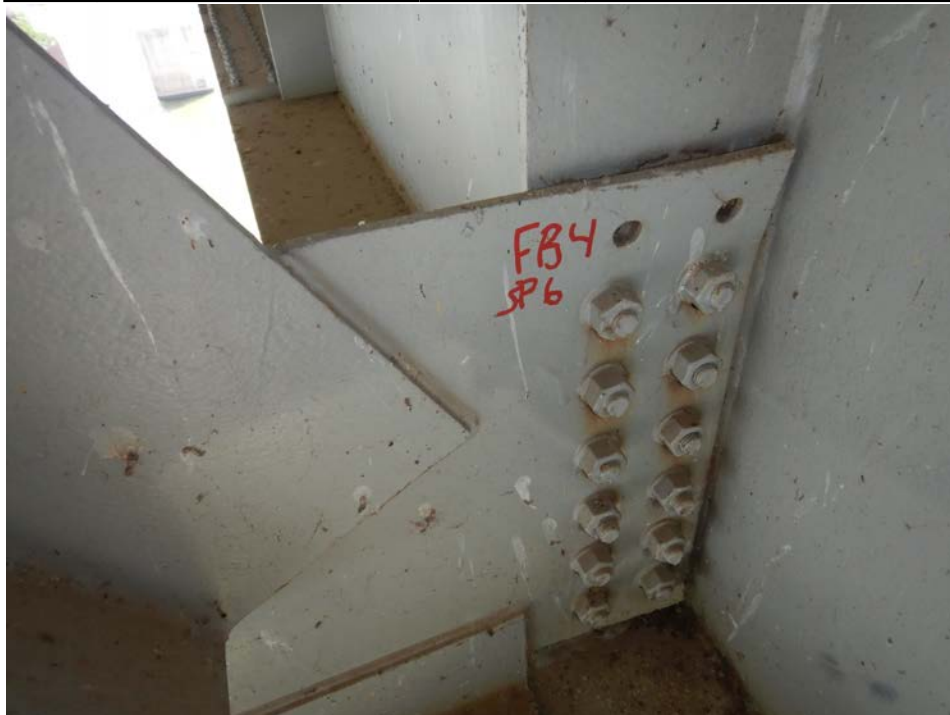
Photograph 44 - Looking east at floor beam 4 span 6, connection to girder 1. Note: 2 blind holes exist in top of the connection plate of the bottom strut. Pack rust is forming between the vertical stiffener and the connection plate.

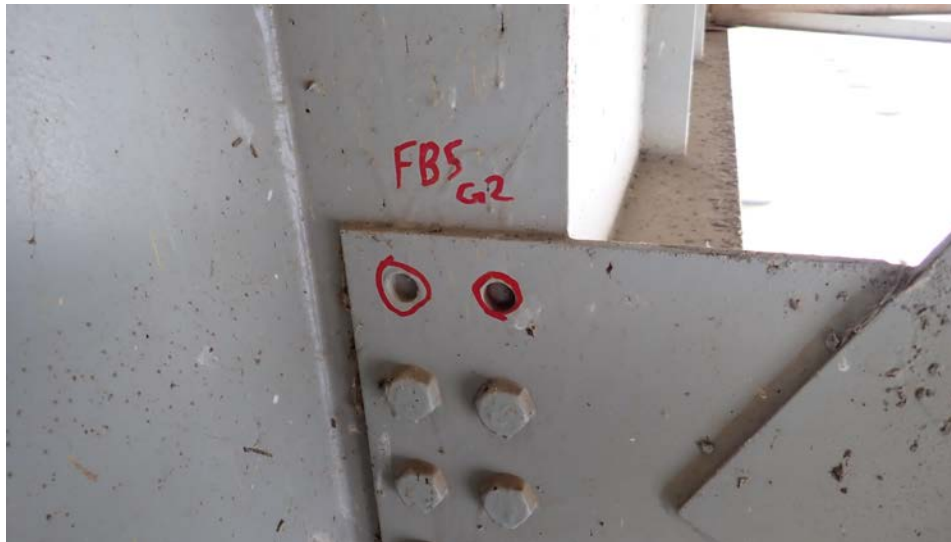
Photograph 45 - Looking east at floor beam 5, span 6 connection to girder 2. Note: 2 blind holes at the top of the connection.

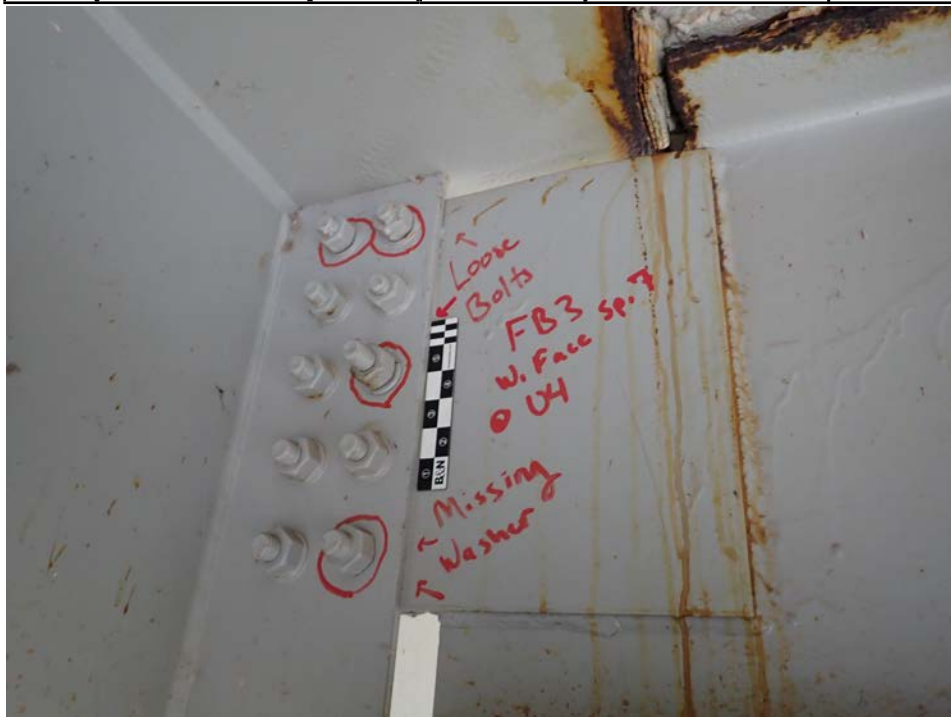
Photograph 46 - Looking east at floor beam 3, span 7 connection to girder 2. Note: 3 loose bolts and 1 missing washer.

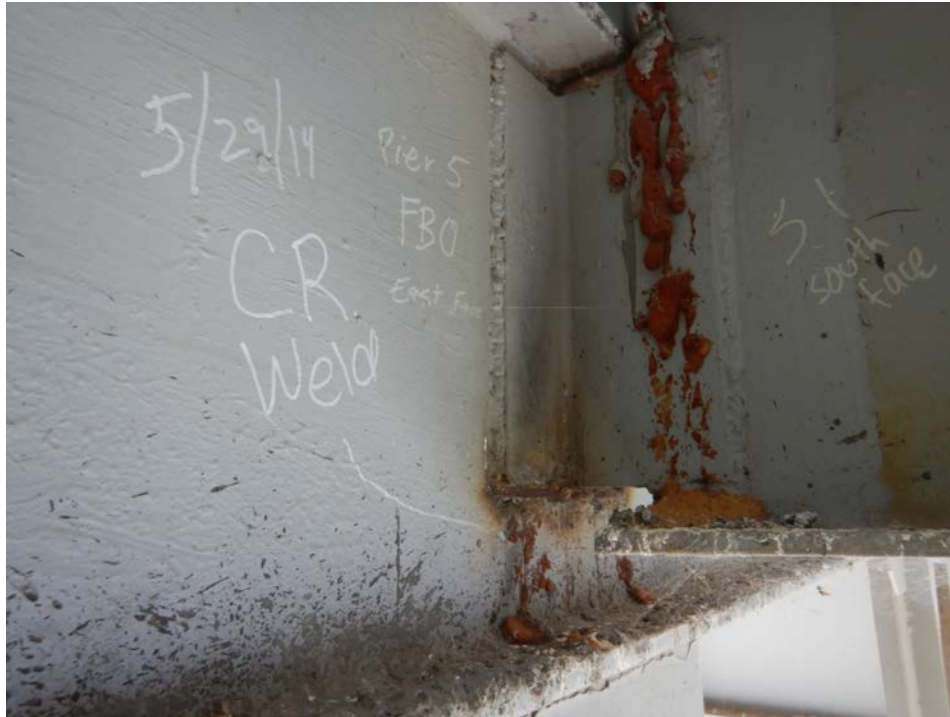
Photograph 47 - Looking northwest at stringer 1 connection to the east face of floor beam 0, span 6.
Note: stringer connection angle has been rewelded along the bottom edge.

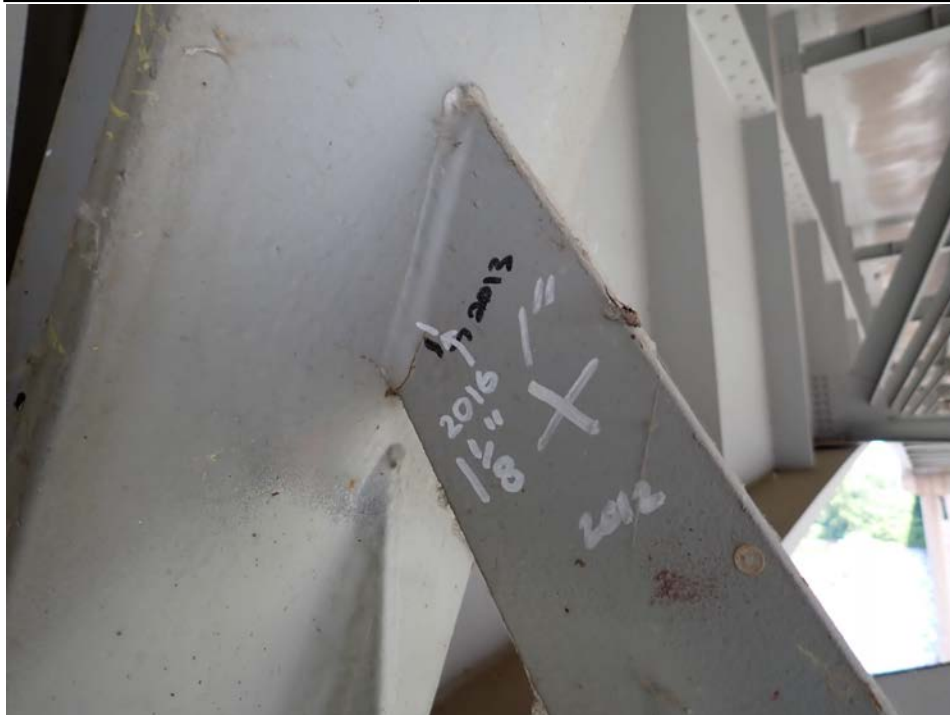
Photograph 48 - Looking northeast at the floor beam 0 lower strut connection to girder 2, span 7.
Note: 1 1/8-inch-long crack in repair plate weld on the west face, 1/2-inch-long crack on the east face.

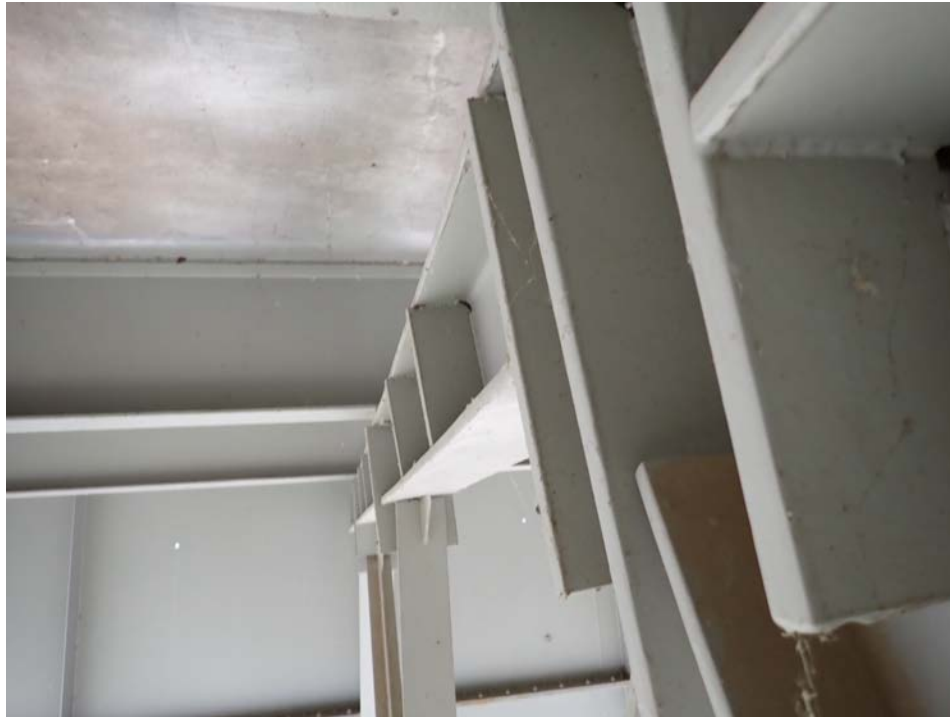
Photograph 49 - Looking south along the top chord of floor beam 1 in span 7 between the stringers. Note: top chord is rotated to the east, kink in upper gusset plate under stringer 3.

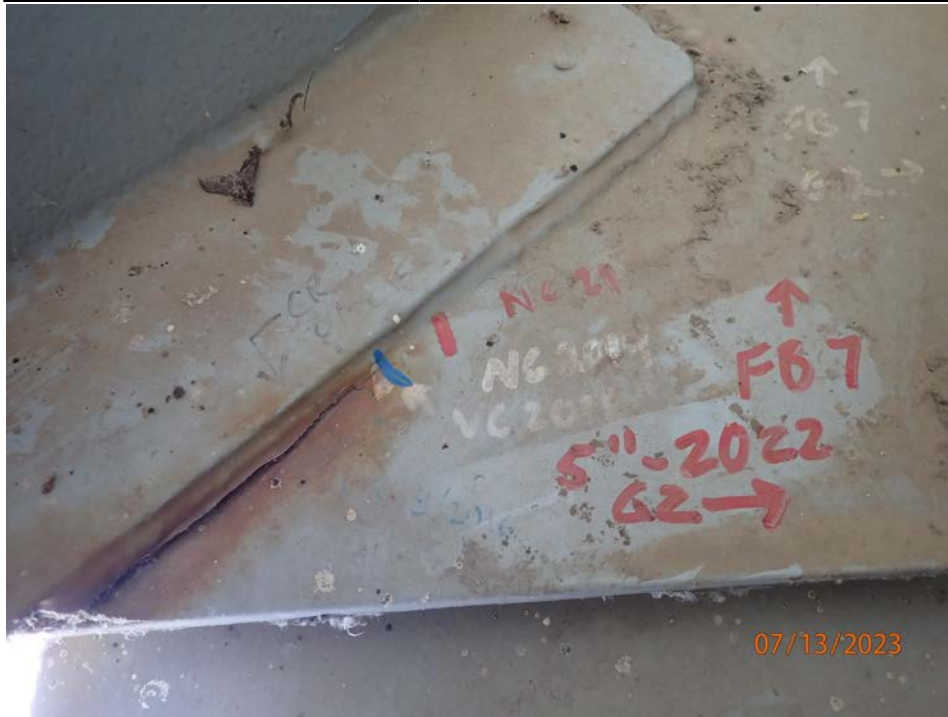
Photograph 51 - Looking west at the lower lateral bracing connection at the east face of floor beam 7 and girder 2, span 5. Note: 5-inch-long crack in the weld between the bottom angle and the bracing gusset plate.

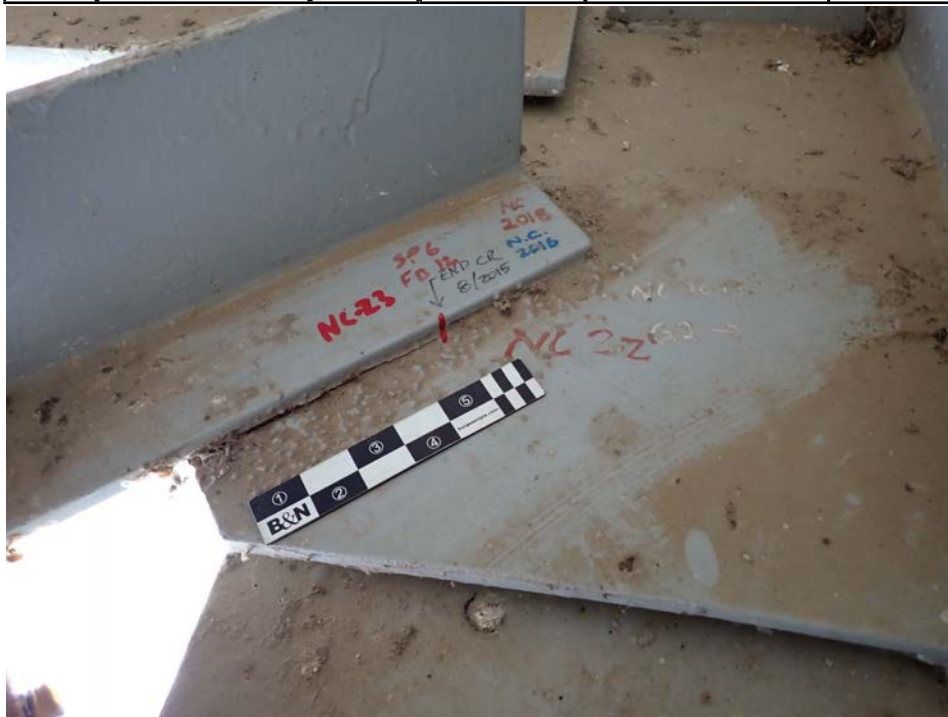
Photograph 52 - Looking west at the lower lateral bracing connection to floor beam 12 and girder 2, span 6. Note: 5 3/4-inch-long crack in weld between lower lateral bracing and gusset plate.

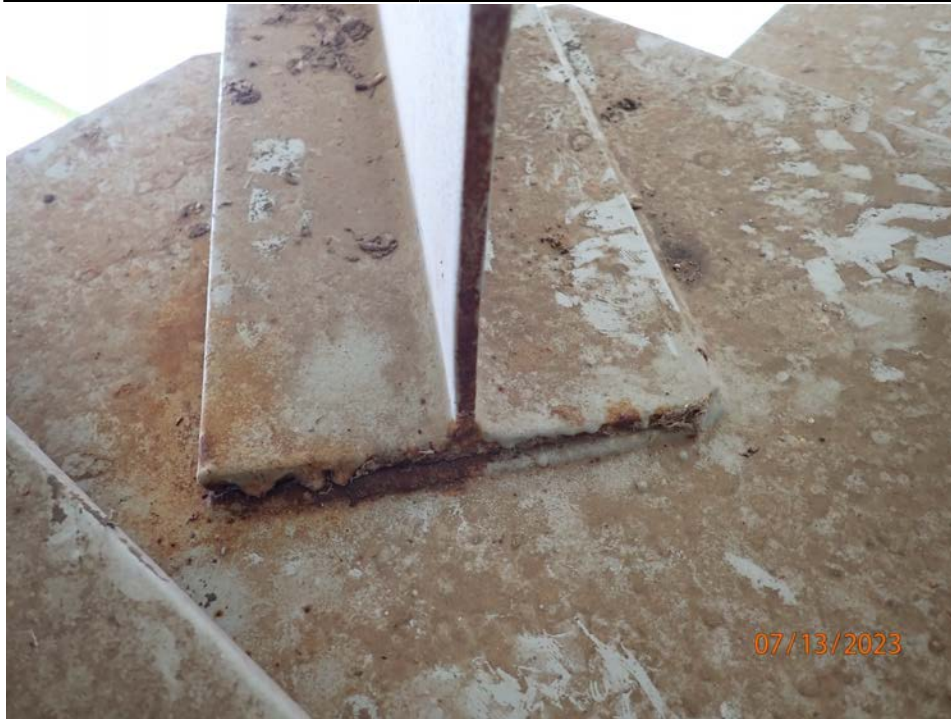
Photograph 53 - Looking southwest at the lower lateral bracing connection to floor beam 1 and girder 2, span 5. Note: bracing is welded along the west edge and end allowing pack rust to form and crack weld at end of bracing.

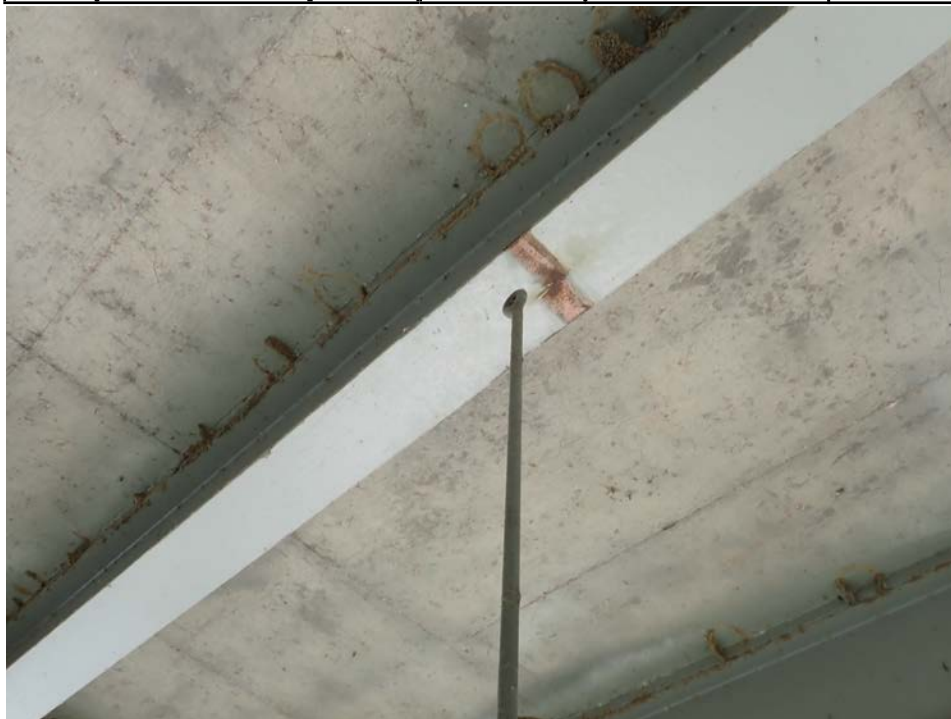
Photograph 54 - Looking southeast at the lower lateral bracing hanger rod in span 6, between floor beams 5 and 6. Note: missing clamp to stringer bottom flange.

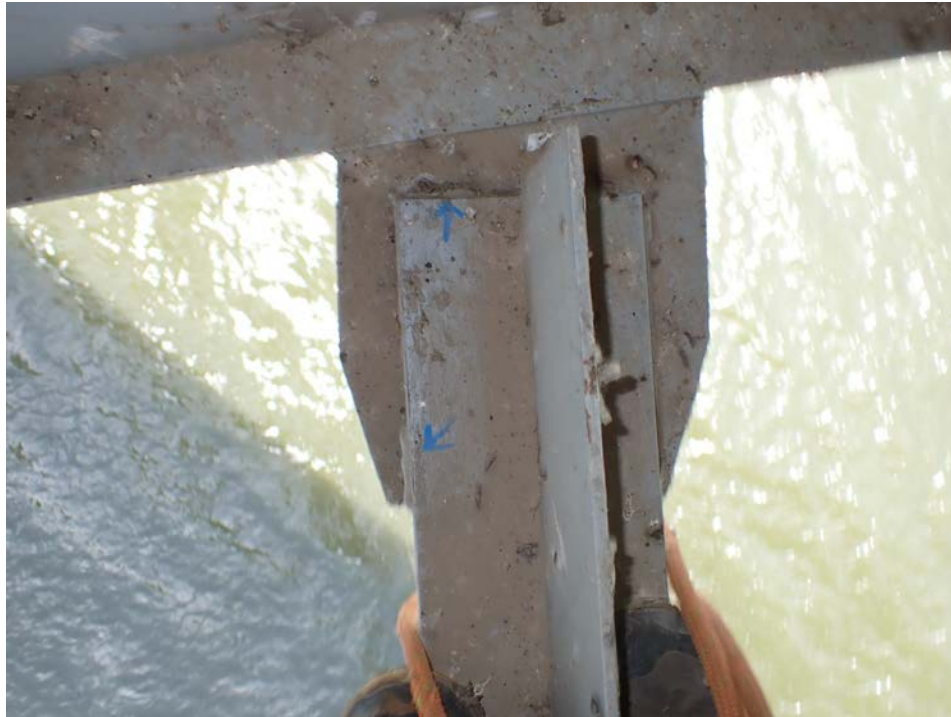
Photograph 55 - Looking southeast at span 6, lower lateral bracing crossbuck connection between floor beams 10 and 11. Note: 2 cracked welds on northeast member due to pack rust.

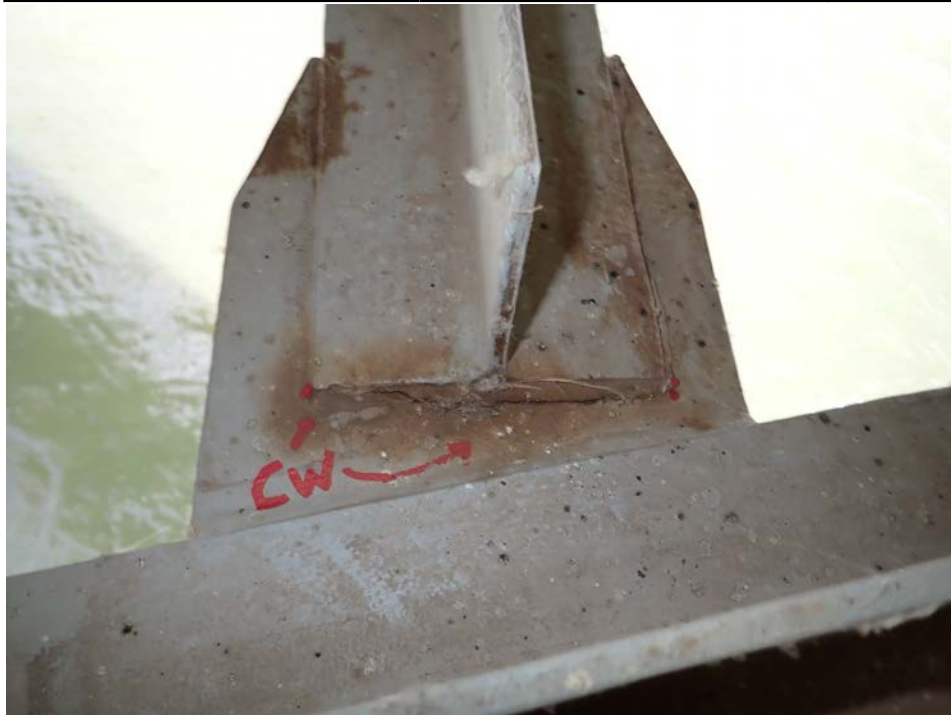
Photograph 56 - Looking southeast at span 7, lower lateral bracing crossbuck connection between floor beams 3 and 4. Note: cracked weld on southeast member due to pack rust.

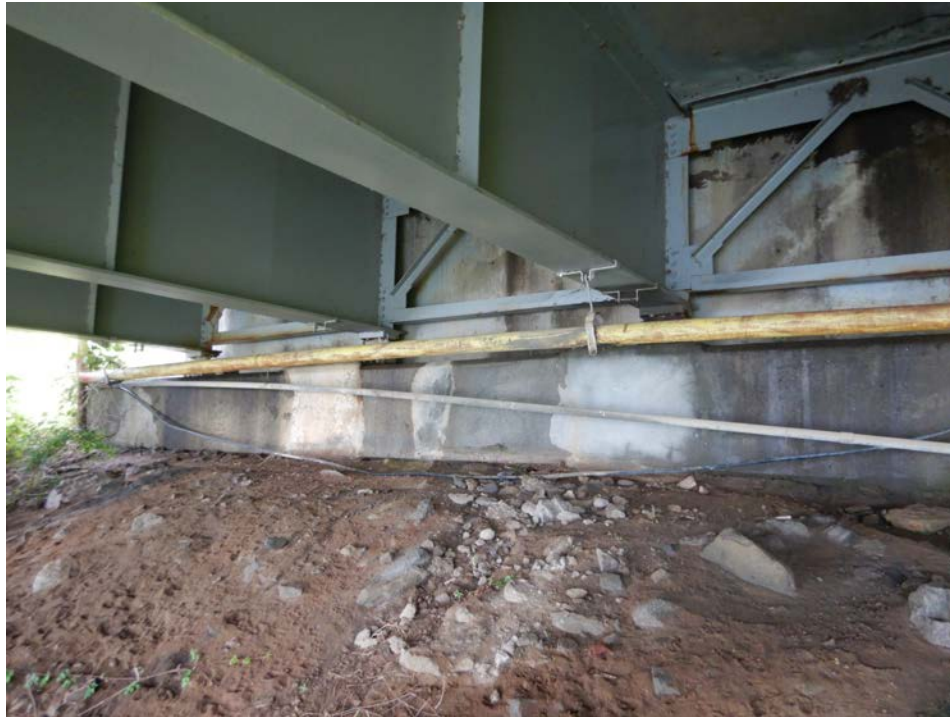
Photograph 57 - Looking northeast at the east abutment. Note: deck drainage leaking on bearing seat. Minor spall along bottom edge of breastwall between girders 2 and 3. 18 inches of penetration noted between girders 2 and 3 with no significant undermining noted vertically.

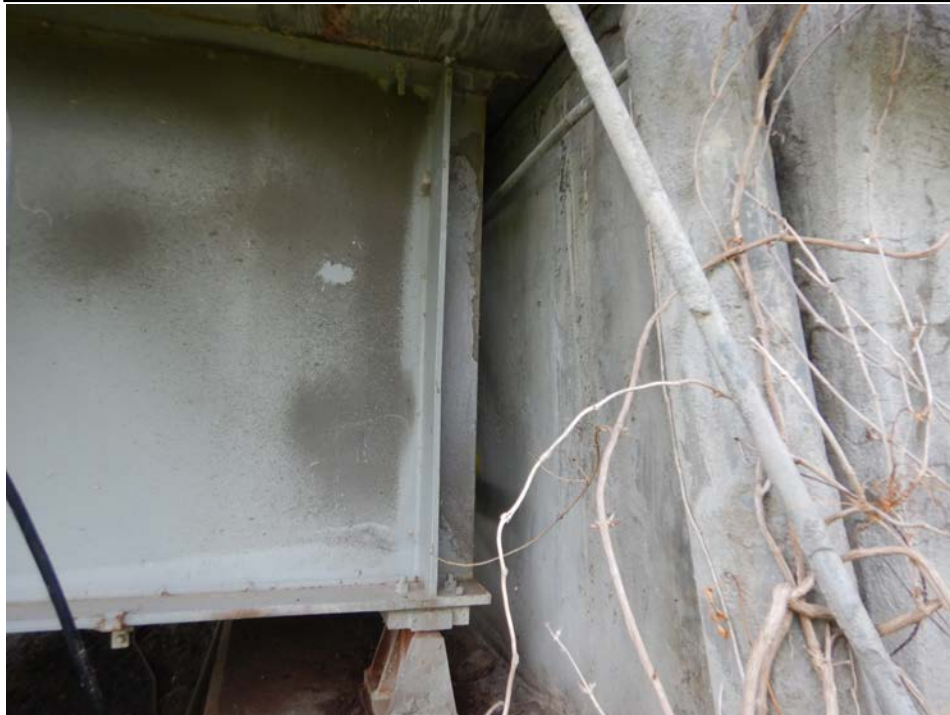
Photograph 58 - Looking south at girder 4, span 1 at the west abutment. Note: backwall is leaning towards the channel with 4 7/8 inches clear to the girder end near the top flange and 7 inches clear near the bottom flange.

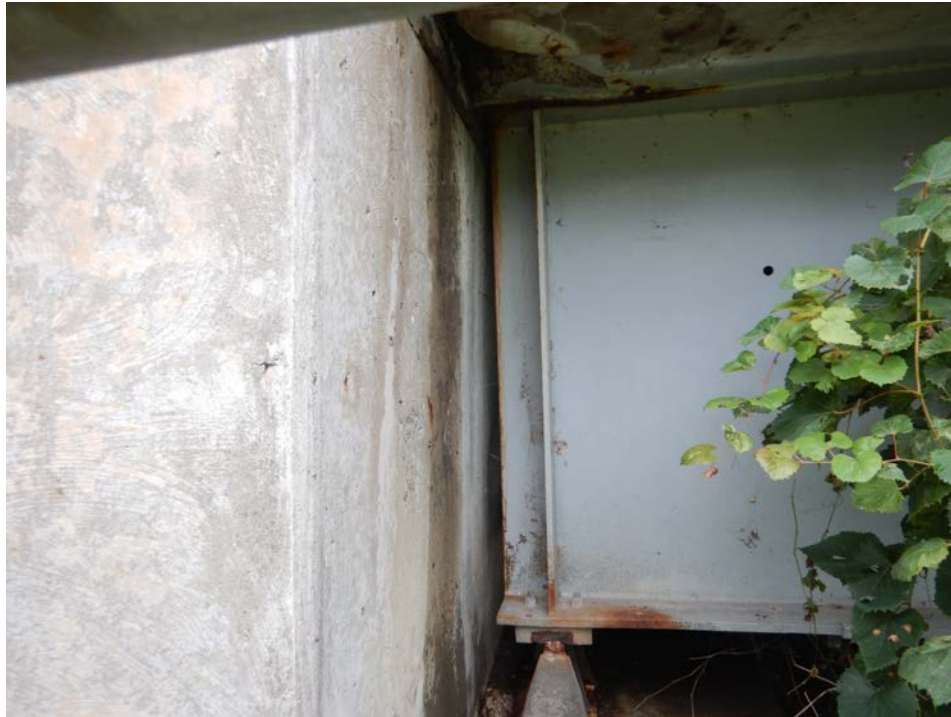
Photograph 59 - Looking south at girder 4, span 15 at the east abutment. Note: backwall is leaning towards the channel with 1 1/8 inches clear to the girder end near the top flange and 3 1/4 inches clear near the bottom flange.

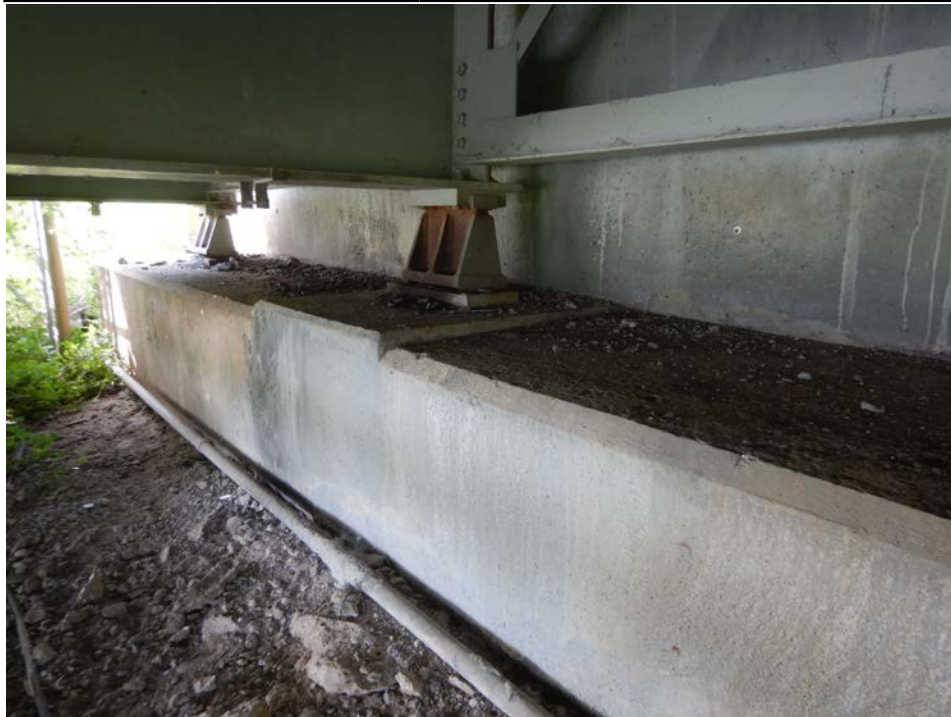
Photograph 60 - Looking southwest at the west abutment. Note: light accumulation of spalled concrete and debris on bearing seat.

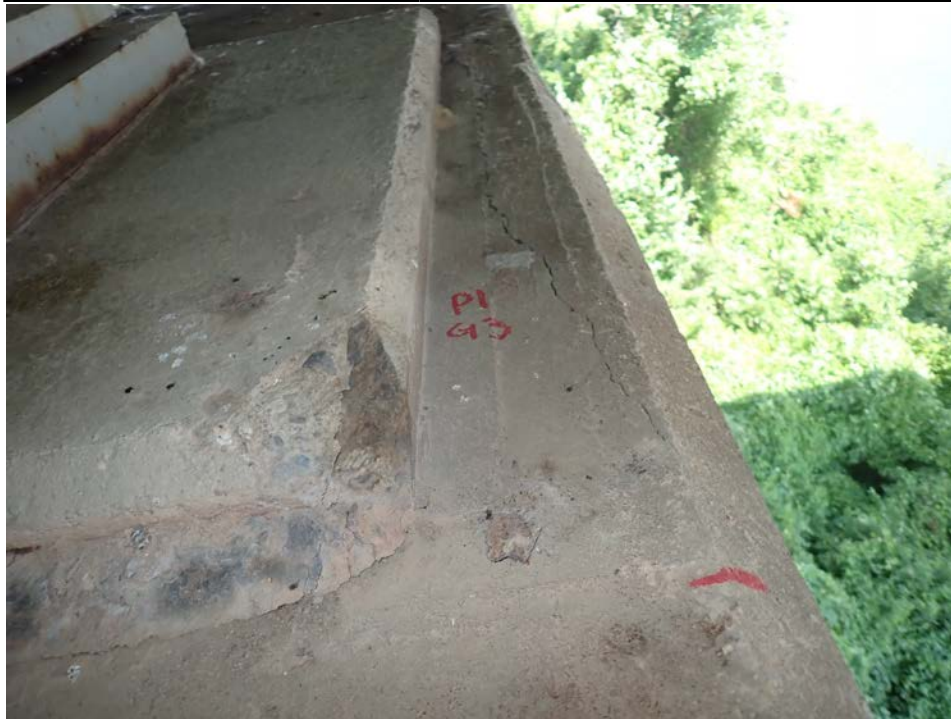
Photograph 61 - Looking north at pier 1 cap east edge near girder 3. Note: 5-foot-long corner spall/delamination.

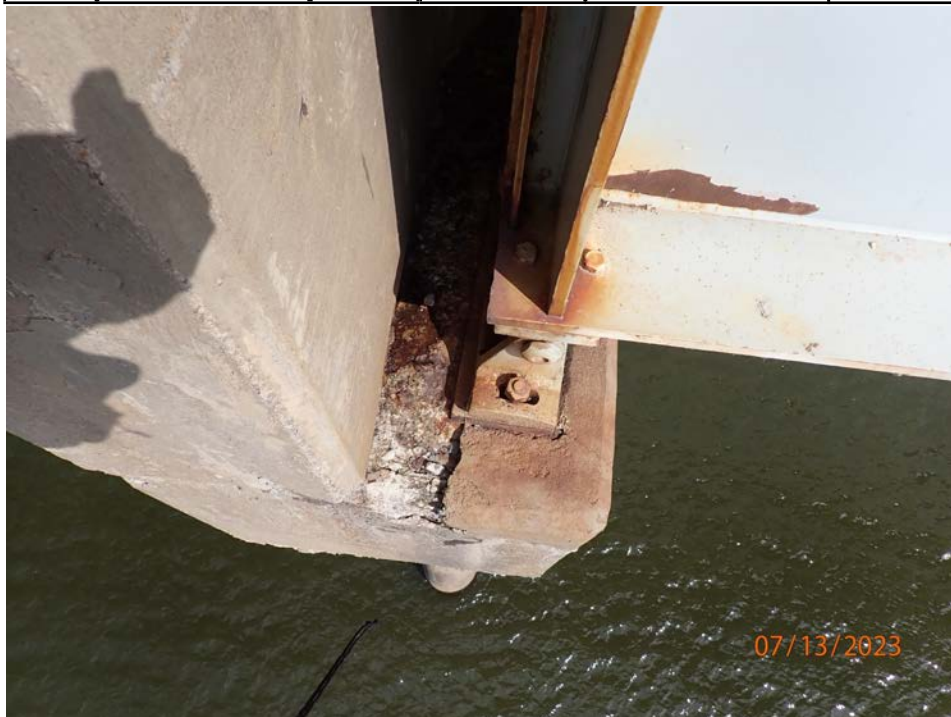
Photograph 62 - Looking north at pier 4 pier cap south end span 5. Note: scaling concrete around the girder 1 bearing.

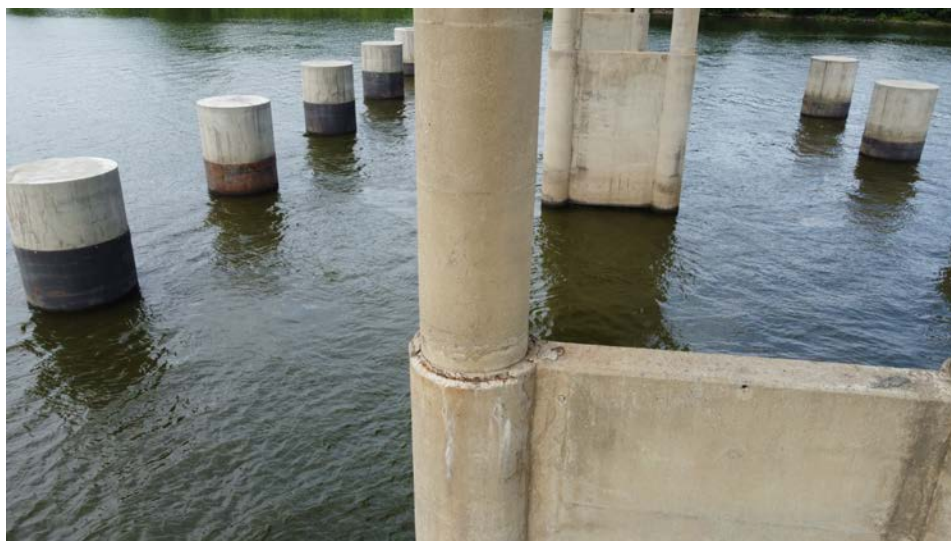
Photograph 63 - Looking west at pier 4, south column at the web wall interface. Note: cracking/spalling with efflorescence.

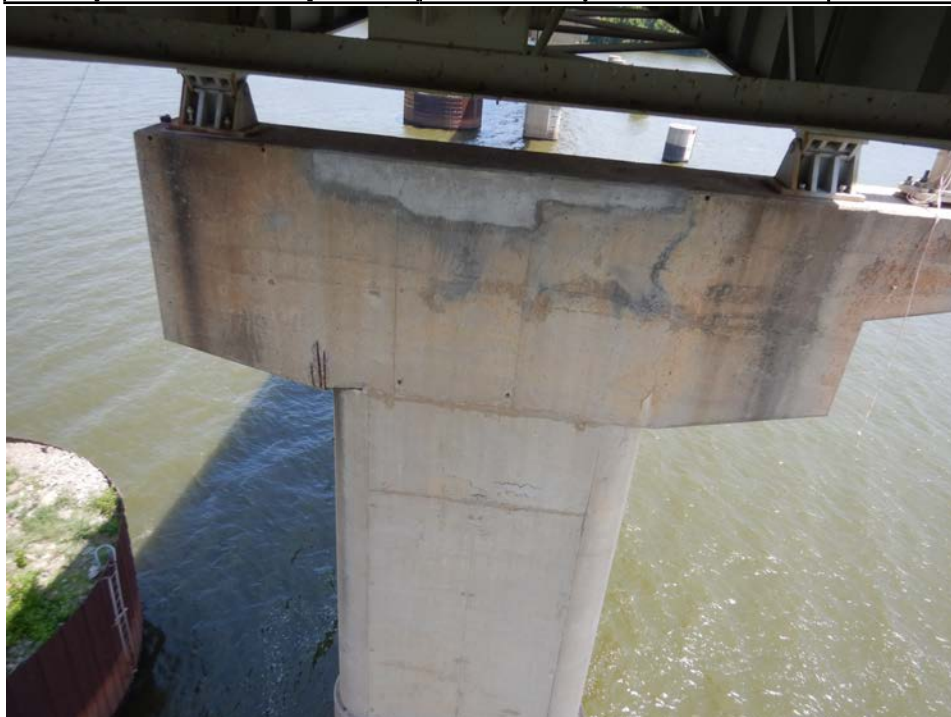
Photograph 64 - Looking east at pier 5. Note: patched area and spall with exposed reinforcing steel in cap due to deck drainage passing through previous deck control joint.
