Fracture Critical Bridge Inspection Report

NBI Bridge No.: 17611

Route S.H. 100 over ARKANSAS RIVER
Muskogee County

7/14/2023

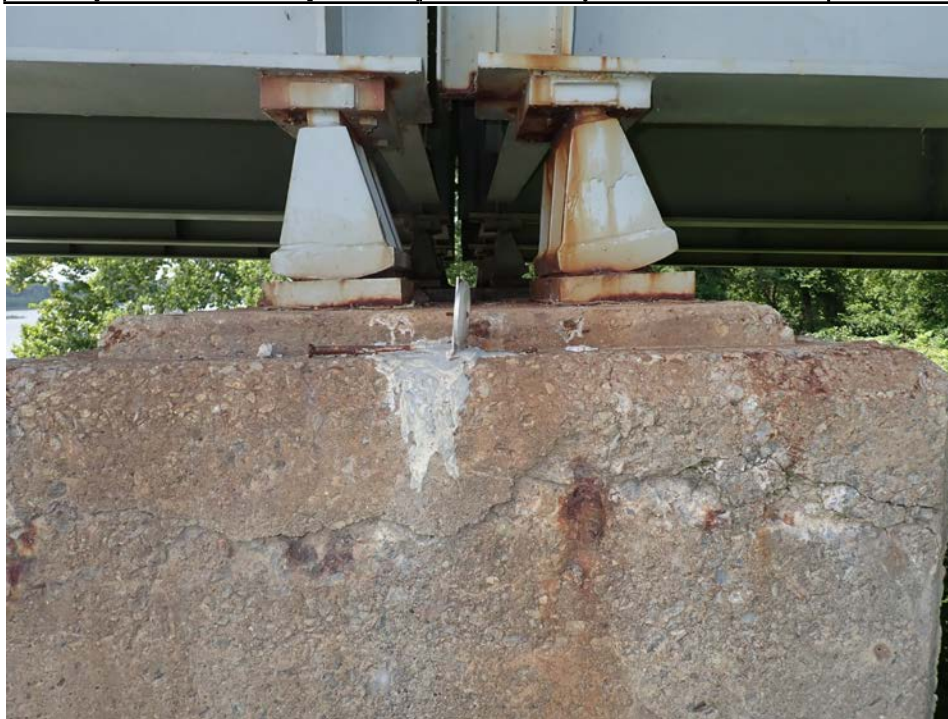
Photograph 65 - Looking north at the end of the pier 14 cap. Note: spalling and delaminations throughout the top of the cap.

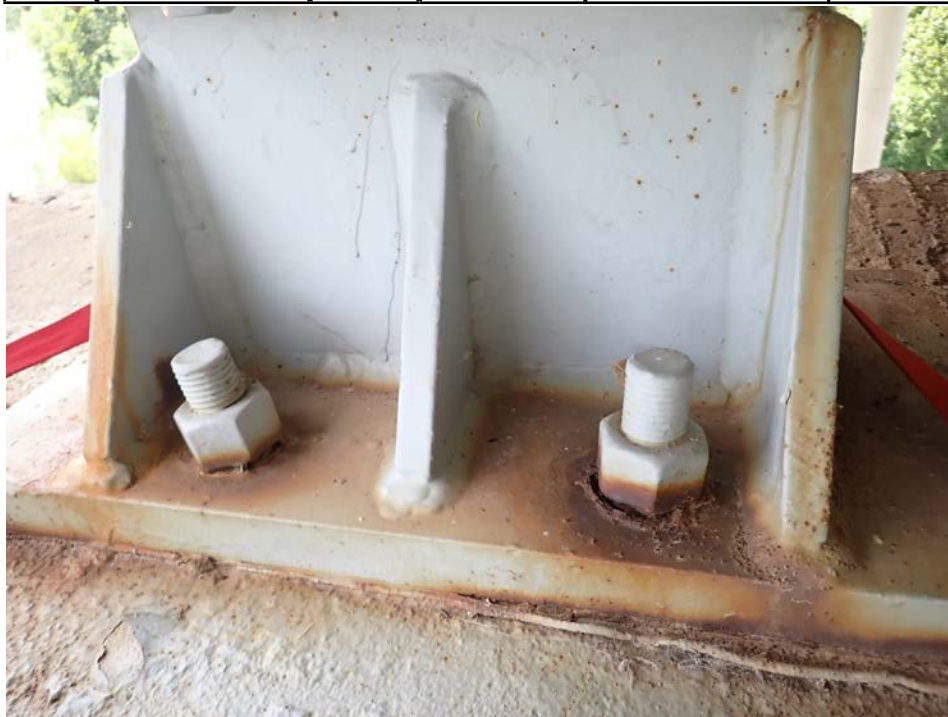
Photograph 66 - Looking west at girder 1, pier 3 bearing. Note: fixed bearing anchor bolts are bent.

- Tighten loose anchor bolts and replace missing or bent anchor bolts.

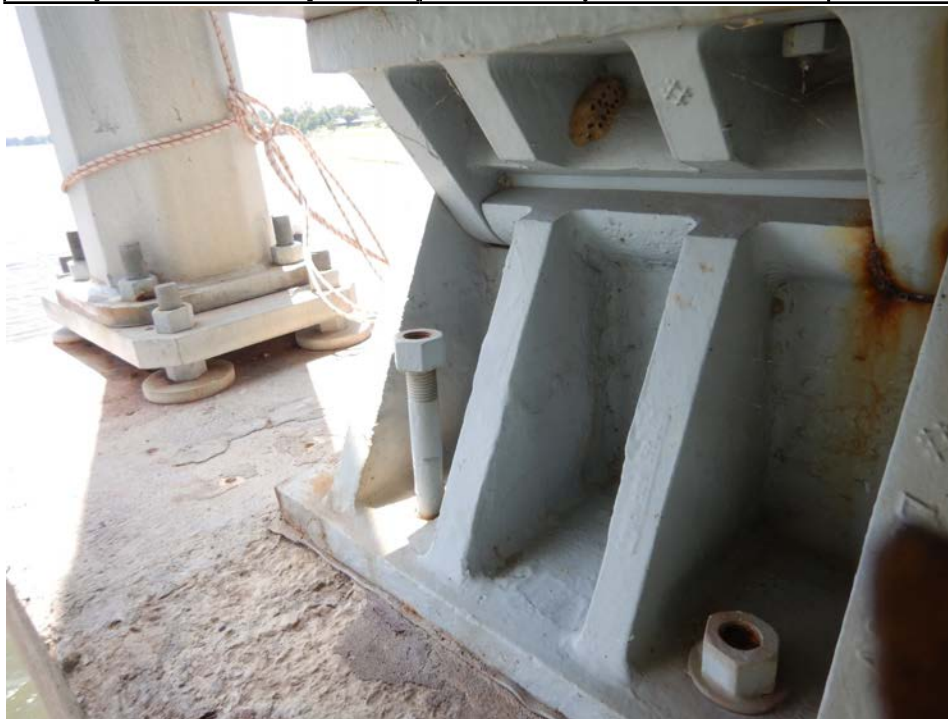
Photograph 67 - Looking southwest at the girder 1, pier 5 fixed bearing. Note: anchor bolt lifted and nuts not fully seated.

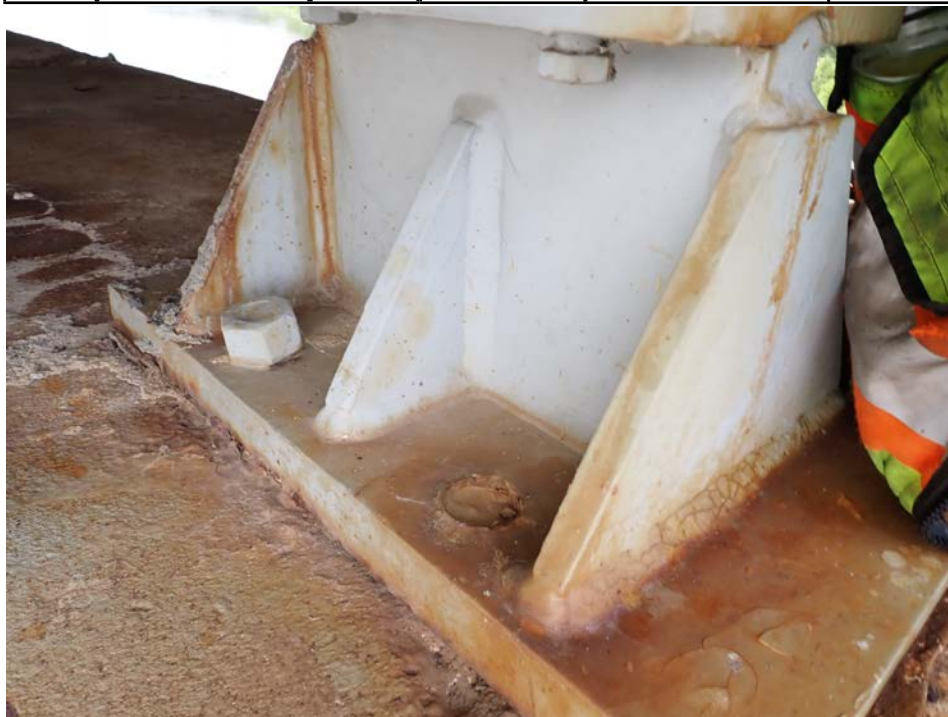
Photograph 68 - Looking northeast at girder 2 fixed bearing at pier 8. Note: missing anchor bolt.

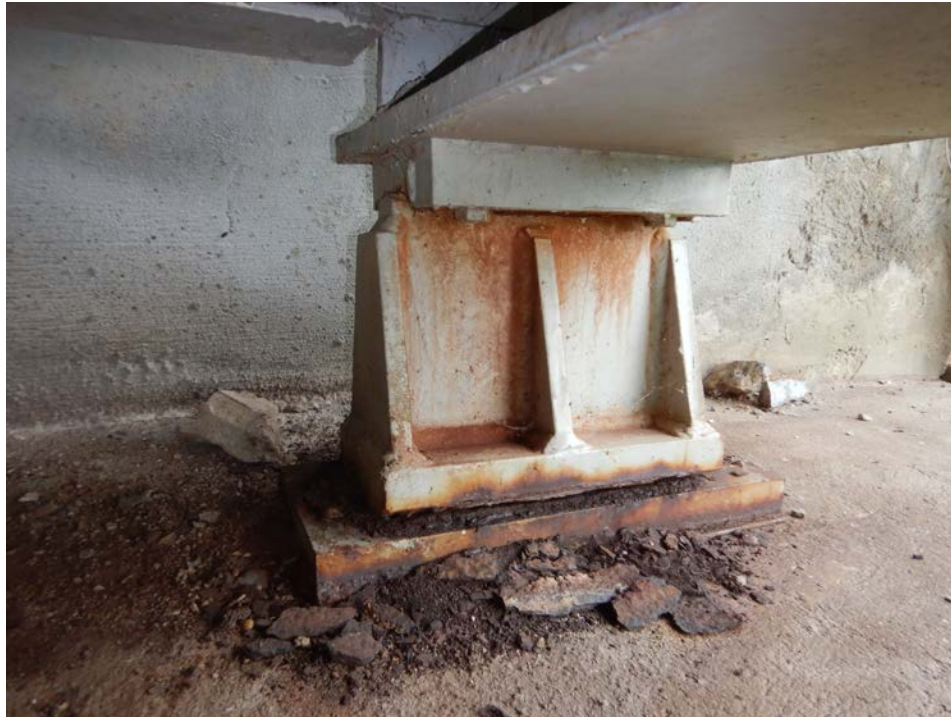
Photograph 69 - Looking west at the girder 4, span 1 expansion bearing at the west abutment. Note: south keeper plate attached to the sole plate is missing and the bearing has moved south 1/2 inch with no significant lateral movement since the last painting.

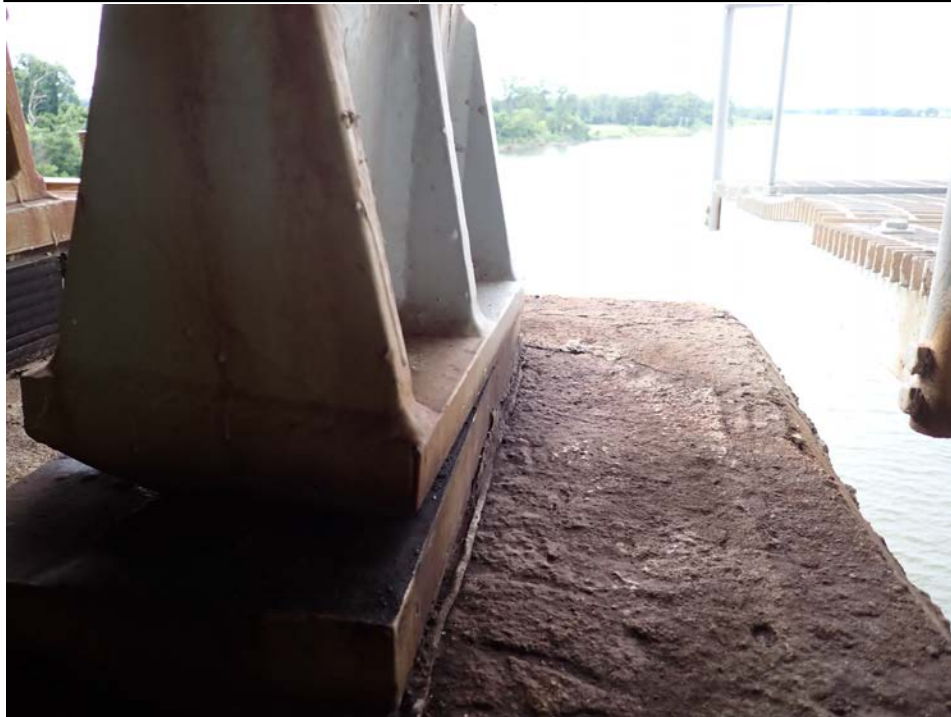
Photograph 70 - Looking south at the girder 1, span 10 expansion bearing at pier 10. Note: misalignment between the rocker and masonry plate with the rocker overhanging the masonry plate 1/4 inch.
