**Underwater Inspection of
SH 100 over the
Arkansas River**
Muskogee County, Oklahoma
October 14, 2022

Structure No. 5159-0300-X
NBI No. 17611

Subject: Underwater Bridge Inspection
NBI 17611, Structure 5159-0300-X, SH 100 over the Arkansas River

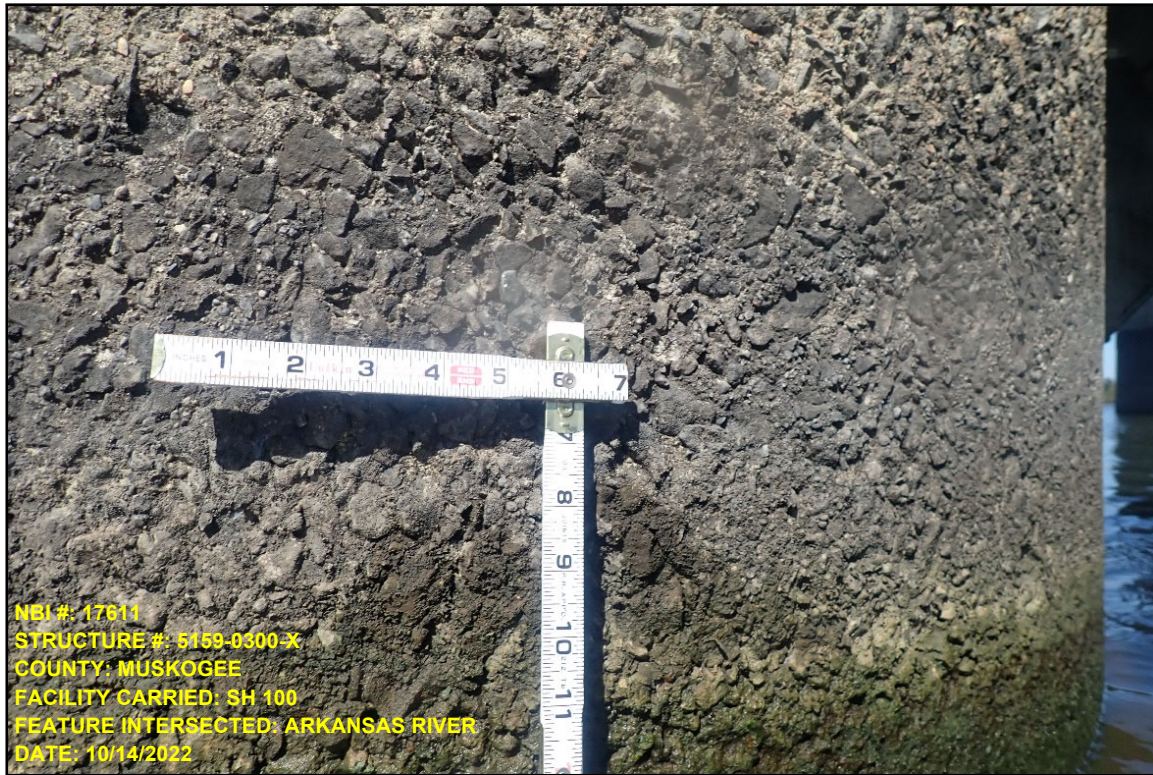
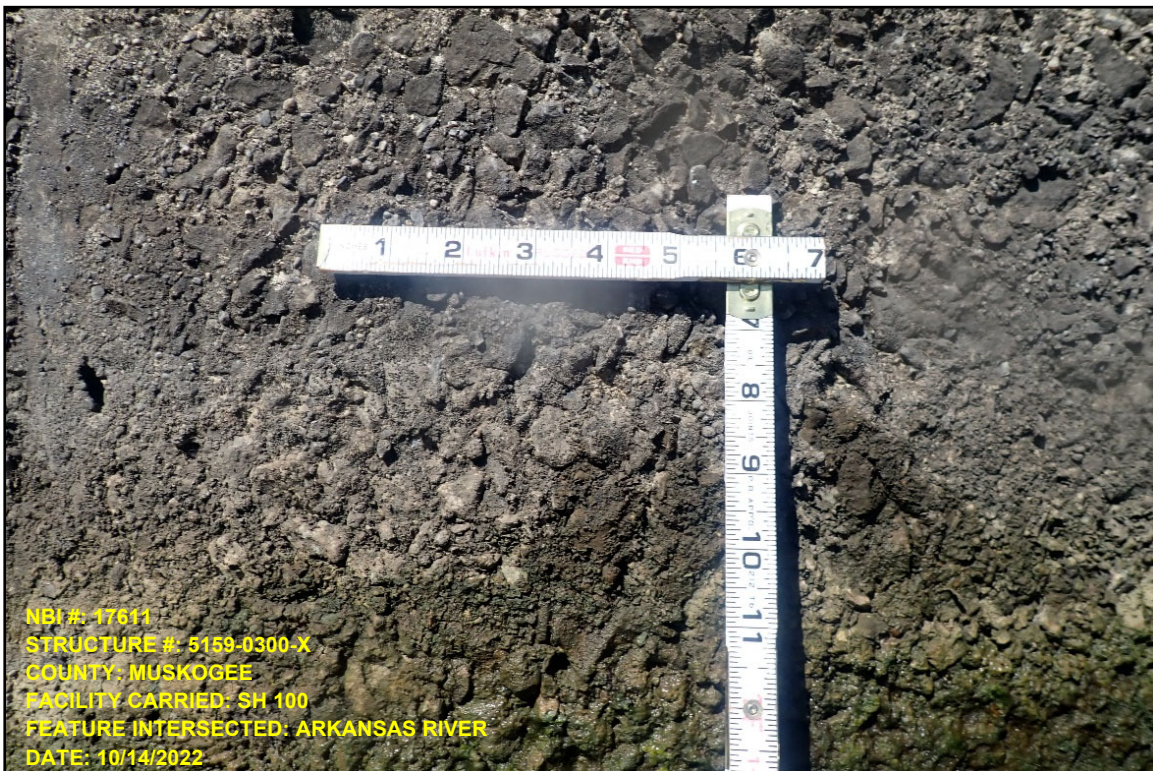
General notes: The submerged portions of the substructure are in satisfactory condition. There is light abrasion on the columns and webwalls ranging from 1/16-in deep to 1/8-in deep and algae growth. Refer to Photos 11 and 12.

Photo 11 – Typical Concrete Condition Above the Waterline (Abrasion)

Photo 12 – Typical Concrete Condition Above the Waterline (Abrasion)

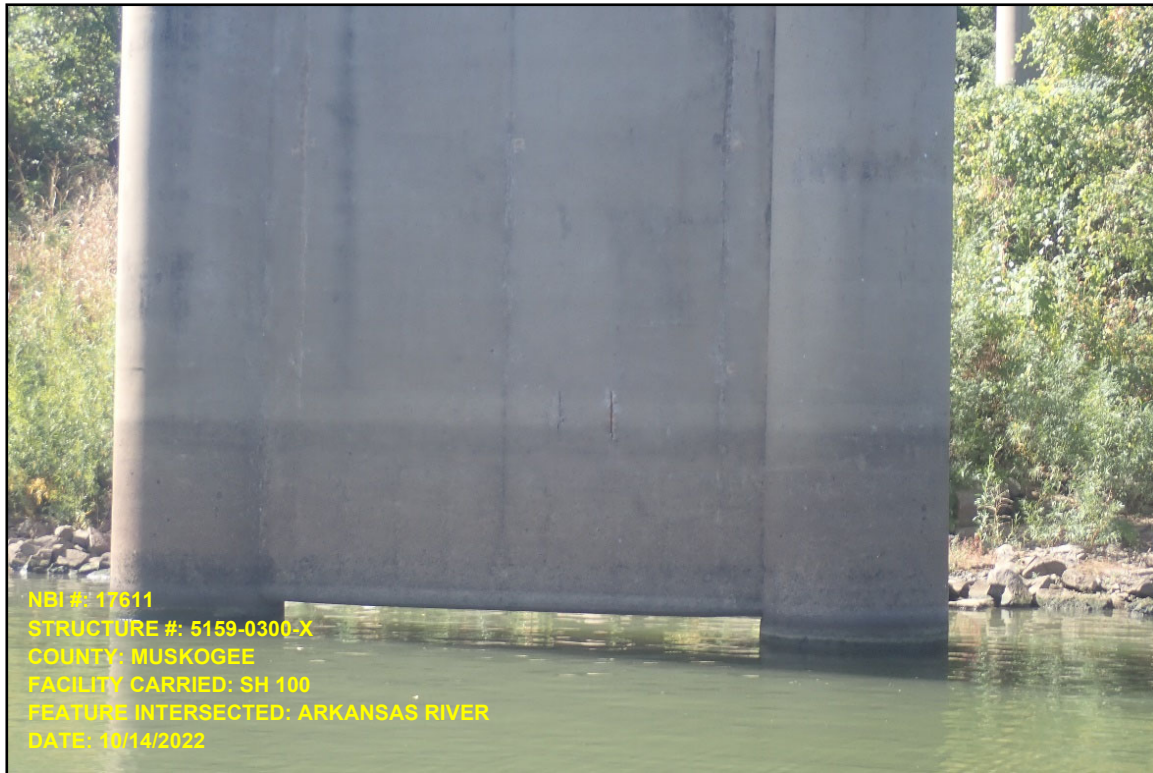
- Webwall, exposed reinforcing due to insufficient cover. Refer to Photo 13.

Photo 13 – Pier 2, Webwall, Exposed Reinforcing

- Clean and patch the spall/honeycombing voids that have exposed reinforcing steel.
- Seal cracks greater than 1/16-in wide.

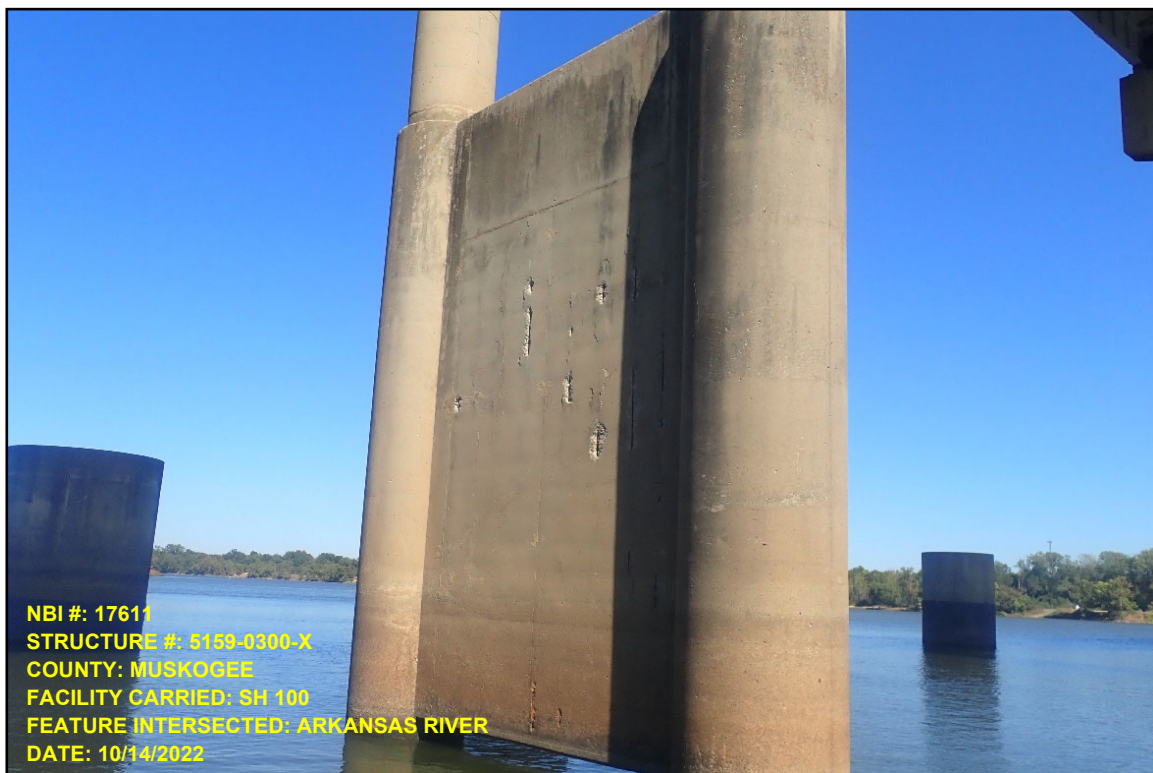
- Column 1, east quadrant at the waterline, area of voiding 12-in H x 3-in W x 2-in D.
- Column 1, east quadrant at the waterline, spall 3-in H x 3-in W x 1-in D.
- Column 1, south quadrant above the step out, void 4-in H x 4-in W x 3/4-in D.
- Webwall, west face above the waterline, shallow spalls. Refer to Photo 14.

Photo 14 – Pier 3, Webwall, Spalls w/Exposed Steel

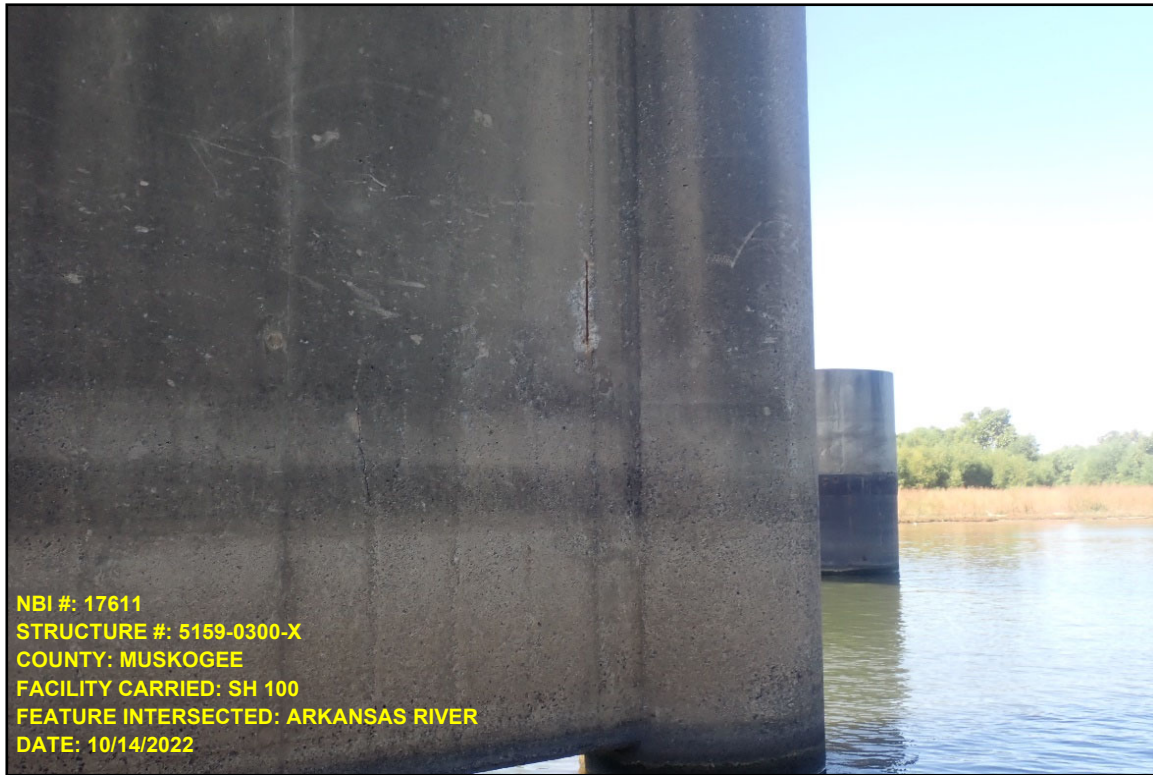
- Webwall, voiding up to 2-in deep on the bottom surface.
- Webwall, exposed reinforcing due to insufficient cover. Refer to Photo 15.

Photo 15 – Pier 4, Webwall, Spall with Exposed Reinforcing

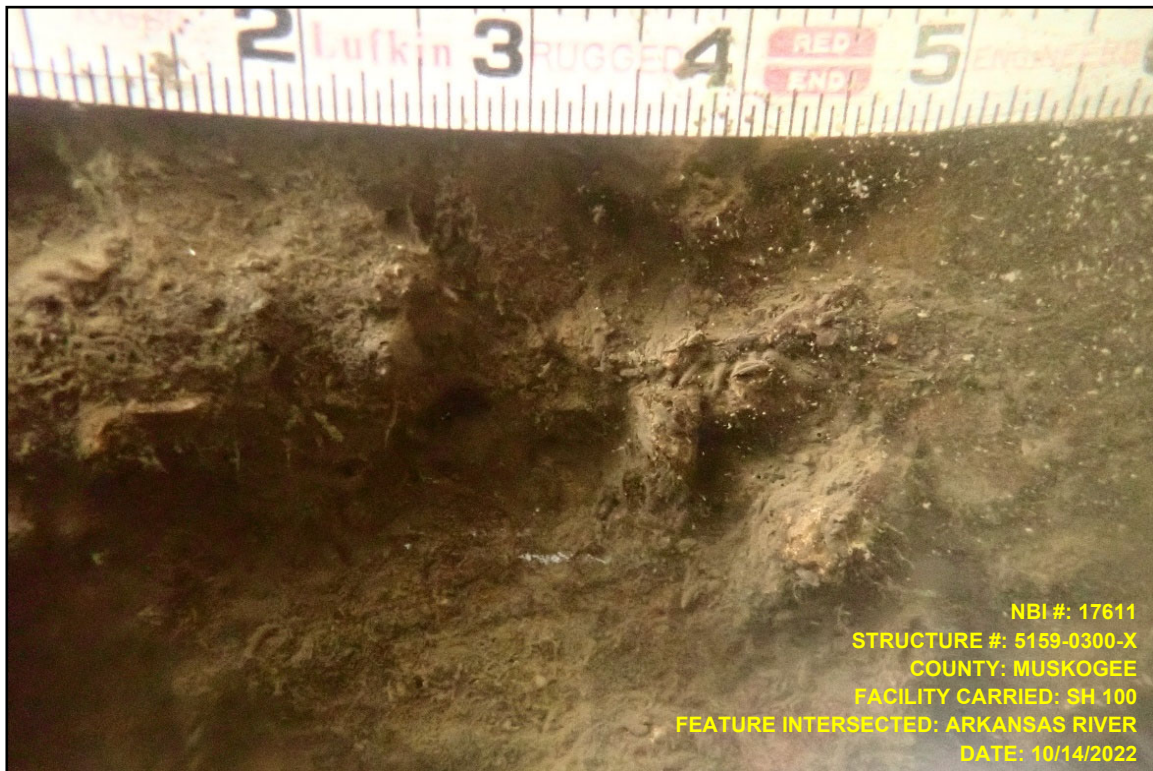
Photo 16 – Pier 6, Footing/Column Interface, Voiding 3-in H x 1/2-D

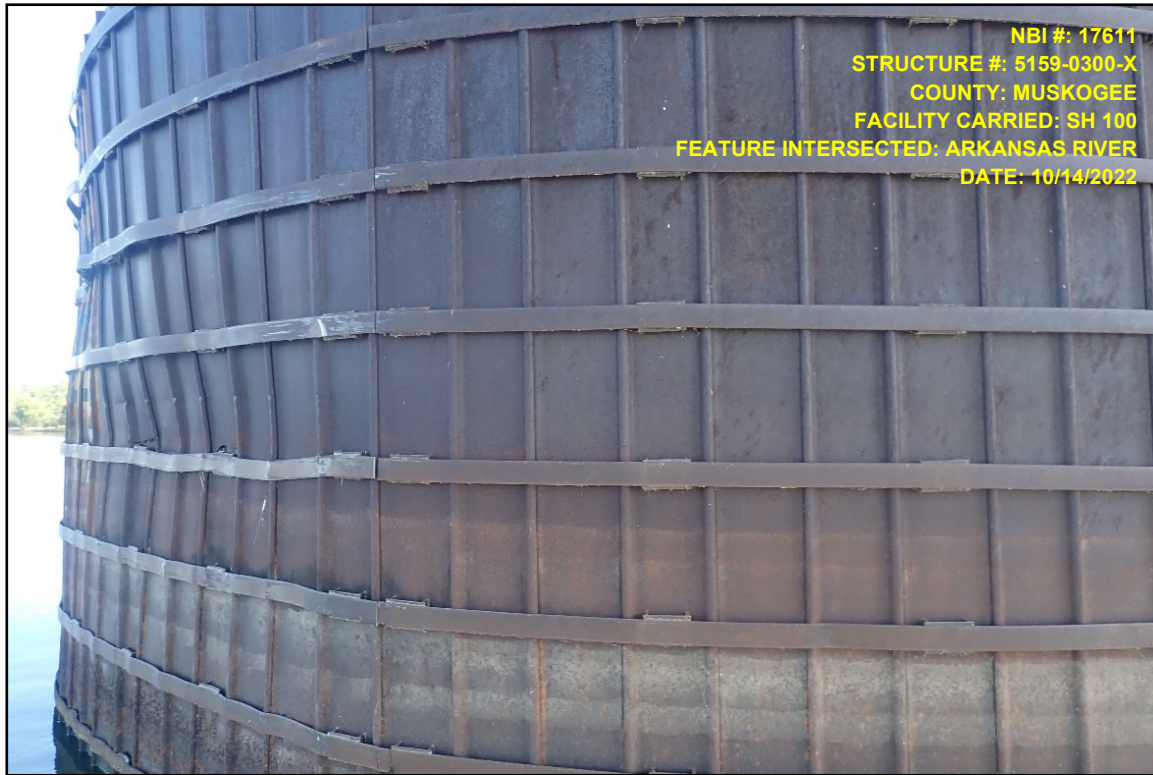
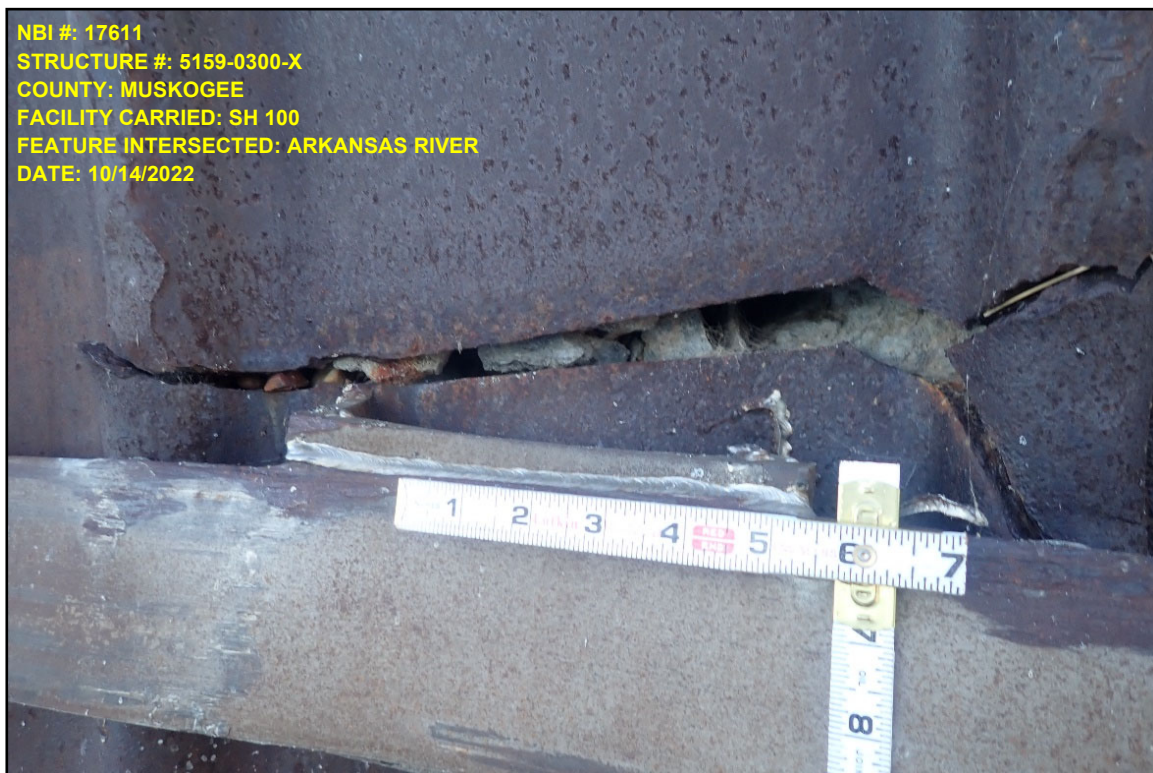
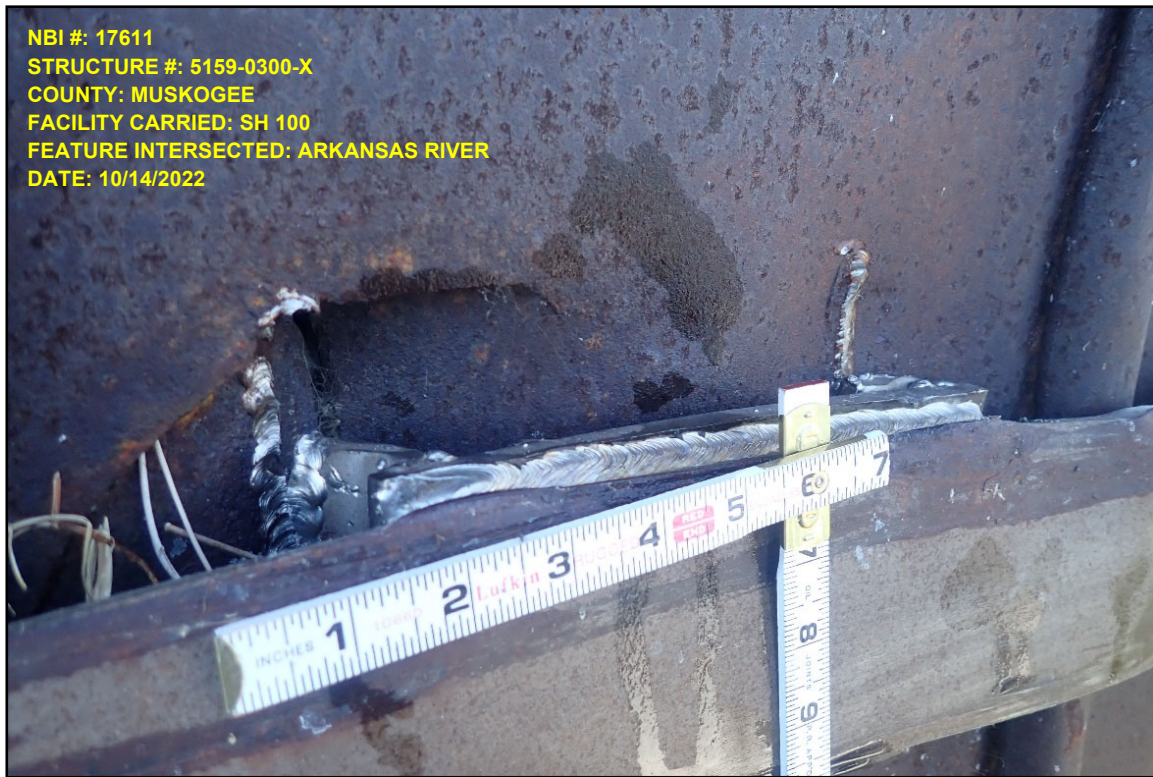
- Column, intermittent voiding up to 5-in H x 1-in D at random locations.
- Footing, the top surface is irregular.
- Column/Footing interface, voiding at the downstream nose up to 3-in H x 1/2-in D. Refer to Photo 16.
- Caisson dolphin, impact damage to the northwest quadrant. Refer to Photos 17 through 19.

Photo 17 – Pier 6 Dolphin, Impact Damage

Photo 18 – Pier 6 Dolphin, Impact Damage

Photo 19 – Pier 6 Dolphin, Impact Damage

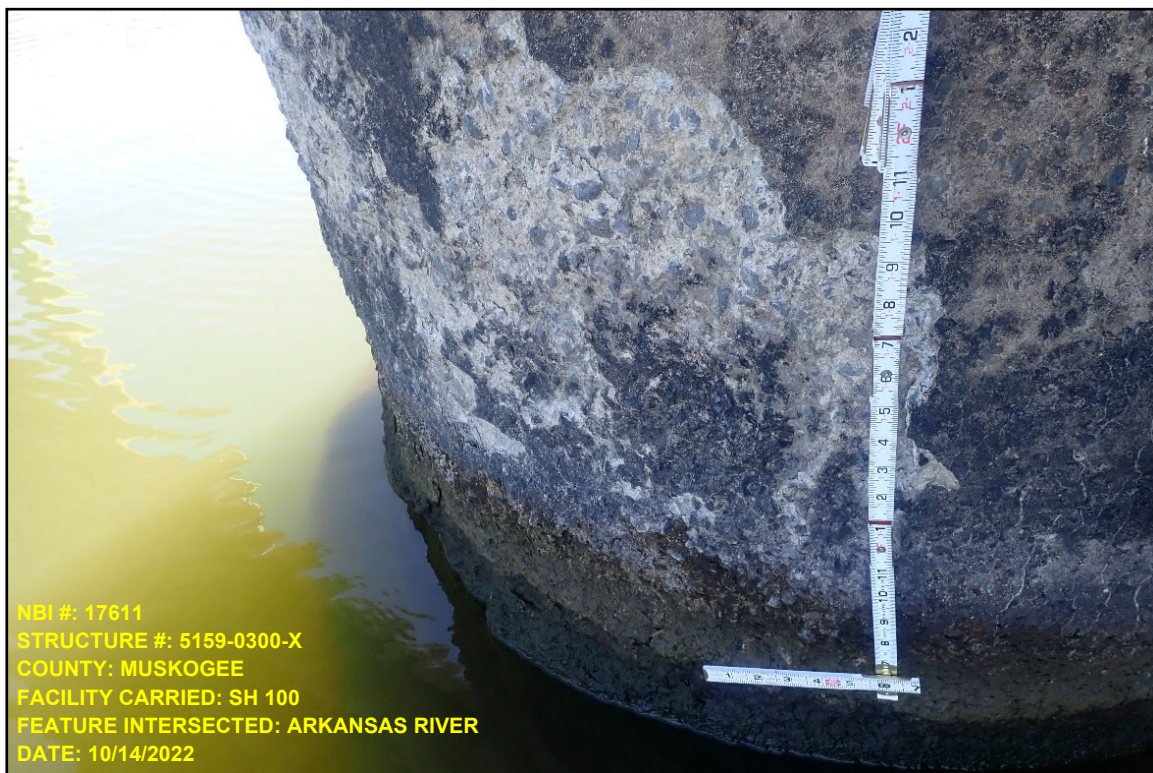
- Column 2, north quadrant, 2-ft above the waterline, area of spalling up to 48-in wide x up to 2 1/2-in deep with associated map cracking up to 1/32-in wide with efflorescence. Refer to Photos 20 and 21.
- Webwall, west face, exposed reinforcing due to insufficient cover

Photo 20 – Pier 7, Column 2, Spall 48-in W x 2 1/2-in D

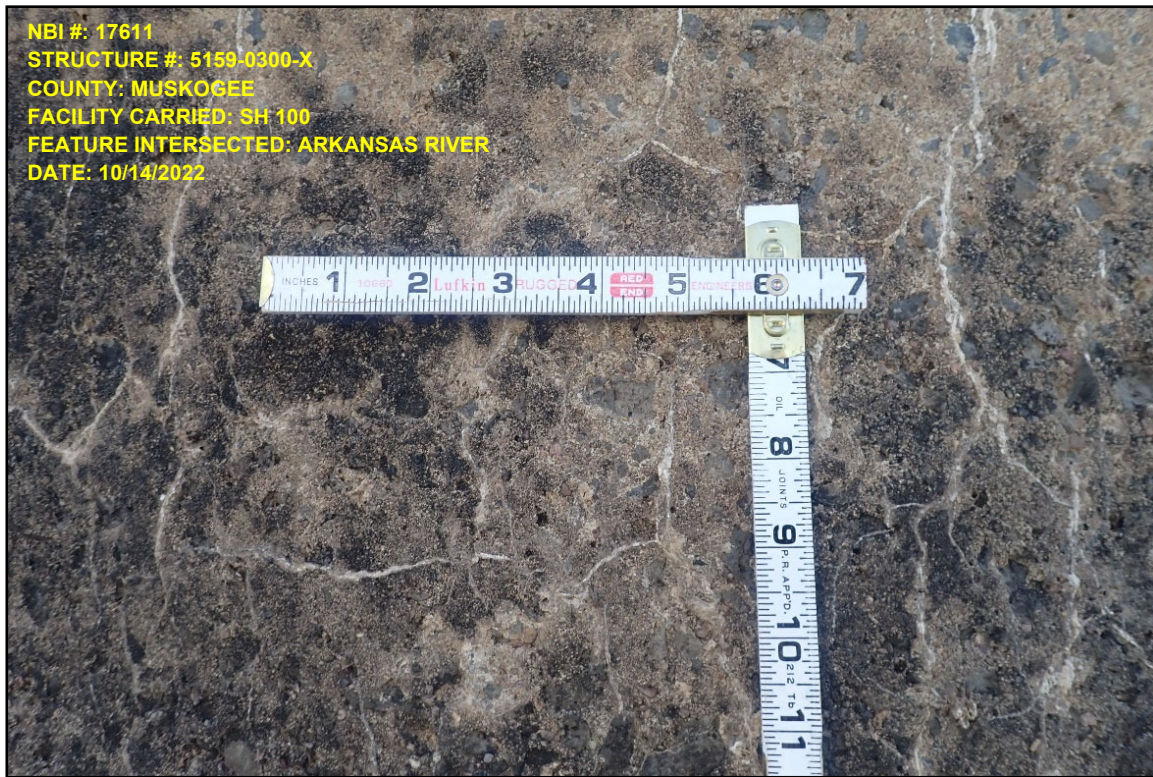
Photo 21 – Pier 7, Column 2, Map Cracking with Efflorescence

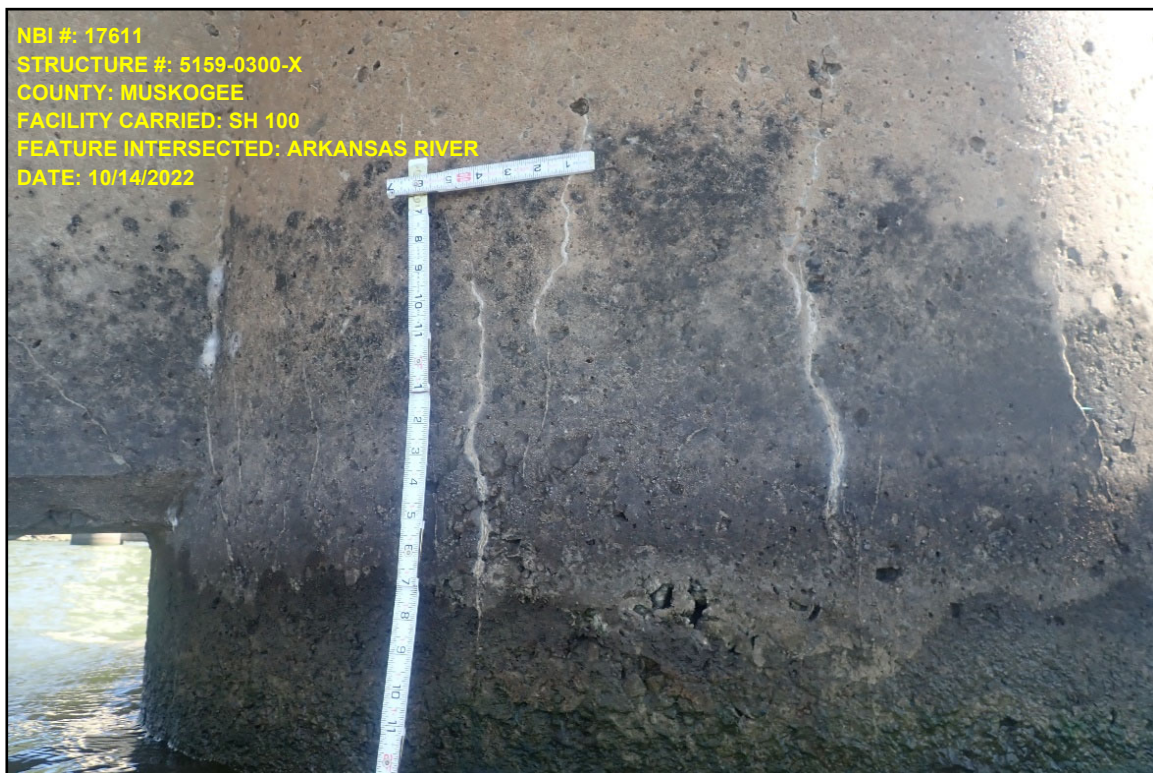
- Webwall, shallow spalls with exposed steel at random locations.
- Column 1, southwest quadrant, from the waterline to the channel bottom, vertical crack up to 1/16-in wide.
- Both columns, at the southwest quadrant, from the waterline to the channel bottom, hairline to 1/16-in wide vertical cracks with efflorescence. Refer to Photo 22.

Photo 22 – Pier 11, Both Columns, Typical Cracks up to 1/16-in Wide with Efflorescence

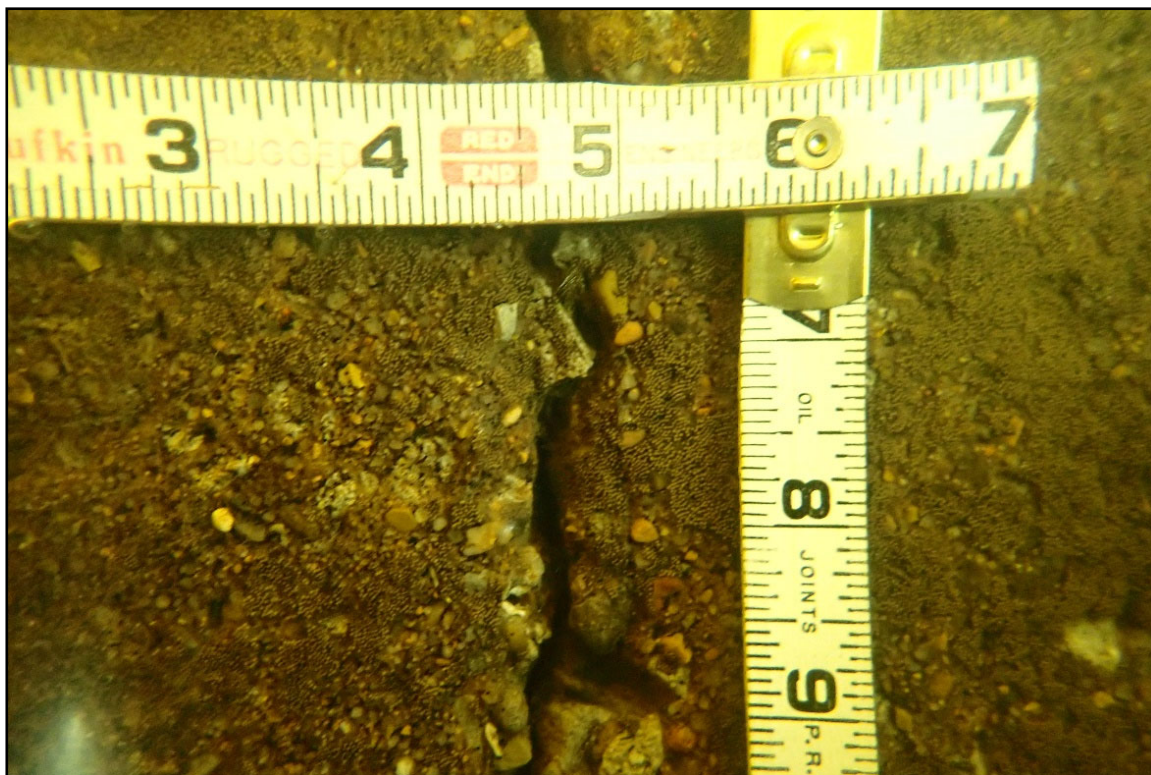
- Both columns, vertical cracks hairline to 1/16-in wide with efflorescence.
- Column 1, southwest quadrant, starting 2-ft below the waterline extending 11-ft below the waterline, vertical crack up to 3/16-in wide. Refer to Photo 23.

Photo 23 – Pier 12, Column 1, Vertical Crack up to 3/16-in Wide
Below the Waterline

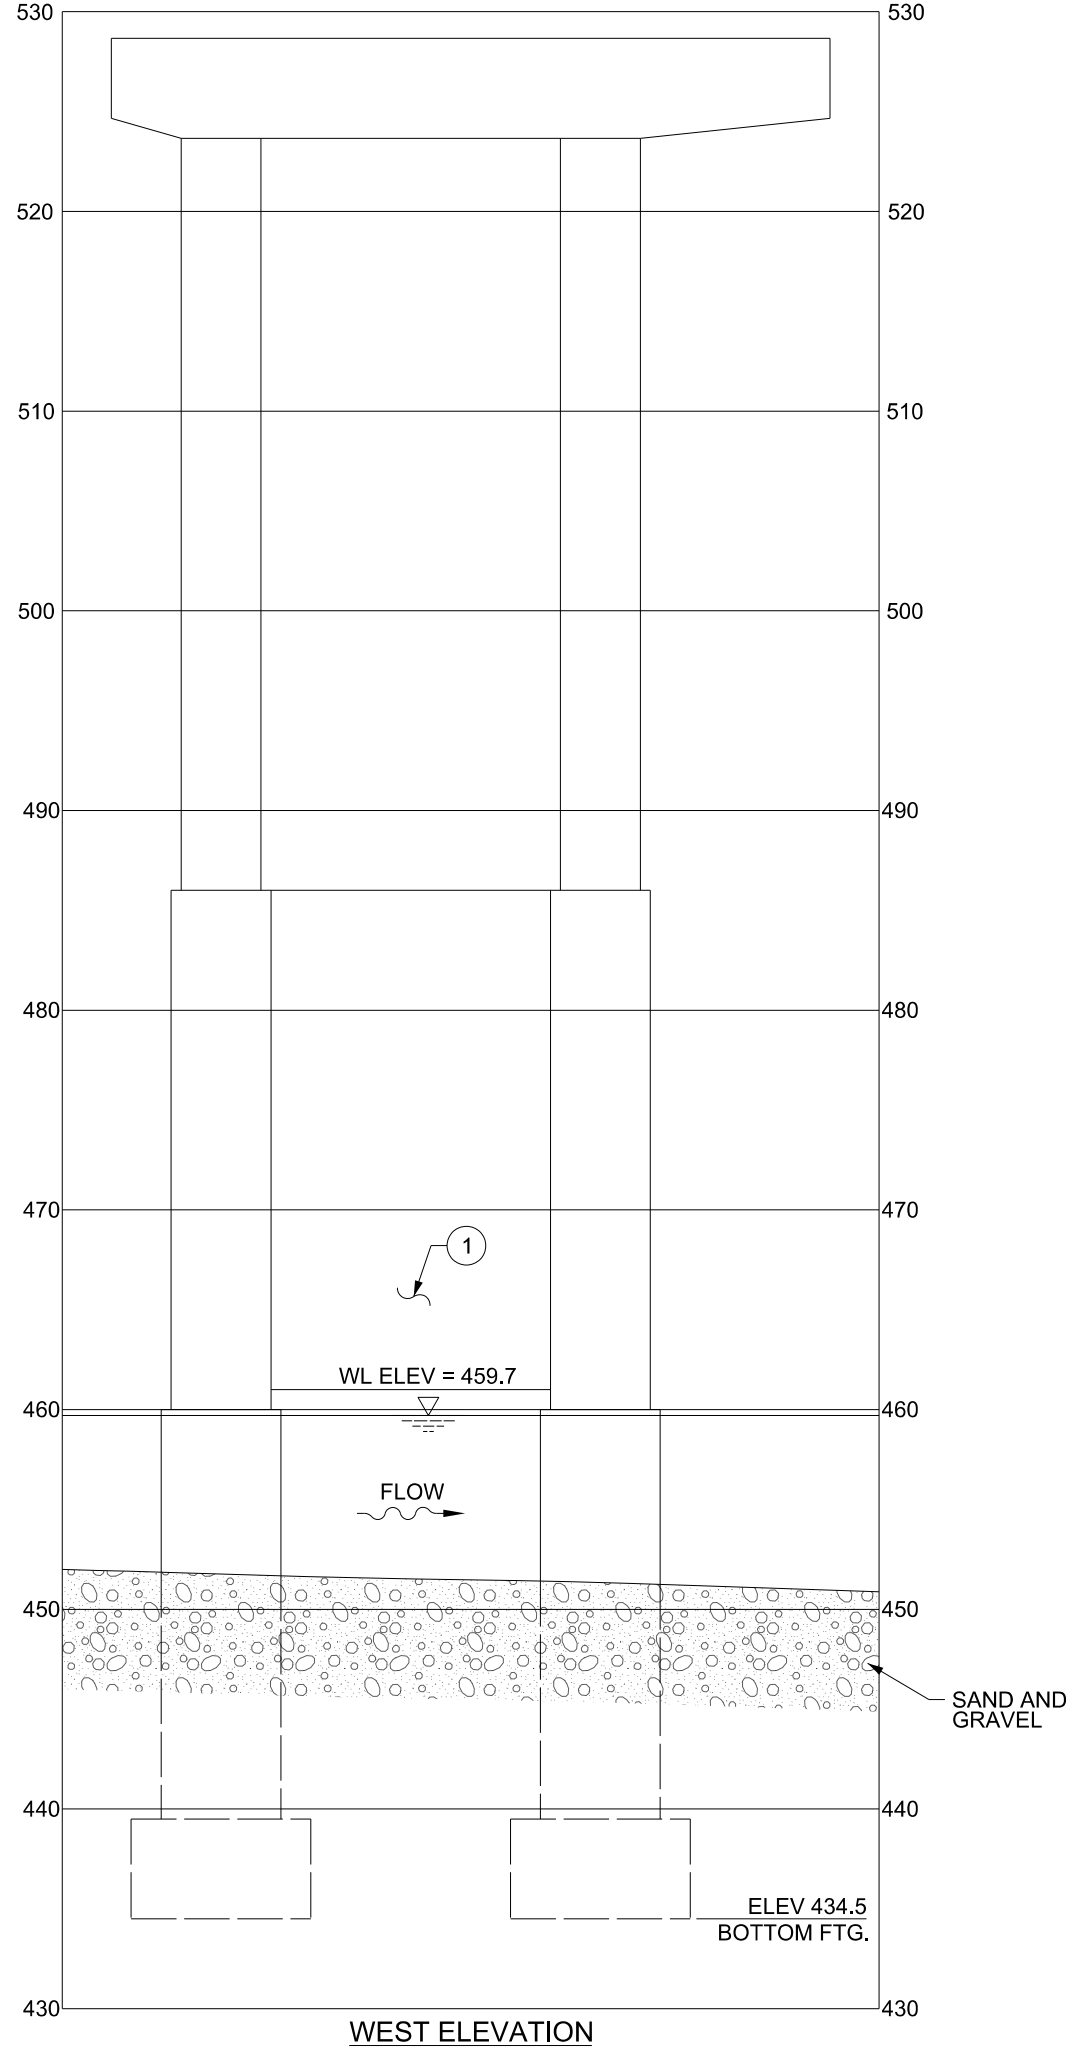
1. WEBWALL, EXPOSED REINFORCING DUE TO LACK OF COVER.

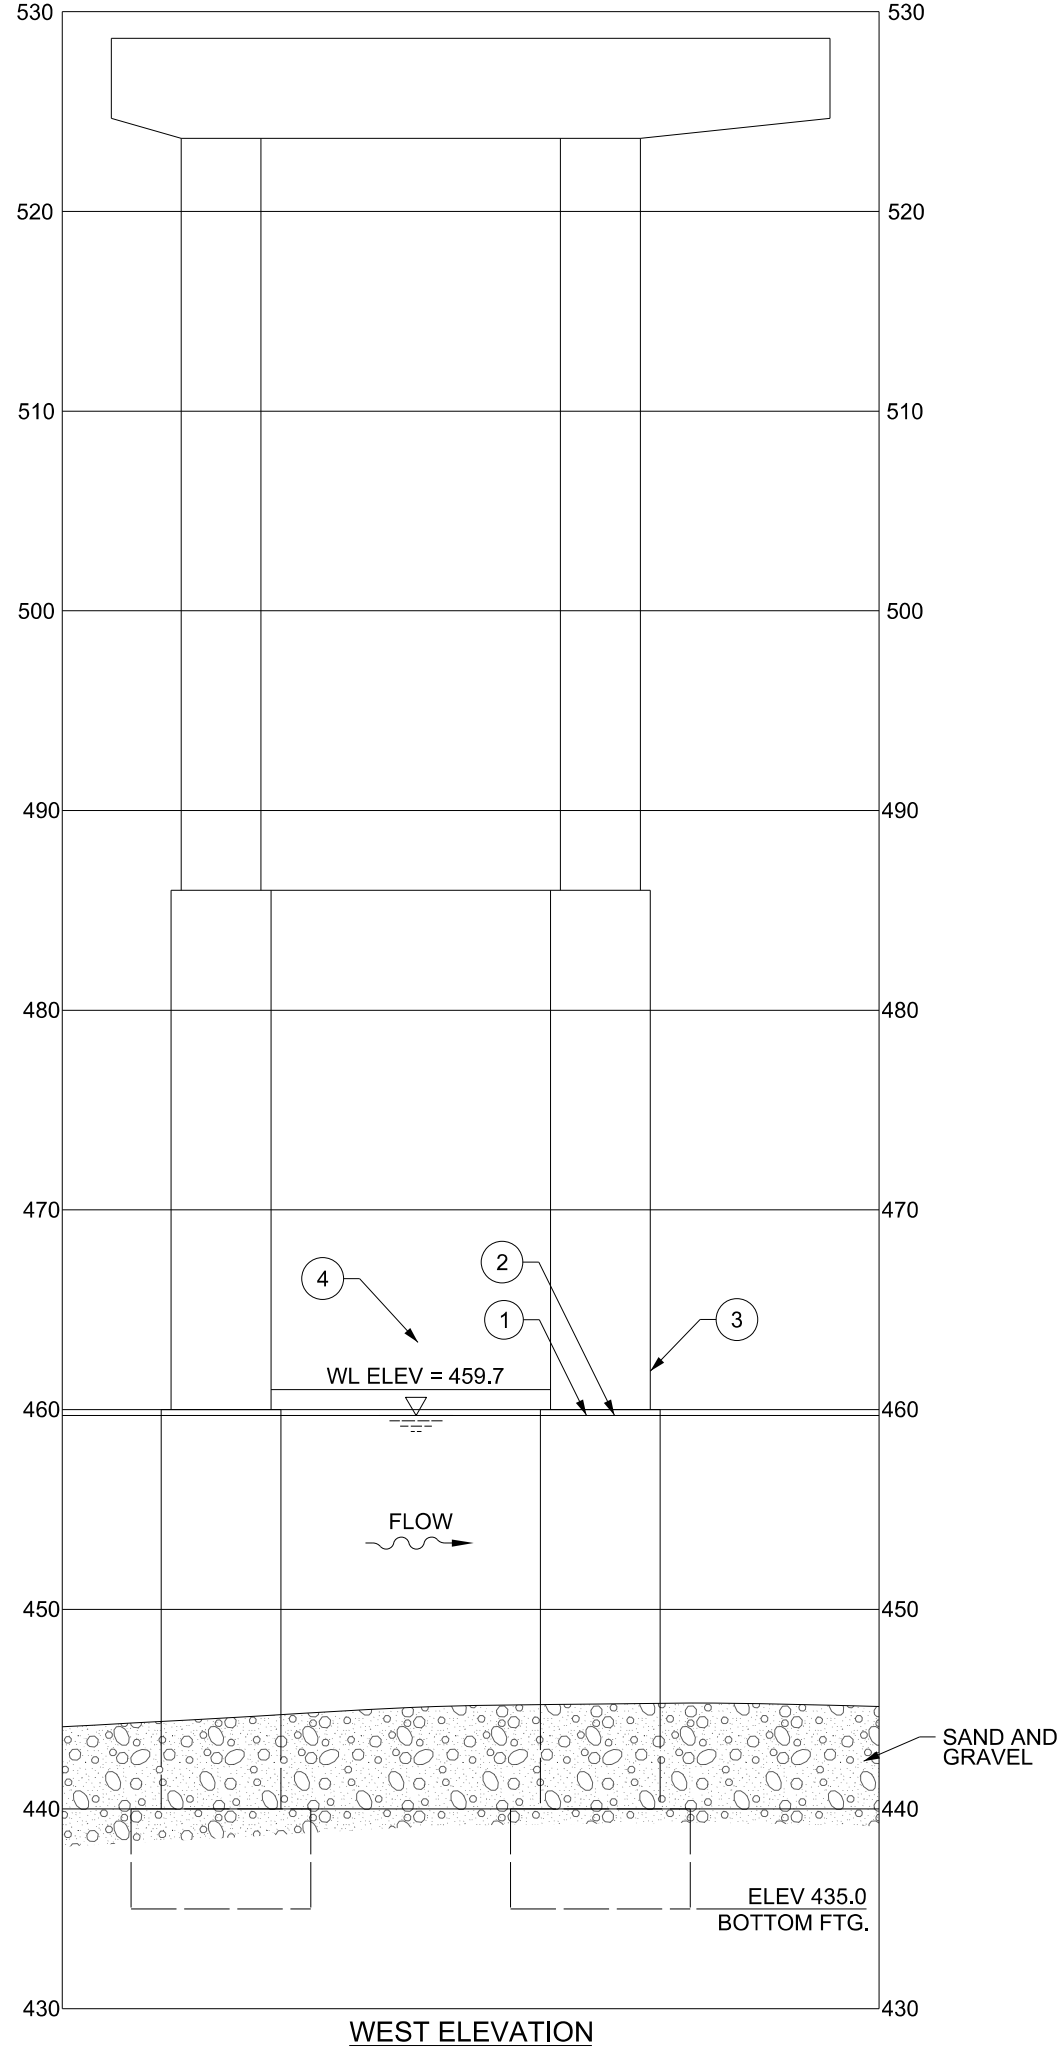
- GN. LIGHT ABRASION ON THE COLUMNS AND WEBWALLS RANGING FROM 1/16-IN DEEP TO 1/8-IN DEEP AND ALGAE GROWTH.
- COLUMN 1, EAST QUADRANT AT THE WATERLINE, AREA OF VOIDING 12-IN H X 3-IN W X 2-IN D.
 - COLUMN 1, EAST QUADRANT AT THE WATERLINE, SPALL 3-IN H X 3-IN W X 1-IN D.
 - COLUMN 1, SOUTH QUADRANT ABOVE THE STEP OUT, VOID 4-IN H X 4-IN W X 3/4-IN D.
 - WEBWALL, WEST FACE ABOVE THE WATERLINE SHALLOW SPALLS.

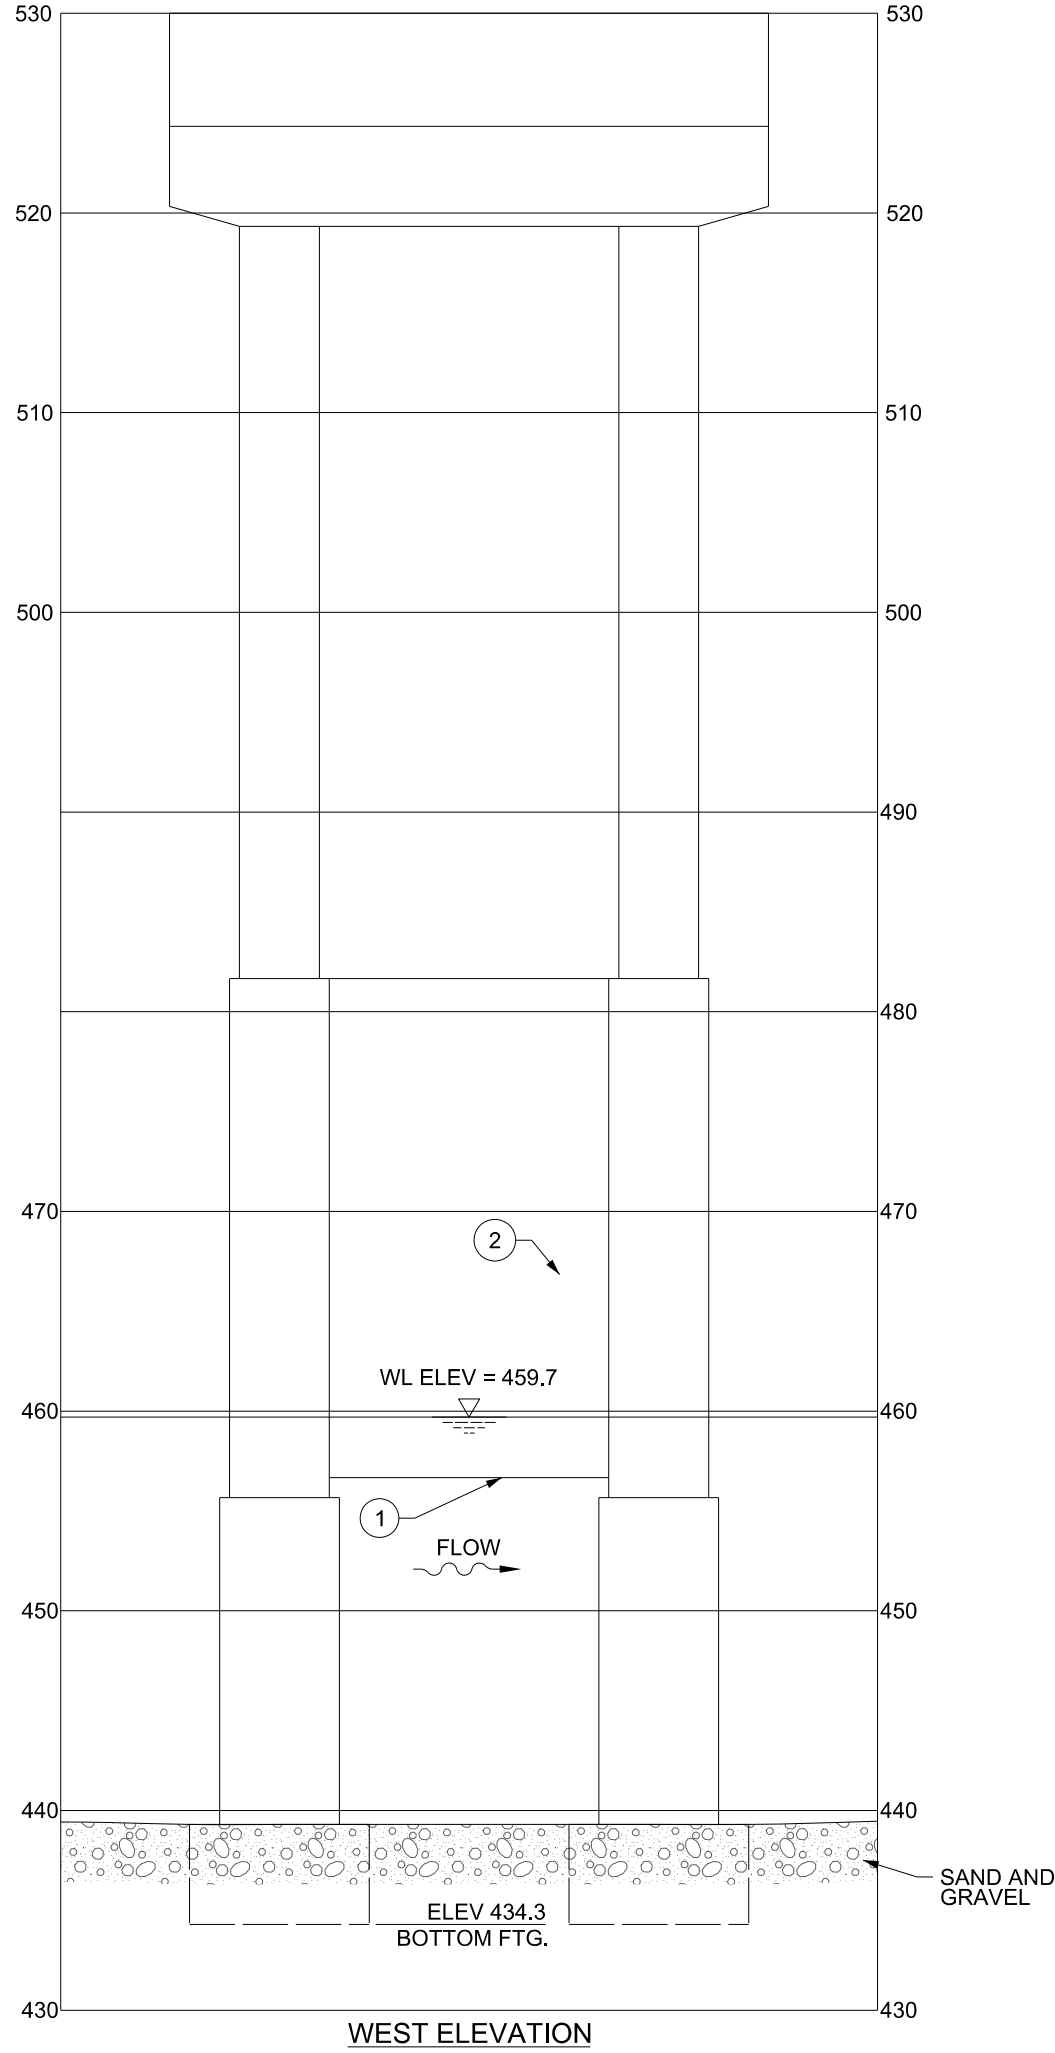
- INSPECTION NOTES:**
- GN. LIGHT ABRASION ON THE COLUMNS AND WEBWALLS RANGING FROM 1/16-IN DEEP TO 1/8-IN DEEP AND ALGAE GROWTH.
1. WEBWALL, VOIDING UP TO 2-IN D ON THE BOTTOM SURFACE.
 2. WEBWALL, EXPOSED REINFORCING DUE TO LACK OF COVER.

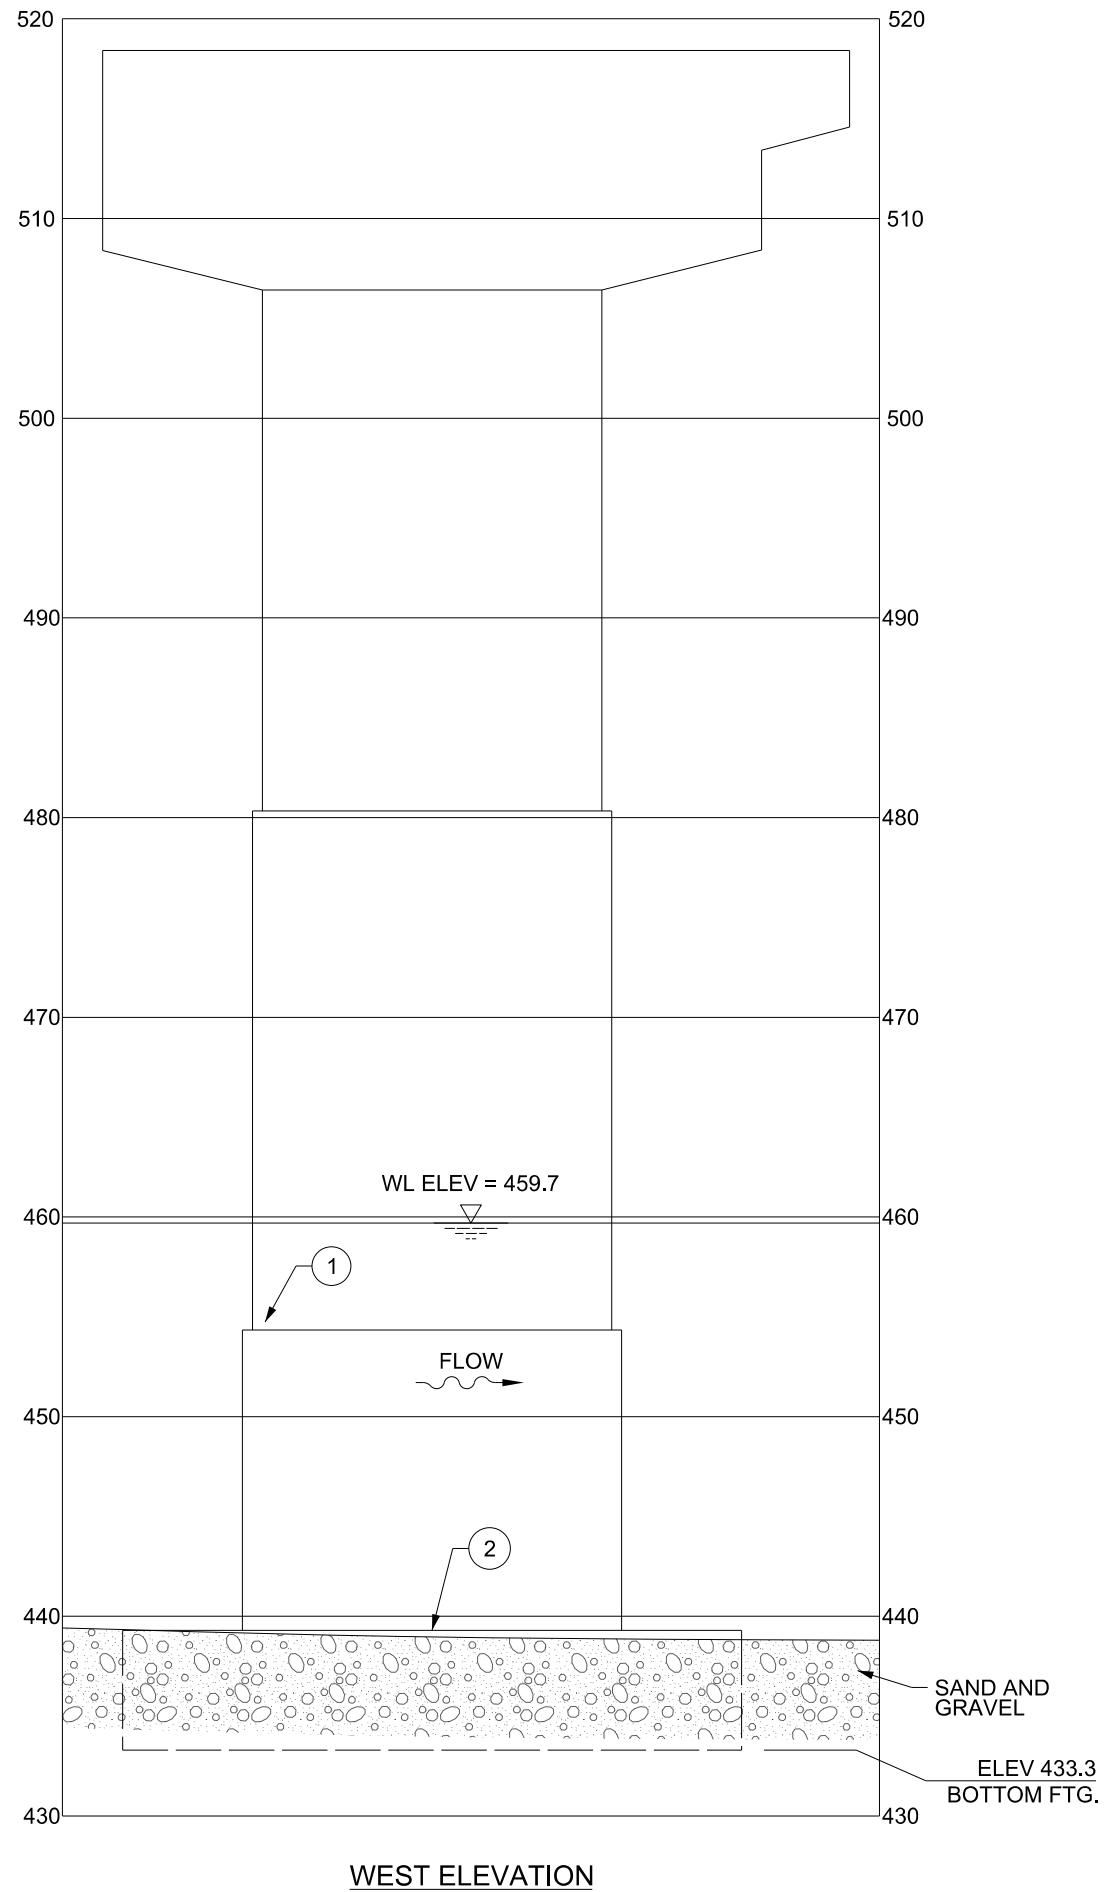
- INSPECTION NOTES:**
- GN. LIGHT ABRASION ON THE COLUMNS AND WEBWALLS RANGING FROM 1/16-IN DEEP TO 1/8-IN DEEP AND ALGAE GROWTH.
- PIER WALL, NORTHEAST QUADRANT NEXT TO THE LOWER STEP OUT, SPALL 3 1/2-IN H X 9-IN W X 2-IN D.
 - FOOTING, AREAS OF ABRASION ON THE TOP SURFACE UP TO 1/4-IN D.
