**Underwater Inspection of
SH 100 over the
Arkansas River**
Muskogee County, Oklahoma
October 14, 2022

Structure No. 5159-0300-X
NBI No. 17611

Subject: Underwater Bridge Inspection
NBI 17611, Structure 5159-0300-X, SH 100 over the Arkansas River

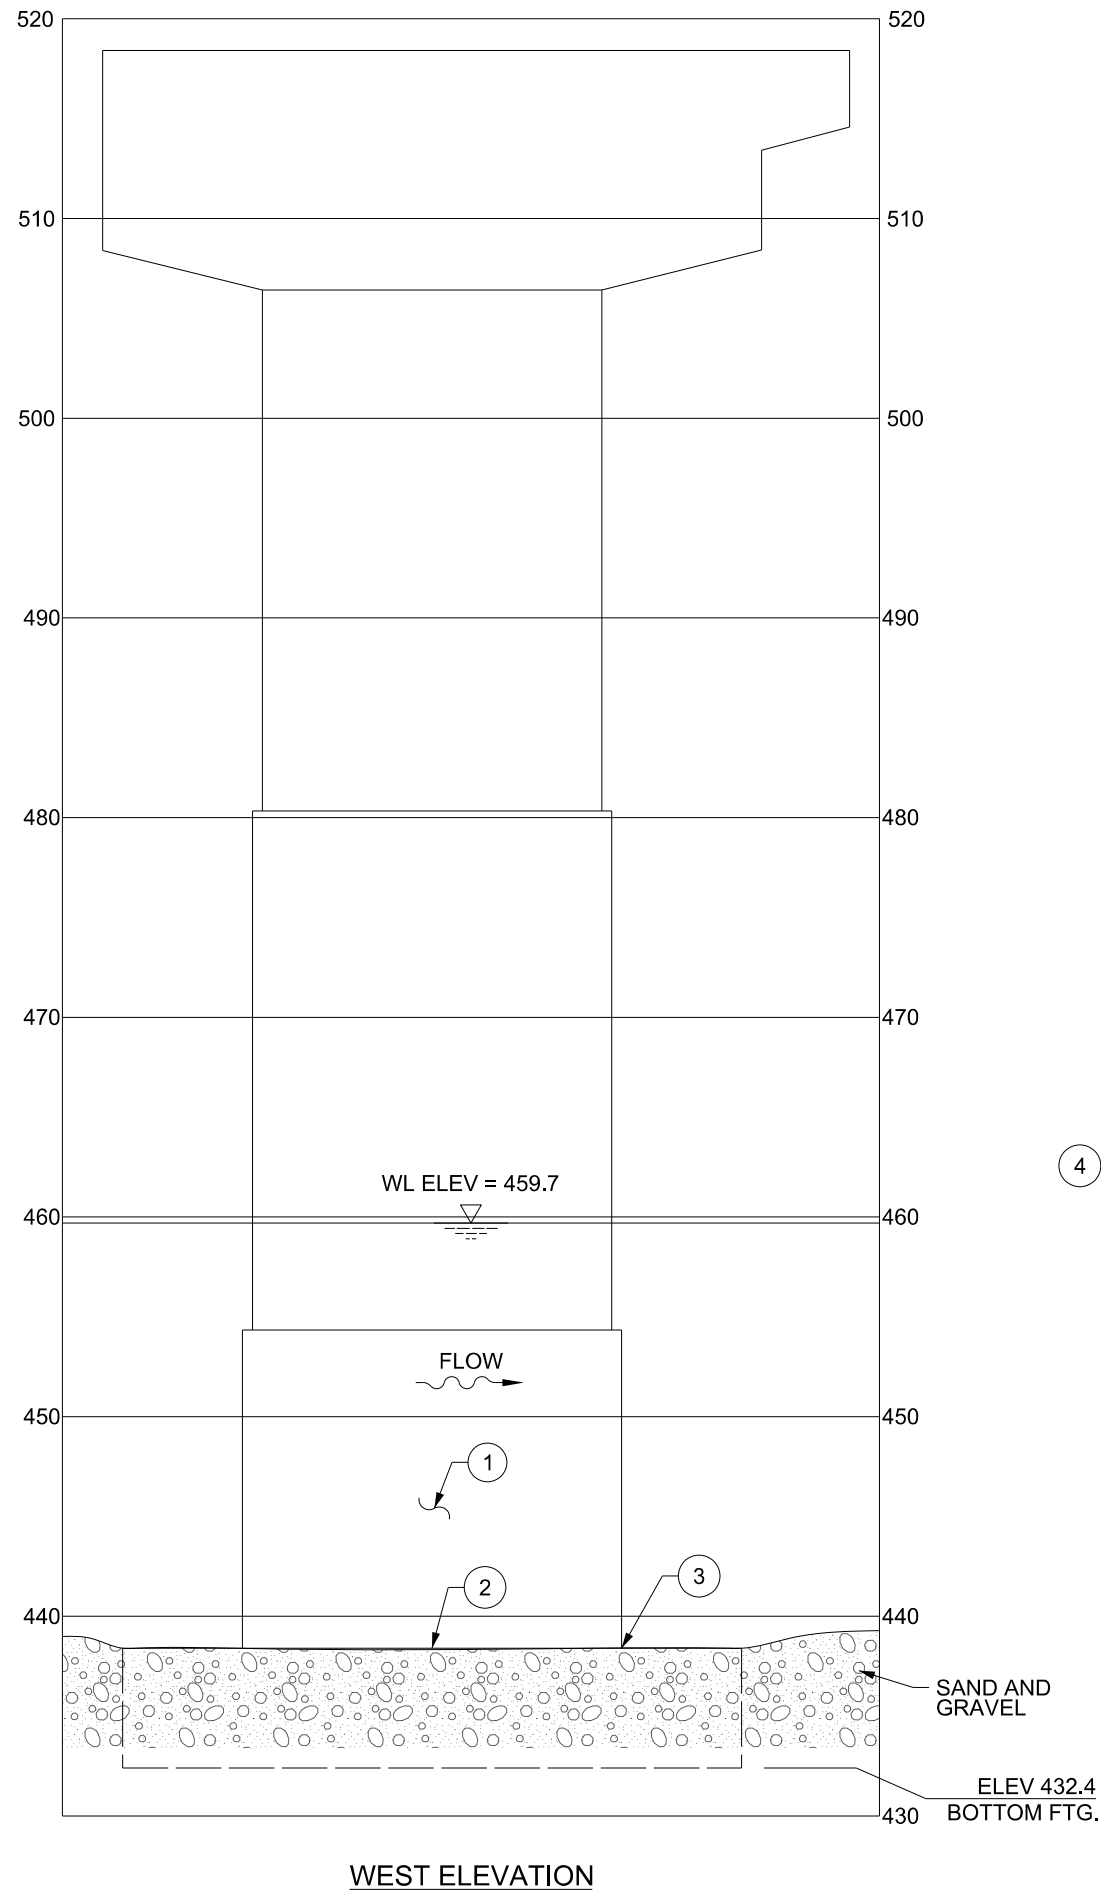
- GN. LIGHT ABRASION ON THE COLUMNS AND WEBWALLS RANGING FROM 1/16-IN DEEP TO 1/8-IN DEEP AND ALGAE GROWTH.
1. PIER WALL, INTERMITTENT VOIDING UP TO 5-IN H X 1-IN D AT RANDOM LOCATIONS.
 2. FOOTING, THE TOP SURFACE IS IRREGULAR.
 3. COLUMN/FOOTING INTERFACE, VOIDING AT THE DOWNSTREAM NOSE UP TO 3-IN H X 1/2-IN D.
 4. DOLPHIN, IMPACT DAMAGE TO THE NORTHWEST QUADRANT.

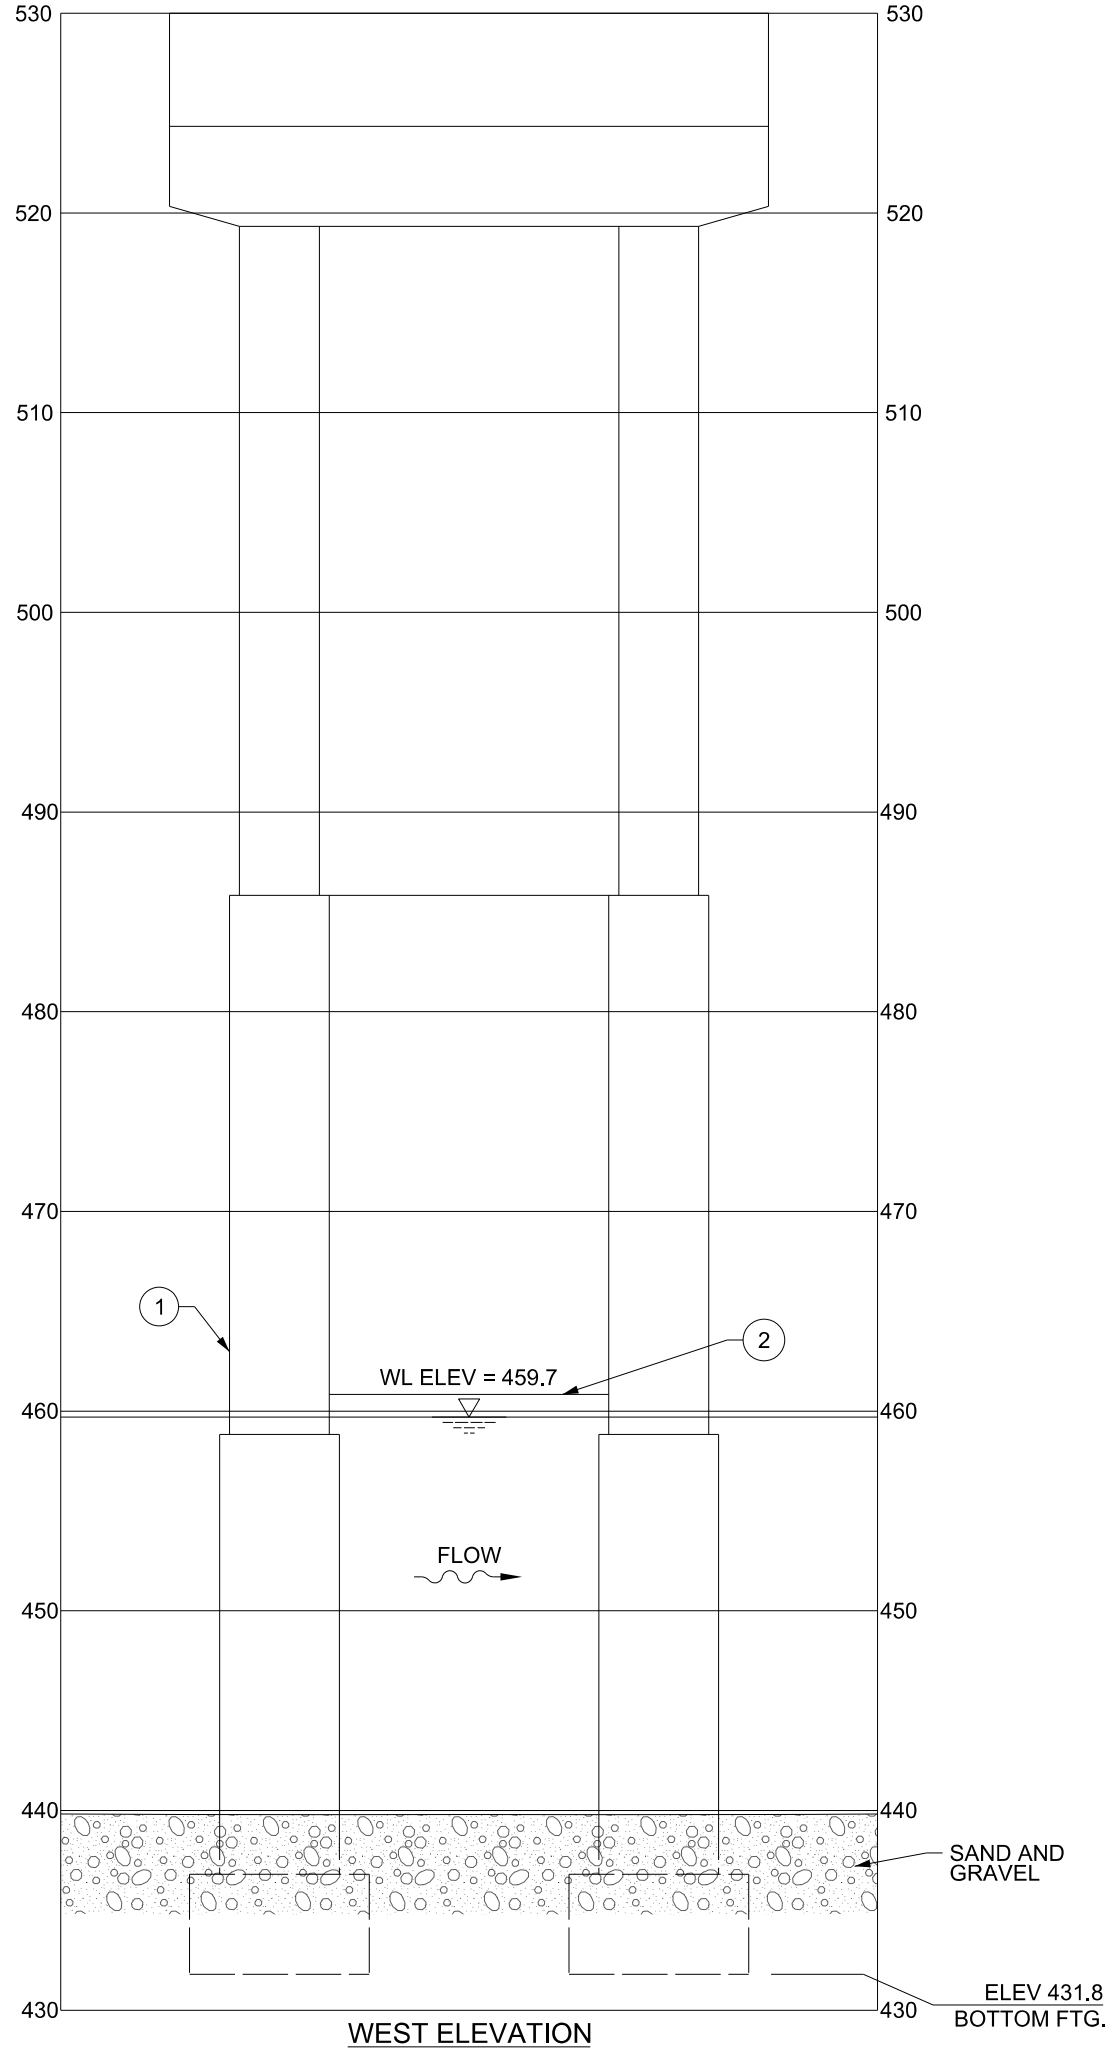
- GN. LIGHT ABRASION ON THE COLUMNS AND WEBWALLS RANGING FROM 1/16-IN DEEP TO 1/8-IN DEEP AND ALGAE GROWTH.
1. COLUMN 2, NORTH QUADRANT, EXTENDING FROM 2-FT ABOVE THE WATERLINE TO 7-FT BELOW THE WATERLINE, AREA OF SPALLING UP TO 48-IN W X X UP TO 2 1/2-IN D WITH ASSOCIATED MAP CRACKING UP TO 1/32-IN W WITH EFFLORESCENCE.
2. WEBWALL, WEST FACE, EXPOSED REINFORCING DUE TO LACK OF COVER.

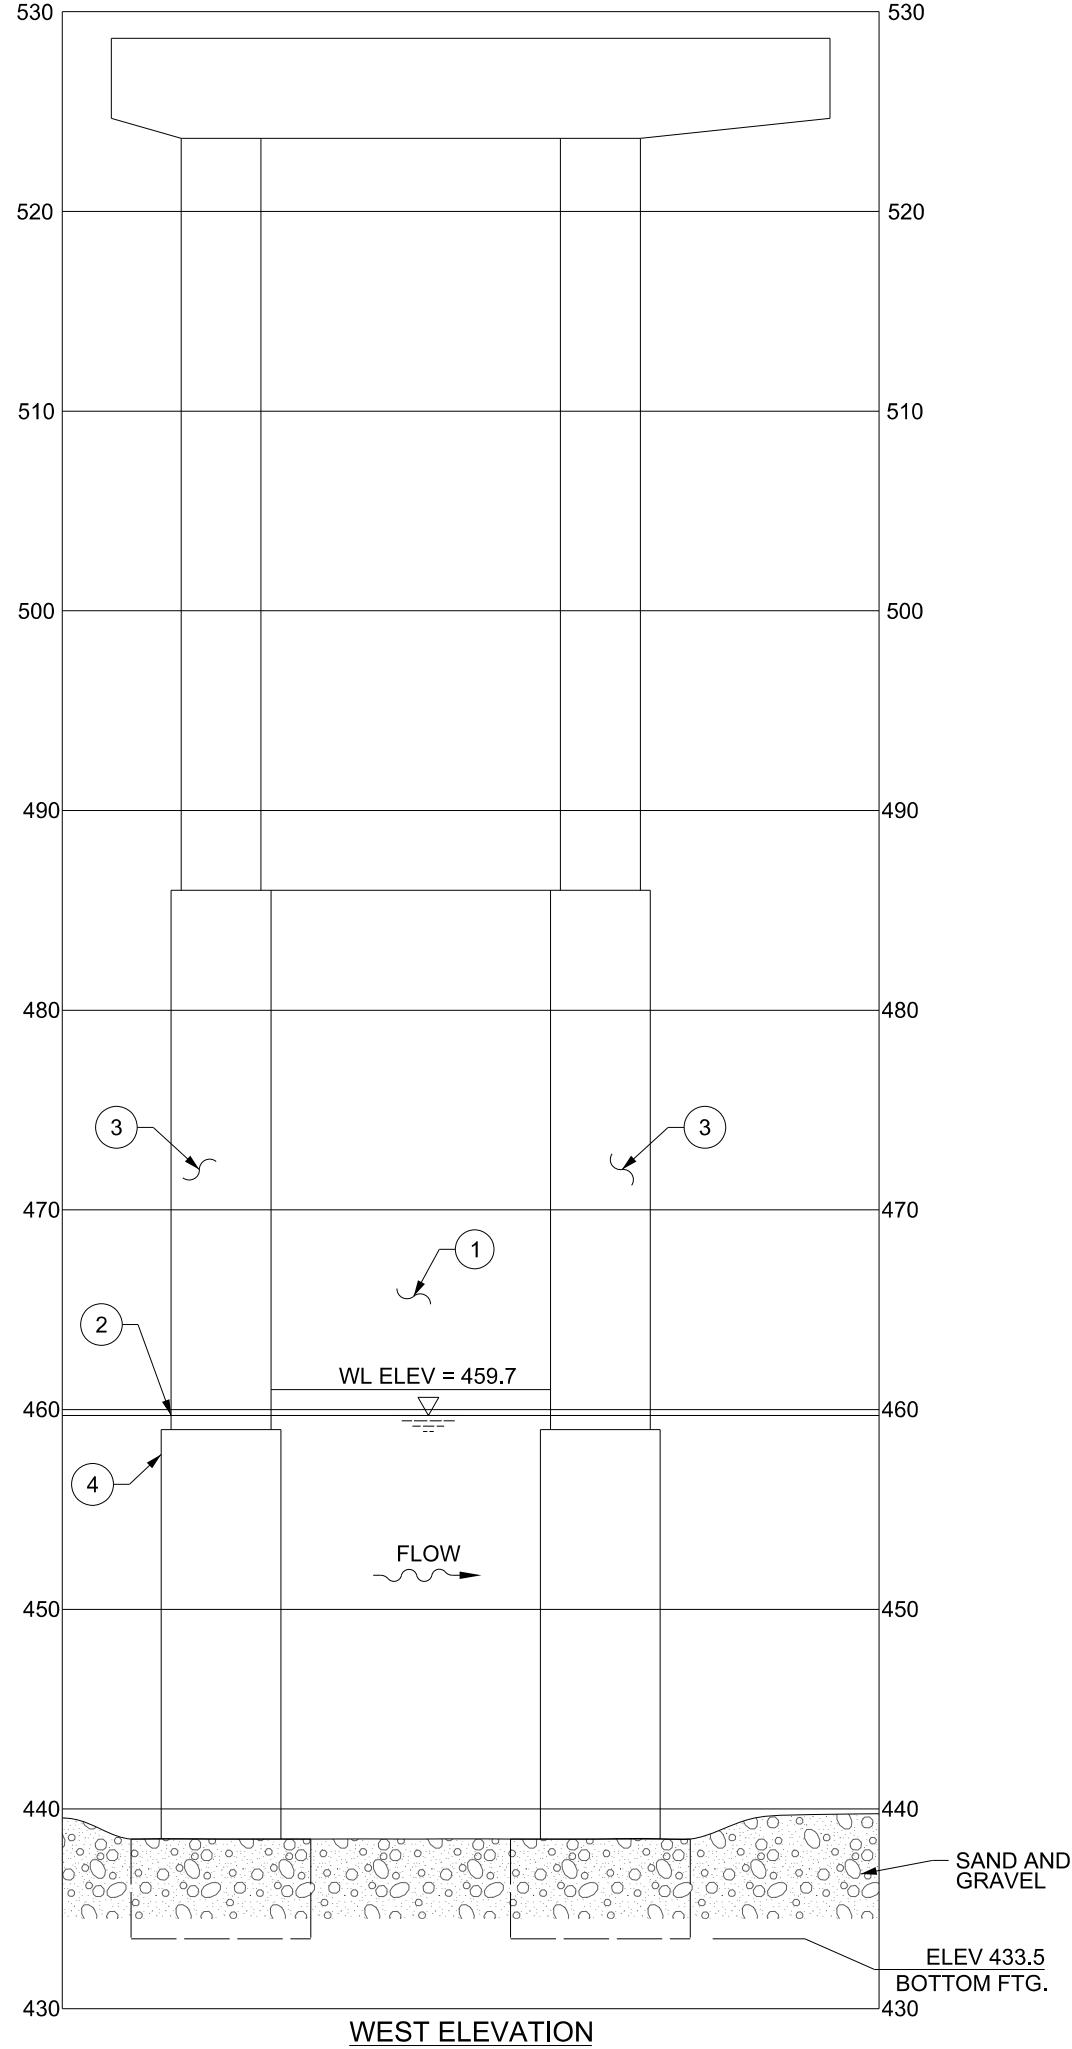
- GN. LIGHT ABRASION ON THE COLUMNS AND WEBWALLS RANGING FROM 1/16-IN DEEP TO 1/8-IN DEEP AND ALGAE GROWTH.
- WEBWALL, ABOVE THE WATERLINE, SHALLOW SPALLS WITH EXPOSED REINFORCING.
 - COLUMN 2, WEST QUADRANT FROM THE LOWER STEP OUT EXTENDING UP, SPALL 24-IN H X 18-IN W X 1-IN D.
 - BOTH COLUMNS, ALL QUADRANTS ABOVE THE WATERLINE, HAIRLINE VERTICAL CRACKS WITH EFFLORESCENCE.
 - COLUMN 2, UPSTREAM NOSE, 15-IN BELOW THE LOWER STEP OUT, SPALL 6-FT H X 6-FT W X 1 1/2-IN D.

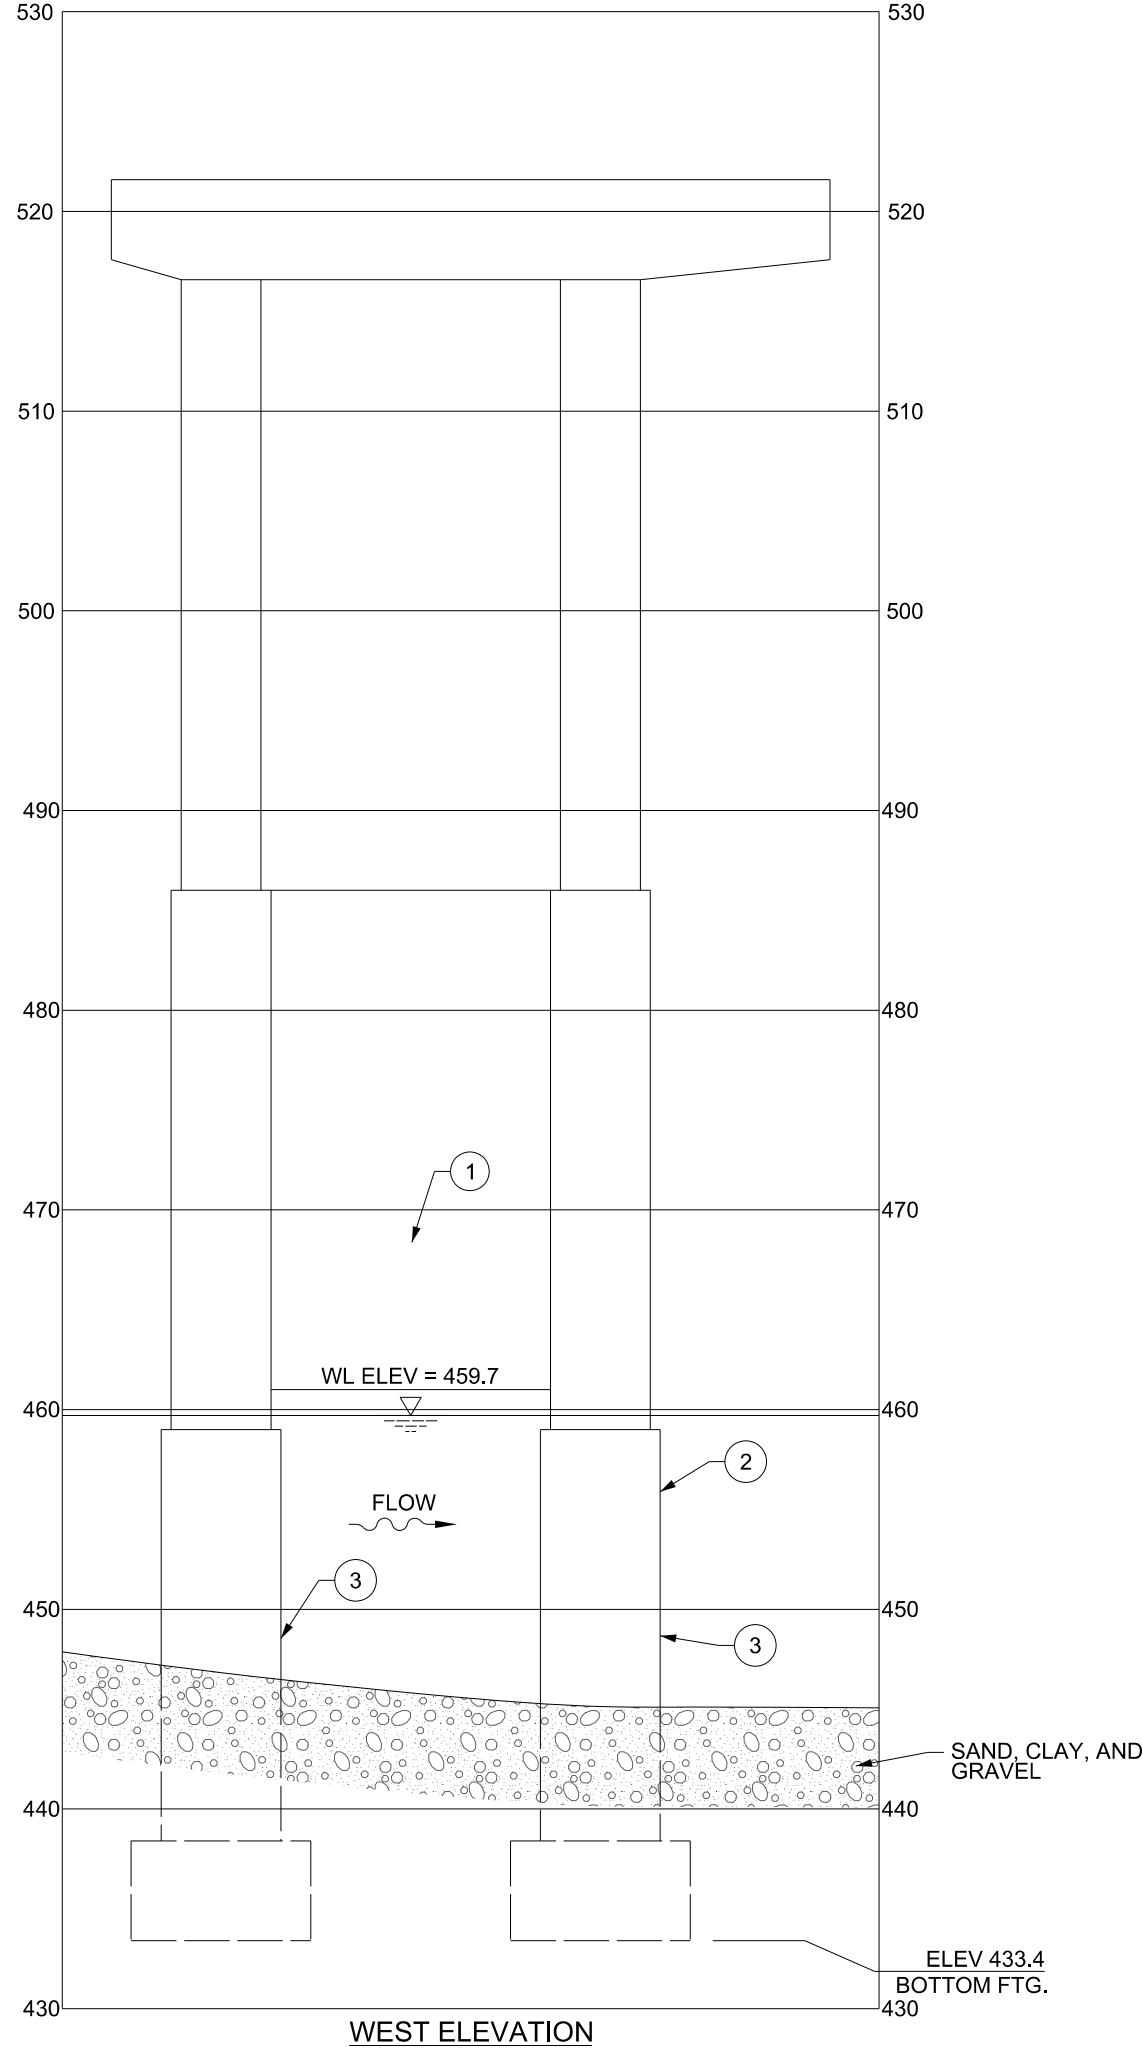
- GN. LIGHT ABRASION ON THE COLUMNS AND WEBWALLS RANGING FROM 1/16-IN DEEP TO 1/8-IN DEEP AND ALGAE GROWTH.
- WEBWALL, SHALLOW SPALLS WITH EXPOSED STEEL AT RANDOM LOCATIONS.
 - COLUMN 1, SOUTHWEST QUADRANT, FROM THE WATERLINE TO THE CHANNEL BOTTOM, VERTICAL CRACK HAIRLINE TO 1/16-IN W.
 - BOTH COLUMNS, AT THE SOUTHWEST QUADRANT, FROM THE WATERLINE TO THE CHANNEL BOTTOM, HAIRLINE TO 1/16-IN W VERTICAL CRACKS WITH EFFLORESCENCE.

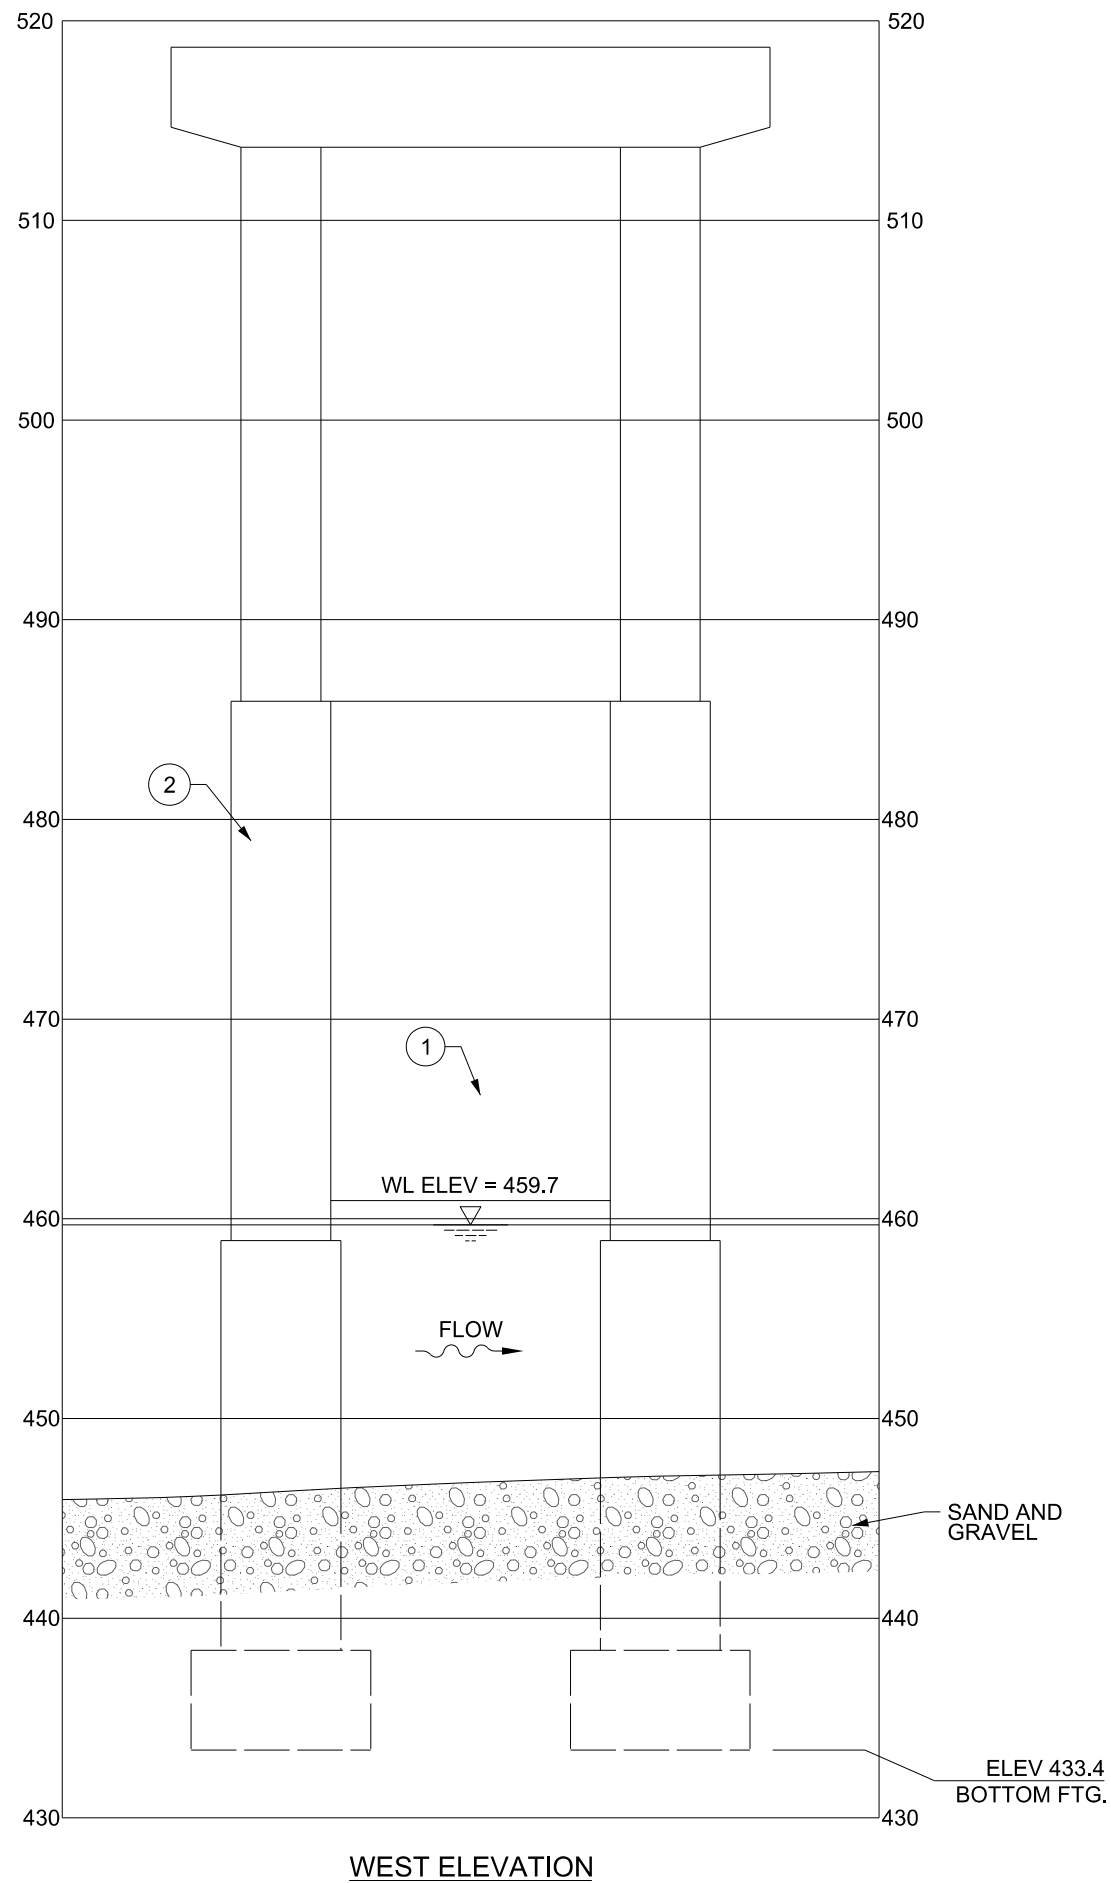
- INSPECTION NOTES:
- GN. LIGHT ABRASION ON THE COLUMNS AND WEBWALLS RANGING FROM 1/16-IN DEEP TO 1/8-IN DEEP AND ALGAE GROWTH.
1. WEBWALL, AREAS OF DELAMINATION AT RANDOM LOCATIONS NEAR THE HIGH WATERLINE.
2. COLUMN 2, EAST QUADRANT, 7-FT BELOW THE STEP OUT, SPALL 4-IN H X 2-IN W X 1/2-IN D.

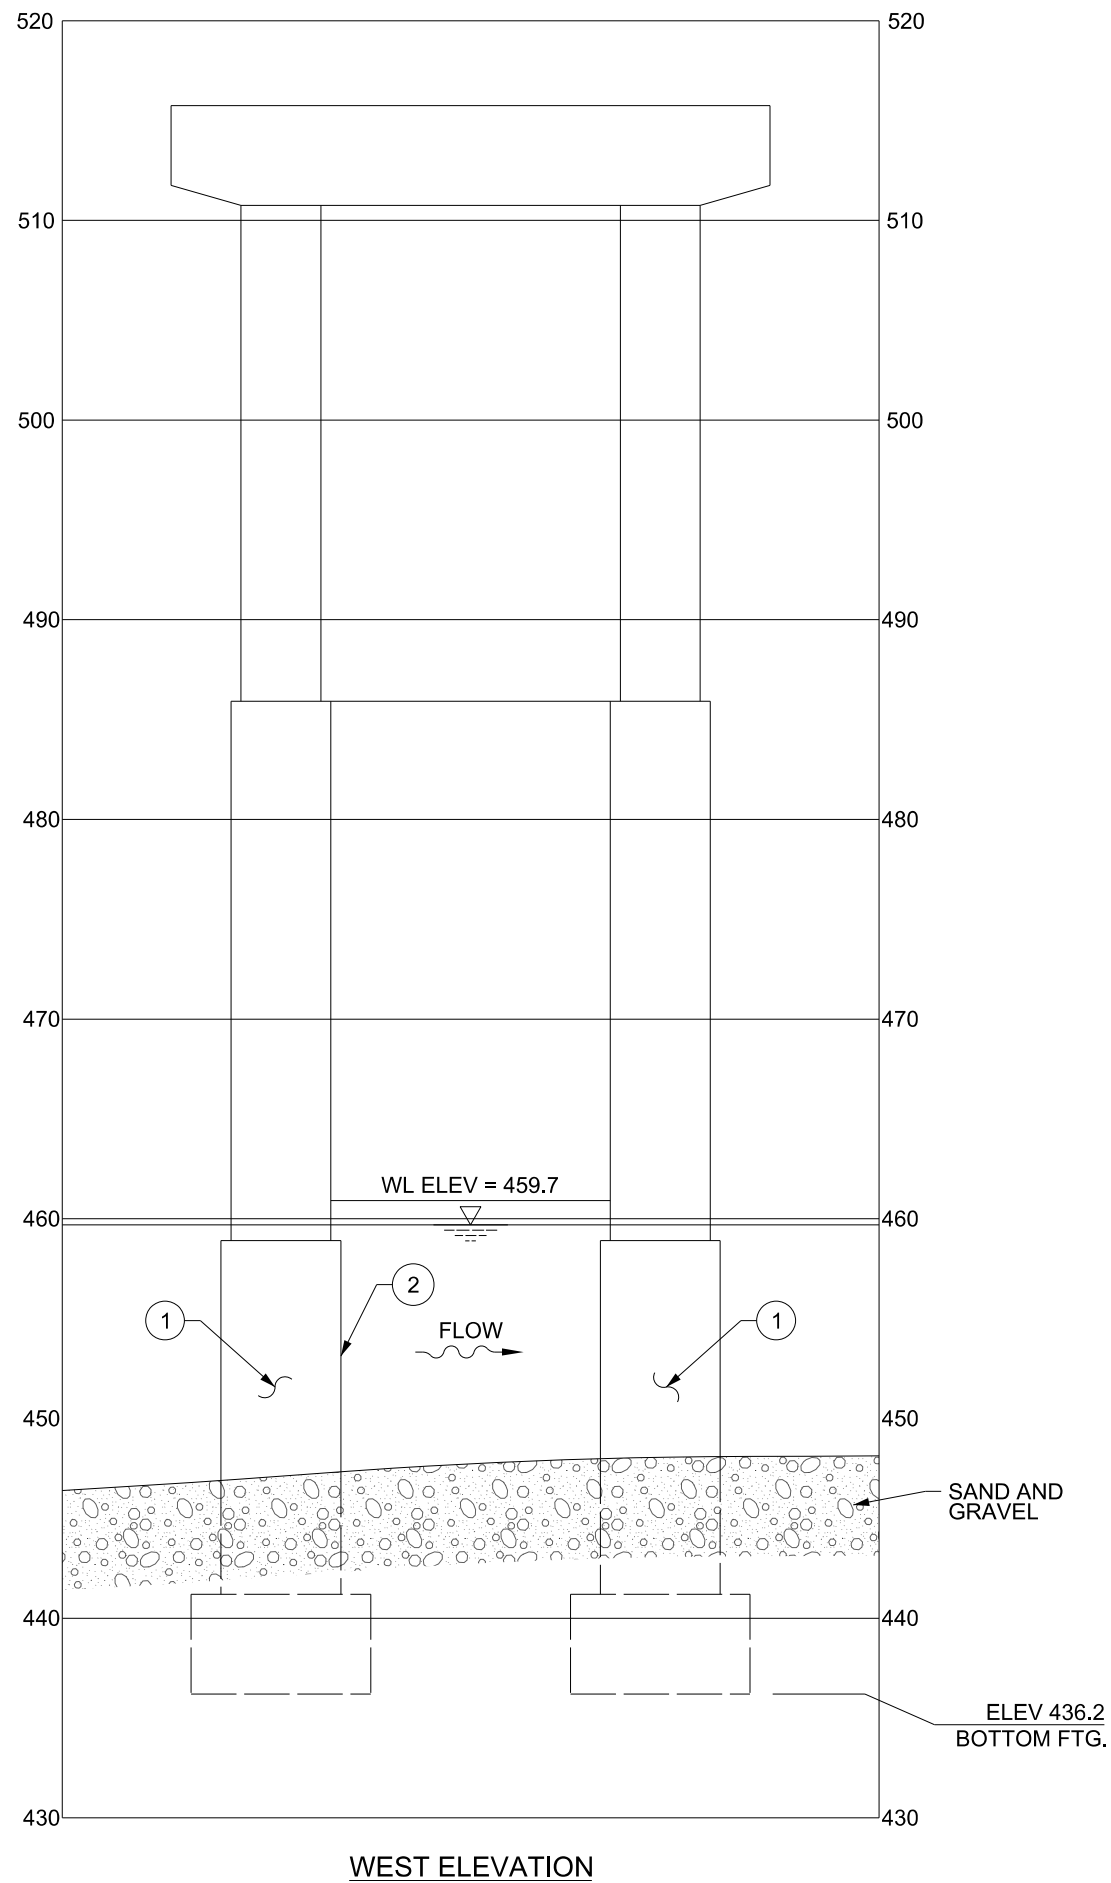
- GN. LIGHT ABRASION ON THE COLUMNS AND WEBWALLS RANGING FROM 1/16-IN DEEP TO 1/8-IN DEEP AND ALGAE GROWTH.
1. BOTH COLUMNS, VERTICAL CRACKS HAIRLINE TO 1/16-IN W WITH EFFLORESCENCE.
 2. COLUMN 2, SOUTHWEST QUADRANT, STARTING 2-FT BELOW THE WATERLINE EXTENDING 11-FT BELOW THE WATERLINE, VERTICAL CRACK UP TO 3/16-IN W.
