Fracture Critical Bridge Inspection Report

NBI Bridge No.: 16159

Route U.S. 81 over UP R.R. UNDER
Kingfisher County

Re: Nonredundant Steel Tension Member Bridge
Inspection Report
Structure No.: 3704 0543EX
NBI No.: 16159
Local ID: 024
US 81 Northbound over Union Pacific Railroad
Kingfisher County, Field Division 4

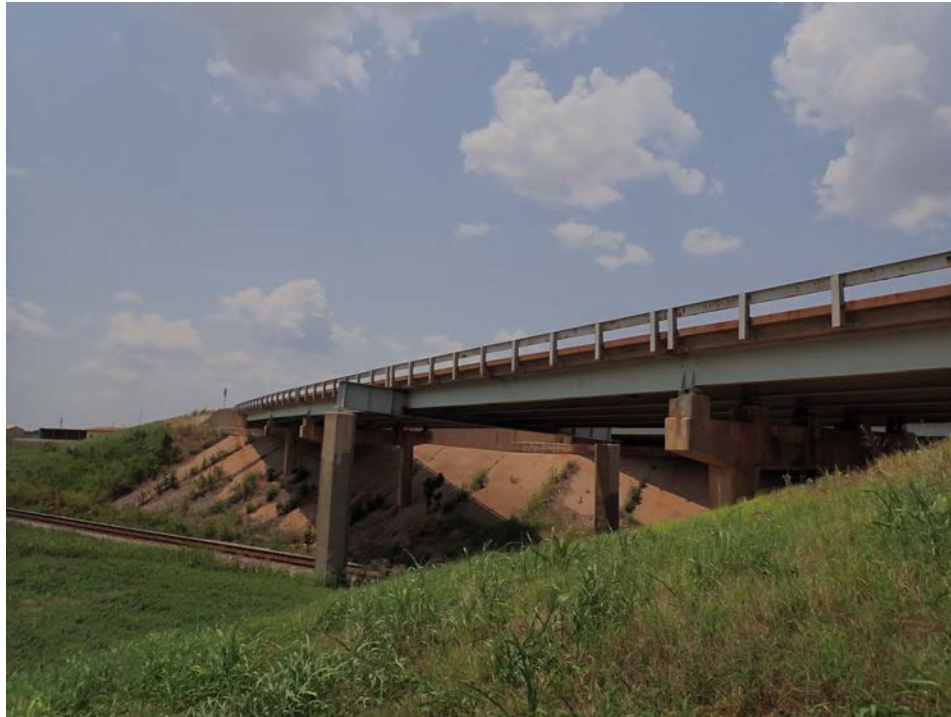
Burgess & Niple (B&N) performed a nonredundant steel tension member and routine inspection of the above referenced bridge on July 24, 2024. The bridge is a six-span structure (**photos 1 and 2**) with a steel pier beam at pier 3. Spans are numbered south to north and consist of:

Photograph 1 - Looking southwest at the bridge elevation.

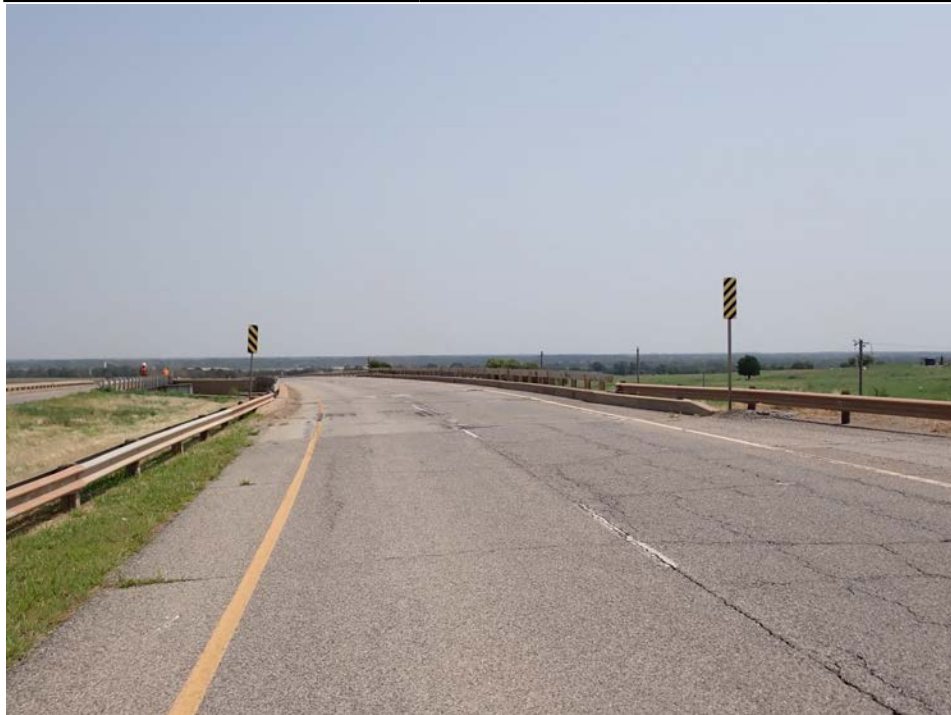
- Transitions - the approach railing at all four transitions is not attached to the bridge railing leaving the end of the bridge railing inadequately protected (**photo 2**). The approach railing also has insufficient post spacing, blockouts are not installed, and the railing is not strengthened with either nested rails or thrie-beam at the transitions

Photograph 2 - Looking north at the bridge end view. Note: approach railing is low especially at the transition. Approach railing is neither attached to nor stiffened at the bridge rail.

- Upgrade the bridge and approach railing, transitions, and terminations to meet current National Highway System standards.
- Perform full-depth patch of deck at locations where spalls in the soffit have compromised the bridge railing post anchorage bolts embedment.

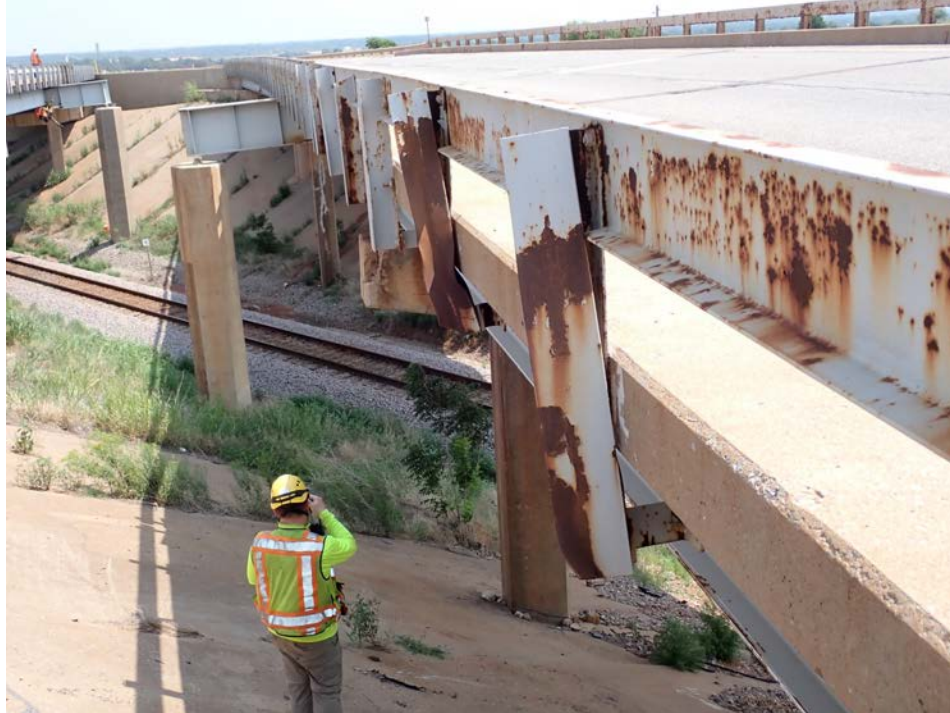
- Bridge railing – the metal bridge railing consisting of a steel channel supported by steel posts with safety curb is obsolete (**photo 3**). Missing bolts between the east bridge rail and post exists near pier 4 and west rail above pier 2 (**photo 4**).

- **PX** – Two posts for the west bridge railing in span 2 near pier 1 have significant damage from a vehicle exiting the southbound bridge (**photo 3**). The posts are still connected to the bridge rail and deck at the time of the inspection.

- **PX** – The bridge railing is corroded with section loss forming at isolated locations (**photo 3**). This section loss has not significantly affected the strength of the railing.

Photograph 3 - Looking north along the west bridge railing from the south abutment. Note: railing consists of a steel channel supported by steel posts. Two posts nearest the south abutment have impact damaged. Railing coating has failed.

- Replace the two damaged railing posts in span 2 near pier 1. *(disregard if bridge railing is upgraded).*
- Abrasively clean and paint steel bridge railing. *(disregard if bridge railing is upgraded).*

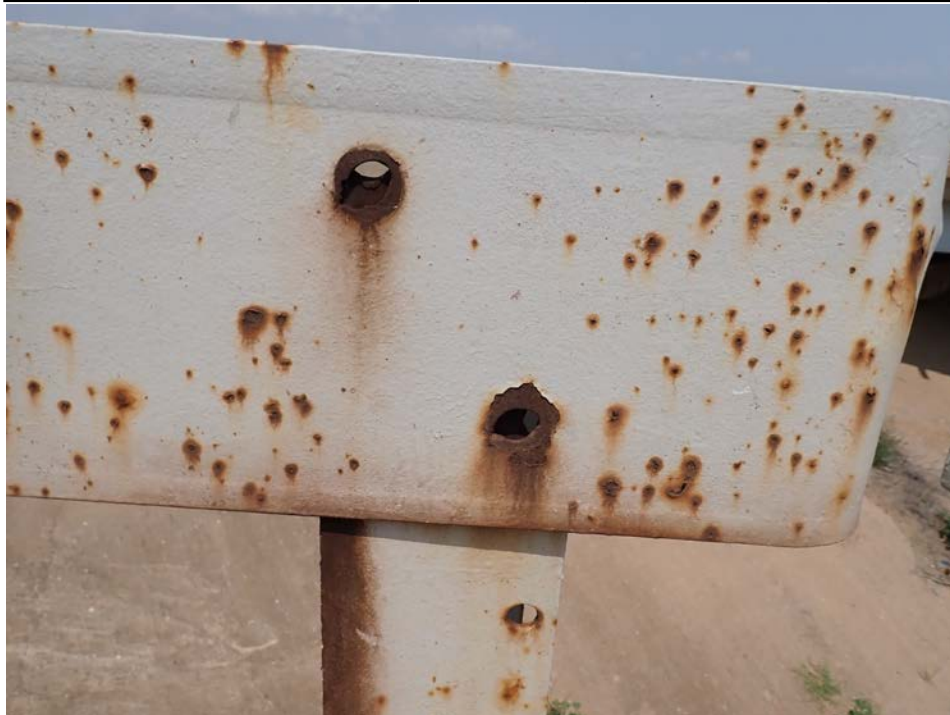
Photograph 4 - Looking west at the west bridge railing above pier 2. Note: missing bolts between the rail and post.

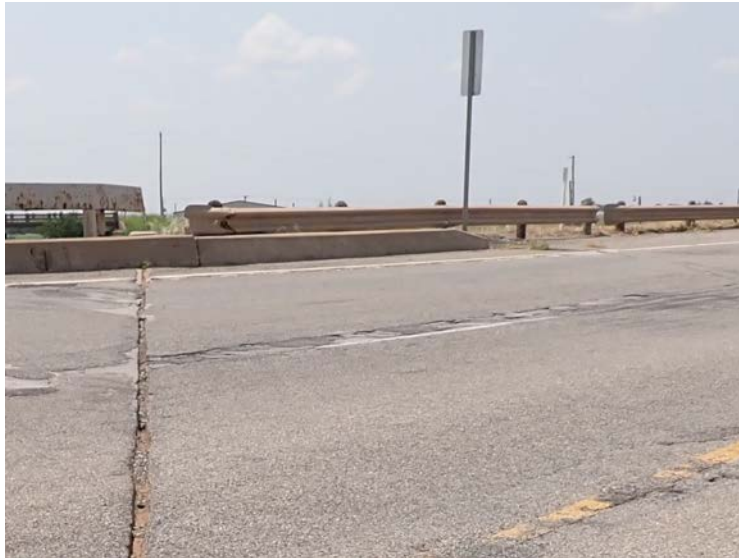
Photograph 5 - Looking southeast at the southeast approach railing. Note: break in railing has flared end treatment.

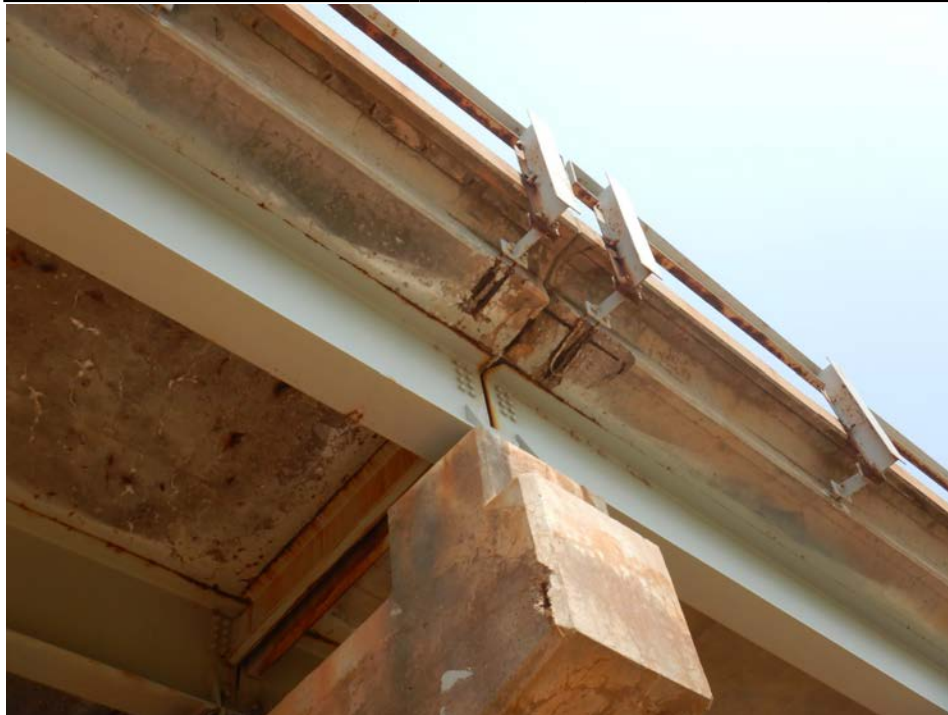
- **PX** – Spalls exposing the embedded anchorage for the lower connection of the bridge rail posts exist adjacent to the joints at the piers (**photos 6 and 7**). The U-bolt anchor bars are exposed at these locations and are no longer adequately embedded into the deck. A bolted repair observed at the west overhang for span 3 at pier 2 does not restore the original embedment strength of the U-bolt and is not sufficient to be considered a permanent repair.

Photograph 6 - Looking up at the underside of the east overhang at pier 1. Note: soffit is spalled and anchorage for the railing posts is exposed and separating from the deck.

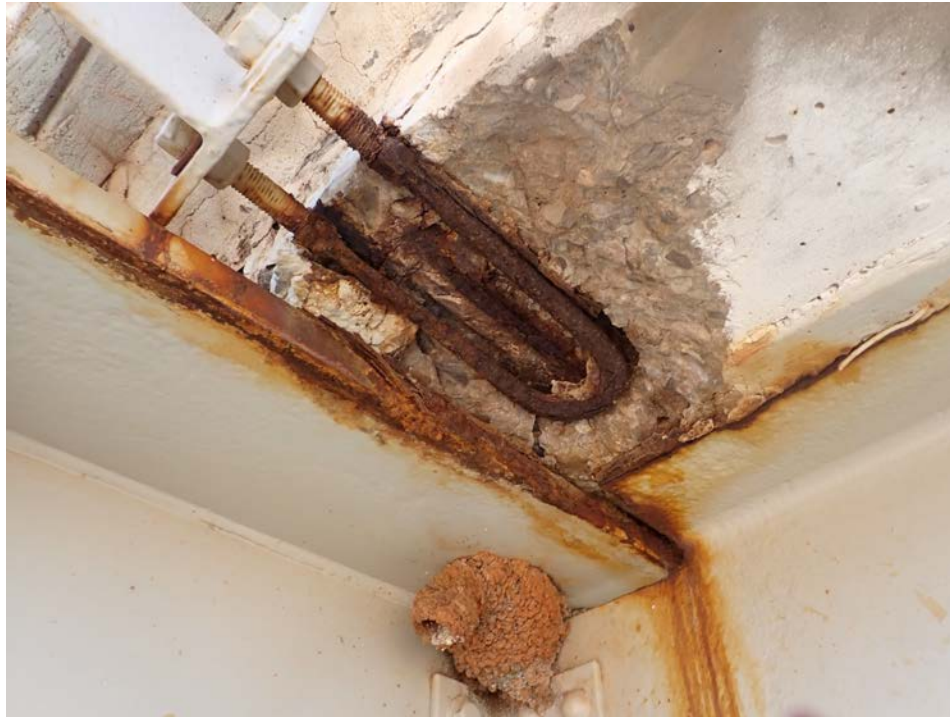
- **PX** – Large spalls exposing the railing connection anchorages exist at the fixed and expansion joints (**photo 7**). These spalls have significantly compromised the railing attachment to the deck.

Photograph 7 - Looking northeast at the underside of the west overhang adjacent to the pier beam at pier 3. Note: heavy spalling with exposed anchor U-bolts for steel railing posts with up to 50% section loss. Corrosion of the pier beam top flange.

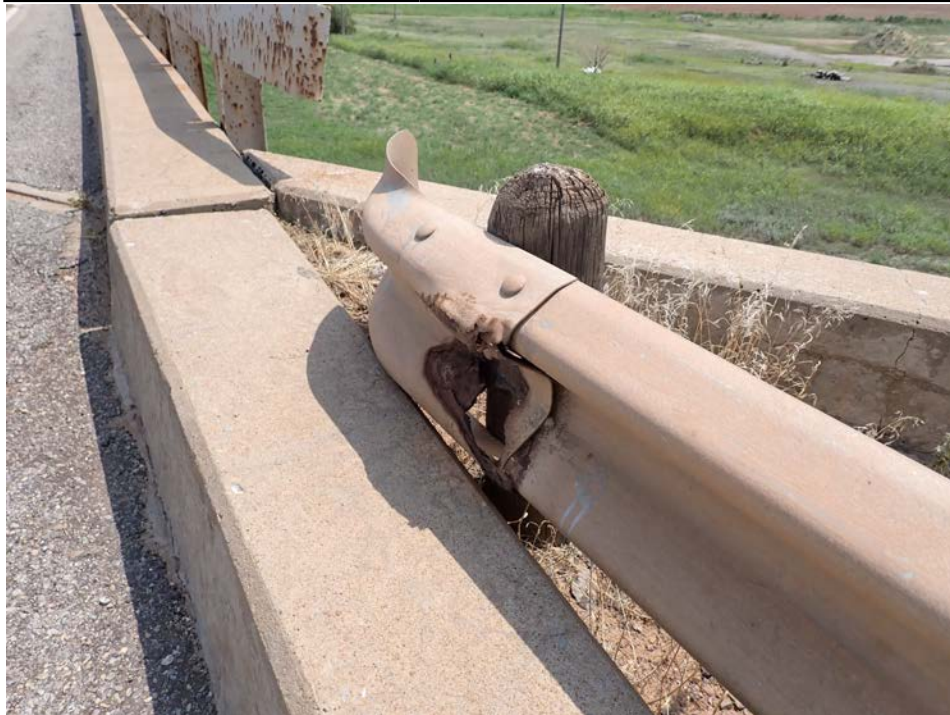
Photograph 8 - Looking north at the south east approach rail. Note: end is corroded and incorrectly lapped.

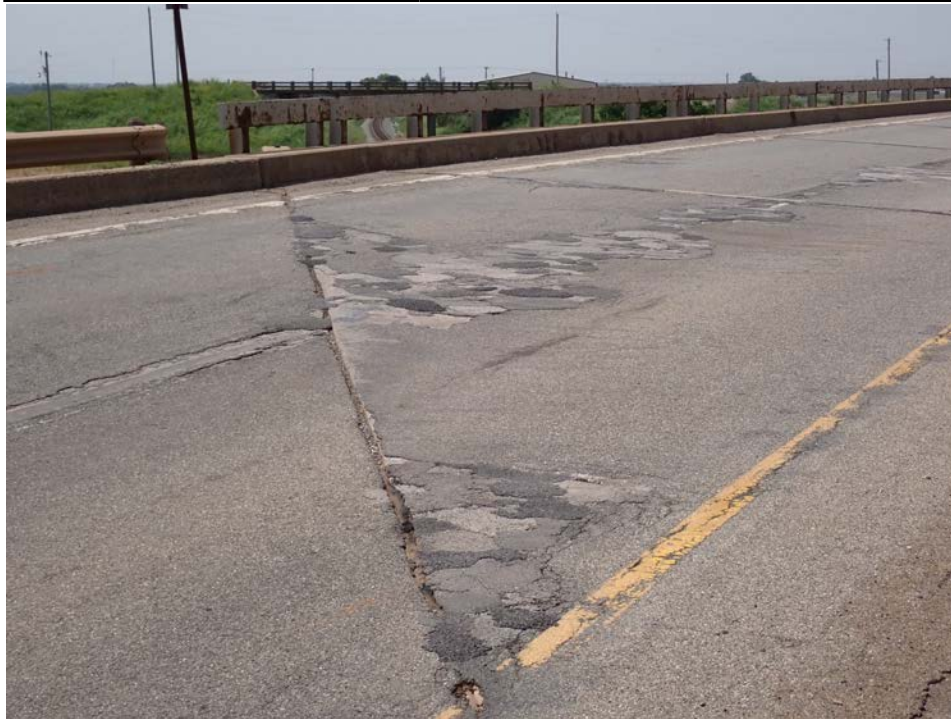
- **PX** – Numerous asphalt and concrete patches exists in the asphalt wearing surface along the deck and expansion joints and along the roadway centerline where a paving construction joint exists (**photos 9, 10 and 11**). Densely spaced 1/16-inch-wide map cracks adjacent to the patches exist in span 1 near the fixed joint at pier 1 and in isolated locations along the roadway centerline. The paving construction joint is a common location where deck drainage leaks through the asphalt. Multiple applications of patch

Photograph 9 - Looking southeast at the driving in span 6. Note: asphalt patches in the driving surface.

- Investigate condition of concrete deck (cores) at locations where asphalt patches exist to determine if deck repair is needed and to what extent.
- Reseal the fixed and expansion joints (removal of asphalt patches along joints may reveal concrete deterioration to extent that joint replacement is required).

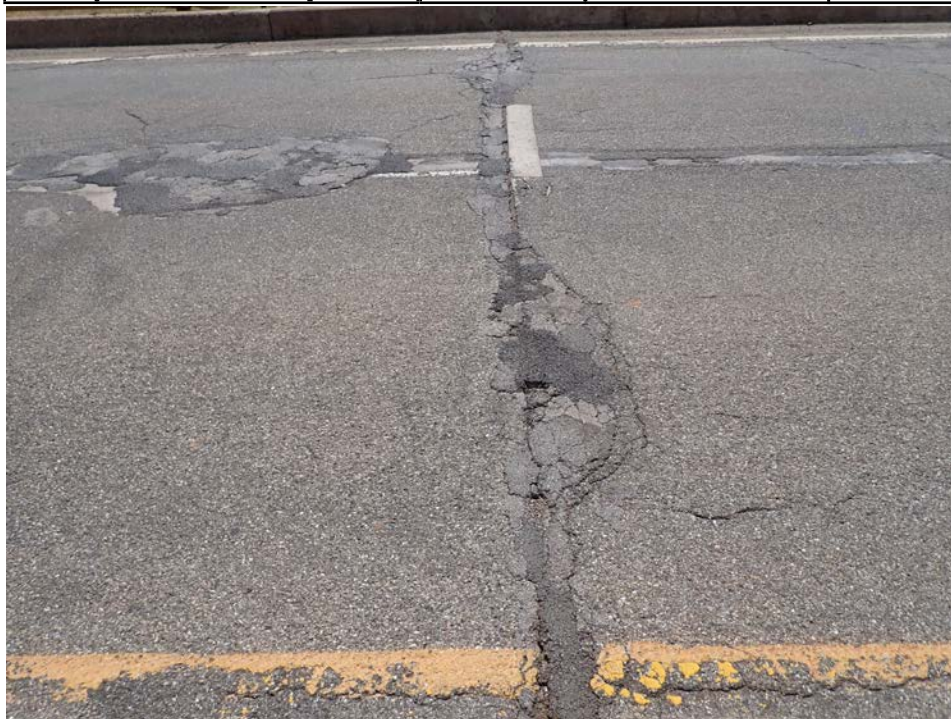
Photograph 10 - Looking east along the fixed joint at pier 5. Note: asphalt and concrete patches in the driving surface and along the joint.

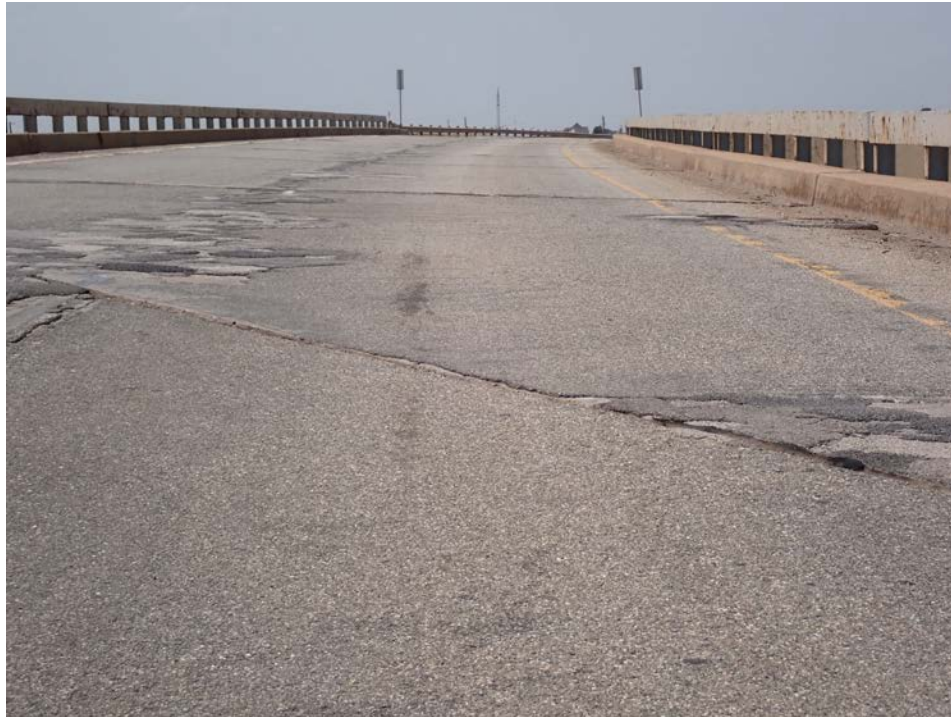
Photograph 11 - Looking south at the driving surface from the north approach. Note: patches in the asphalt overlay along the roadway centerline and joints. Minor rutting in the wheel lines and weathering of the asphalt overlay.

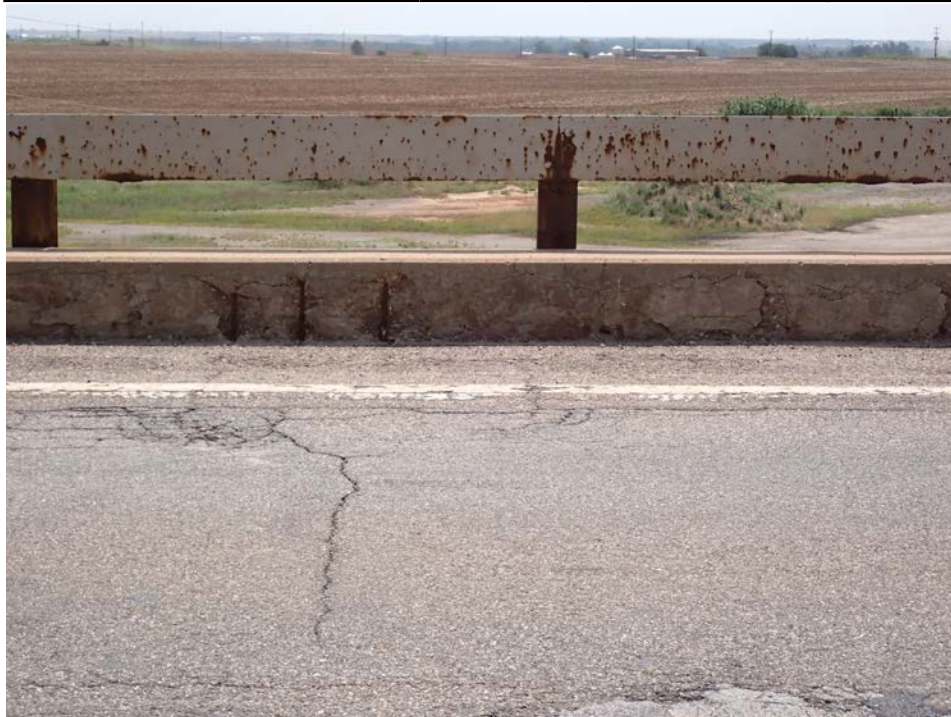
- Shallow spalls with exposed reinforcing steel exist at isolated locations in the face of both curbs (**photo 12**). The spalls are due to shallow cover over the reinforcing steel.
- The edge of the deck is supported by the backwall and abuts the approach slab (the edge of the approach slab is also assumed to be supported on the backwall). The deck is offset longitudinally away from the embankment 1 3/8 inches at the north abutment and 5/16 inch at the south abutment (**photo 13**). This offset has not changed since the 2021 inspection when first documented and may be an indication of approach pavement growth.
- Minor rutting in the wheel lines and weathering of the asphalt overlay exist throughout the bridge (**photo 11**).
- No deck drains exist on the bridge.

Photograph 12 - Looking east at the east curb in span 5. Note: spalls with exposed reinforcing steel due to shallow cover.

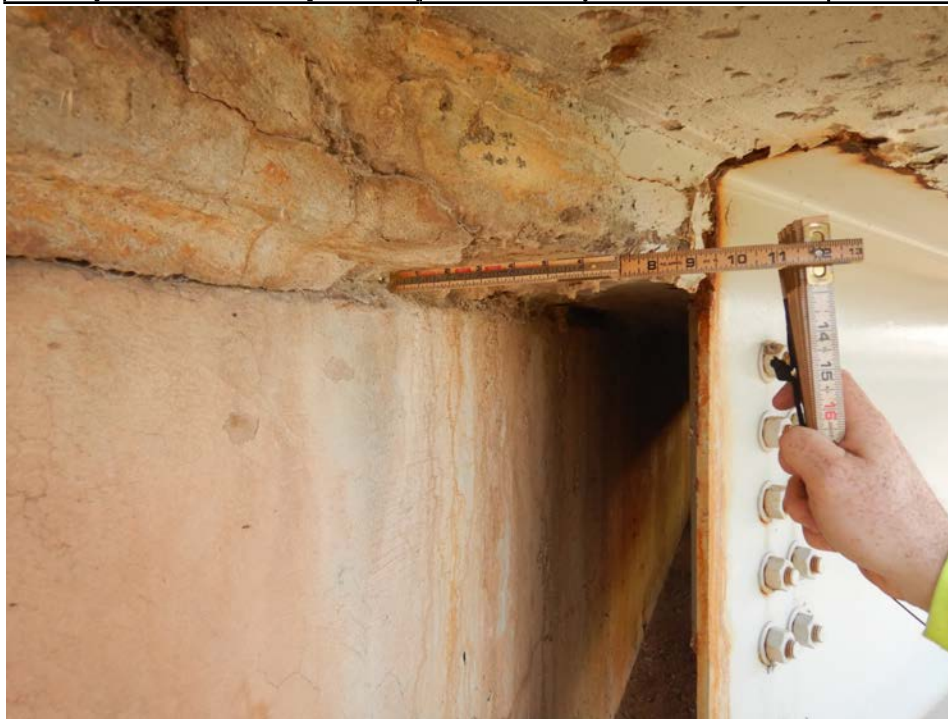
Photograph 13 - Looking east at the north abutment backwall near beam 1. Note: 1 3/8-inch longitudinal offset between end of deck and abutment backwall.

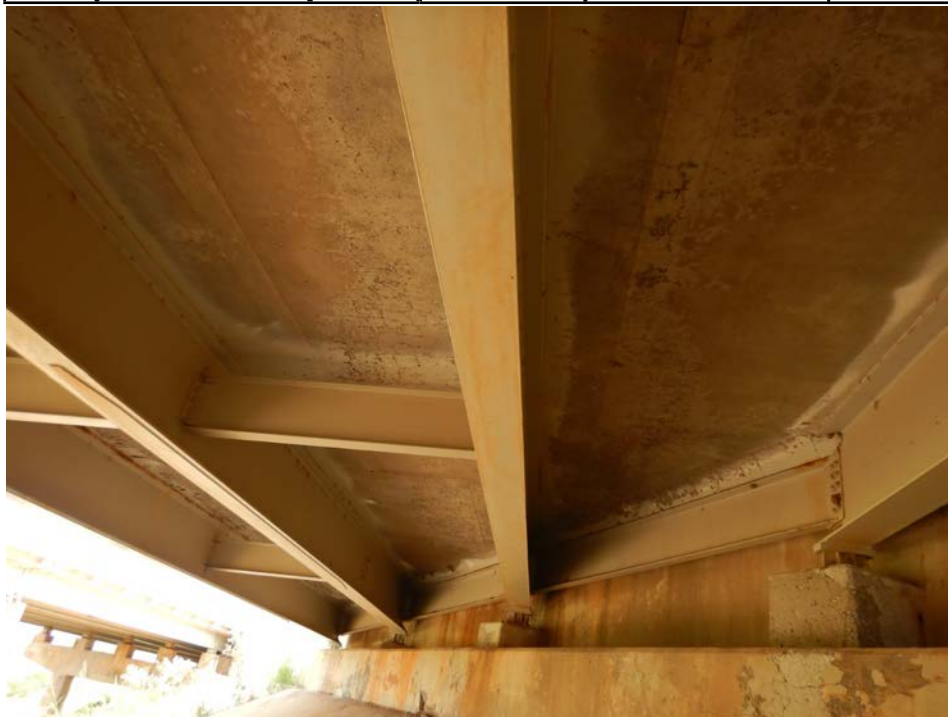
- **FX** – Discolored concrete, and cracks with efflorescence and corrosion stains exist in the deck soffit along the fixed and expansion joints and along the roadway centerline (**photo 14**). These locations tend to exist below patching in the driving surface.

Photograph 14 - Looking north at underside of span 6 between beams 2 thru 4. Note: discolored concrete and pattern cracking in soffit.

- Monitor the deck adjacent to the joints for further deterioration. Consider full depth repair along and near joints where cracking and discoloration are present.
- Monitor the beam 1, span 4 connection to the pier beam at pier 3 for crack growth.
- Monitor the alignment of beam 1, span 2 (1 1/4 inches to the east with stringline between bearings) and the distress in the beam web at the midspan diaphragm where bent from collision damage.
- Monitor the painted over 1/4-inch-deep section loss in the bottom flange of the pier beam under beam 2 at pier 3.

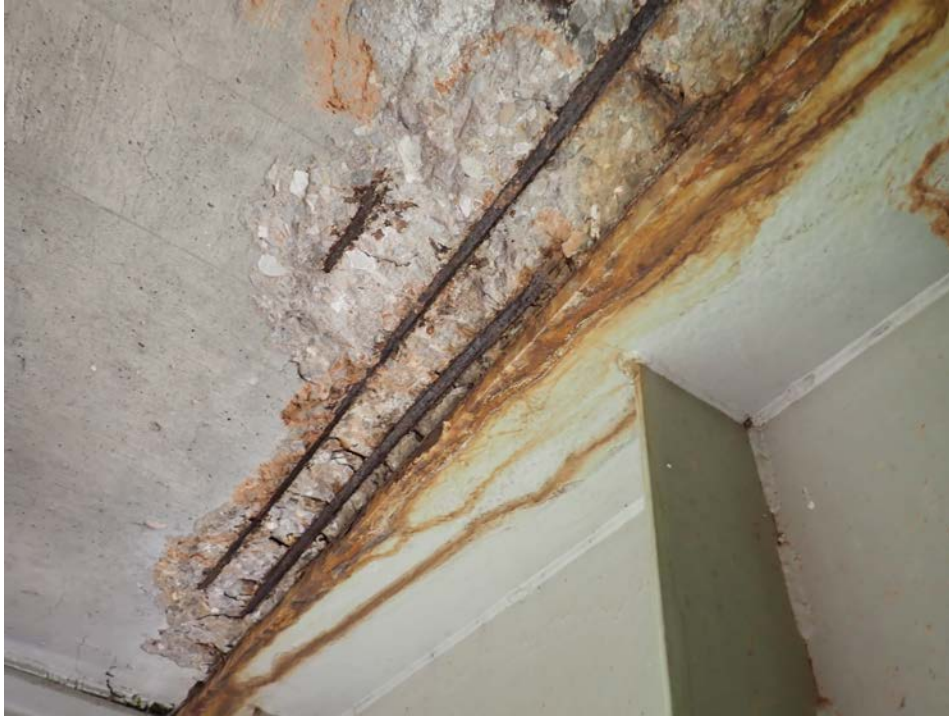
Photograph 15 - Looking southeast at the pier beam at pier 3 between beams 2 and 3. Note: spalling adjacent to the pier beam flange with exposed and corroded reinforcing steel. Corrosion reactivating where painted over pitting exists in the underside of the pier beam top flange.

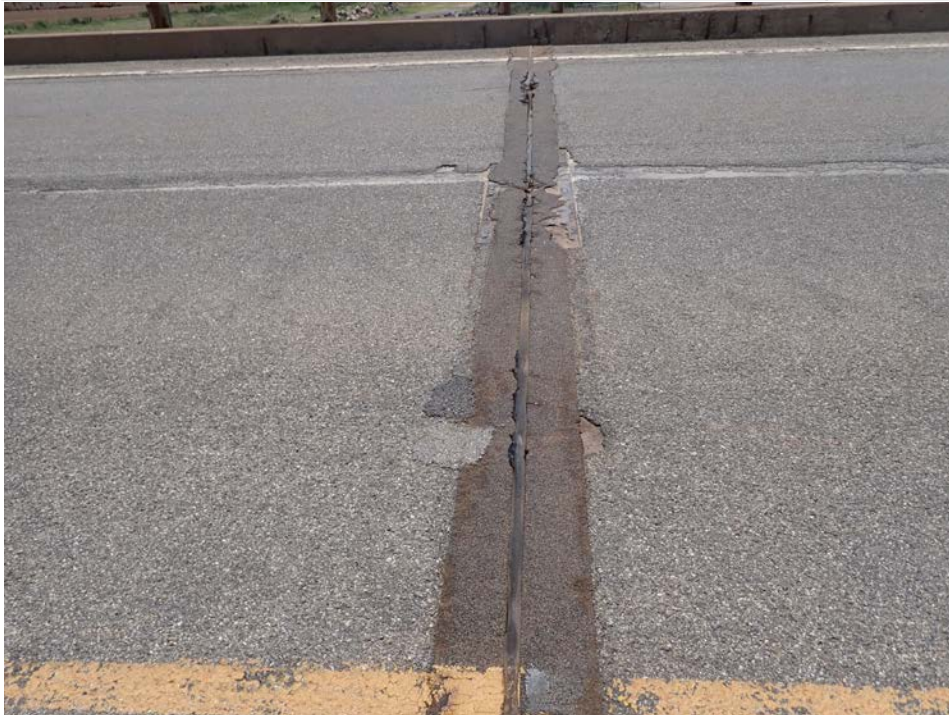
- Pier 2 – Adhesion failure exists between the poured seal and armor, and isolated areas of missing seal material were observed in the east lane (**photo 16**). The joint header consisting of elastomeric concrete placed above the remnants of the finger joint is spalled along the joint opening in the east lane and near the roadway centerline. Corrosion stains from the finger joint exists along the edges of the elastomeric concrete header.

Photograph 16 - Looking east along the expansion joint over pier 2. Note: spalling at the centerline of the east travel lane, the joint seal has failed in this area. Spalling of the elastomeric covering the original finger joint plates.

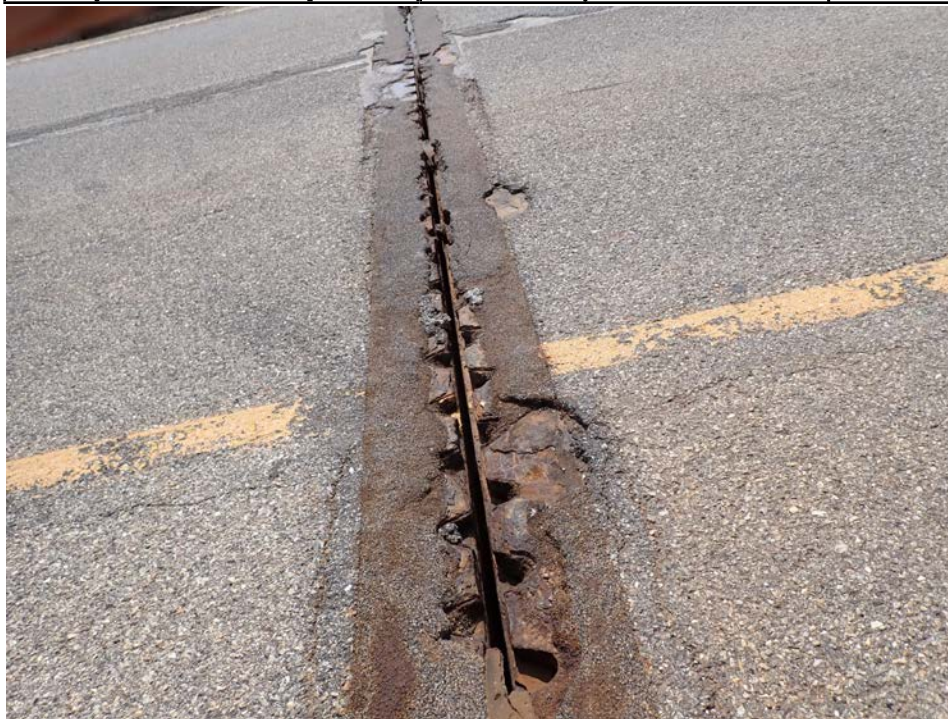
- Pier 4 – The poured seal is missing in the majority of the lanes (**photo 17**). The elastomeric concrete header is cracked and spalled exposing the retrofitted finger joint. The asphalt wearing surface adjacent to the header is cracking and spalling with isolated areas of corrosion stains from the finger joint.

Photograph 17 - Looking east at the joint over pier 4. Note: Looking west at the pourable joint seal above pier 4. Note: seal is missing along the west travel lane and partially along the west half of the east lane.

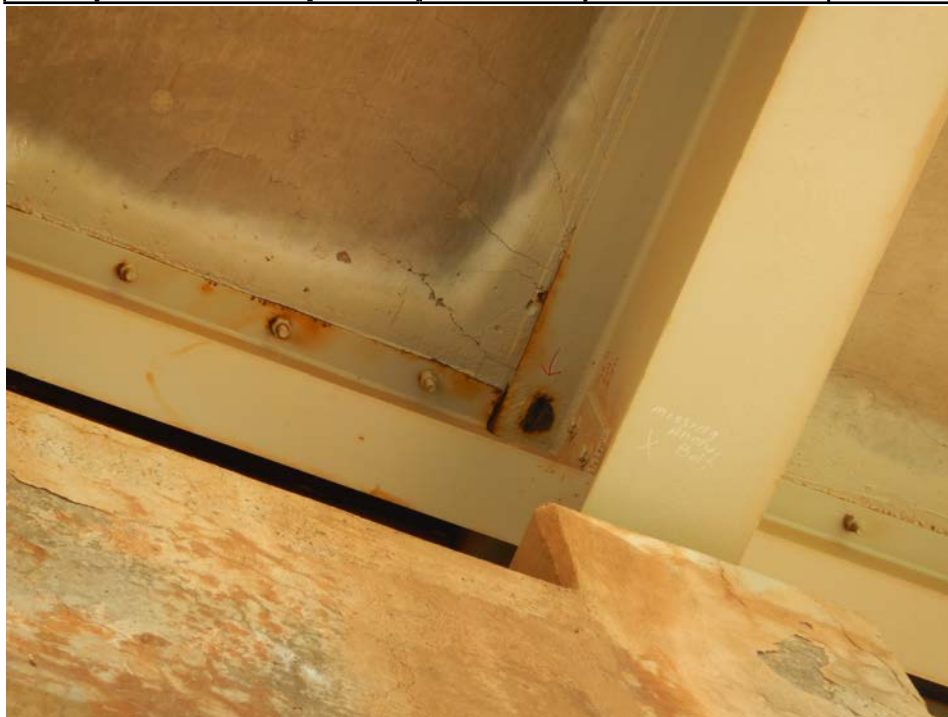
- A missing anchor bolt for the expansion joint exists at beam 4, span 4 at pier 4 (**photo 18**).
- **PX** – The poured seal fixed joints exist at both abutments and piers 1, 3, and 5. Both abutments are skewed 60 degrees while the piers are normal to the roadway centerline. Piers 1 and 5 are linked to allow longitudinal movement of the superstructure with no opening of the joint. The beams at pier 3 frame into the pier beam with no evidence of a strap plate over the pier beam.

Photograph 18 - Looking up at the underside of span 4, beam 4 at the west face of pier 4. Note: missing expansion joint anchor bolt.

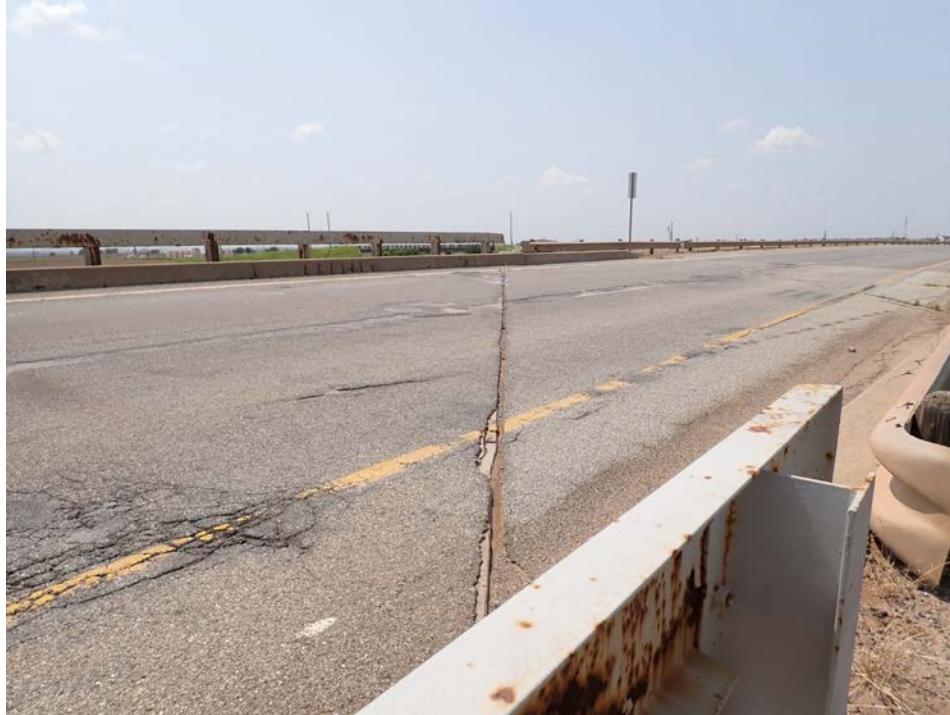
- South Abutment – Minor edge spalls and patches exists in the asphalt wearing surface along the joint with evidence of leakage (**photo 19**). No obvious signs of seal damage were observed.

Photograph 19 - Looking southeast along the fixed joint over the south abutment. Note: minor edge spalls and patches exists in the asphalt wearing surface along the joint with evidence of leakage.

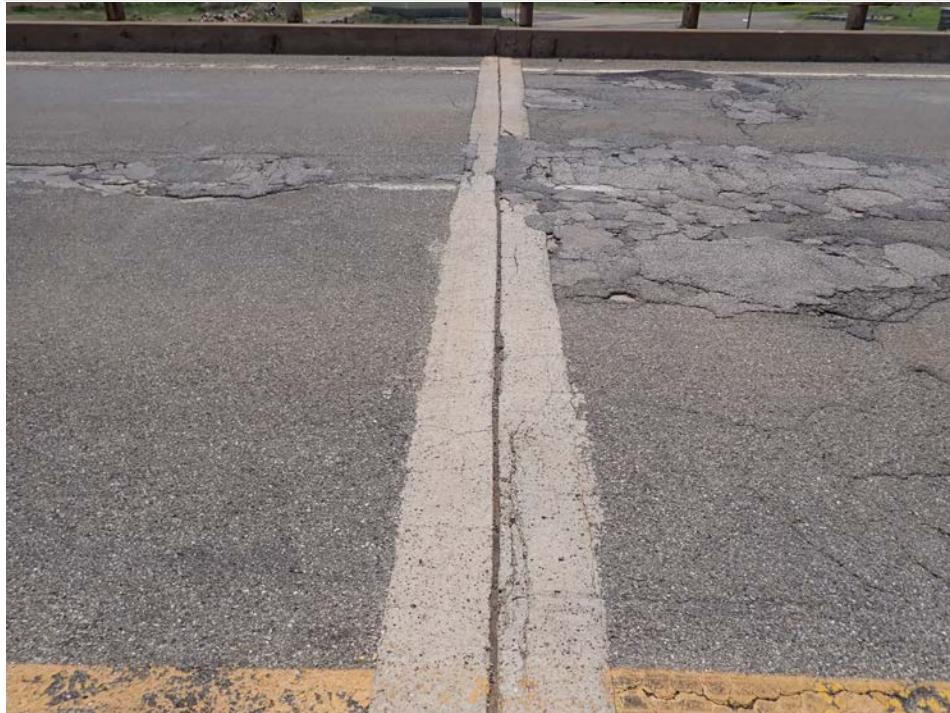
- Pier 1 – The joint header has been replaced with concrete (**photo 20**). The concrete header is cracked and spalled at the roadway centerline with multiple asphalt patches in the header at this location. The poured seal exhibits adhesive failure in isolated areas throughout with evidence of leakage on the pier cap below.

Photograph 20 - Looking east at the fixed joint over pier 1. Note: joint header has been replaced with concrete with multiple asphalt patches at the roadway centerline. Poured seal exhibits adhesive failure in isolated areas throughout with evidence of leakage on the pier cap below.

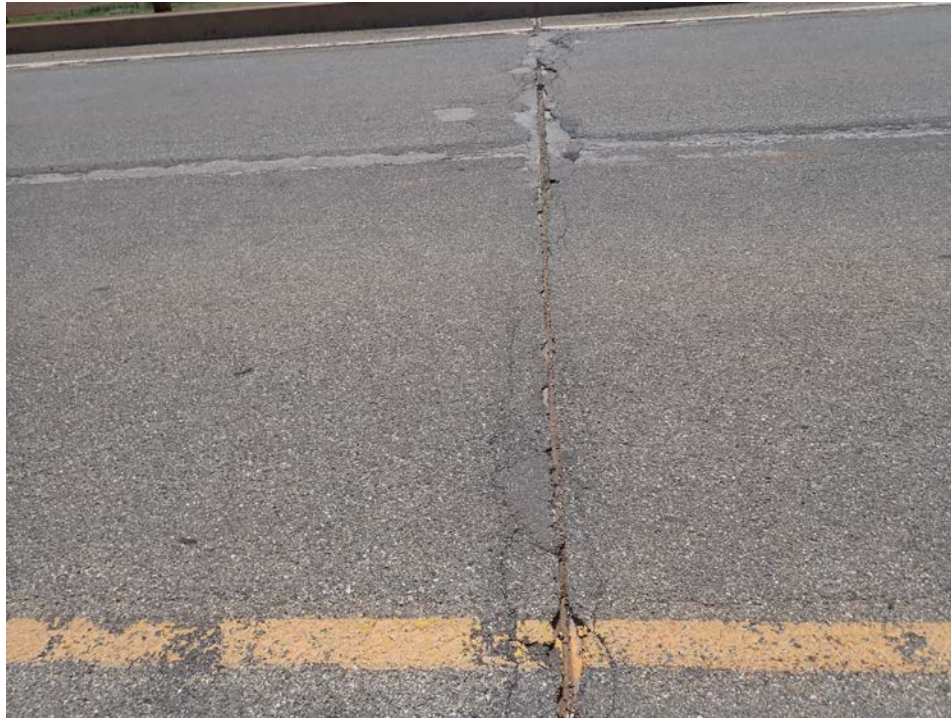
- Pier 3 (over pier beam) – Parallel cracks and asphalt patches exist in the asphalt wearing surface along the joint and are most prominent in the east lane (**photo 21**). The joint seal exhibits some tears and is partially paved over. Corrosion of the pier beam top flange indicates that leakage through the seal has occurred.

Photograph 21 - Looking east along the fixed joint over the pier beam at pier 3. Note: parallel cracks and asphalt patches exist in the asphalt wearing surface along the joint and are most prominent in the east lane. The joint seal exhibits some tears and is partially paved over.

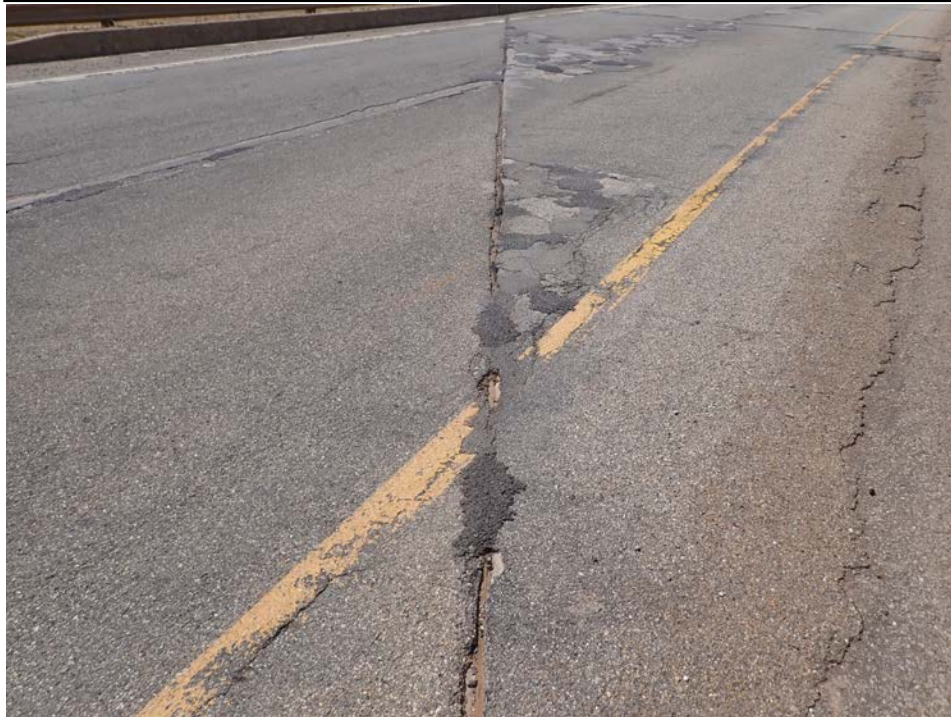
- North Abutment – Multiple asphalt patches exist in the wearing surface along the joint with evidence of past leakage (**photo 22**). Isolated areas of the seal exhibit signs of debonding from the header.

Photograph 22 - Looking southeast along the joint over the north abutment. Note: multiple asphalt patches exist along the joint. Isolated areas of the seal exhibit signs of debonding from the header.

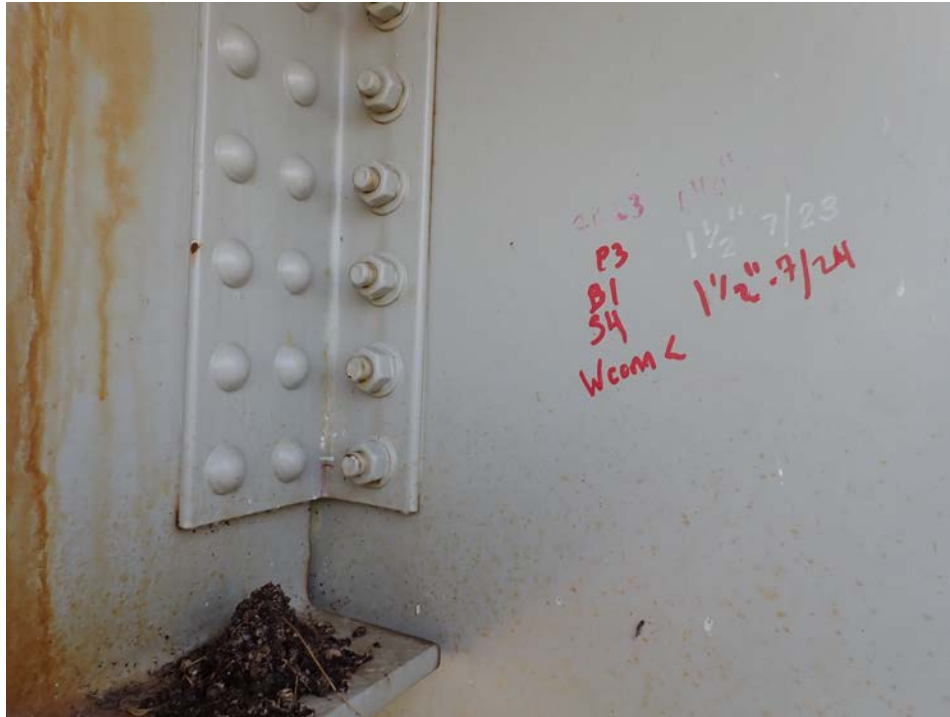
Photograph 23 - Looking southeast at the beam 1, span 4 connection angle to the pier beam at pier 3. Note: 1 1/2-inch-long vertical crack at the bottom of the connection angle. Bird droppings on beam bottom flange.

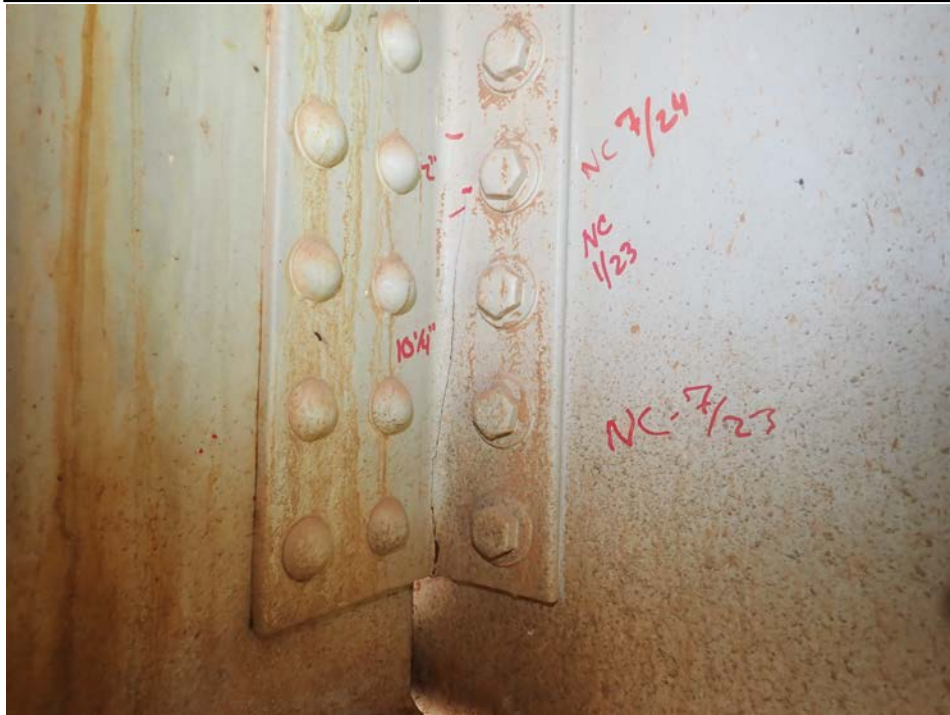
Photograph 24 - Looking southeast at the beam 2, span 4 connection angle to the pier beam at pier 3. Note: 11 3/4-inch-long crack and 2-inch-long paint crack.

- Install seats under beams where vertical cracks exist in beam connection angles to the pier beam at pier 3:
 - Beam 2, span 4 east connection angle to south face of pier beam (10 1/4-inch-long and 2-inch-long cracks).

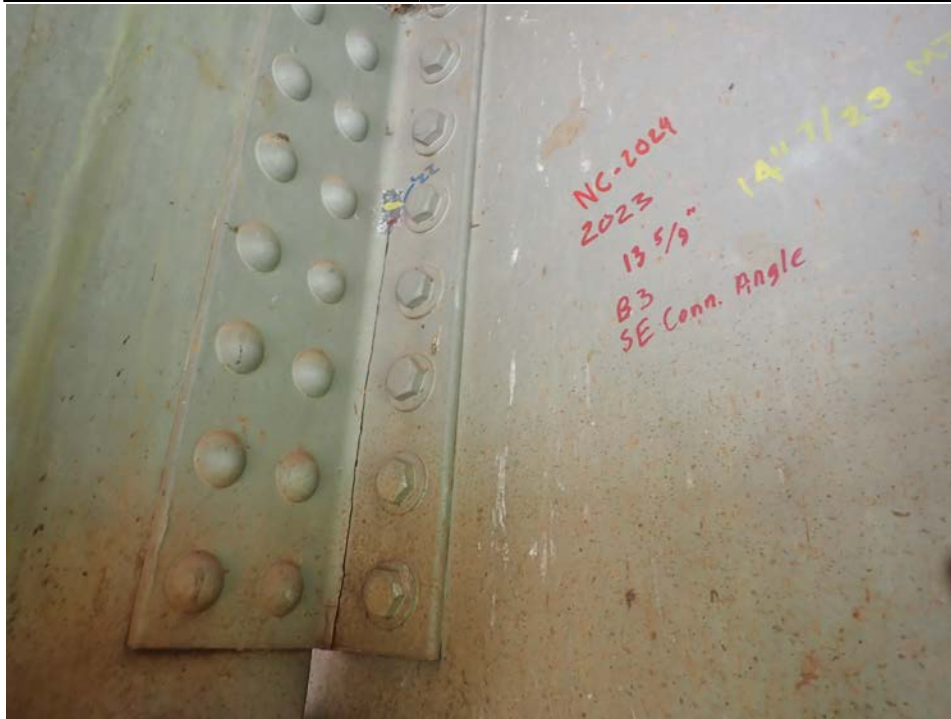
Photograph 25 - Looking northwest at the beam 3 connection angle to the pier beam at pier 3. Note: 14-inch-long crack along the bottom of the connection angle.

- Beam 3, span 3 east connection angle to south face of pier beam (13 5/8-inch-long crack).
 - Beam 4, span 3 west connection angle to south face of pier beam (14 1/4-inch-long crack).

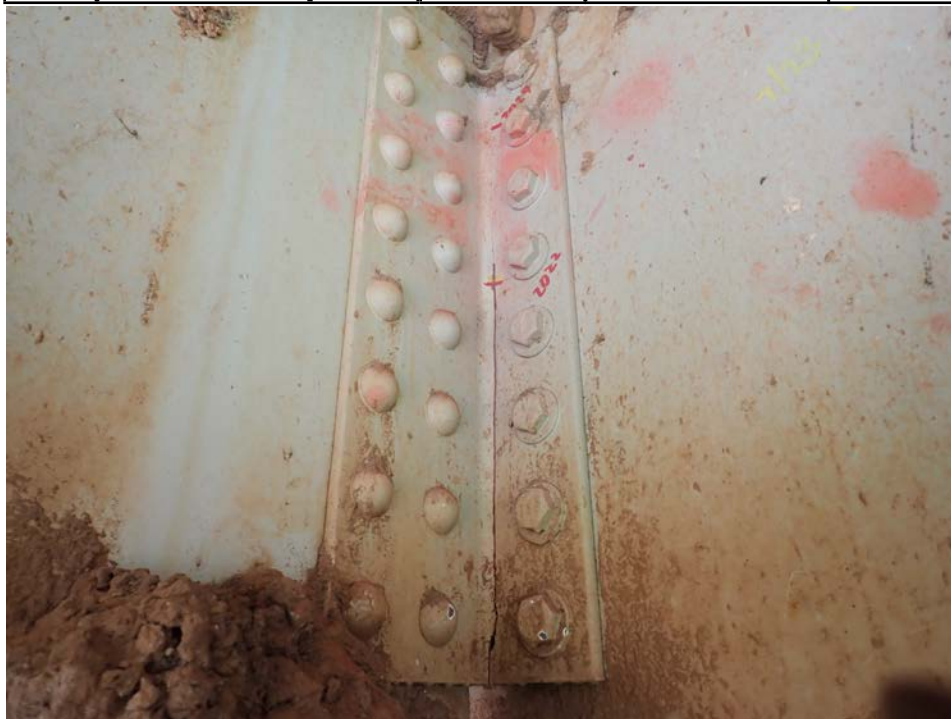
Photograph 26 - Looking northwest at the beam 4 connection angle to the pier beam at pier 3. Note: 14 1/4-inch-long crack in connection angle (1-inch growth) with additional 7-inch-long paint crack. Soil from bird nests on beam bottom flange.

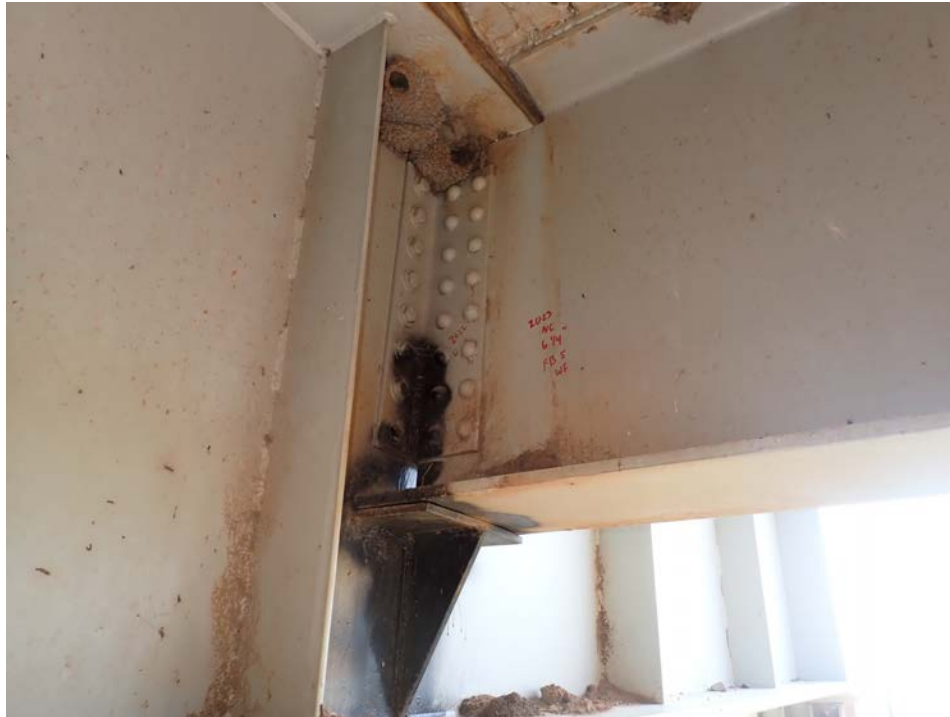
Photograph 27 - Looking northeast at the beam 5 connection angle to the pier beam at pier 3. Note: crack welded in connection angle and beam seat welded to the pier beam web. Bird nests along top flange and soil on bottom flange of pier beam.

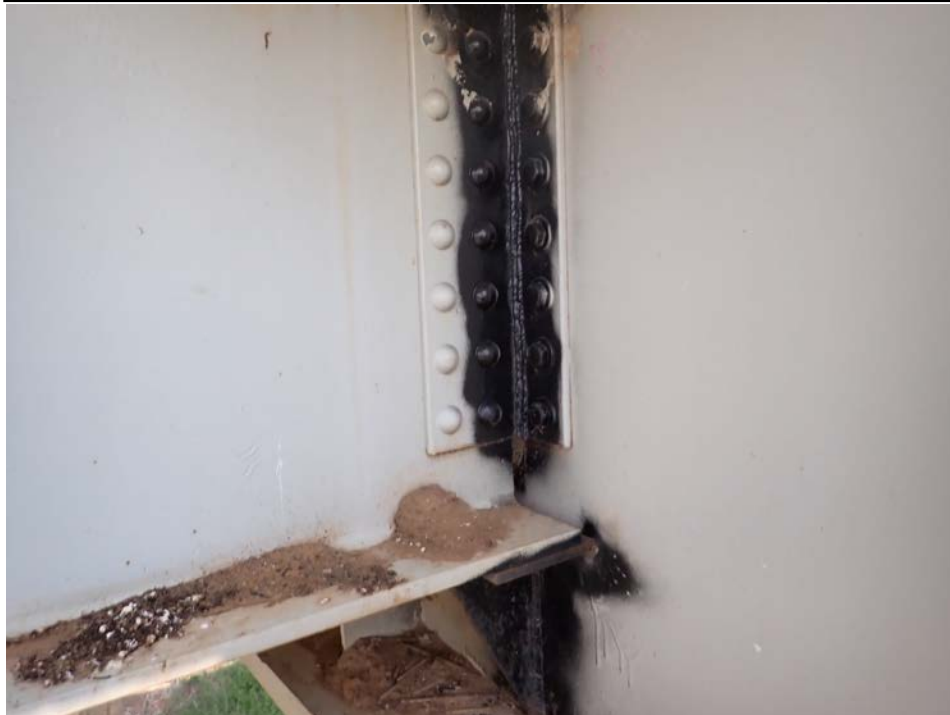
Photograph 28 - Looking northwest at the beam 5 connection angle to the pier beam at pier 3. Note: crack welded in connection angle and beam seat welded to the pier beam web. Soil and bird droppings on the beam and pier beam bottom flange.
