Fracture Critical Bridge Inspection Report

NBI Bridge No.: 16159

Route U.S. 81 over UP R.R. UNDER
Kingfisher County

Re: Nonredundant Steel Tension Member Bridge
Inspection Report
Structure No.: 3704 0543EX
NBI No.: 16159
Local ID: 024
US 81 Northbound over Union Pacific Railroad
Kingfisher County, Field Division 4

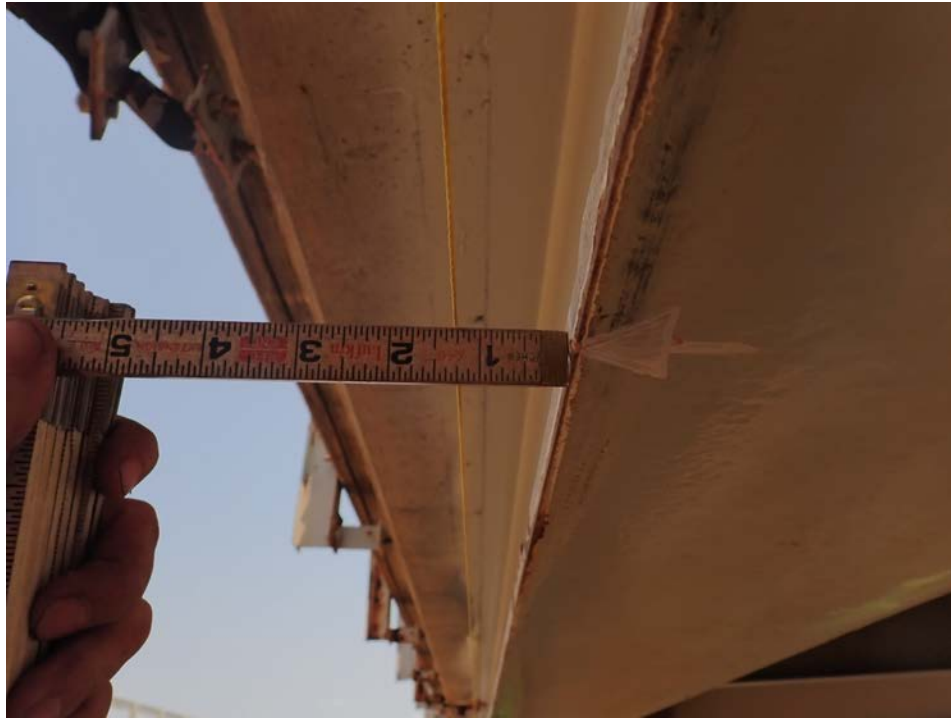
Photograph 29 - Looking north along the beam 1, span 2, near the 1/4 span. Note: 1 1/4-inch global sweep to the east.

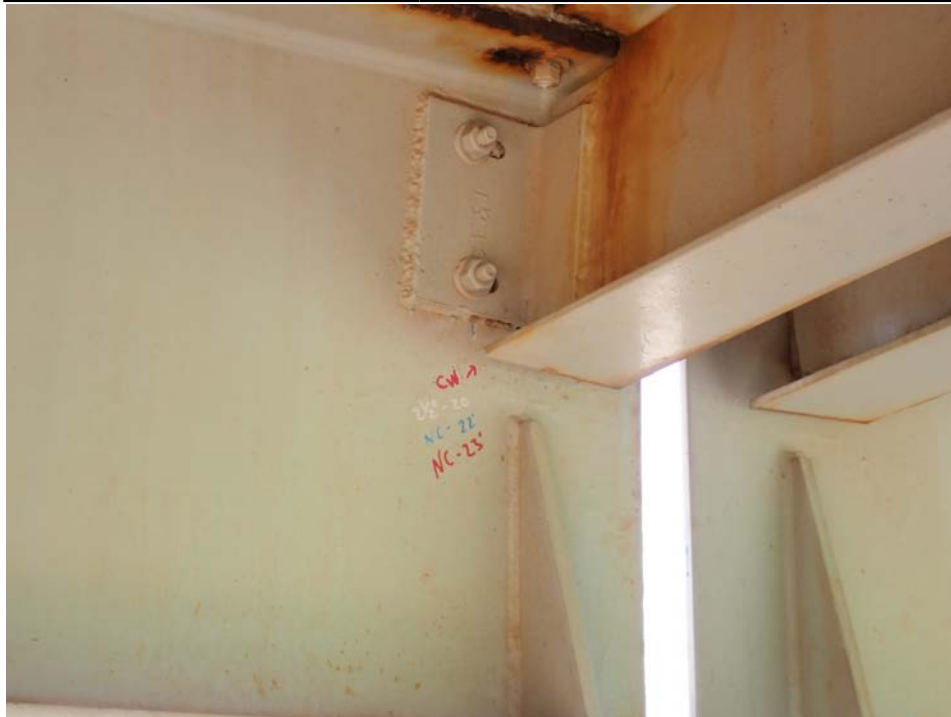
Photograph 30 - Looking northwest at beam 1, span 2, over pier 2. Note: 2 1/2-inch-long horizontal crack in weld.

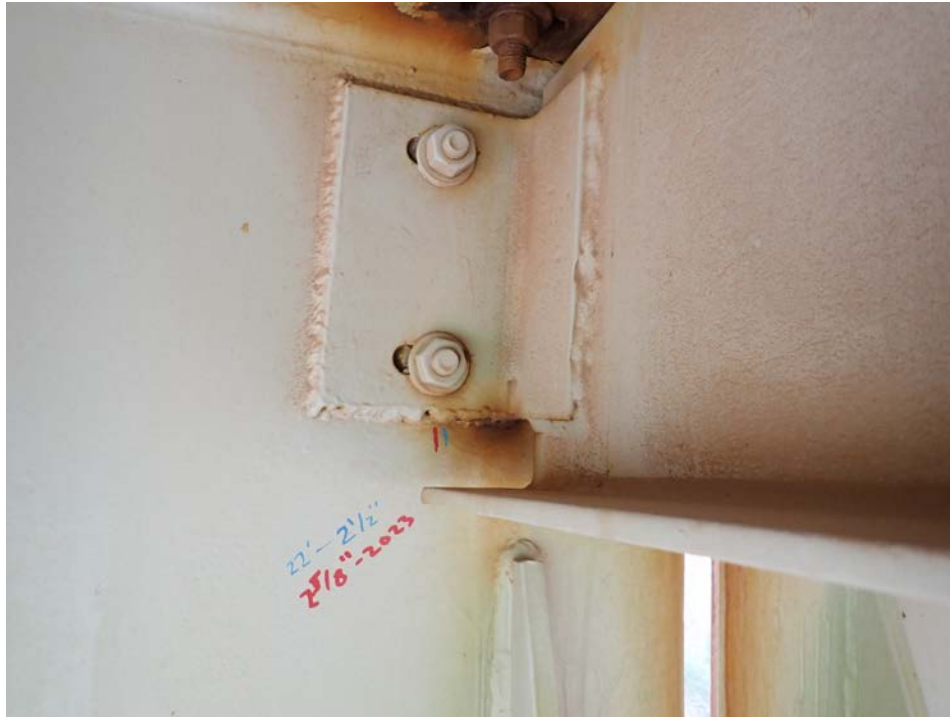
Photograph 31 - Span 4, beam 1 over pier 4. Note: 2 5/8-inch-long horizontal crack in weld.

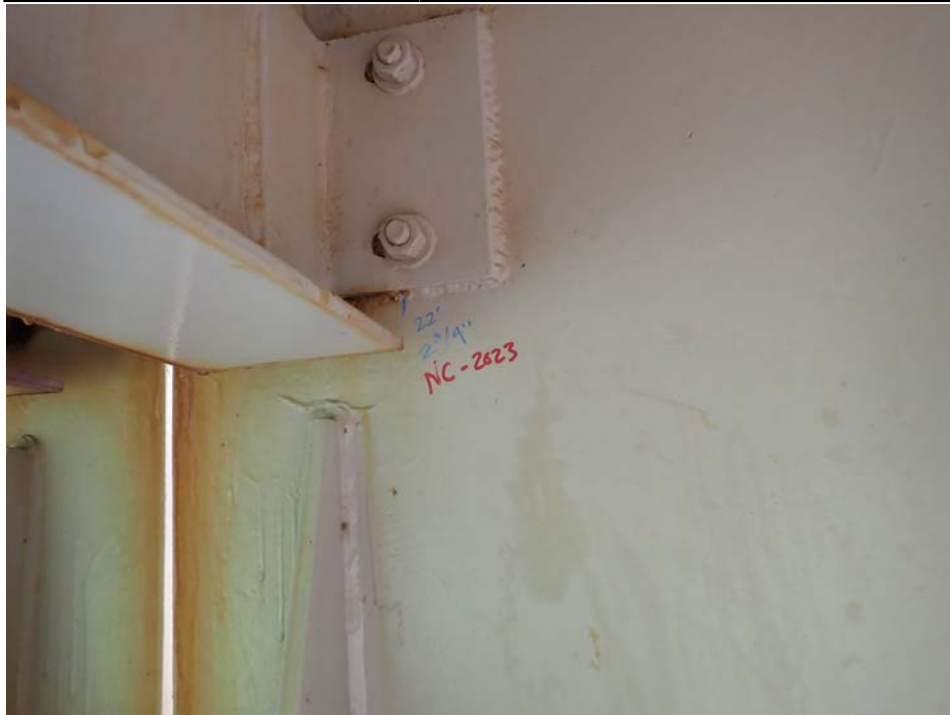
Photograph 32 - Looking west at beam 1, span 5 over pier 4. Note: 2 3/4-inch-long horizontal crack in weld.

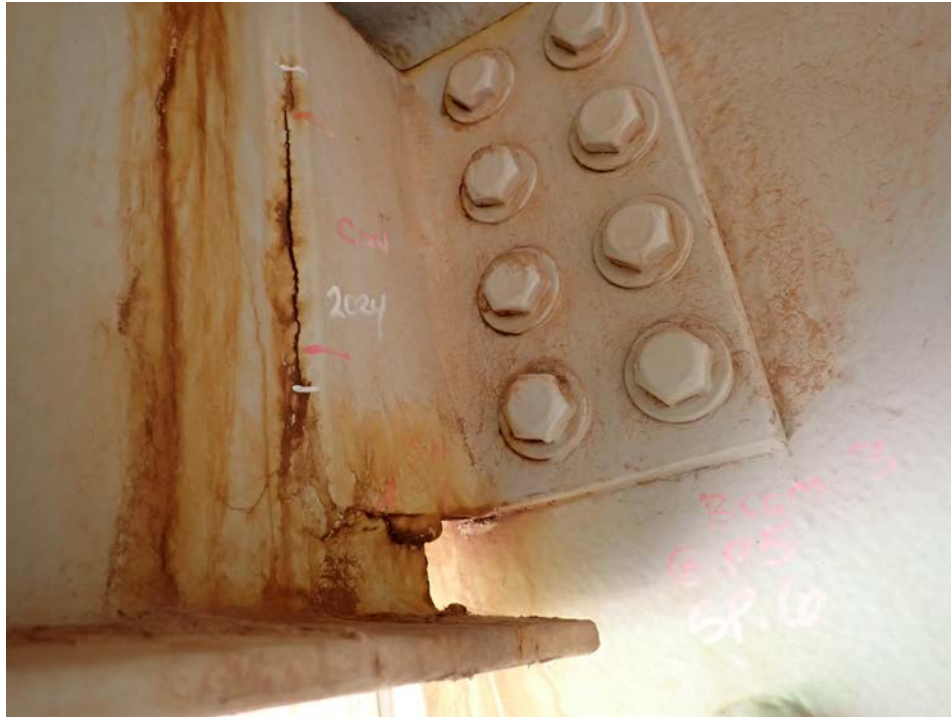
Photograph 33 - Looking northeast at beam 3, span 5 at pier 5. Note: 8-inch-long vertical crack and full length horizontal crack in the weld.

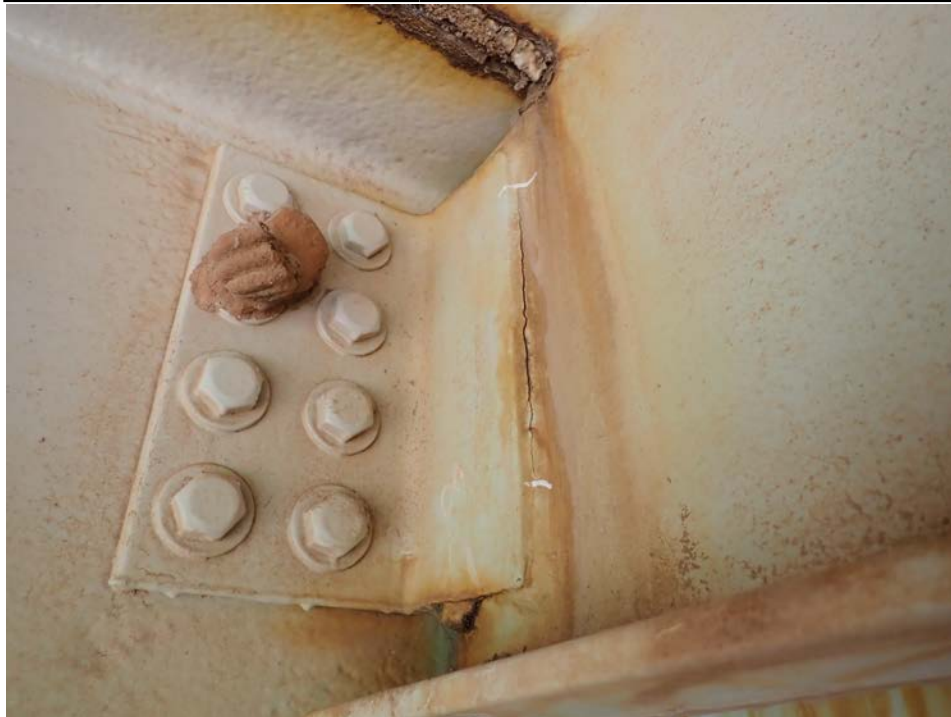
Photograph 34 - Looking southeast at beam 5, span 6 at pier 5. Note: 9-inch-long vertical crack and 4-inch-long horizontal crack in the weld.

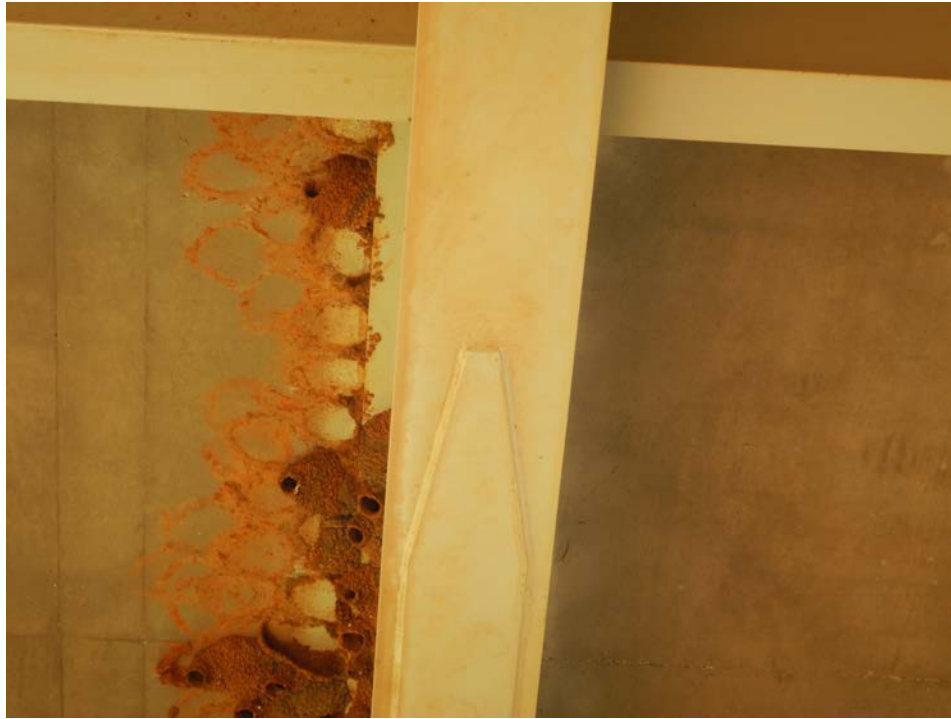
Photograph 35 - Looking up at beam 4, span 4 at the 1/4-span location. Note: welded cover plate tapered end termination.

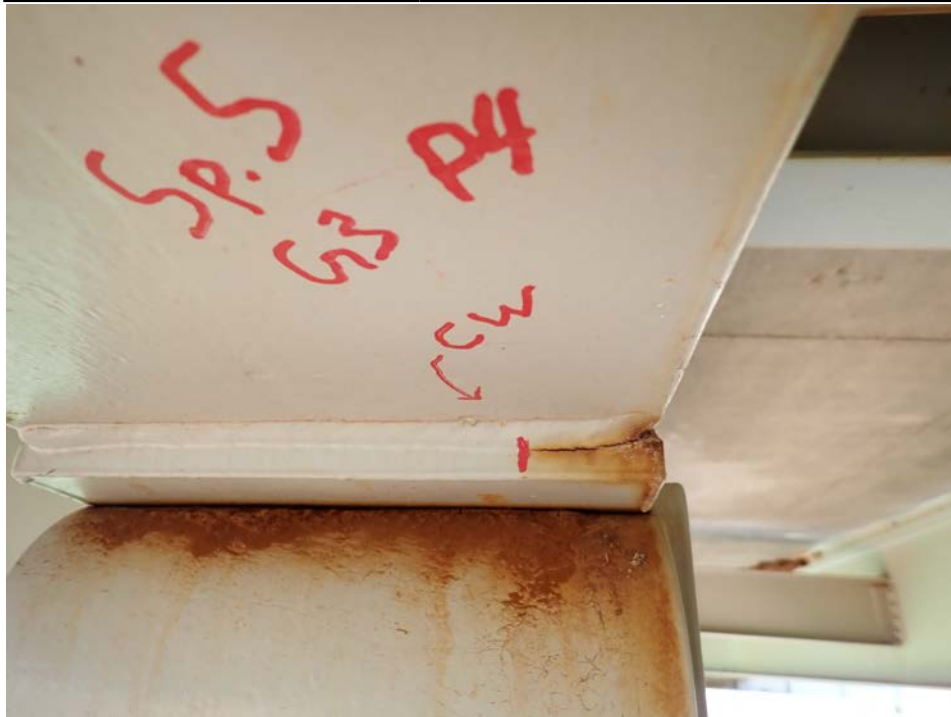
Photograph 36 - Looking south at the beam 3, span 5 canister bearing at pier 4. Note: 1 5/8-inch-long horizontal crack in the weld between the beam bottom flange and sole plate.

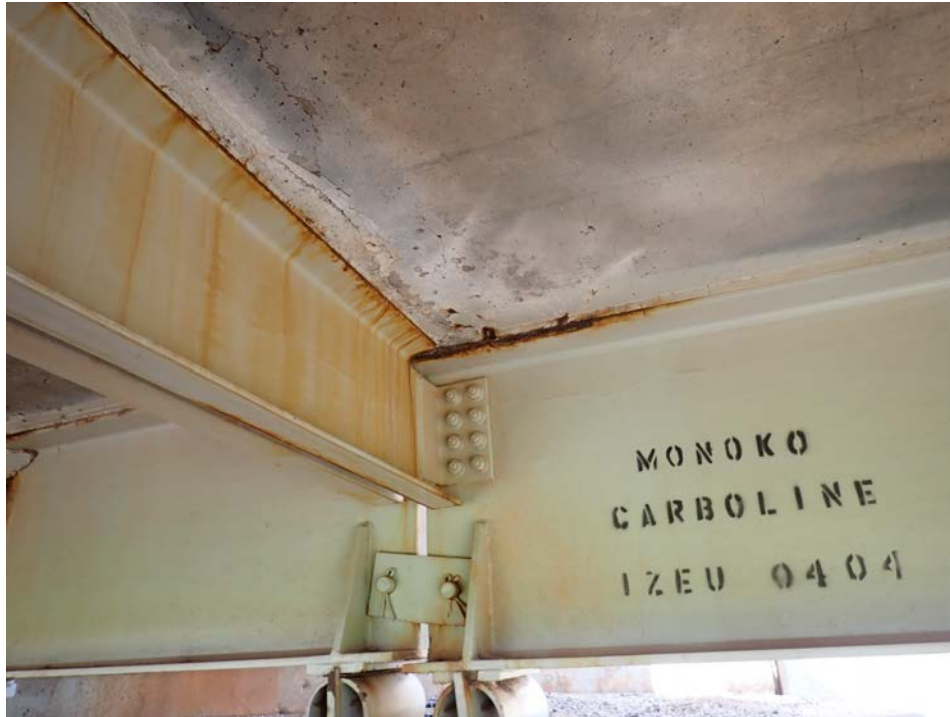
Photograph 37 - Looking southwest at beam 1 over pier 1. Note: pack rust between the beam and diaphragm top flange and the deck. Paint stencil notes IZEU paint applied April, 2004.

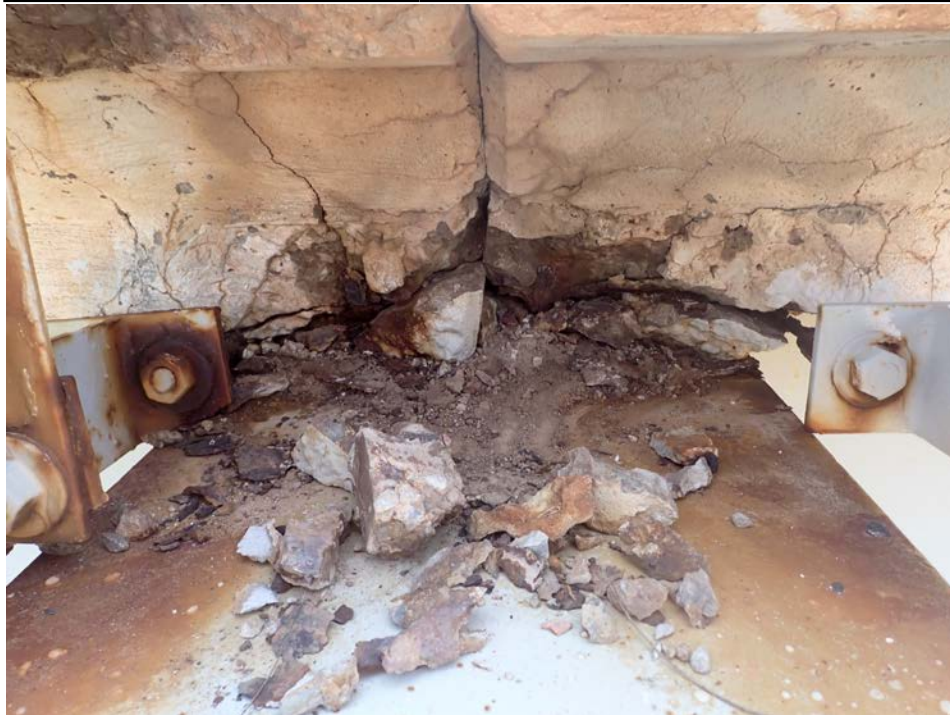
Photograph 38 - Looking east at the west deck edge over pier beam 3. Note: pack rust and active corrosion in the pier beam top flange with spalling of the deck.

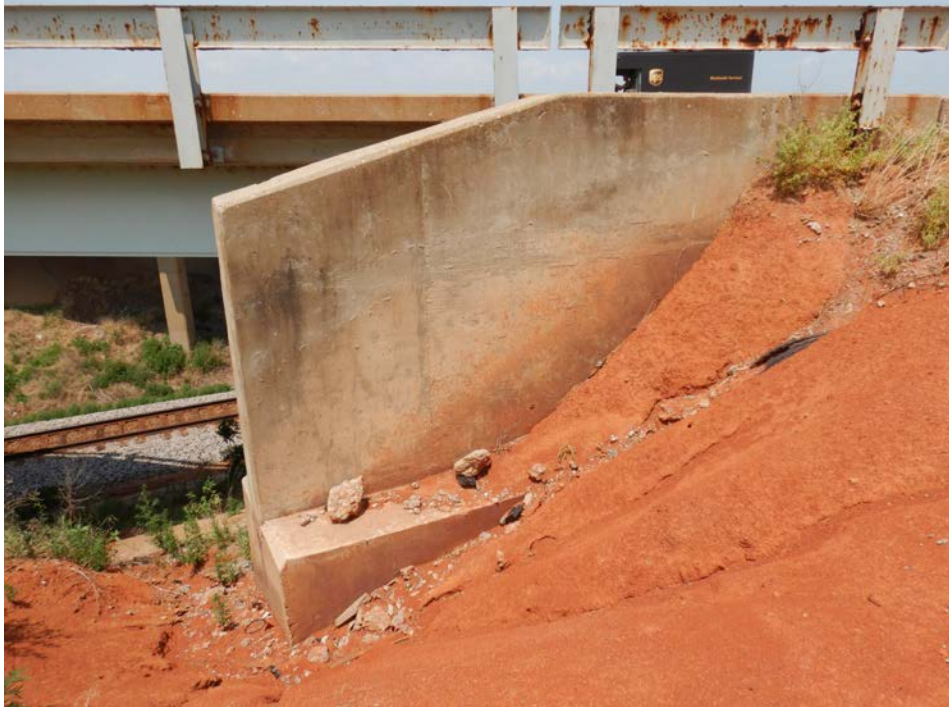
Photograph 39 - Looking south at end of the northeast wingwall. Note: erosion has exposed the top of the pile cap for 31 inches vertically. The abutment is supported by concrete piles.

- Backfill and armor the eroded area behind and around the northeast wingwall.
- Remove and patch deteriorated and delaminated concrete in the abutments and seal bearing seats with CIM 1000.

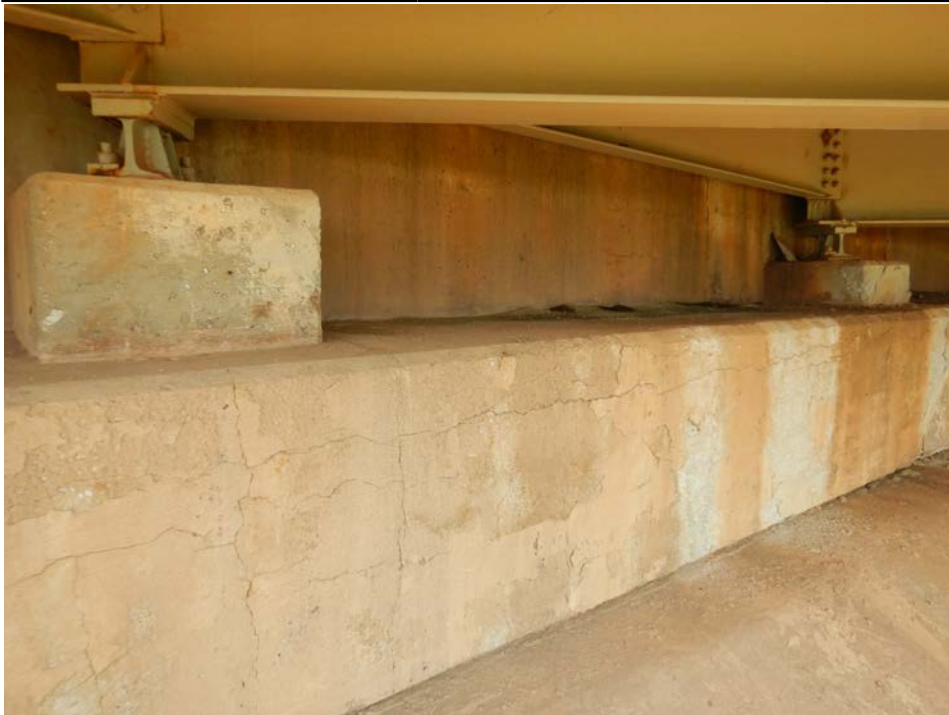
Photograph 40 - Looking southwest at the south abutment breastwall between beams 3 and 4. Note: 1/16-inch-wide vertical and horizontal cracks with delaminations throughout.

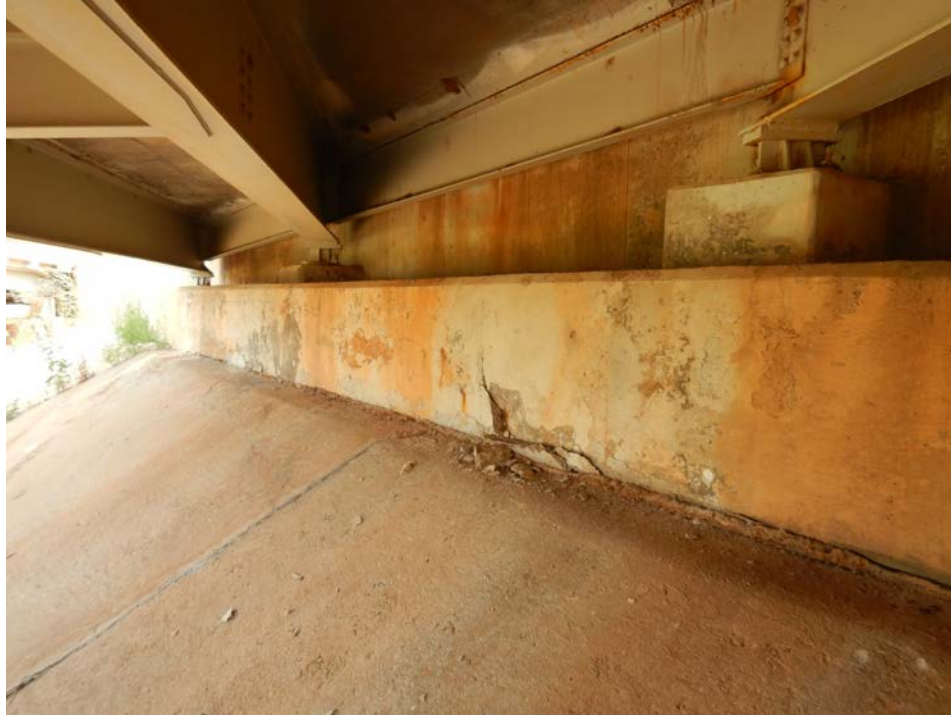
Photograph 41 - Looking northwest at the north abutment breastwall between beams 1 and 3. Note: spall with exposed reinforcing steel. Horizontal crack along the top reinforcing steel in the face of the breastwall.

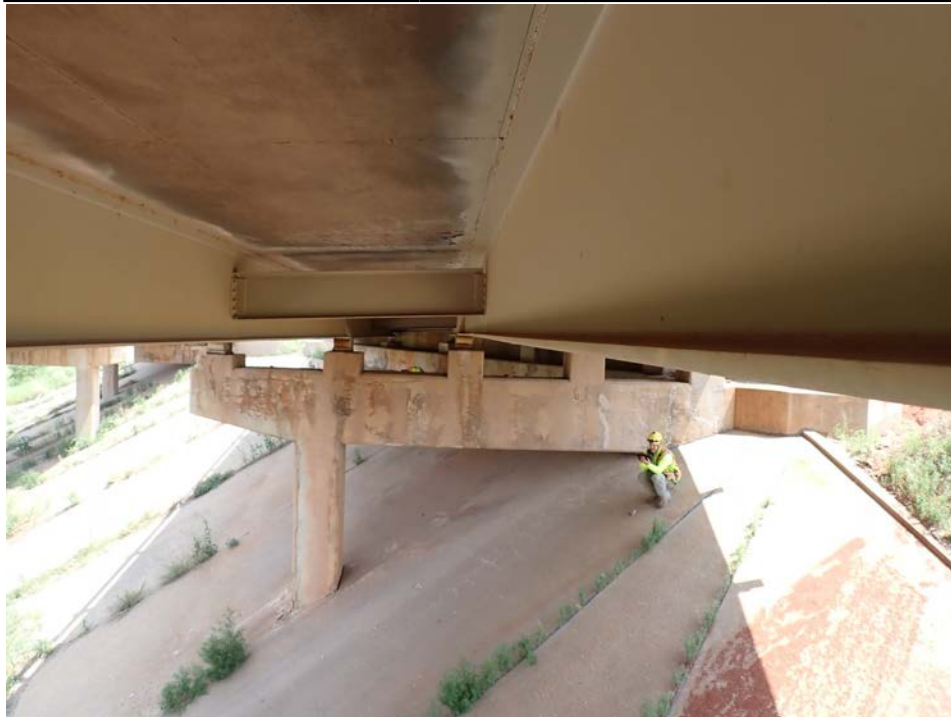
Photograph 42 - Looking north at the north embankment slope wall. Note: vegetation growing through the joints and cracks.

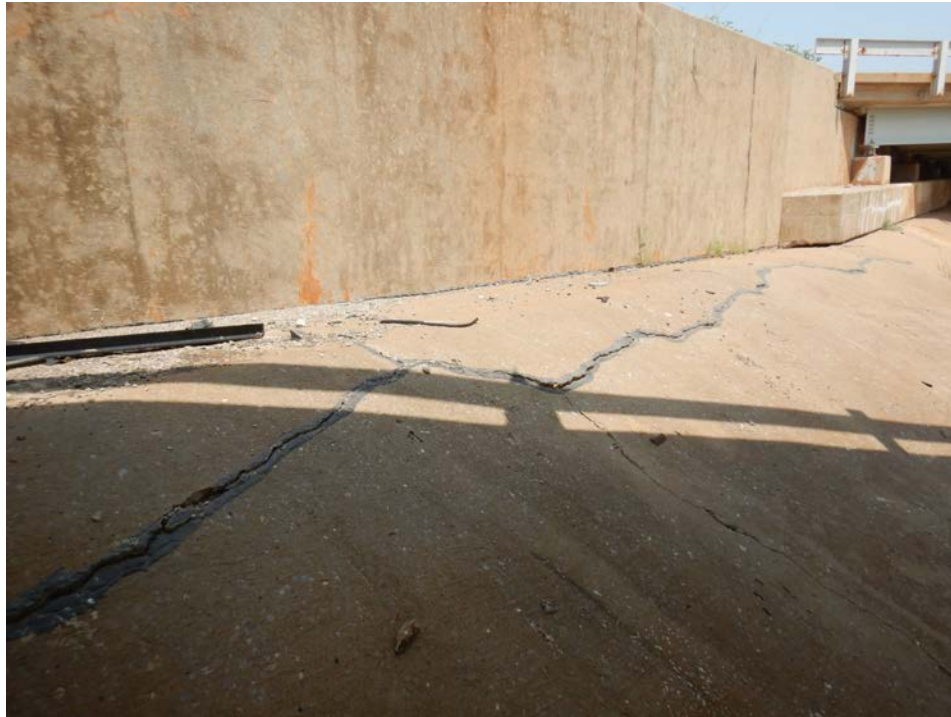
Photograph 43 - Looking west at the south embankment slope wall in the median. Note: previously sealed crack has reopened.

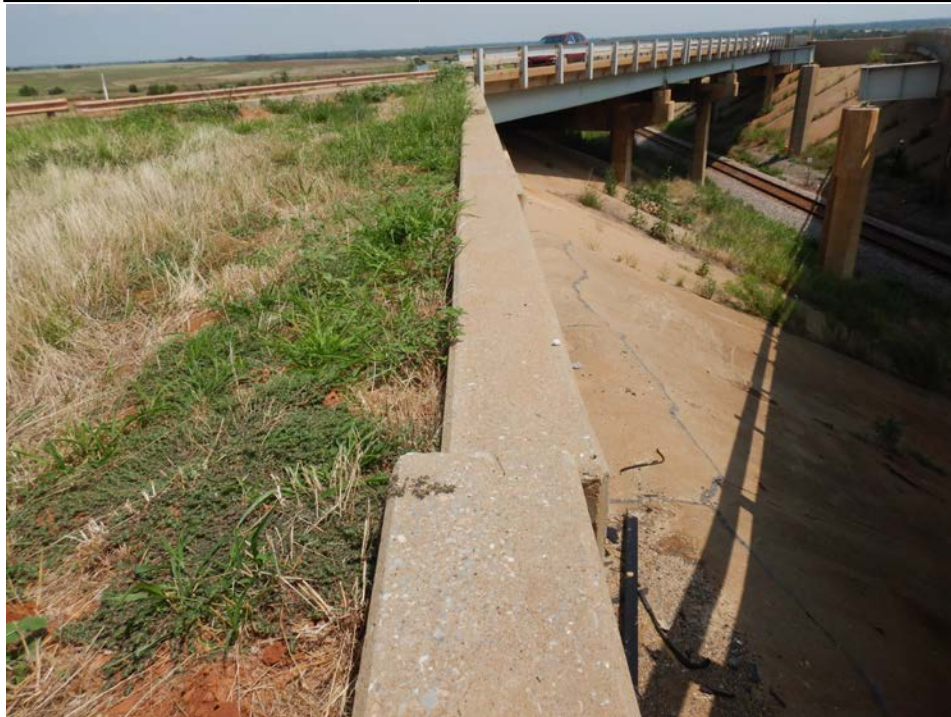
Photograph 44 - Looking northwest along the south embankment retaining wall in the median. Note: wall has rotated 3 1/2 inches north relative to the wingwall.

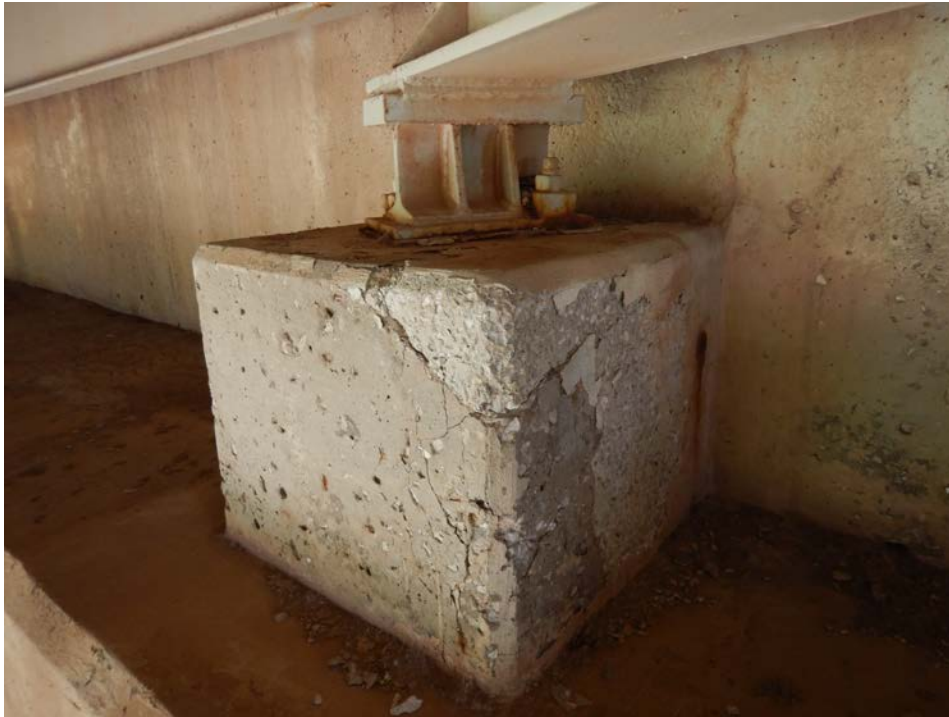
Photograph 45 - Looking north at the beam 4, span 6 bearing pedestal at the north abutment. Note: cracks and scaling concrete in the bearing pedestal. Popouts exposing aggregate and rust stains exist in the face of the pedestal. Lead bearing pad is extruding.

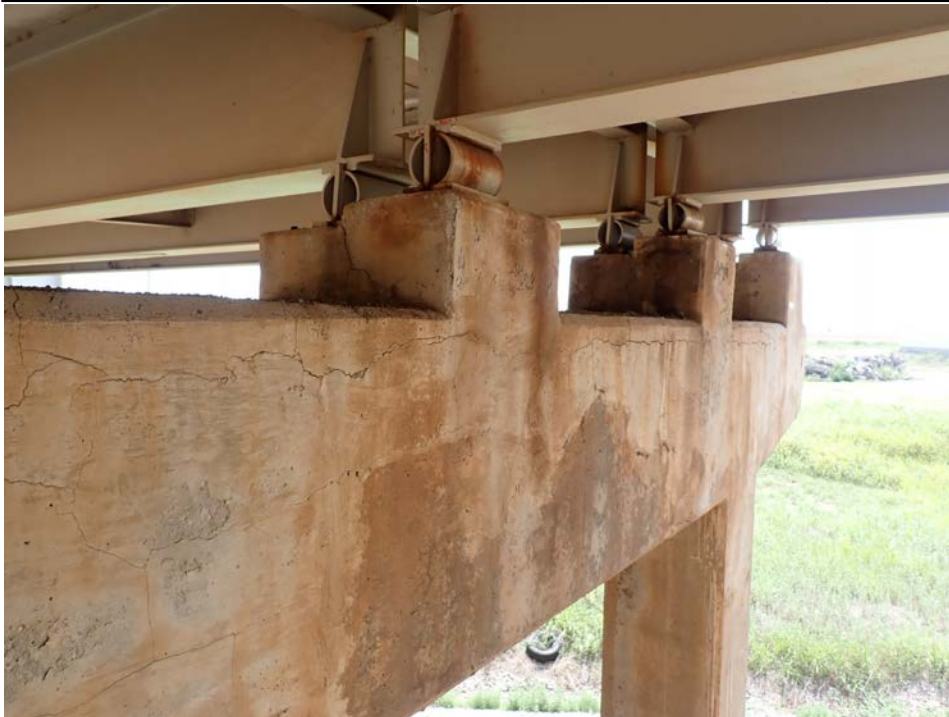
Photograph 46 - Looking northeast at pier 2. Note: pier exhibits cracking and delaminations.

- Remove and patch deteriorated and delaminated concrete in the piers, apply FRP wrap to patched areas and seal bearing seats with CIM 1000.
- Replace the beam 4, span 2 canister bearing at pier 2 due to corrosion hole and crack in canister.

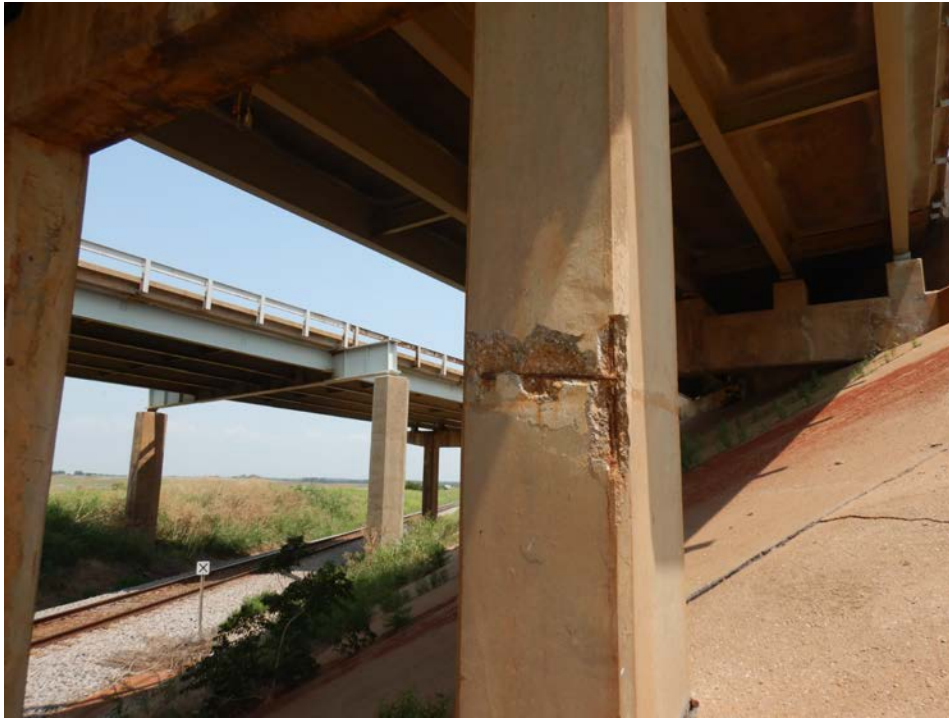
Photograph 47 - Looking north at column 2, pier 4. Note: 2-foot-vertical by full-width spall with exposed corroded reinforcing hoop steel.

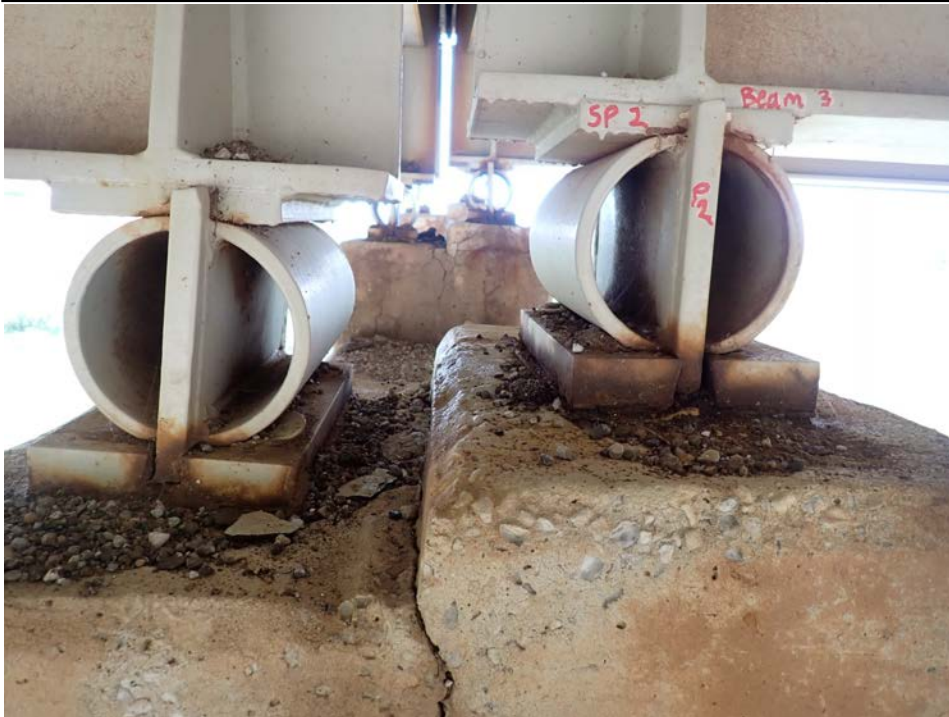
Photograph 48 - Looking east at the beam 3 canister bearings at pier 2. Note: light scaling of the concrete. Lead plugs over the anchor studs are extruded and inhibit movement of the canister.

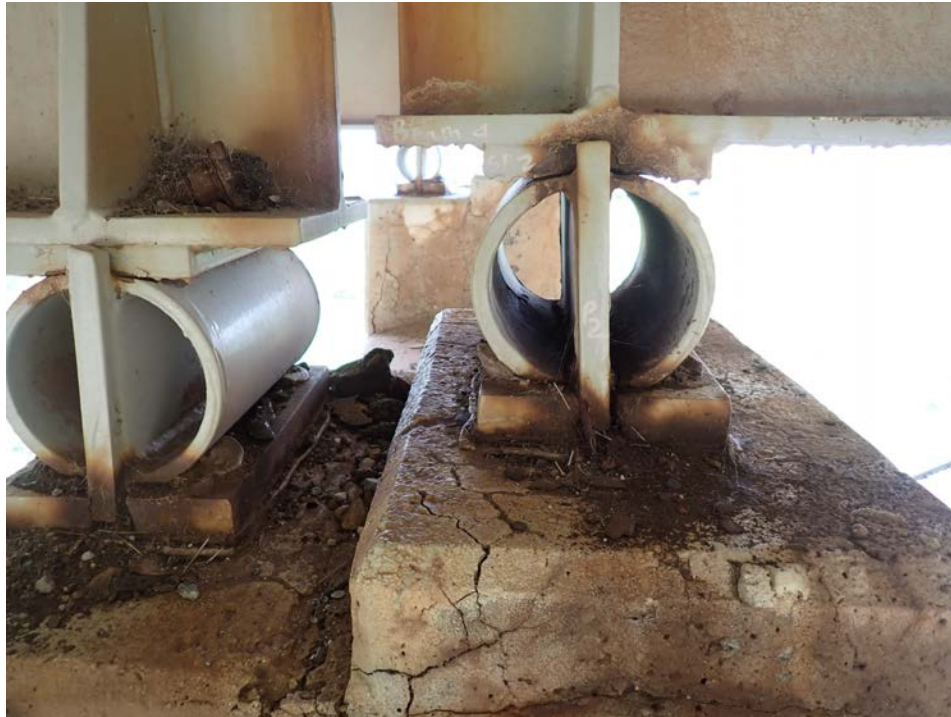
Photograph 49 - Looking east at the beam 4, span 2 canister bearing at pier 2. Note: bearing pedestal exhibits cracking and delaminations. Lead plugs over the anchor studs are extruded and inhibit movement of the canister.

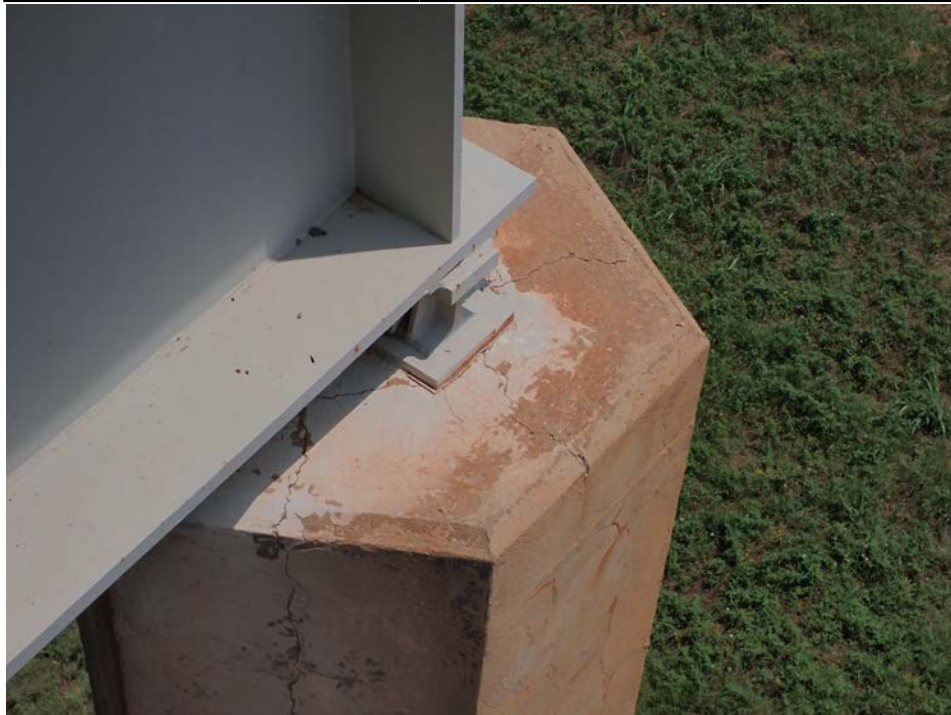
Photograph 50 - Looking northeast at column 2 at pier 3. Note: vertical cracks in column radiating from the bearing. Extruding lead bearing pad under the fixed bearing.

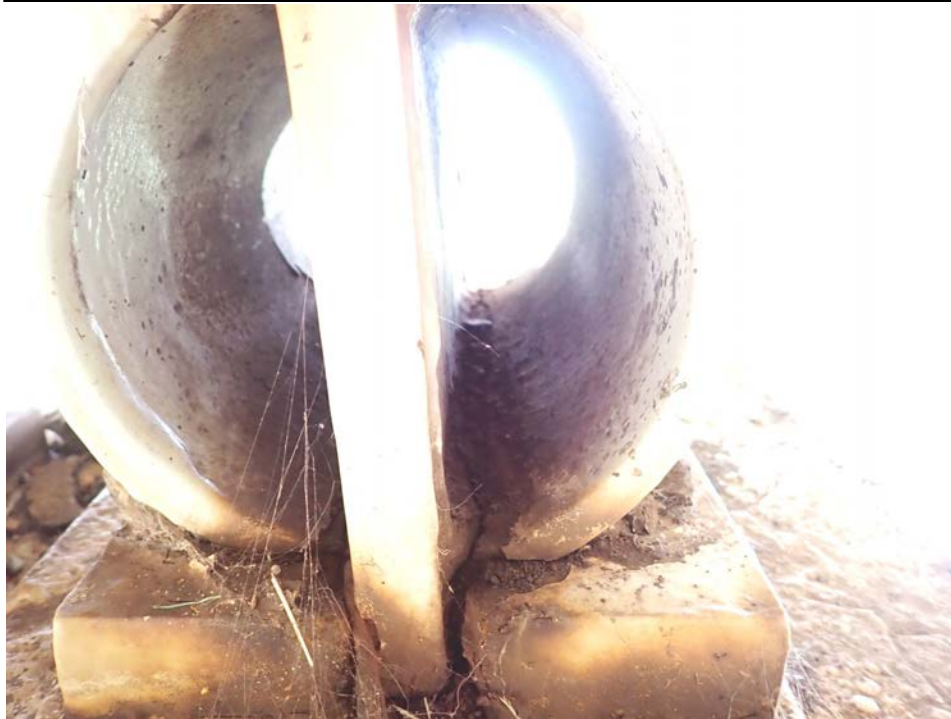
Photograph 51 - Looking east at the beam 4, span 2 canister bearing at pier 2. Note: corrosion hole in bottom of bearing with crack between canister and stiffener.

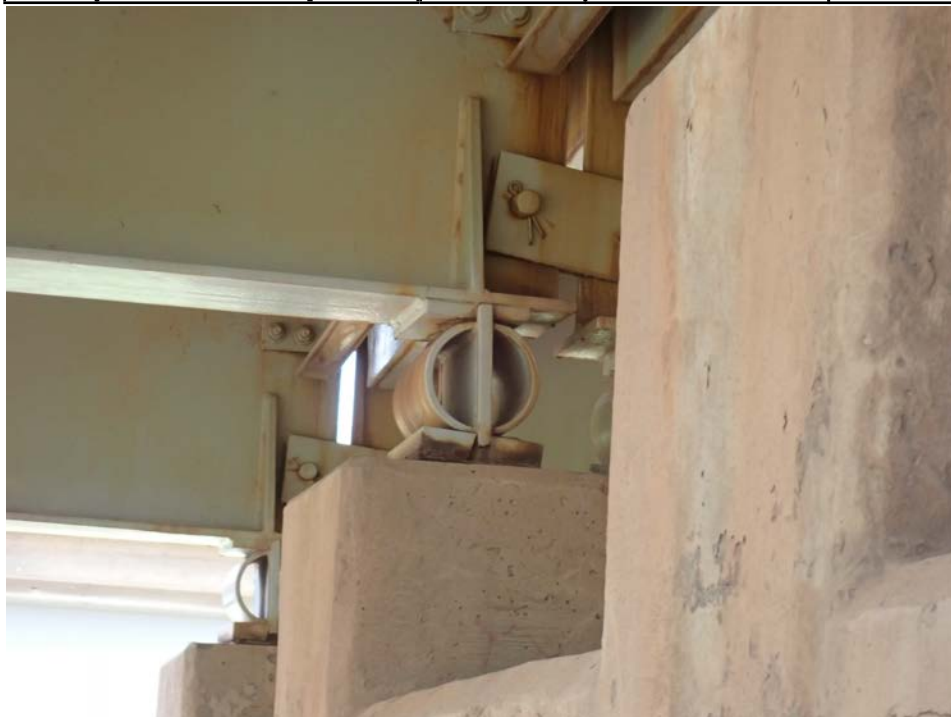
Photograph 52 - Looking northwest at the beam 2, span 5 canister bearing at pier 5. Note: beam is lifted from the canister bearing 1/16 inch.

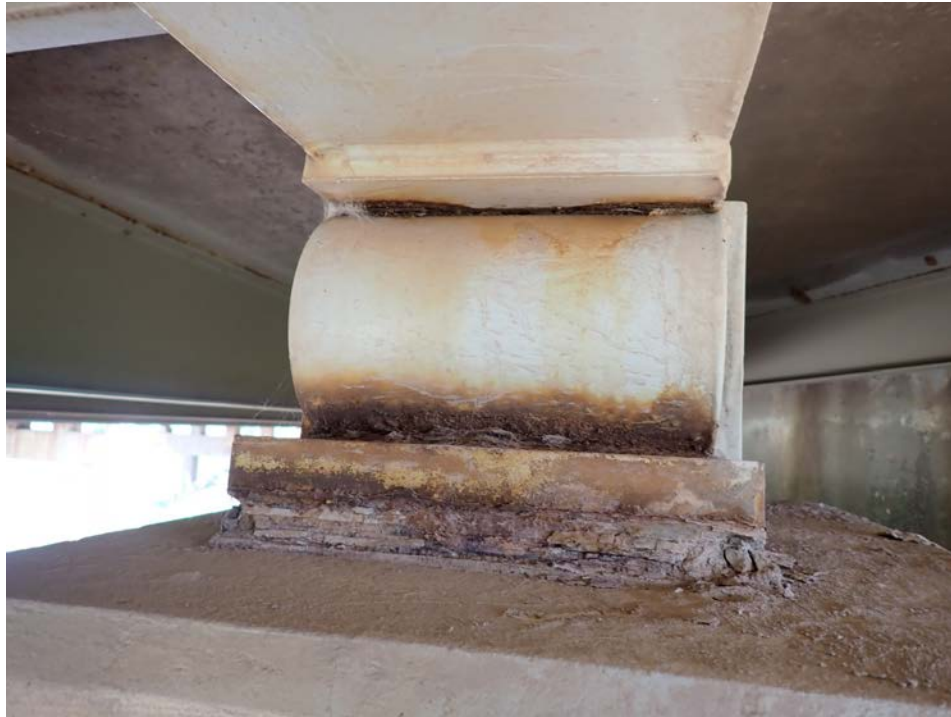
Photograph 53 - Looking north at the beam 4, span 5 canister bearing at pier 5. Note: 1-inch-thick pack between bearing pedestal and the masonry plate. Corrosion exists at the contact point between the canister and masonry and sole plates.

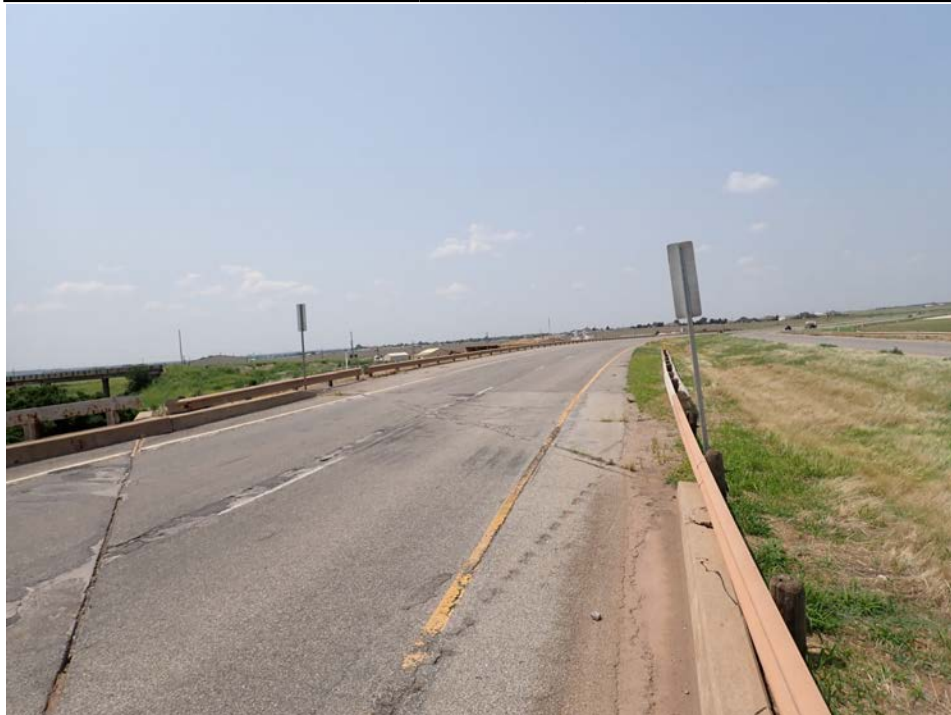
Photograph 54 - Looking south at the south approach. Note: cracks in the asphalt at the end of the approach slab.
