Oklahoma Dept. of Transportation - Bridge Inspection Report

NBI No.: 16159	Structure No.: 3704 0543EX	Local ID: 024	Suff. Rating: 53.30	SD
Bridge Description: 30ft., 44ft., 2-57ft., 42ft., 35ft. I-BM. SPANS WITH 2-1.5ft. SAFETY CURBS SKEW. VARIES		INSPECTION		
IDENTIFICATION

<u>NBI No.:</u> 16159	<u>Structure No.:</u> 3704 0543EX	<u>Local ID:</u> 024	<u>Suff. Rating:</u> 53.30	SD
Inspection Date: 1/15/24		Shaun Fillmore		
Invoice No.: 1131453		Inspected With: -1

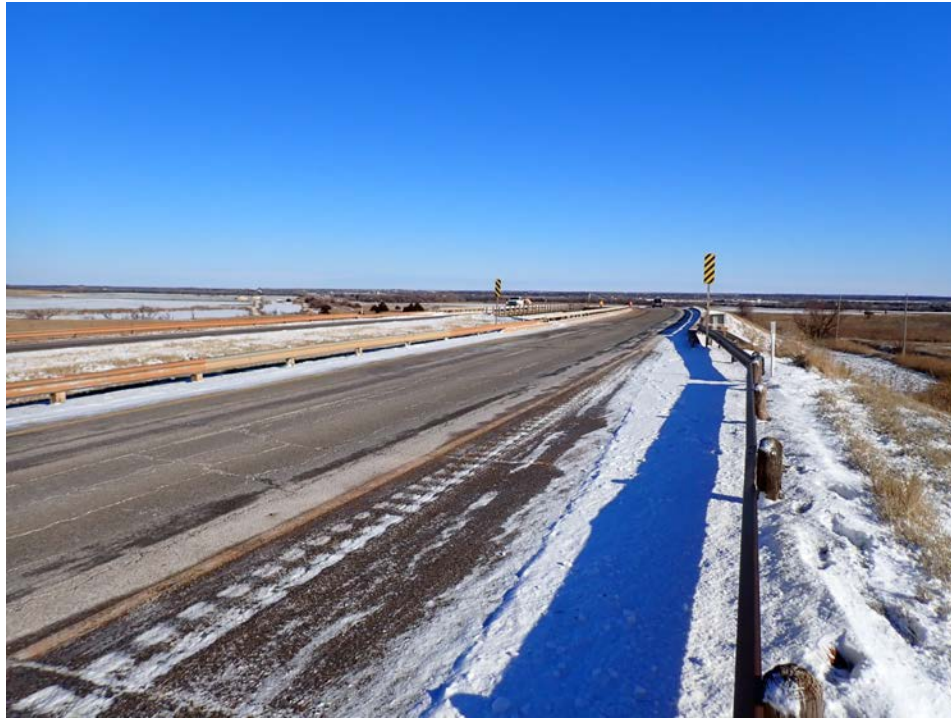
Photograph 1 - Looking north at bridge end view.

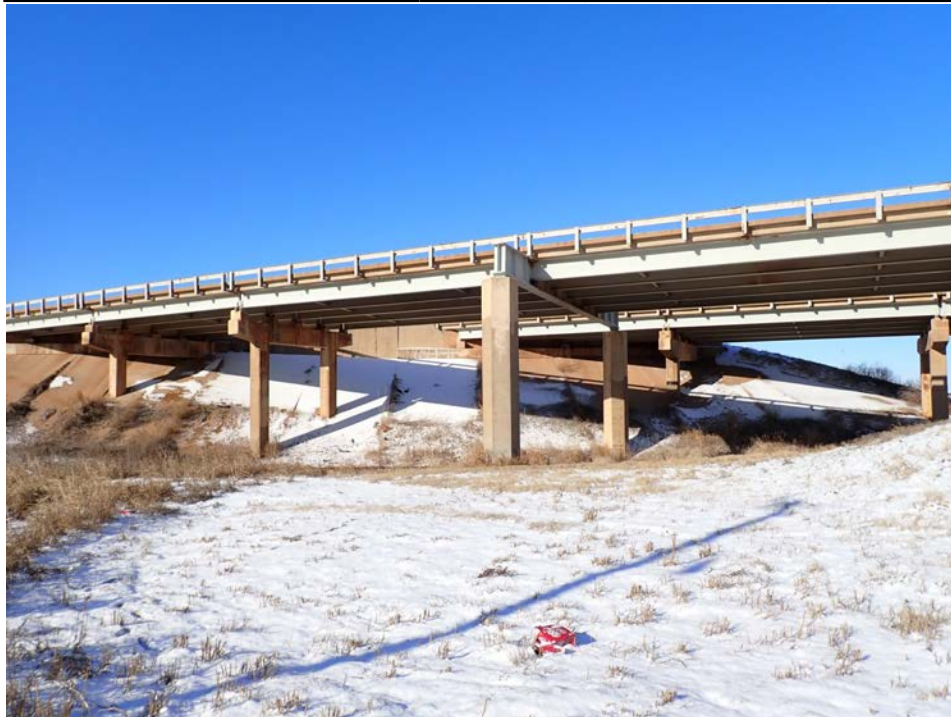
Photograph 2 - Looking southwest at the bridge elevation

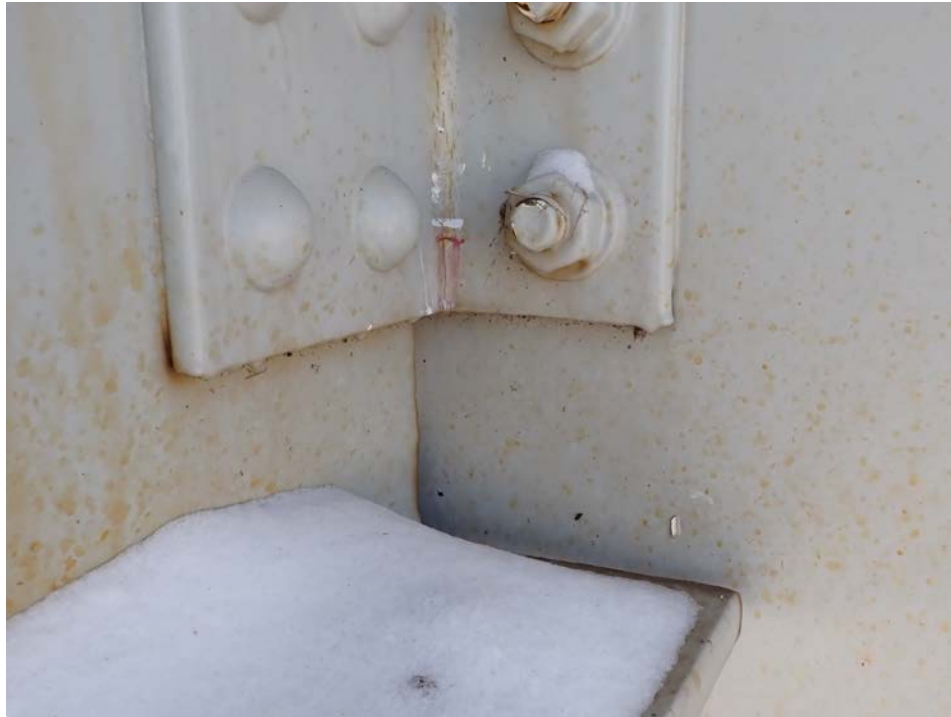
- Monitor cracked connection angles between the beams and pier beam at pier 3 (railroad flagger required):
 - Beam 1 - Northwest connection angle = 1 1/2-inch-long crack (no change).
 - Beam 2 - Southeast connection angle = 10 1/4-inch-long and 2-inch-long cracks, 11 3/4-inch total length (no change).
 - Beam 3 - Southeast connection angle = 14-inch-long crack (no change).
 - Beam 4 - Southeast connection angle = 13 3/4-inch-long crack (1/2" growth)
 - Beam 5 - South connection angles repair welds and seat added (no change).
- Monitor misalignment and global sweep of beam 1, span 2 = 1 5/16 inches to the east with stringline between bearings (could not get accurate stringline measurement due to wind; however, visually shows no change).

Photograph 3 - Looking southeast at the beam 1, span 4 west connection angle to the north face of the pier beam at pier 3. Note: 1 1/2-inch-long vertical crack (no change).

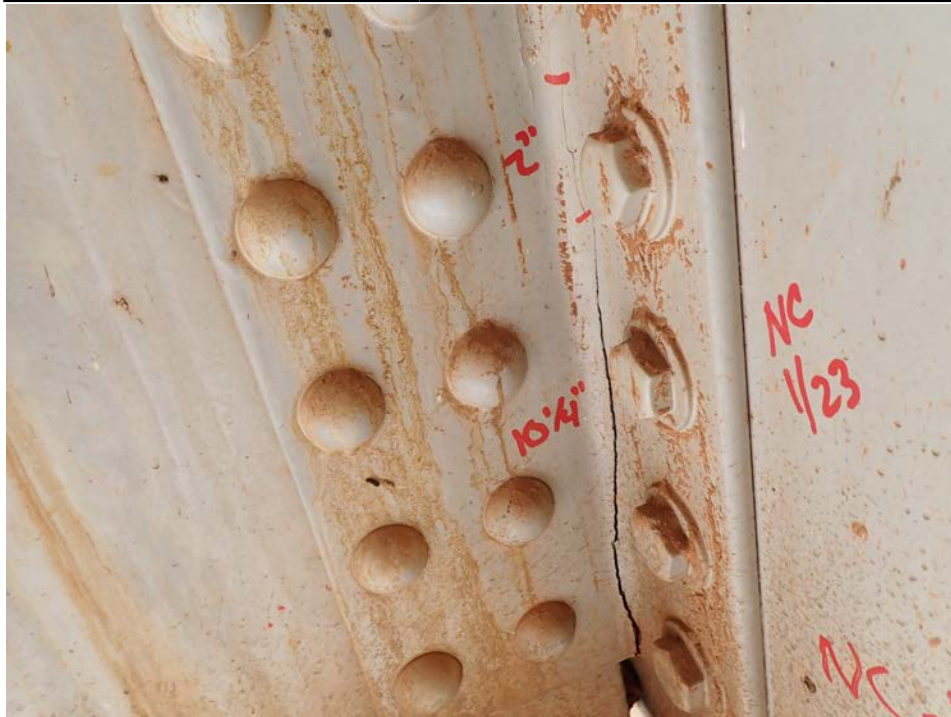
Photograph 4 - Looking northwest at the beam 2, span 3 east connection angle to the pier beam at pier 3. Note: 11 3/4-inch-long overall vertical crack (no change).

PX' – Highly Recommended Action.
 • Install seats under beams with connection angle cracks at south face of pier beam at beams 2 through 4.

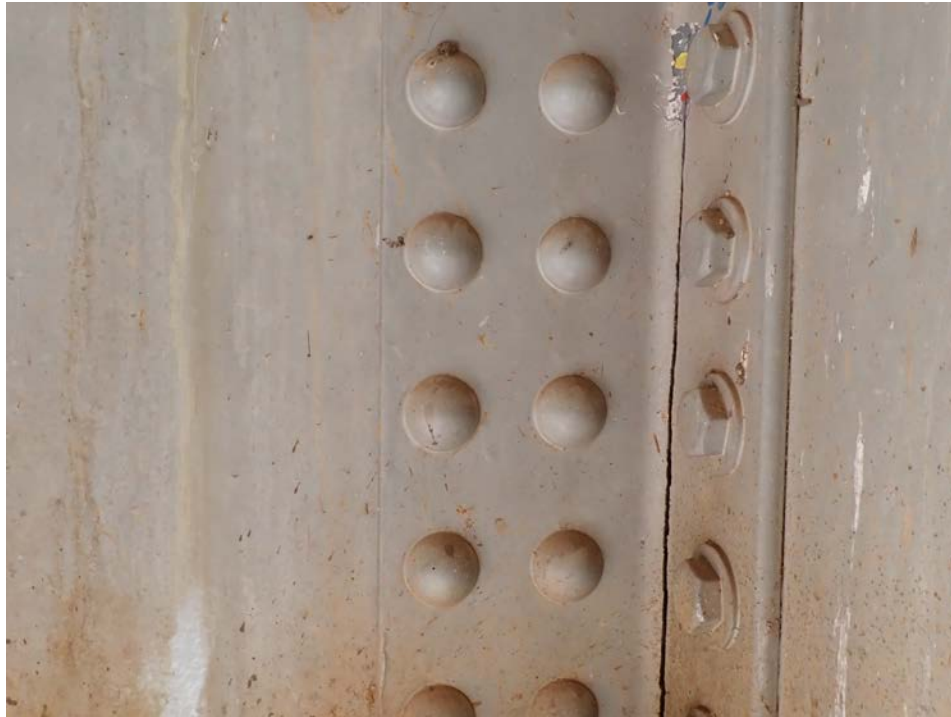
Photograph 5 - Looking northwest at the beam 3, span 3 east connection angle to the south face of the pier beam at pier 3. Note: 14-inch-long overall vertical crack (no change).

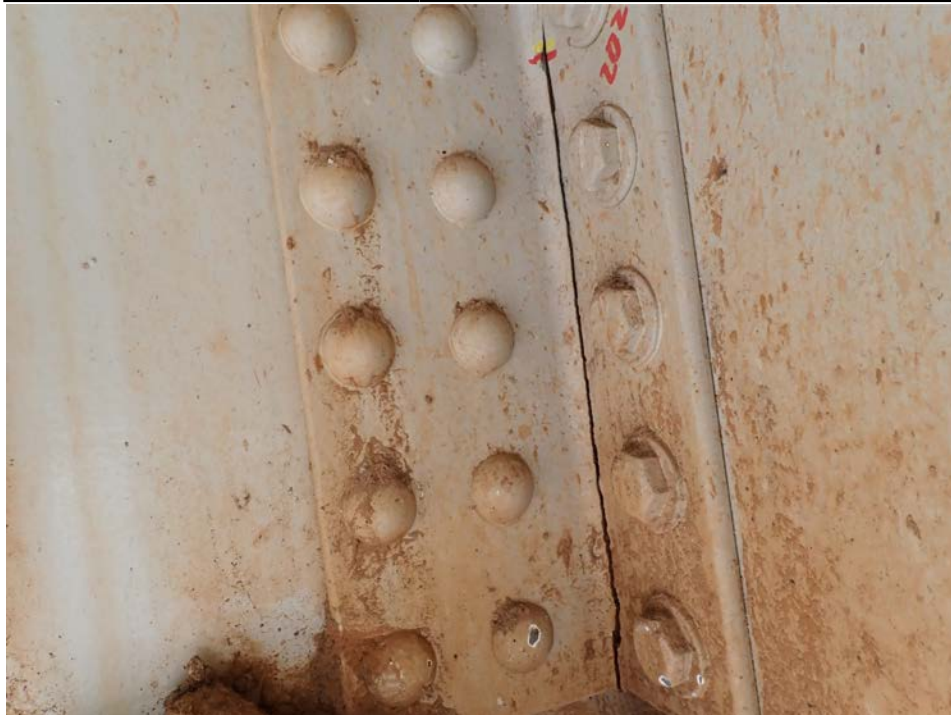
Photograph 6 - Looking northwest at the beam 4, span 3 east connection angle to the south face of the pier beam at pier 3. Note: 13 3/4-inch-long vertical crack (1/2-inch growth)..

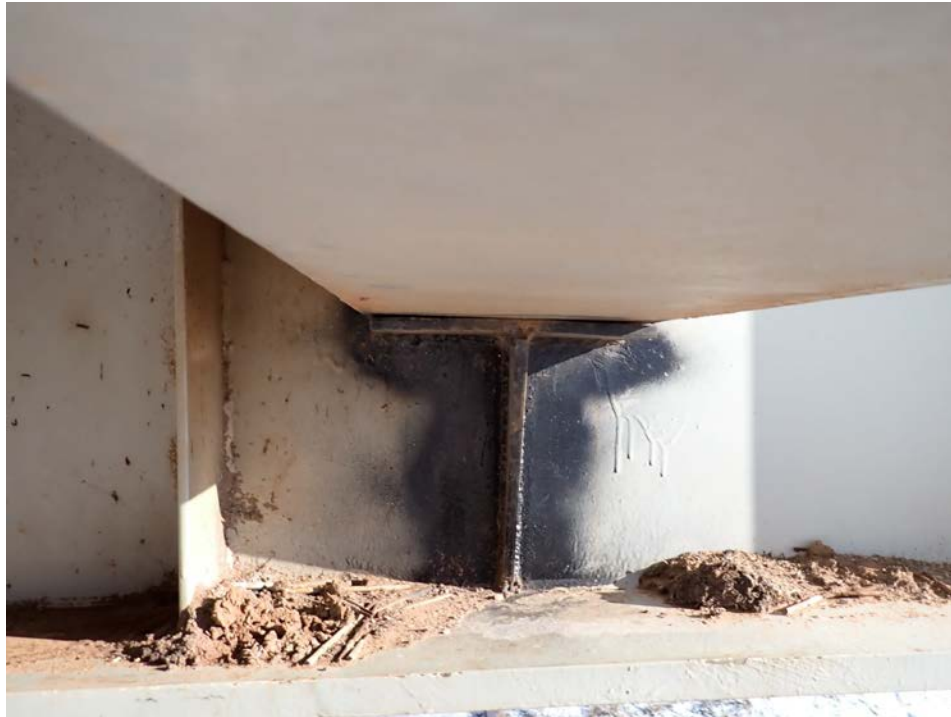
Photograph 7 - Looking north along the beam 5, span 3 bottom flange at the connection to the pier beam at pier 3. Note: seat has been installed beneath the beam.
