# Fracture Critical Bridge Inspection Report

NBI Bridge No.: 16167

Route U.S. 81 over UP R.R. UNDER  
Kingfisher County

Re: Nonredundant Steel Tension Member Bridge  
Inspection Report  
Structure No.: 3704 0543WX  
NBI No.: 16167  
Local ID: 024A  
US 81 Southbound over Union Pacific Railroad  
Kingfisher County, Field Division 4

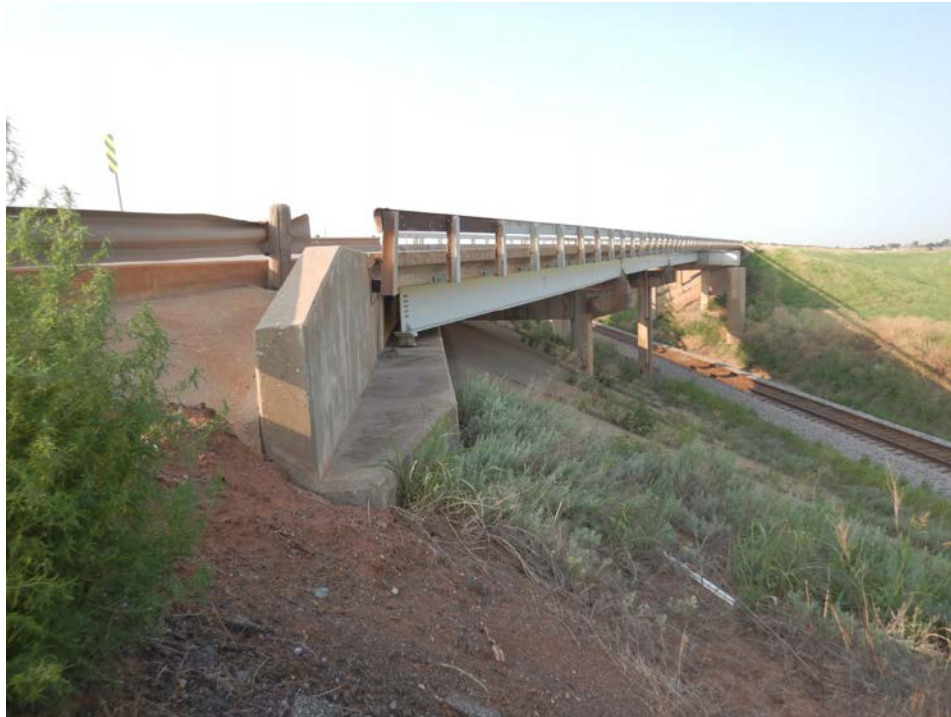
Photograph 1 - Looking south at the bridge elevation

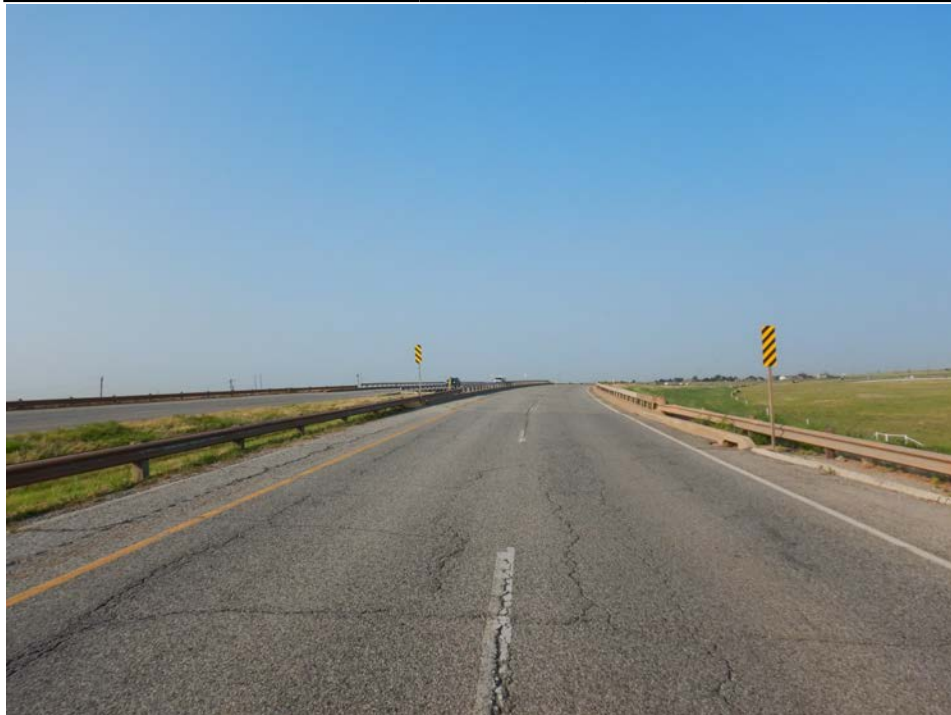
Photograph 2 - Looking south at the bridge end view.

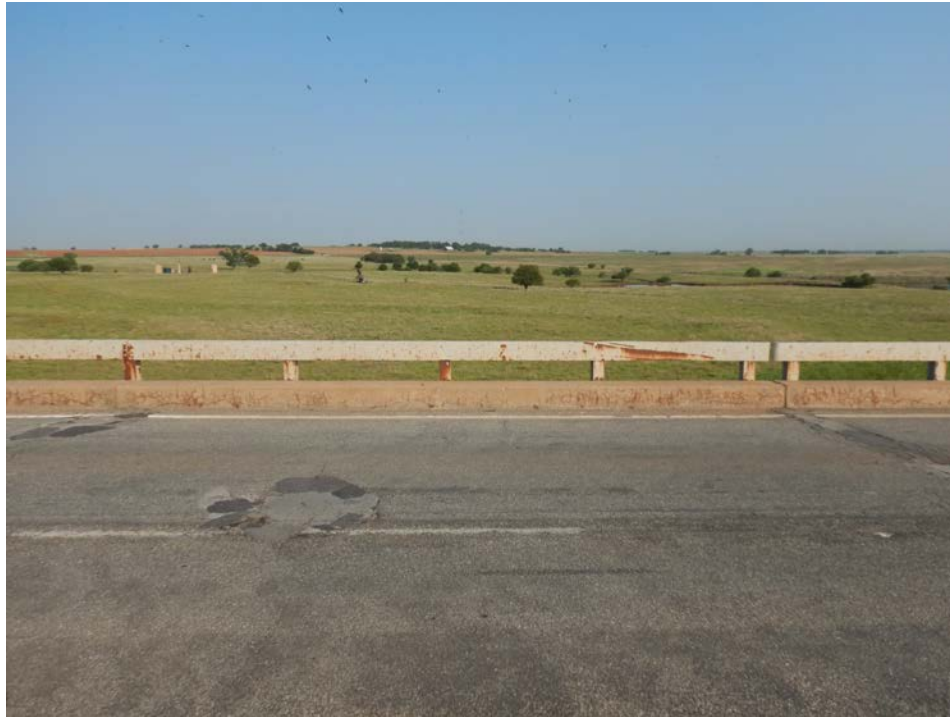
- Cracks with corrosion stains are present throughout the face of the curb **(photo 3)**. Shallow spalls with exposed reinforcing steel exist in the face of the east curb in spans 4, 5 and 6. The spalls are due to shallow cover over the reinforcing steel.

Photograph 3 - Looking west at the west bridge railing in span 4. Note: the railing is obsolete. Cracks with corrosion stains exists in the face of the curb and impact damage exists to the rail.

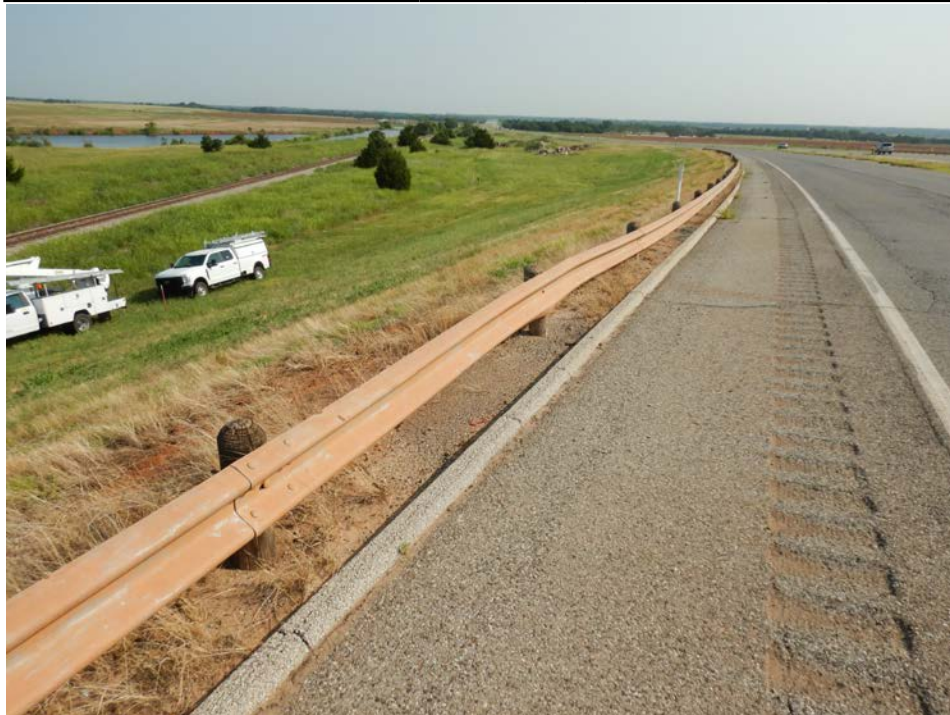
Photograph 4 - Looking north along the northwest approach railing. Note: approach railing is low and blockouts were not used.

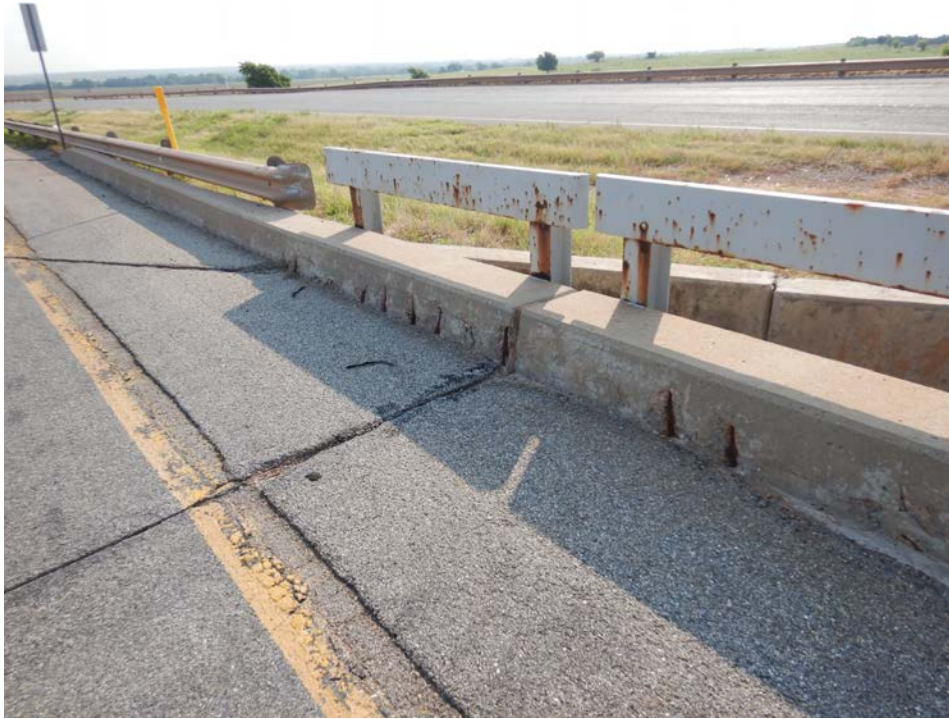
- Transitions - the approach railing at all four transitions is not attached to the bridge railing leaving the end of the bridge railing inadequately protected **(photo 5)**. The approach railing also has insufficient post spacing, blockouts are not installed, and the railing is not strengthened with either nested rails or thrie-beam at the transitions

Photograph 5 - Looking northeast at the northeast approach railing and east bridge railing in spans 5 and 6. Note: approach railing transition is insufficient with flared end approach rail termination at the bridge. Curb is spalled with exposed reinforcing steel due to insufficient cover.

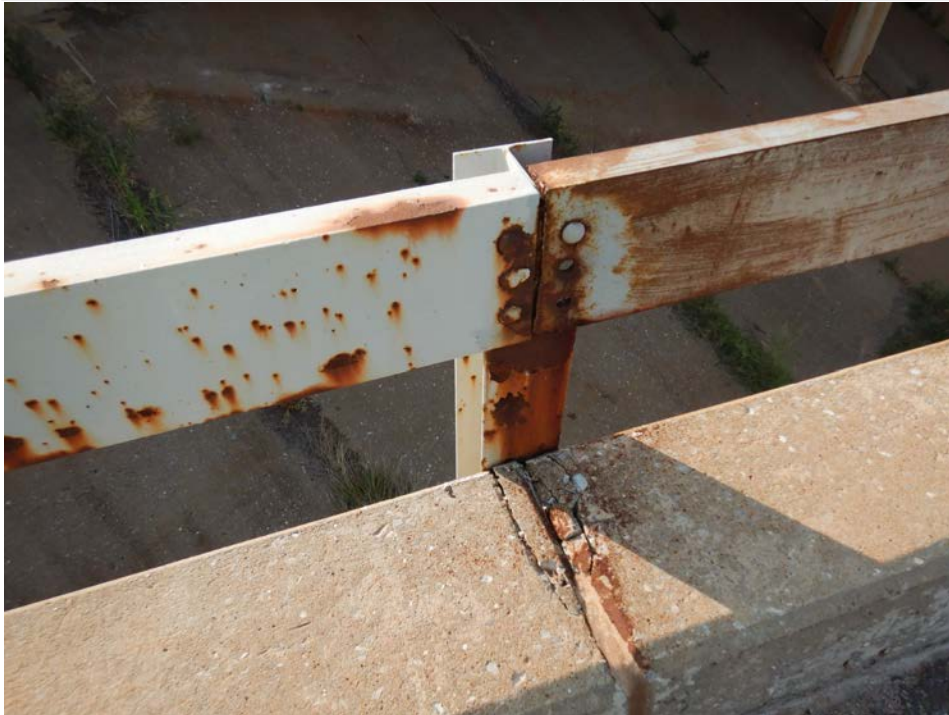
- **PX** – The bridge railing is corroded with section loss and missing bolts at isolated locations **(photo 6)**. This loss has not significantly affected the strength of the rail.

Photograph 6 - Looking east at the east bridge railing at the 5th post in span 3. Note: typical surface corrosion to the rail and post, and missing connection bolts

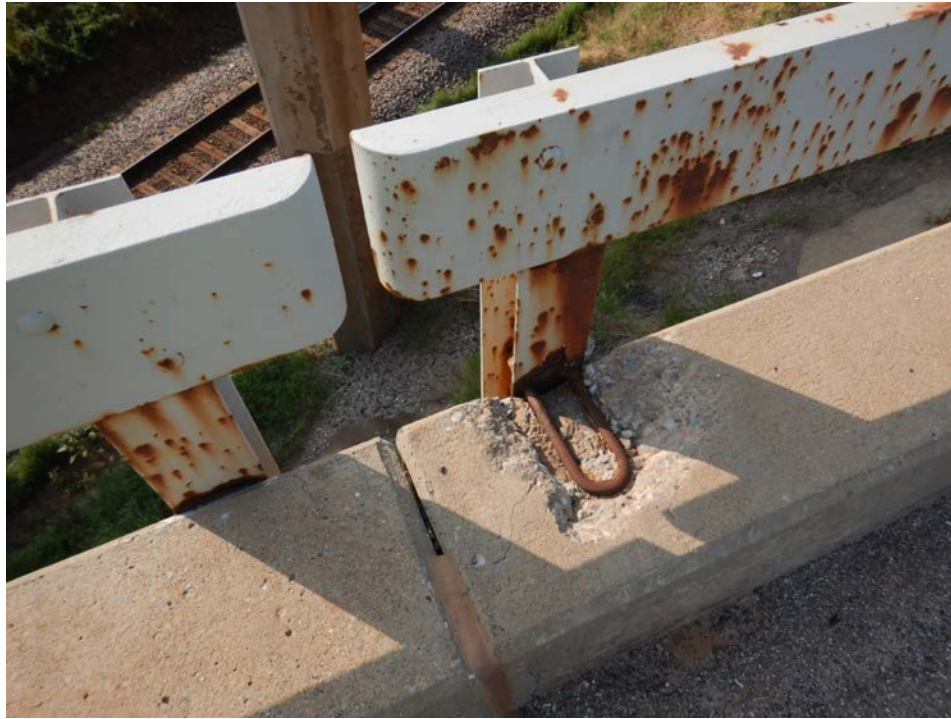
- **PX** – Spall exposing the embedded U-bolt anchorage for the railing posts exist at several locations in the curb top surface and soffit affecting the strength of the bridge railing **(photos 7 and 8)**.

Photograph 7 - Looking east at the east curb in span 1 at pier 1. Note: spall in the top face of the curb exposing the U-bolt anchorage for the bridge railing post.

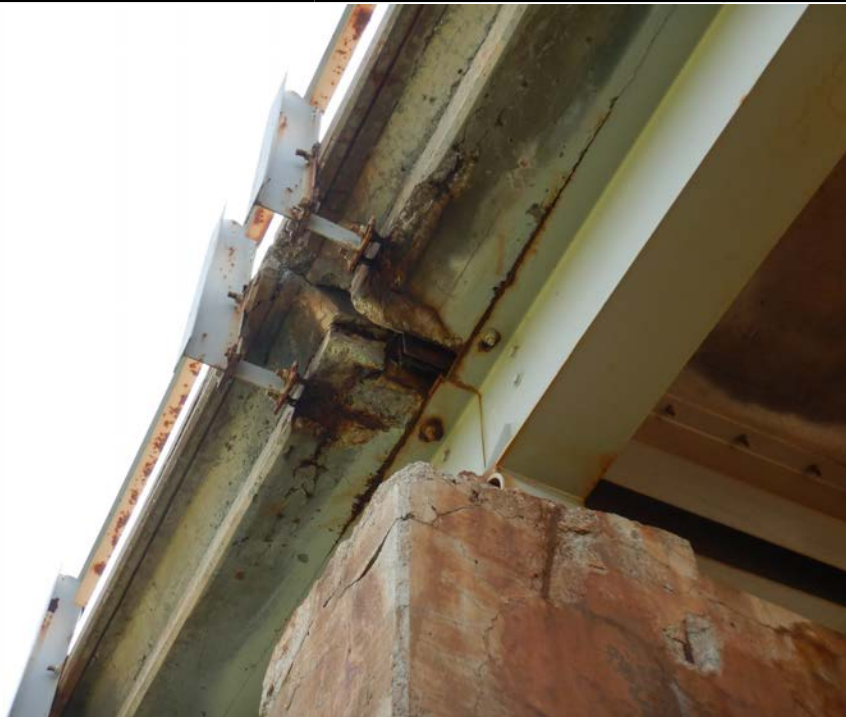
- **FX** – Spalls with exposed corroding reinforcing steel exist in both overhangs over most of the piers and abutments (**photos 8 and 14**). Spalls, averaging 1 square foot in size, are exposing the railing connection anchorage which have active corrosion and minor section loss.

Photograph 8 - Looking northeast at the west overhang at pier 2. Note: spall in soffit exposing the U-bolt anchorage for the bridge railing post.

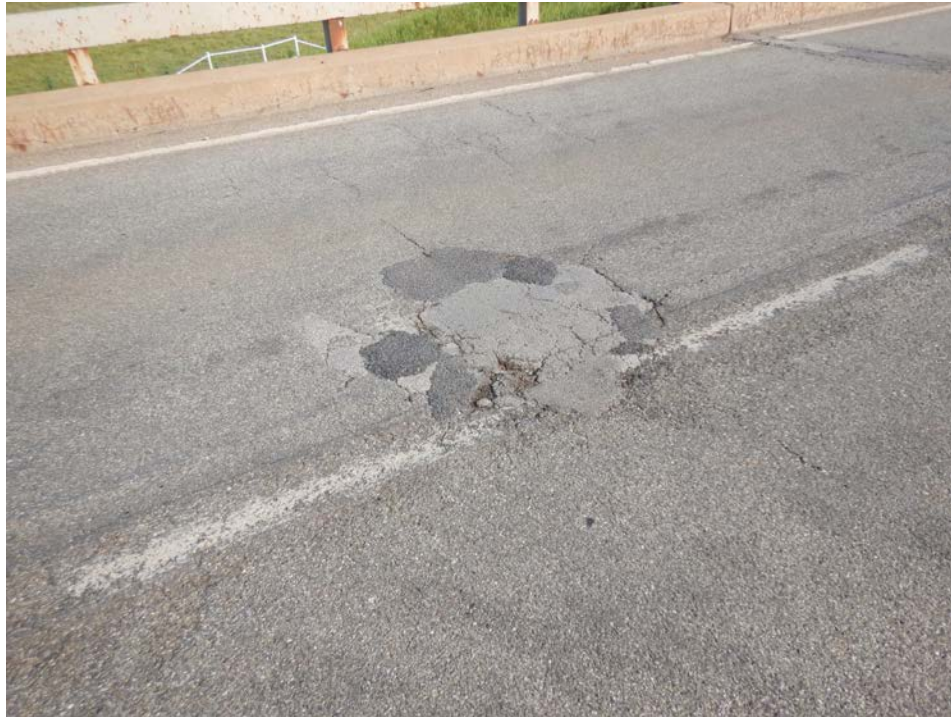
- **PX** – Asphalt patches exist in the asphalt wearing surface. These patches are most prominent in spans 2 and 3 near the roadway centerline and along the fixed and deck control joints **(photos 9 and 10)**. Multiple applications of patch material exist at most patches. Full-depth concrete patches exist at piers 1 and 3. Less than 2% of the overlay/deck surface has been patched.

- The asphalt wearing surface is weathered and exhibits longitudinal and map cracks in the west lane and along the roadway centerline, most prominent in spans 3 and 5 (**photo 9**). Minor rutting is present in the wheel lines.
- No deck drains exist on the bridge.

Photograph 9 - Looking northwest at the driving surface in span 3. Note: 3-foot-diameter asphalt patch at the roadway centerline. Cracks exist in the asphalt along the roadway centerline and the west lane.

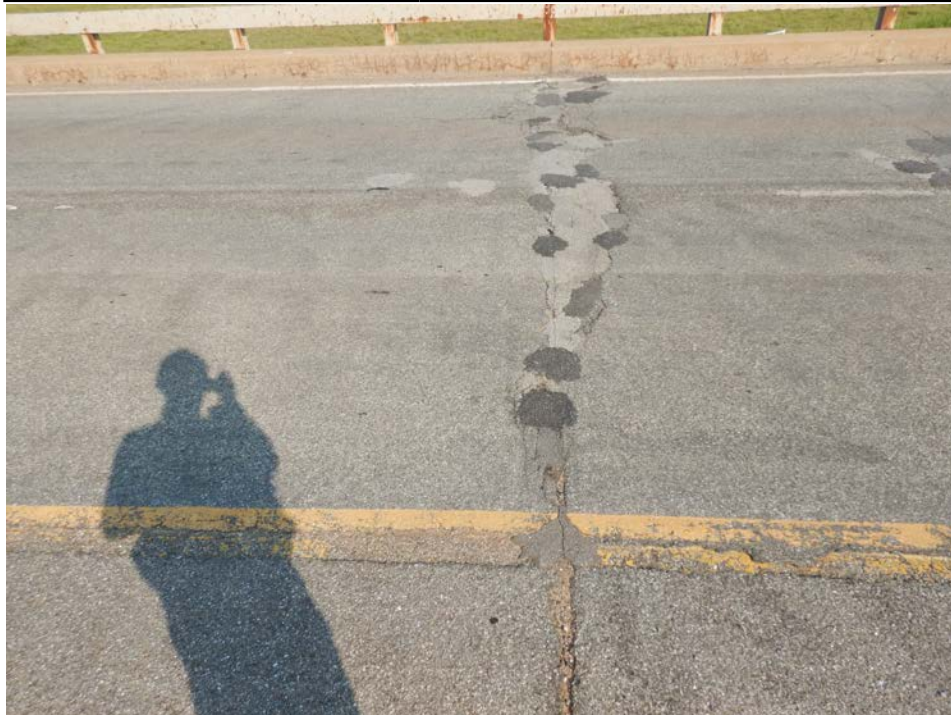
Photograph 10 - Looking west along the north deck control joint in span 3. Note: asphalt patches along the control joint.

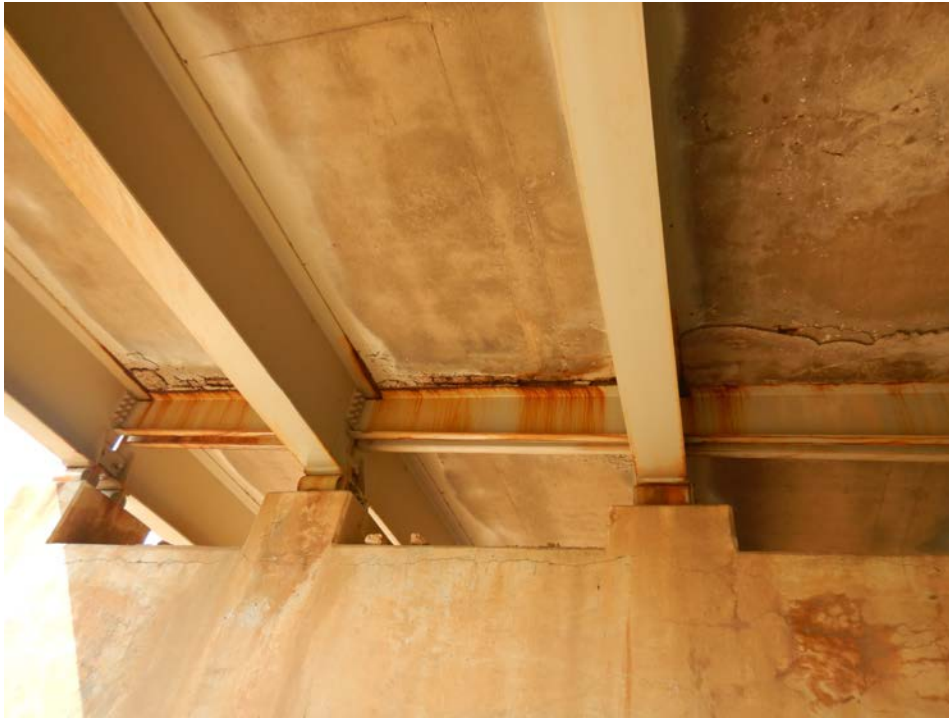
- **PX** – Spalling and cracking is typical in the soffit along the end diaphragms at the expansion and fixed joints (**photos 11 and 12**). The spall between beams 1 and 2, span 2 above pier 1 extends above the bottom reinforcing steel and an asphalt patch exists in the deck surface above the spall. A full depth patch exists between beams 2 and 3 above pier 1, adjacent to the spall (**photo 13**). The spalls appear to be a combination of corrosion of the reinforcing steel and pack rust between the deck and the end diaphragms resulting in more load being applied to the diaphragm.

Photograph 11 - Looking south at the underside of span 2 at pier 1 between beams 1 and 4. Note: spalling with exposed reinforcing steel along the end diaphragm. Full-depth patch exists between beams 3 and 4.

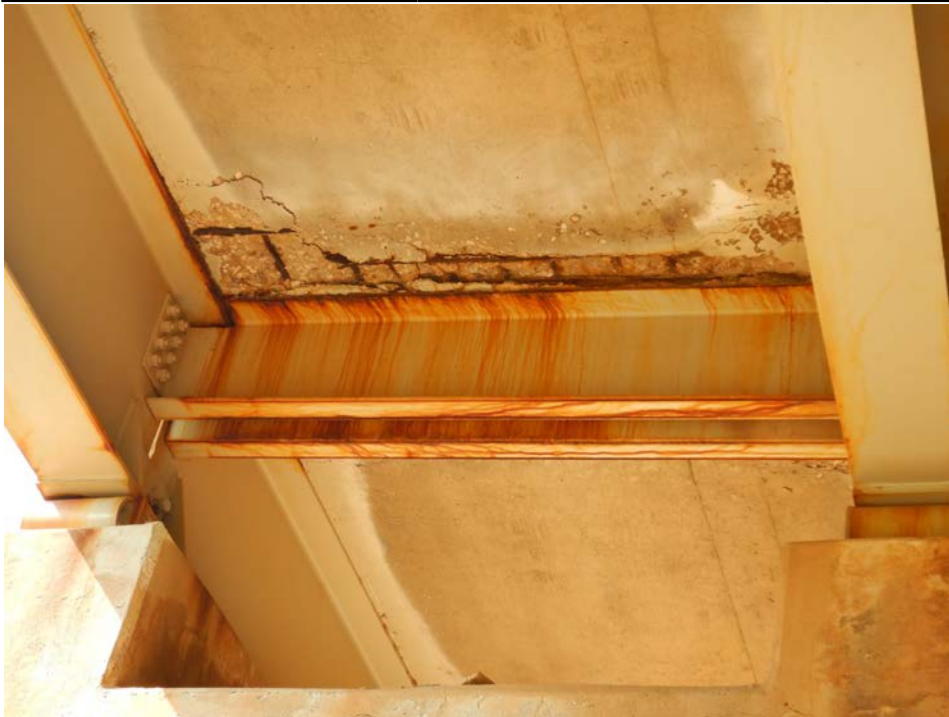
Photograph 12 - Looking south at the underside of span 2 at pier 1 between beams 1 and 2. Note: spall extending above the bottom reinforcing steel.

- Repair the spall in the soffit between beams 1 and 2 above pier 1 with a full depth patch.
- Reseal the fixed and expansion joints.
- Place crushed aggregate slope protection in eroded areas around the southwest wingwall.

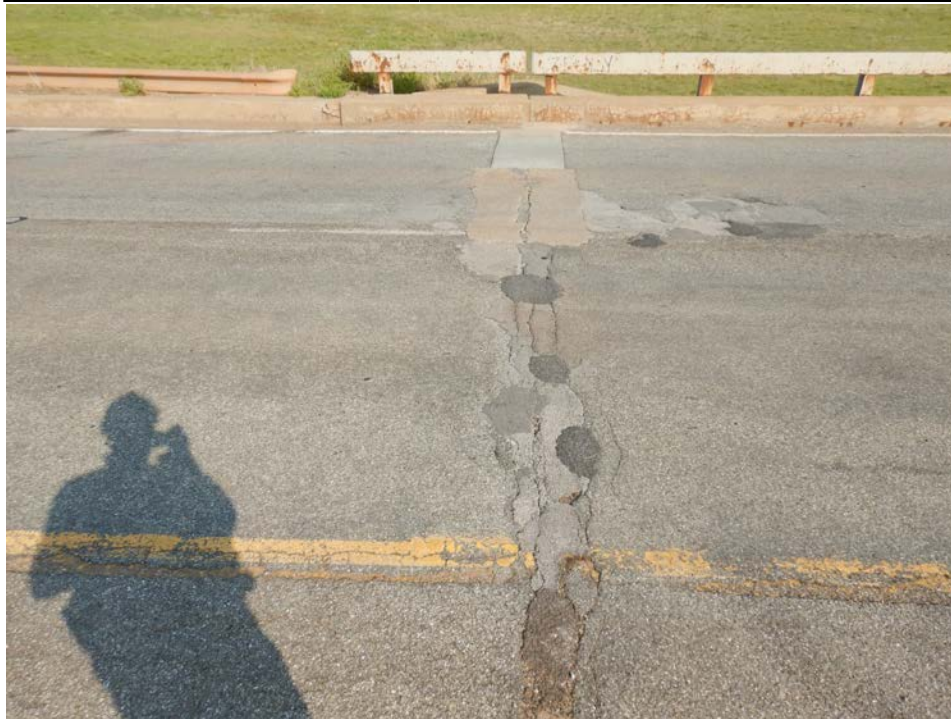
- Pier 1 – A full-depth concrete patch exists between beams 2 and 3 with an unsealed crack in line with the joint (**photo 13**). A deep spall exists in the underside of the deck adjacent to the joint between beams 1 and 2 with spalls forming between the remaining beams (**photos 11 and 12**). Asphalt patches with adjacent cracks exist over the joint within the travel lanes.

Photograph 13 - Looking north along the expansion joint over pier 1. Note: asphalt and concrete patches exist along the joint.

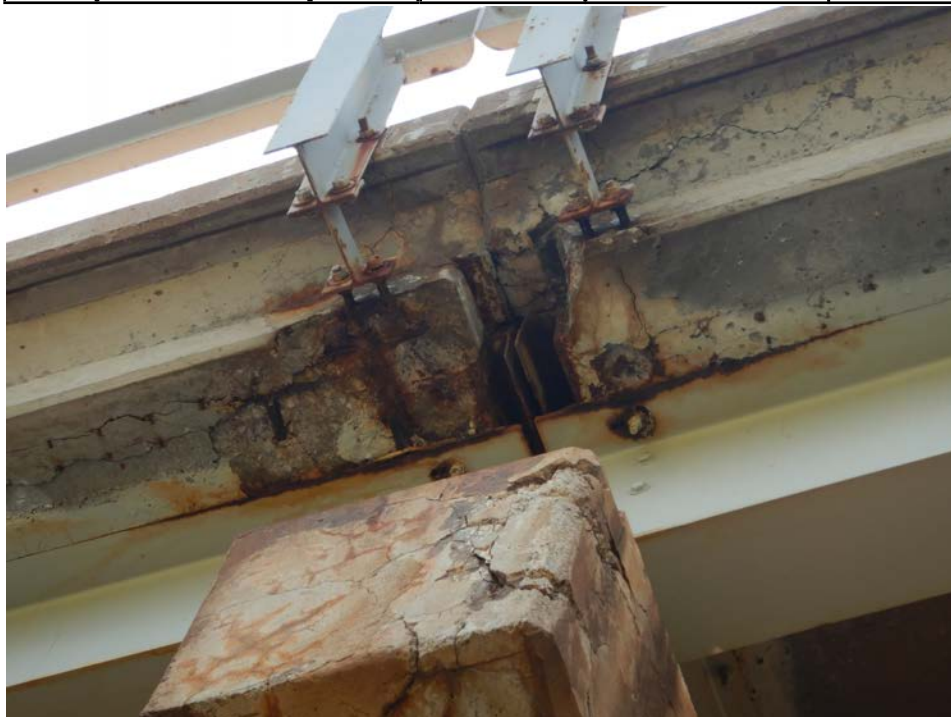
Photograph 14 - Looking east at Underside of deck overhang at Pier 4. Note: spalling and cracking at u bolts for bridge railing.

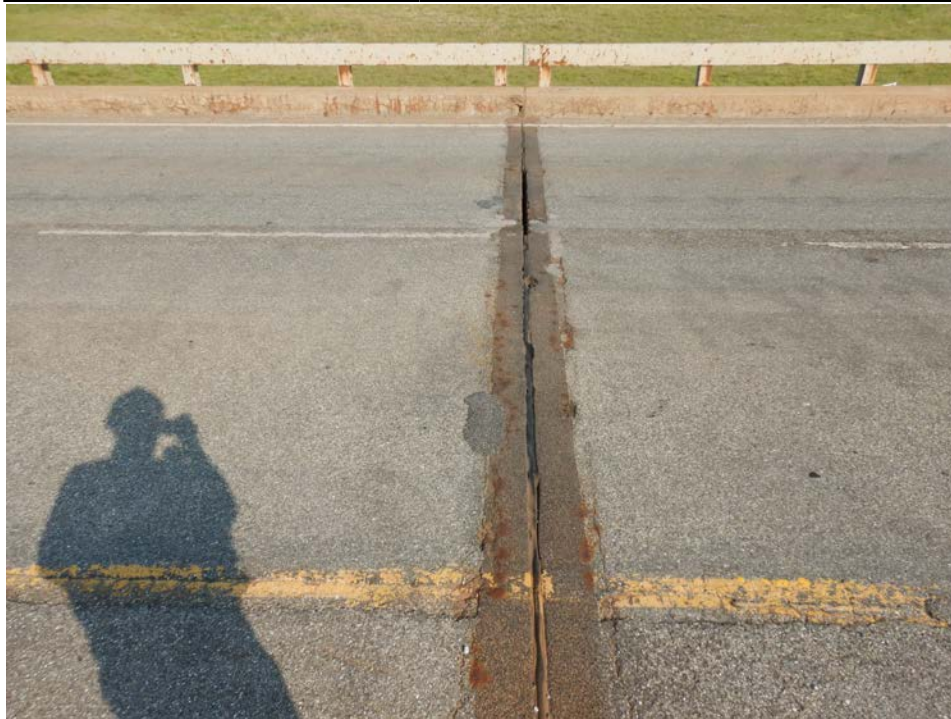
- Pier 2 – The seal is missing in the west lane and exhibits adhesion failure at isolated areas along the length of the joint (**photo 15**). The ends of the west bridge railing are in contact over the joint.

- An elastomeric concrete header exists on the original finger joint steel with rust stains occurring in the travel lanes (**photos 15 and 16**).
- **PX** – The poured seal fixed joints exist at both abutments and piers 1, 3, and 5 and have been paved over with asphalt and asphalt patches. Both abutments are skewed 60 degrees while the piers are normal to the roadway centerline. Piers 1 and 5 are linked to allow longitudinal movement of the superstructure with no opening of the joint. The beams at pier 3 frame into the pier beam with no evidence of a strap plate over the pier beam.

Photograph 15 - Looking west along the poured seal expansion joint over pier 2. Note: seal is missing in the west lane. Joint is closed at the west bridge railing. Rust stains exist along the edges of the elastomeric concrete header.

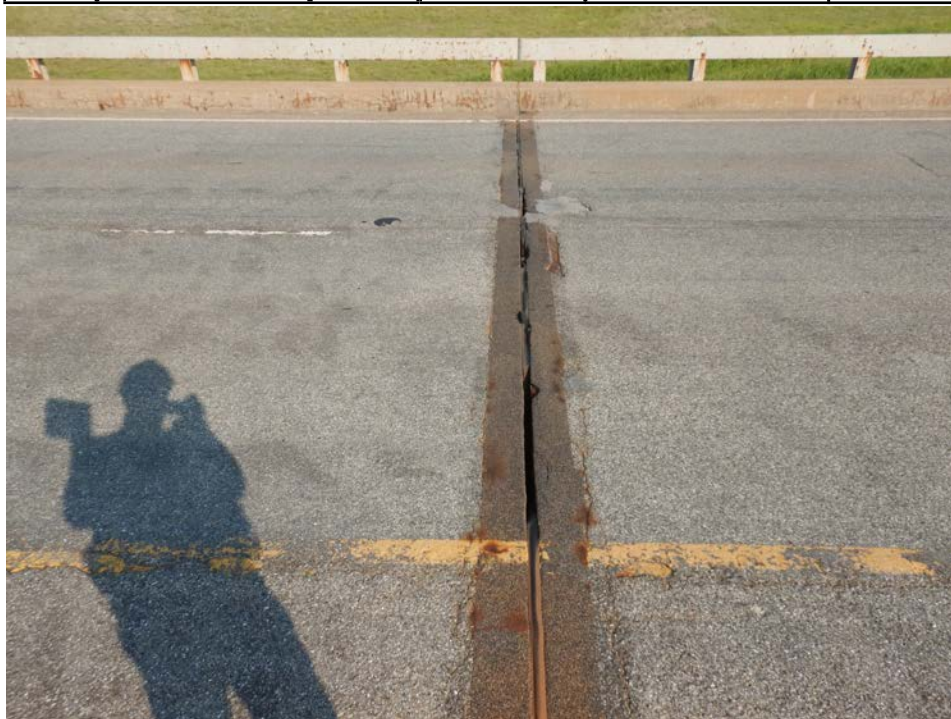
- Pier 4 – The seal is missing in both lanes and exhibits adhesion failure at isolated areas along the length of the joint (**photo 16**). The ends of the west bridge railing are in contact over the joint.

Photograph 16 - Looking west along the poured seal expansion joint over pier 4. Note: seal is missing in both lanes. Joint is closed at the west bridge railing. Rust stains exist along the edges of the elastomeric concrete header.

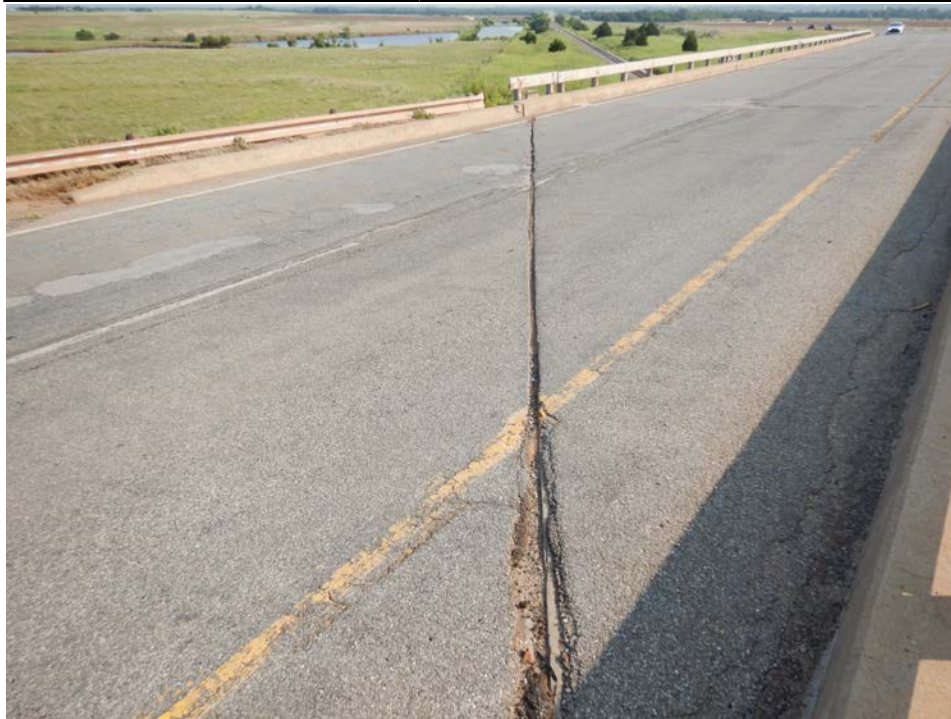
- South abutment – Minor spalls exist in the asphalt wearing surface adjacent to the joint (**photo 17**). The deck overshoots the backwall with evidence of past leakage onto the abutment seat. No obvious signs of seal damage were observed.

Photograph 17 - Looking northwest along the poured seal fixed joint over the south abutment. Note: minor spalling and patching of the asphalt exists along the joint.

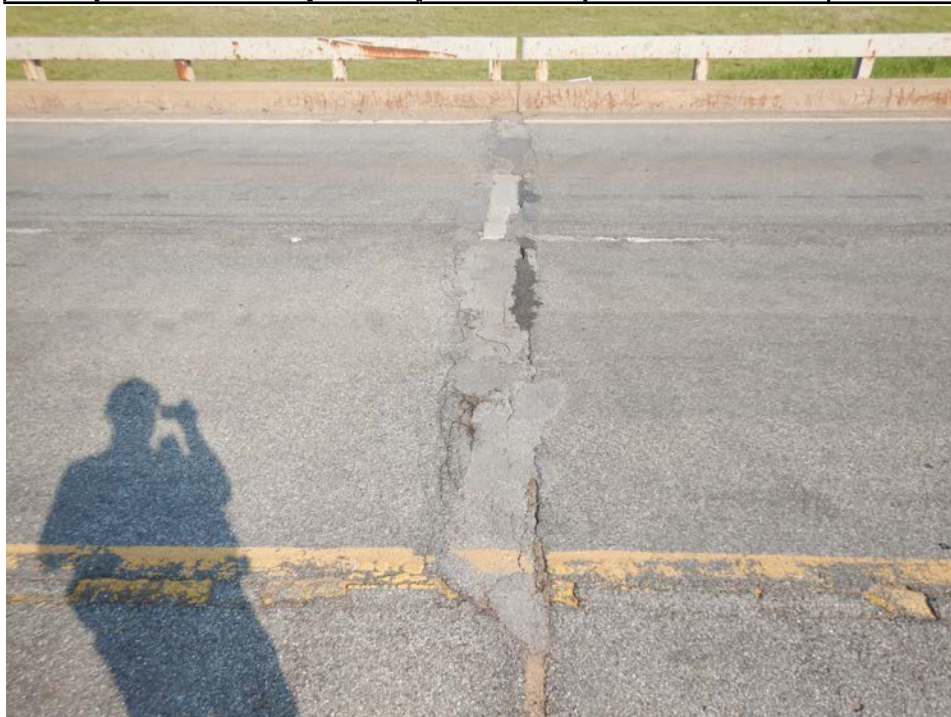
- Pier 3 (over pier beam) – A full-depth concrete patch exists in span 3 between beams 2 and 3 adjacent to the joint (**photo 18**). Multiple asphalt patches with adjacent cracks exist in span 3 adjacent to the joint within the travel lanes. The patches are beginning to fail. Corrosion and debris on the pier beam confirm that the joint is leaking.

Photograph 18 - Looking west along the poured seal fixed joint over pier 3. Note: asphalt and concrete patches exist along the joint.

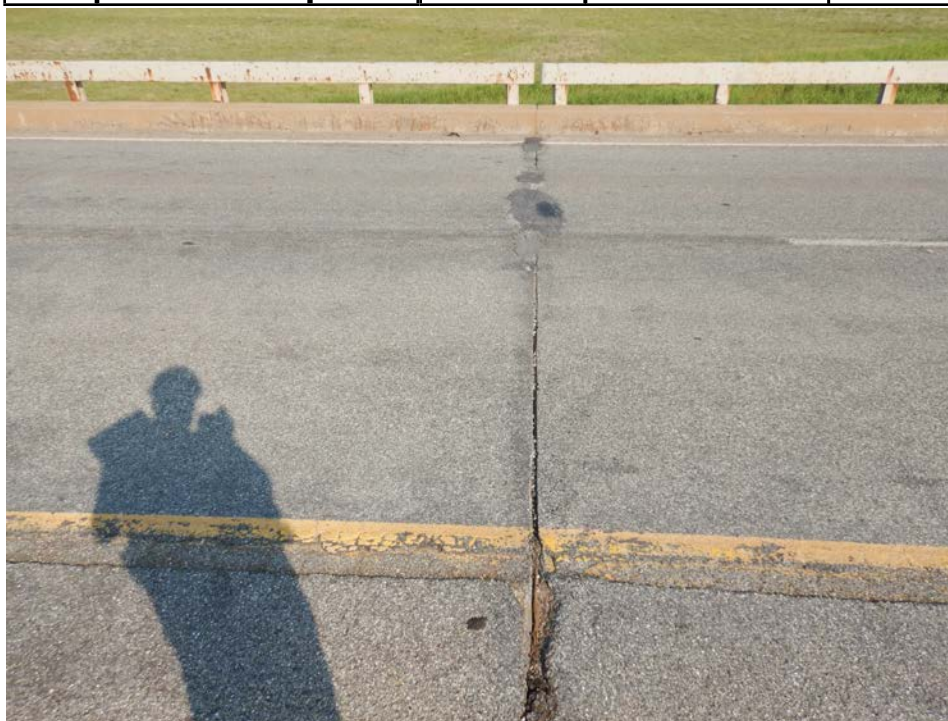
- Pier 5 – Multiple asphalt patches and adjacent cracks exist over the joint in the west lane (**photo 19**). The joint seal has debonded and is depressed within the joint in the travel lanes allowing free flow of deck drainage onto the bridge components below.

Photograph 19 - Looking west along the poured seal fixed joint over pier 5. Note: asphalt patches exist along the joint in the west lane.

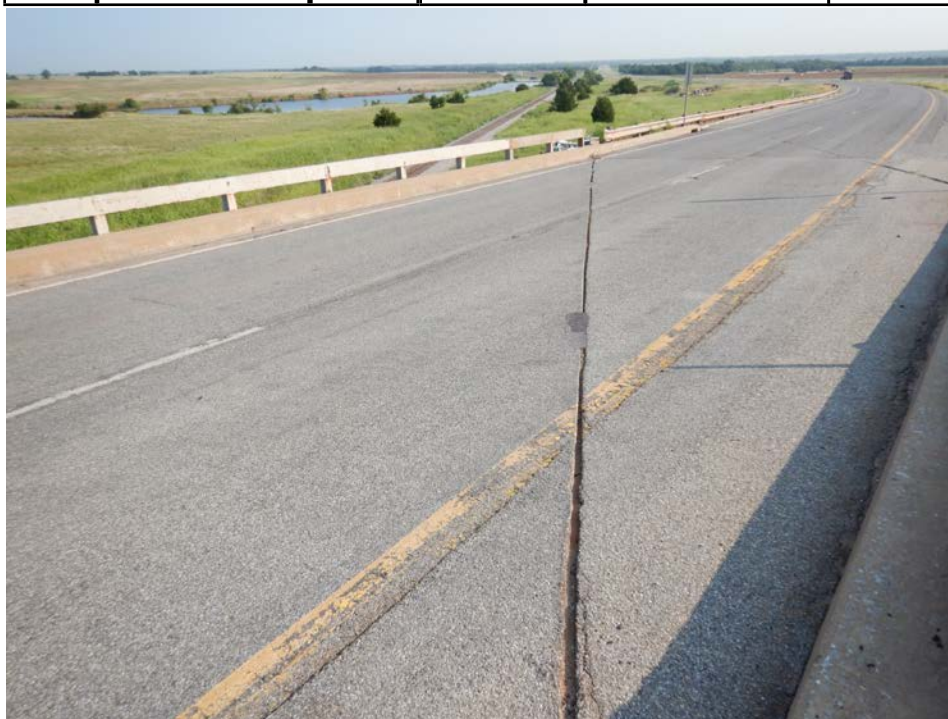
- North abutment – A few asphalt patches exist in the asphalt wearing surface adjacent to the joint (**photo 20**).
- Deck control joints with poured seals exist at midspan in spans 3 and 4. These spans are continuous with the pier beam at pier 3.

Photograph 20 - Looking northwest along the poured seal fixed joint over the south abutment. Note: few asphalt patches along the joint.

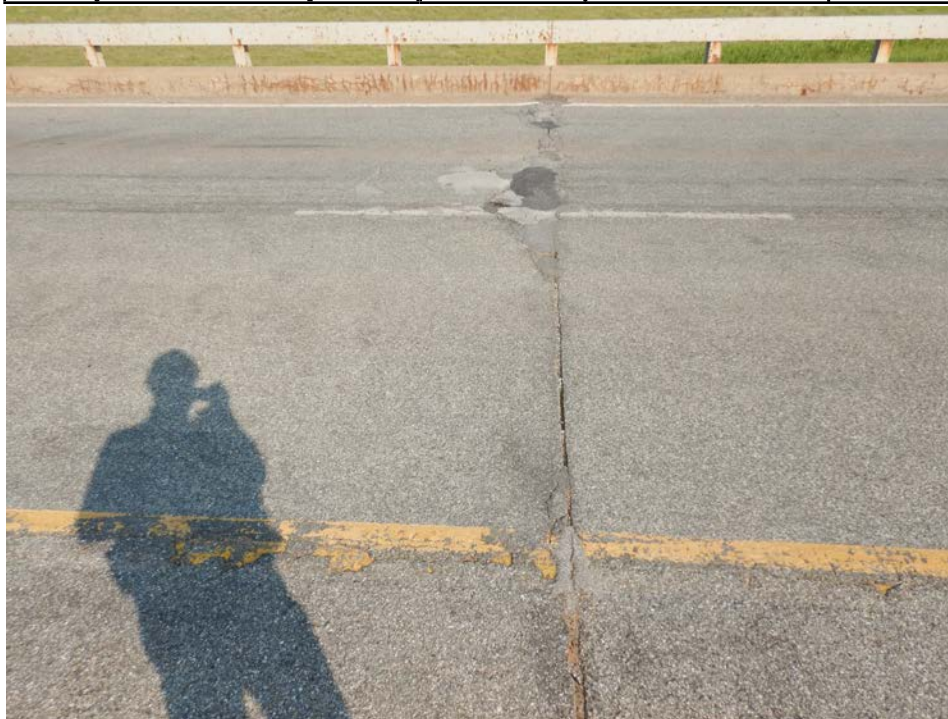
Photograph 21 - Looking west along the north deck control joint in span 4. Note: asphalt patches along the control joint.

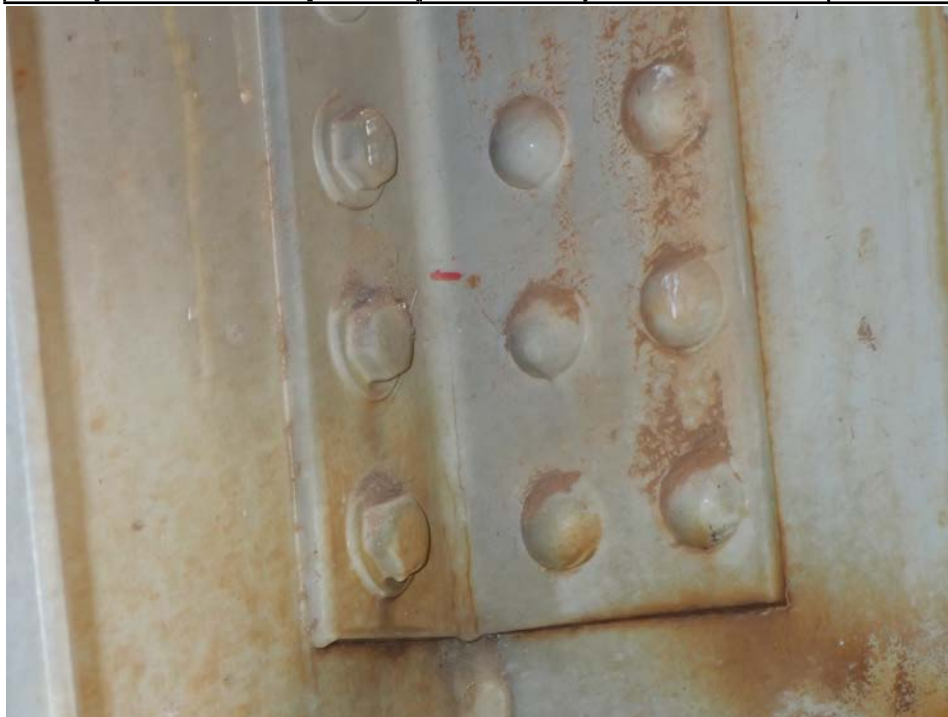
Pier Beam Face	Beam No.	Connection Angle	Comment	Photo
South	4	West	5 3/4-inch-long vertical paint crack at the bottom of the connection angle. No change from 2023.	<b>22</b>
South	5	West	4 1/8-inch-long vertical paint crack at the bottom of the connection angle. No change from 2023.	<b>23</b>
North	3	West	Fine paint cracks were observed in the bottom 1 1/2 inches of the connection angle. New for 2024	<b>24</b>
North	5	West	2 1/2-inch-long vertical paint crack. New for 2024.	<b>25</b>

Photograph 22 - Looking northeast at the beam 4, span 3 southwest connection angle to the pier beam at pier 3. Note: 5 3/4-inch-long vertical paint crack at the bottom of the connection angle.

- Monitor the spalling in the curb and soffit at the joints for conditions which would compromise the strength of the bridge railing connection.
- Monitor the paint cracks in the beam connection angles to the pier beam at pier 3 at:
  - Beam 4, span 3 – 5 3/4 inches in southwest connection angle.
  - Beam 5, span 3 – 4 1/8 inches in southwest connection angle.

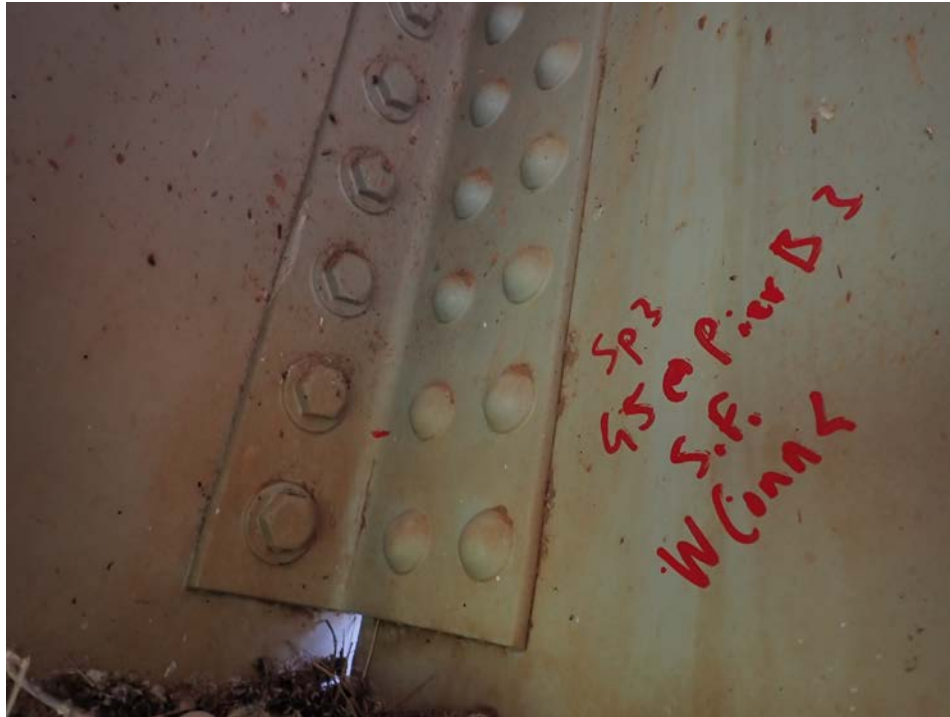
Photograph 23 - Looking northeast at the beam 5, span 3 southwest connection angle to the pier beam at pier 3. Note: 4 1/8-inch-long vertical paint crack at the bottom of the connection angle.

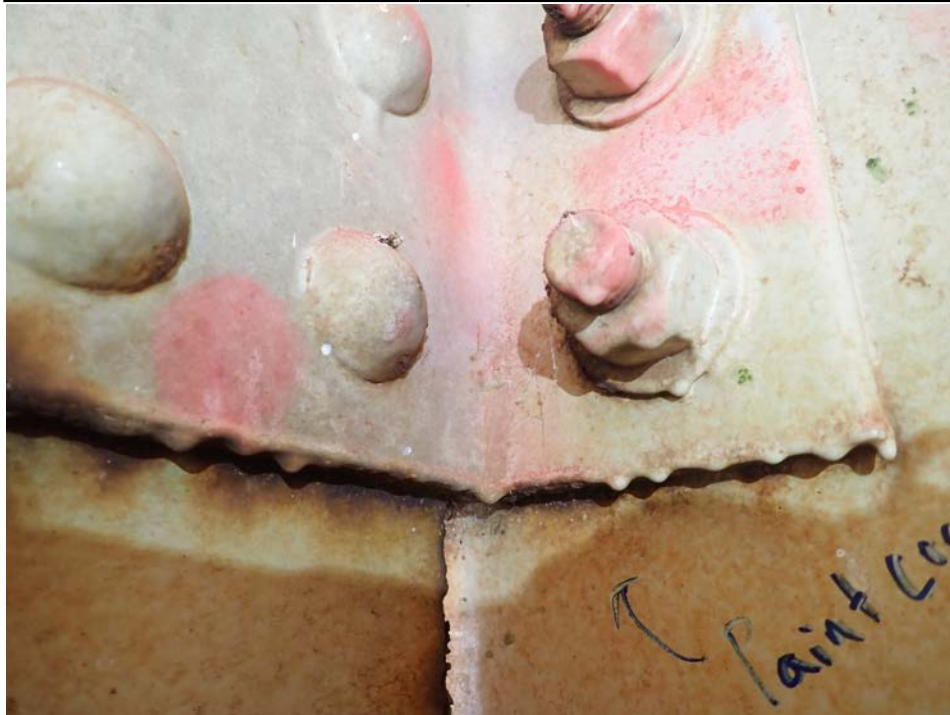
Photograph 24 - Looking southeast at the beam 3, span 4 northwest connection angle to the pier beam at pier 3. Note: fine paint cracks in the bottom typical paint cracks at the bottom of the connection angle.

- Beam 3, span 4 – Fine cracks in northwest connection angle.
- Beam 5, span 4 – 2 1/2 inches in northwest connection angle.
- Monitor the corrosion and section loss to the top flange of the pier beam at pier 3.

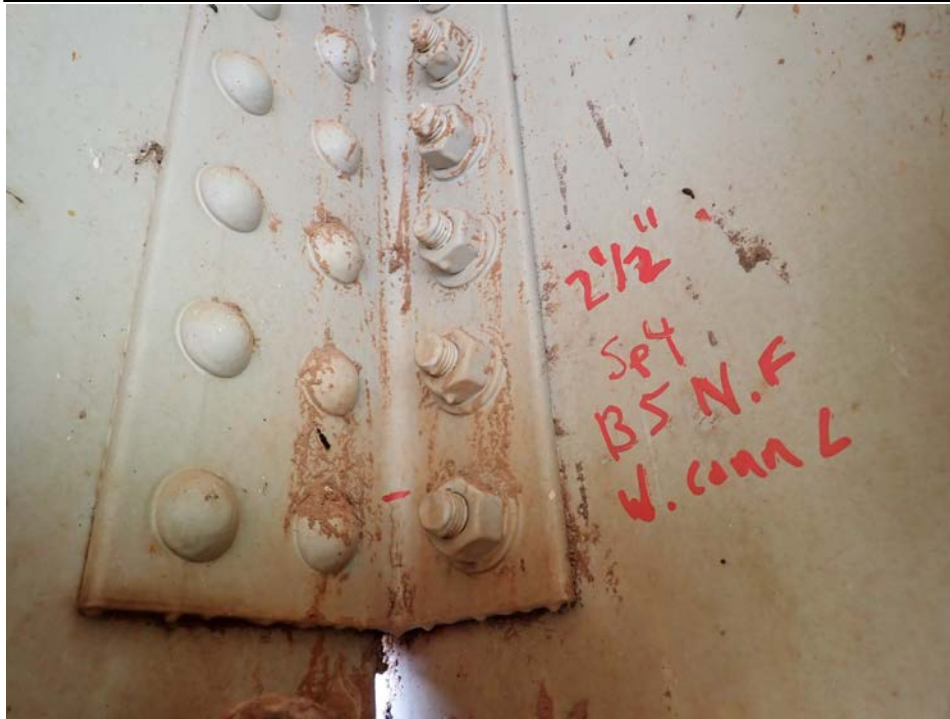
Photograph 25 - Looking southeast at the beam 5, span 4 northwest connection angle to the pier beam at pier 3. Note: 2 1/2-inch-long vertical paint crack in the bottom of the connection angle.

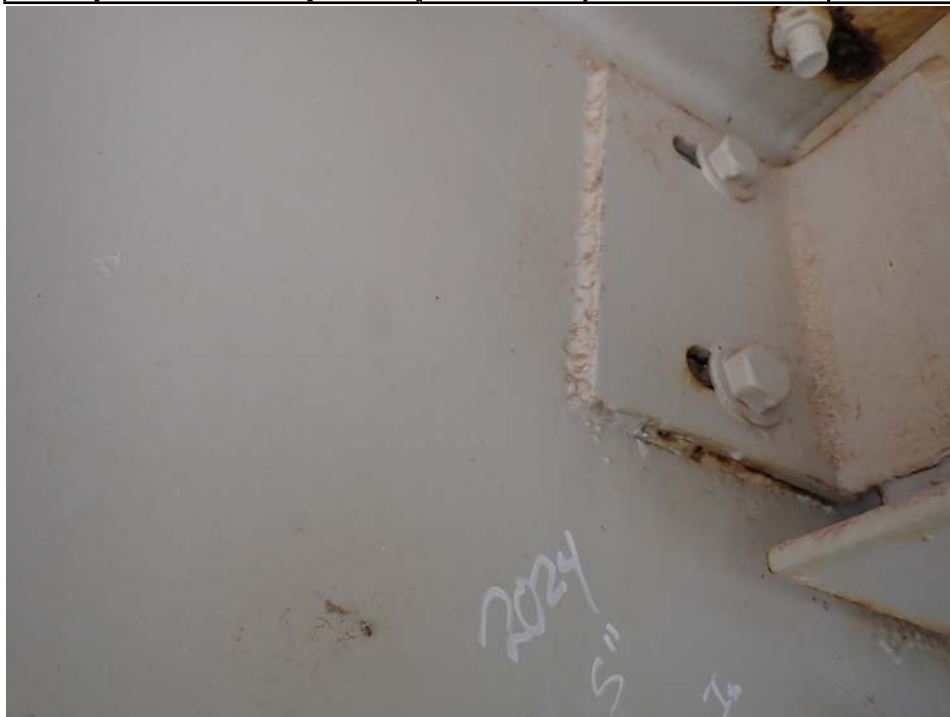
- Pack rust induced cracks are typical in the horizontal welds for the end diaphragm connection angles at pier 4 (**photo 26**). The crack lengths have grown since the 2020 inspection; however, the connection angle is still adequately attached by welds along the vertical edge of the angle leg and along the top weld. Two bolts used during erection to aid in aligning the original finger joint also exist between the connection angle and the beam web.

Photograph 26 - Looking northwest beam 2, span 4 at pier 4. Note: 5-inch-long horizontal crack in the bottom weld between the end diaphragm connection angle and the beam web.

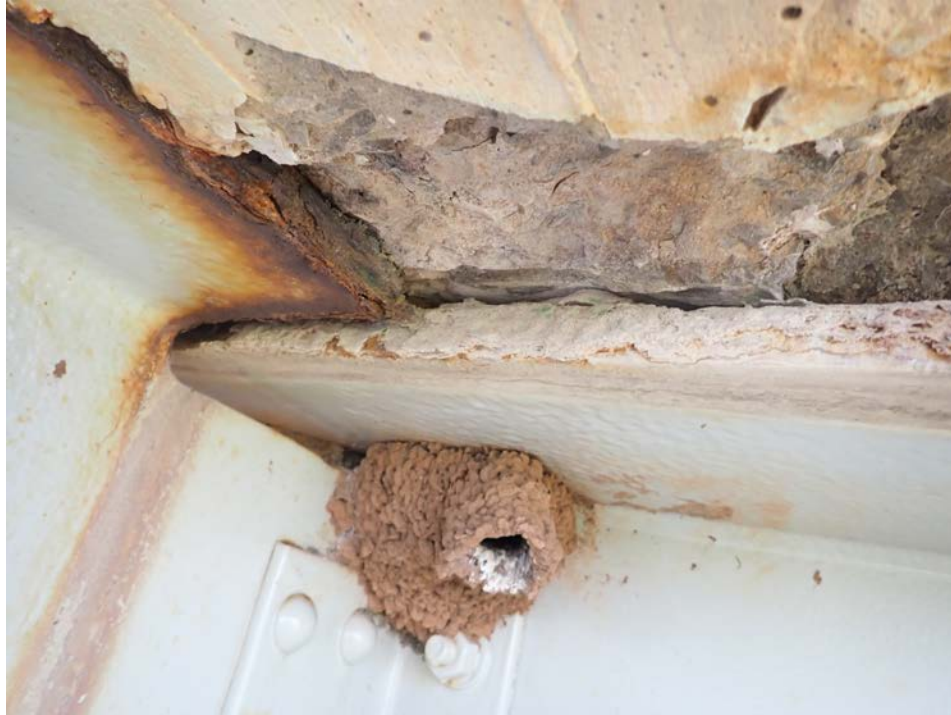
Photograph 27 - Looking southeast at the beam 1, span 4 top flange at the pier beam at pier 3. Note: laminating corrosion and 1/8-inch-deep section loss in the top flange of the beam. 16-inch-deep section loss to the top flange of the pier beam. Deck is lifted off the pier beam top flange.

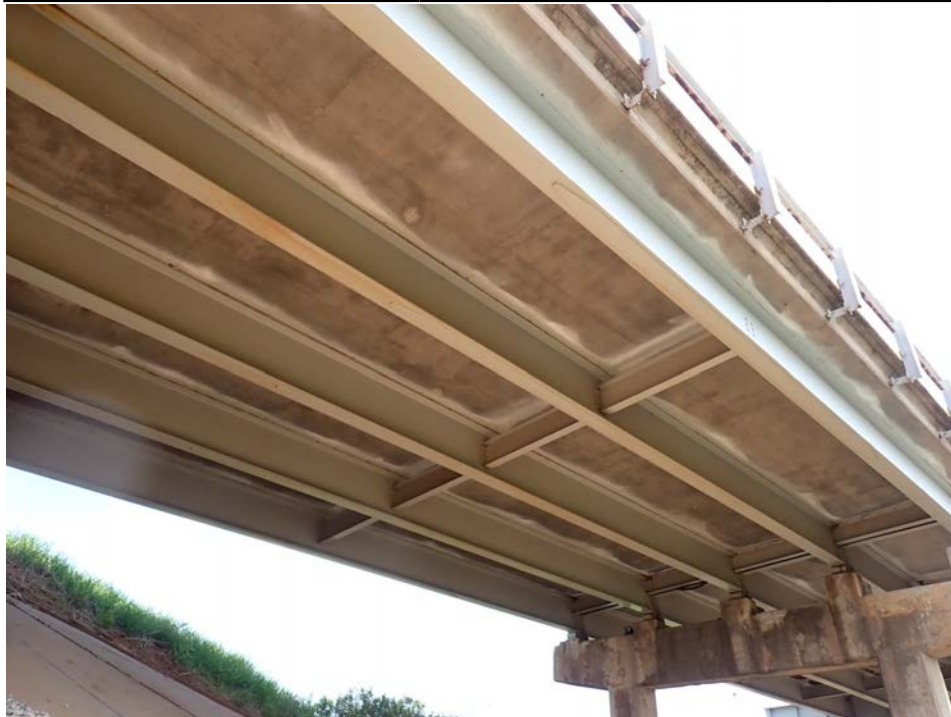
Photograph 28 - Looking northwest at the underside of span 2. Note: partial-length welded cover plates exist on the bottom flange of the beams.

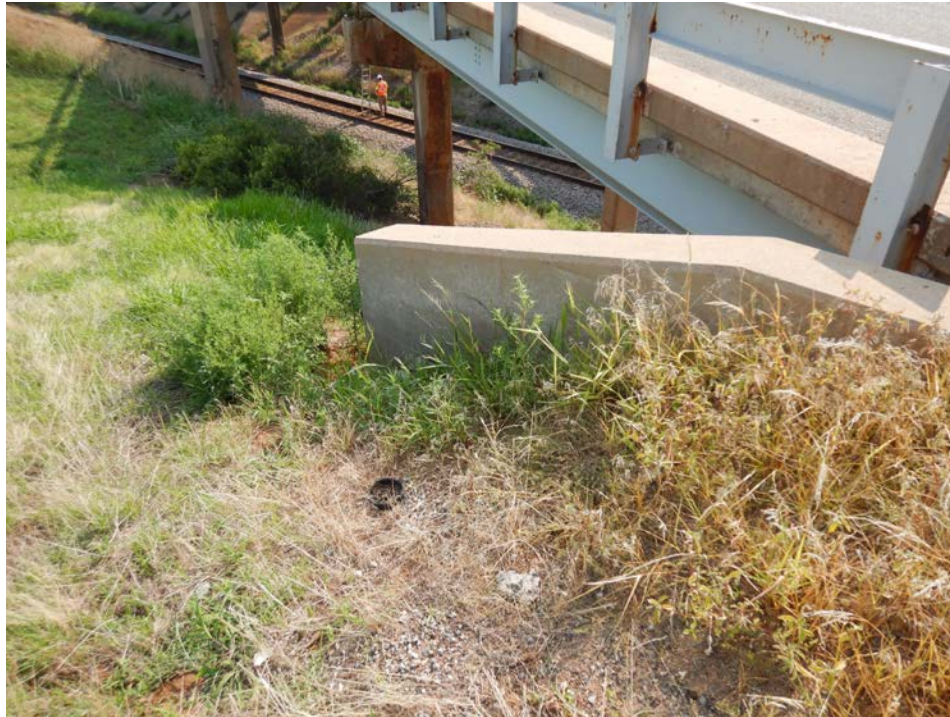
Photograph 29 - Looking northeast at the southwest wingwall. Note: back face of wingwall exposed due to erosion.
