# Fracture Critical Bridge Inspection Report

NBI Bridge No.: 16167

Route U.S. 81 over UP R.R. UNDER  
Kingfisher County

Re: Nonredundant Steel Tension Member Bridge  
Inspection Report  
Structure No.: 3704 0543WX  
NBI No.: 16167  
Local ID: 024A  
US 81 Southbound over Union Pacific Railroad  
Kingfisher County, Field Division 4

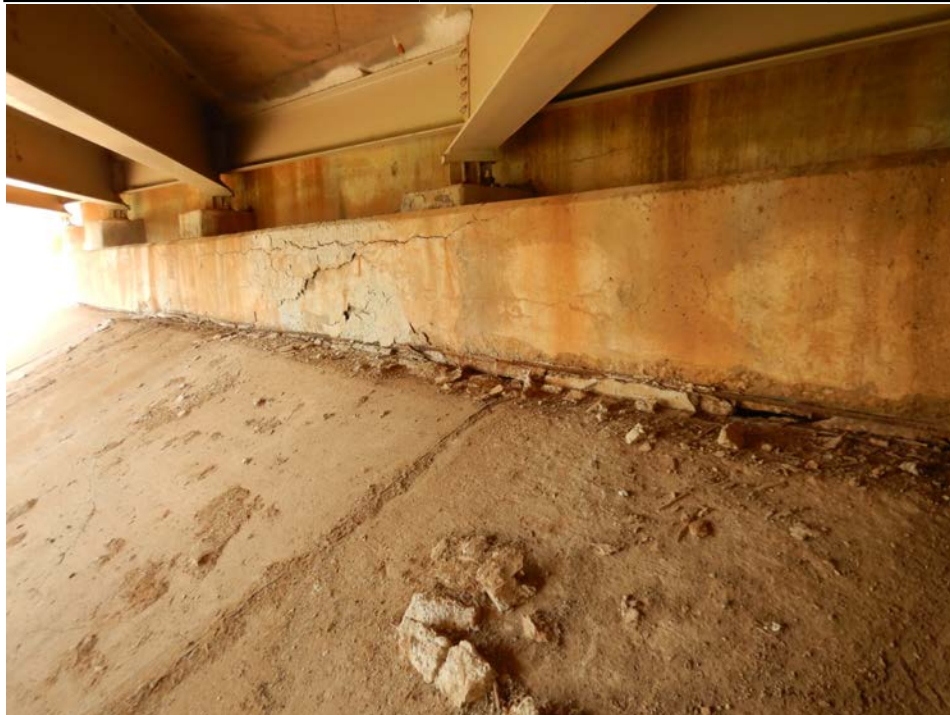
Photograph 30 - Looking south at the south abutment. Note: horizontal cracks in the breastwall with areas of delaminations and spalls forming.

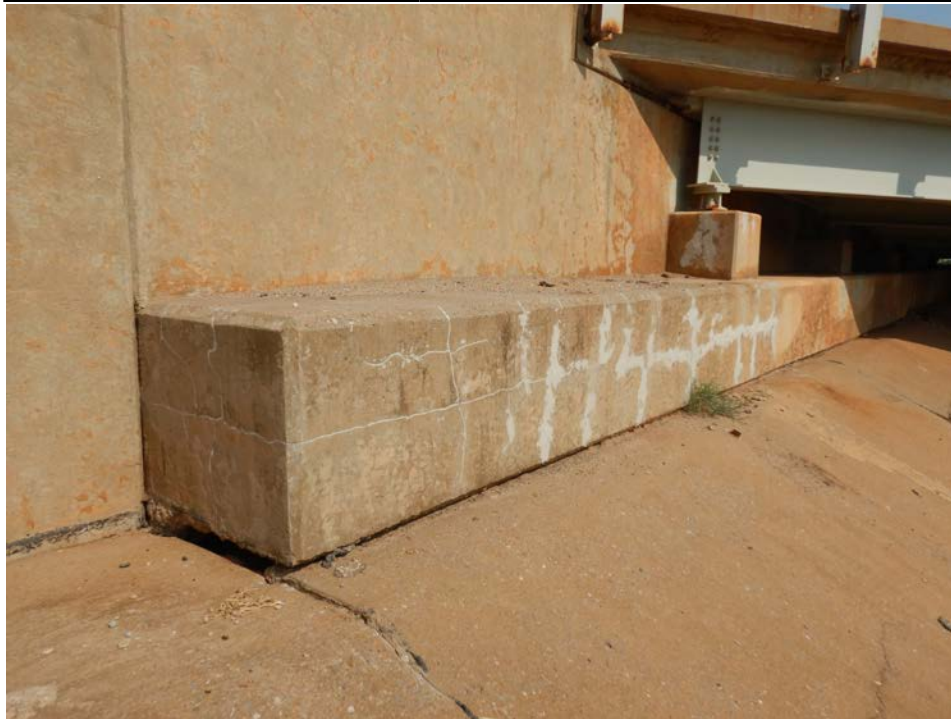
Photograph 31 - Looking southwest at east end of the south abutment. Note: cracks in the breastwall have been seal. Breastwall and slope wall undermined due to settlement of the embankment.

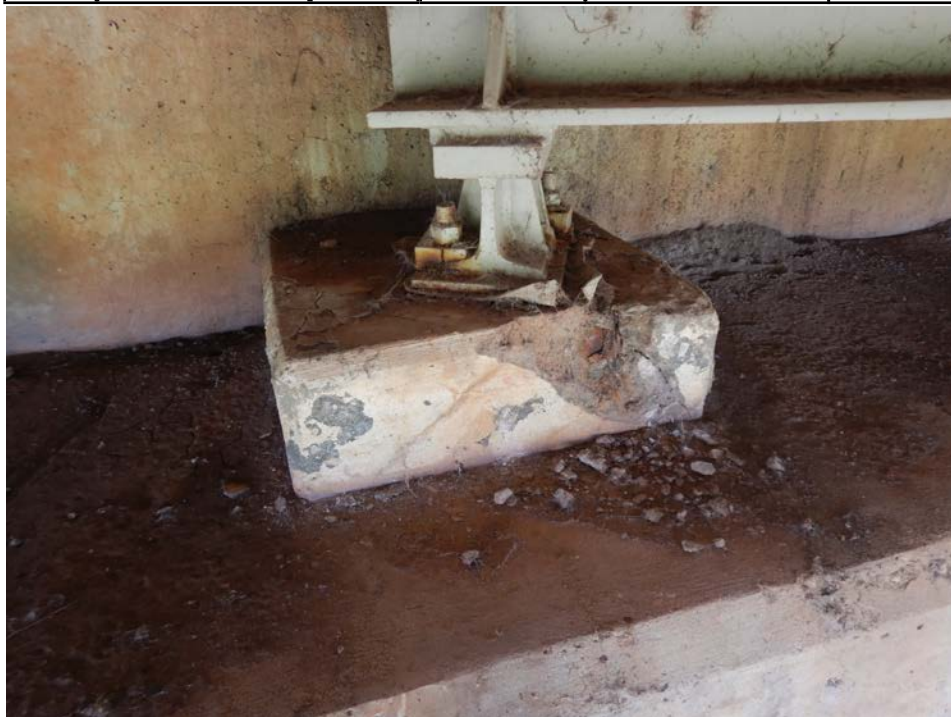
Photograph 32 - Looking east at the beam 2, span 6 bearing pedestal at the north abutment. Note: spall encroaching on the bearing. Lead bearing pad extruded along the south and west edges.

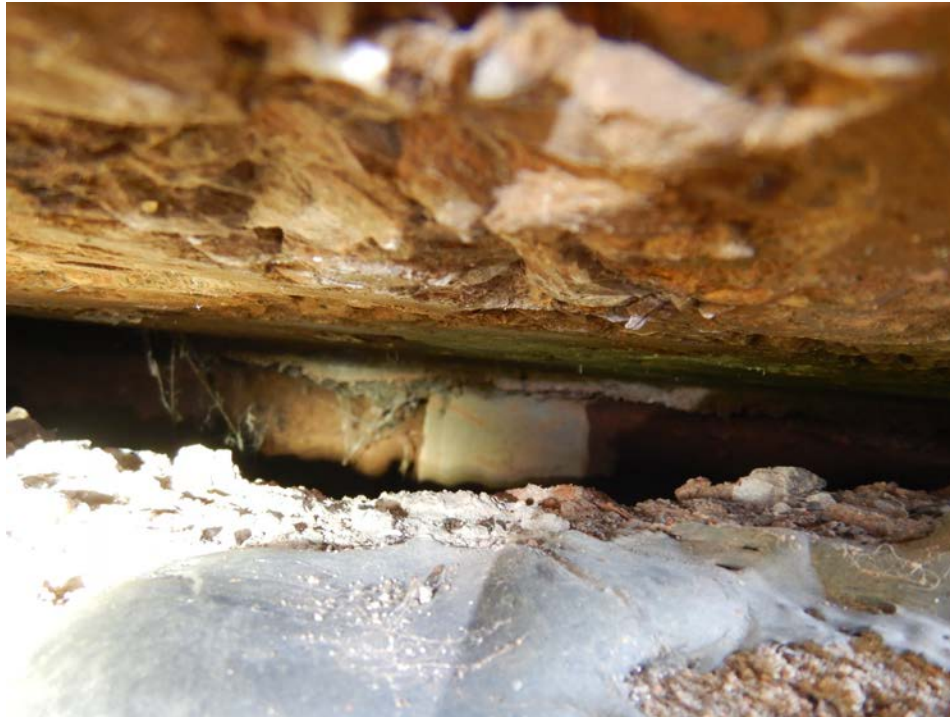
Photograph 33 - Looking south beneath the south abutment breastwall near the west end. Note: settlement of the embankment has exposed one concrete pile.

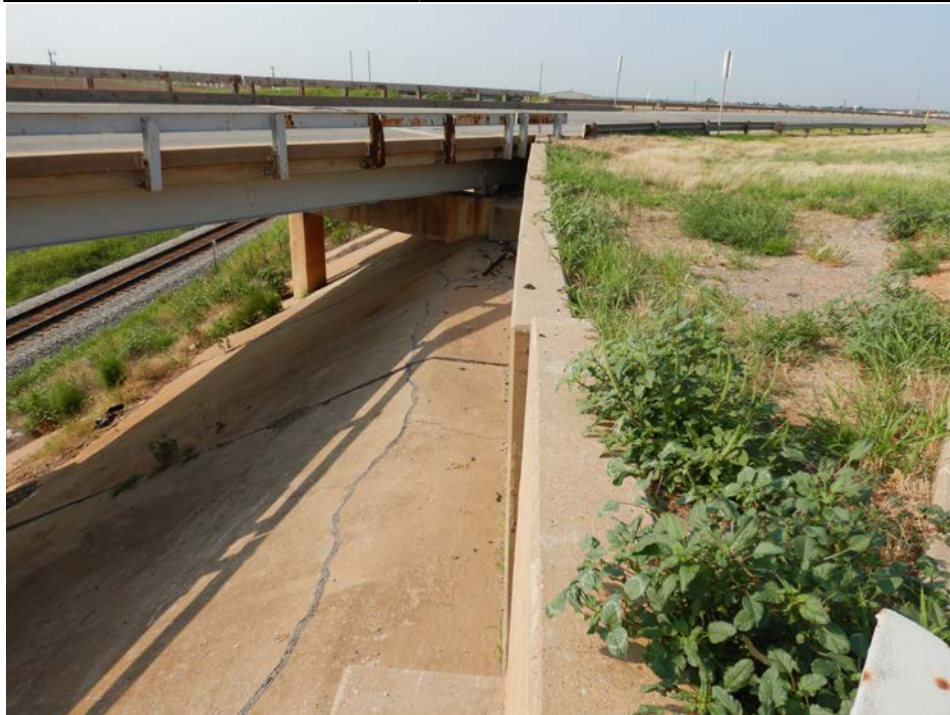
Photograph 34 - Looking southeast along the south retaining wall in the median. Note: wall is leaning 3 1/2 inches away from the embankment relative to the wingwall.

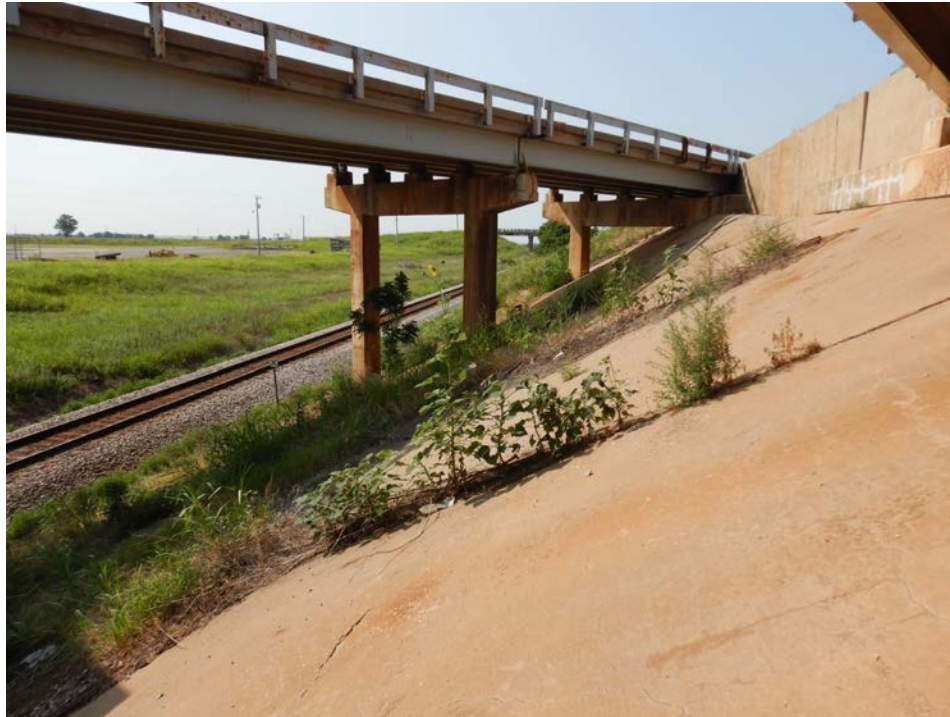
Photograph 35 - Looking southeast at the south slope wall. Note: vegetation growing in joints.

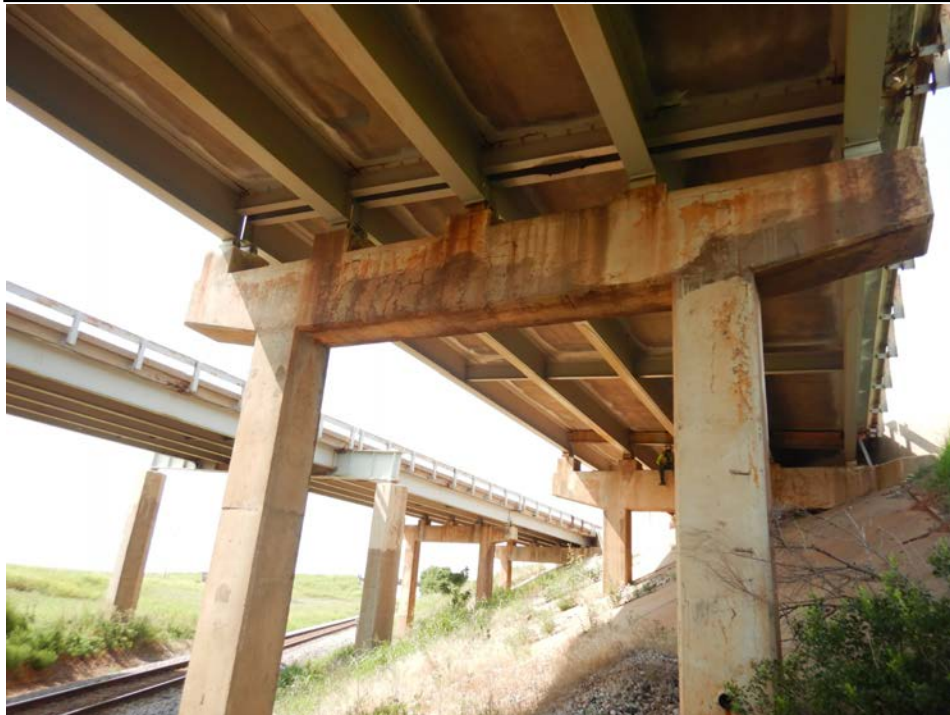
Photograph 36 - Looking south at pier 2. Note: cracking and spalling in column 1 and pier cap.

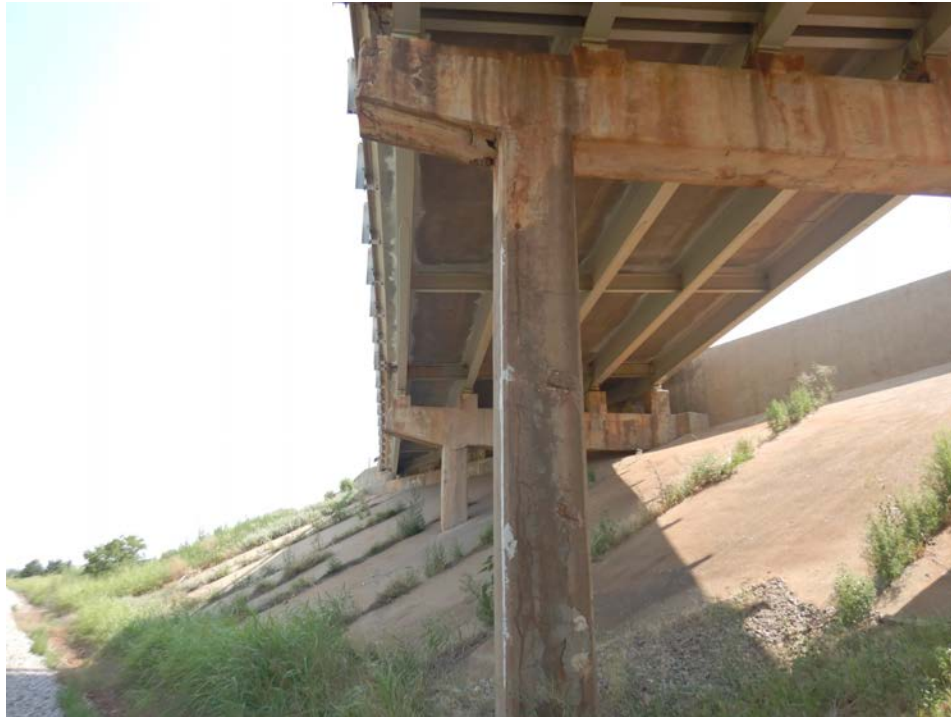
Photograph 37 - Looking north at pier 4, column 1. Note: cracks and spalls with exposed reinforcing steel.

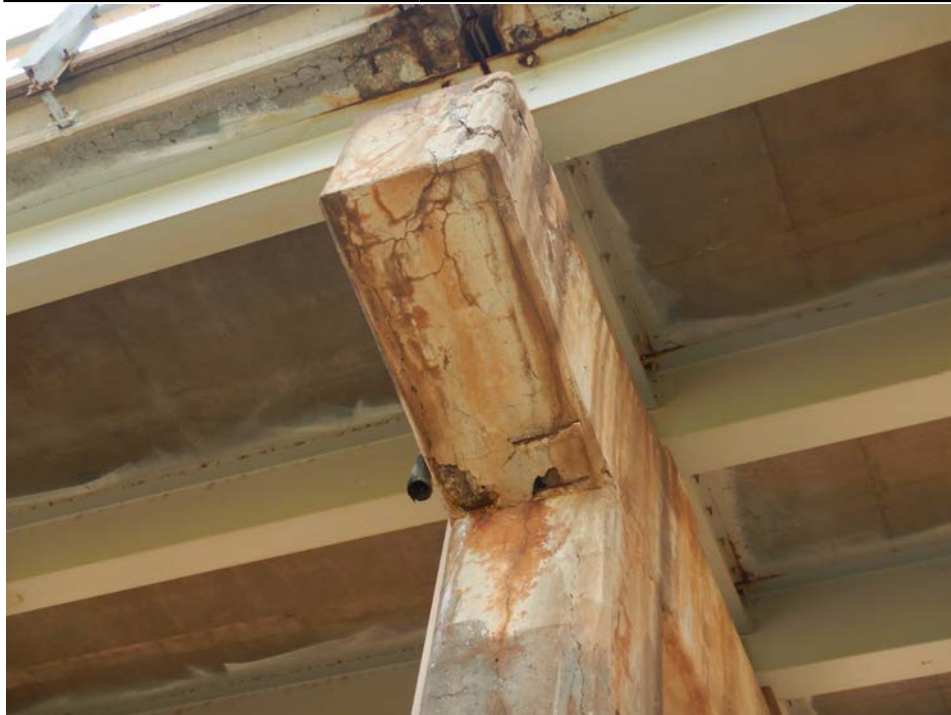
Photograph 38 - Looking up at the west end of the pier 4 cap. Note: cracking and spalling.

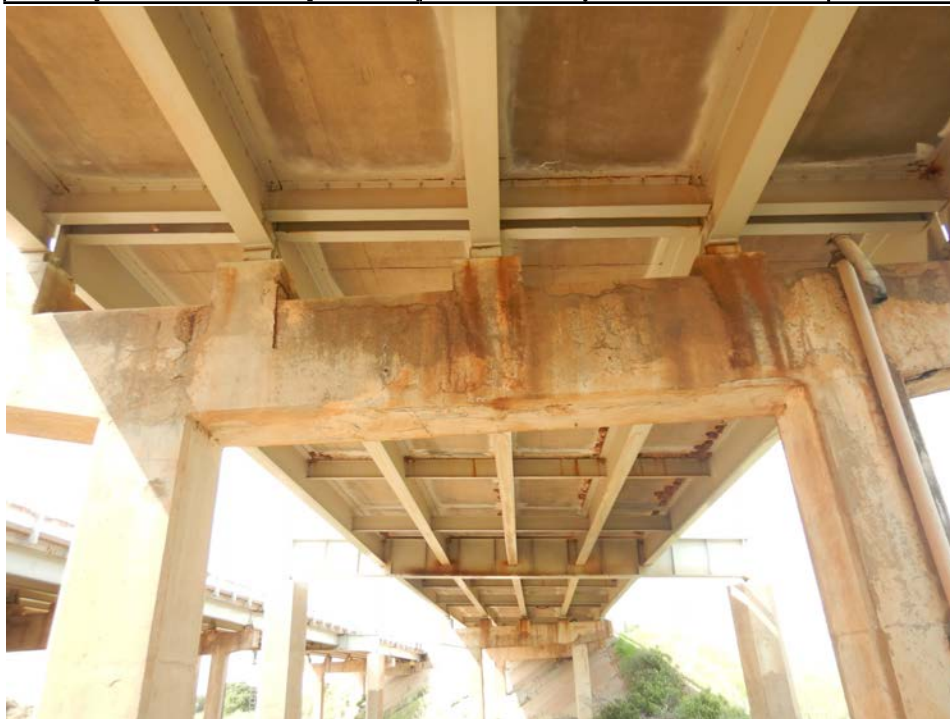
Photograph 39 - Looking south at pier 4. Note: cracking and spalling with exposed reinforcing steel in the beam 2 pedestal.

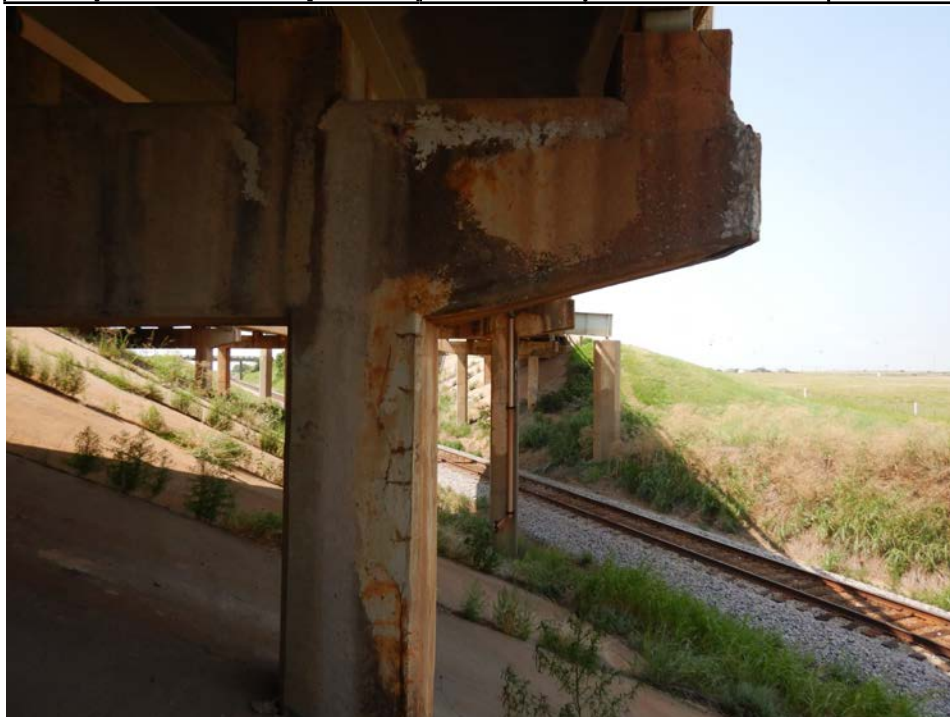
Photograph 40 - Looking south at the west end of the pier 5 cap. Note: vertical cracking up to 1/8 inch wide in column 1 in the west and north faces of the column.

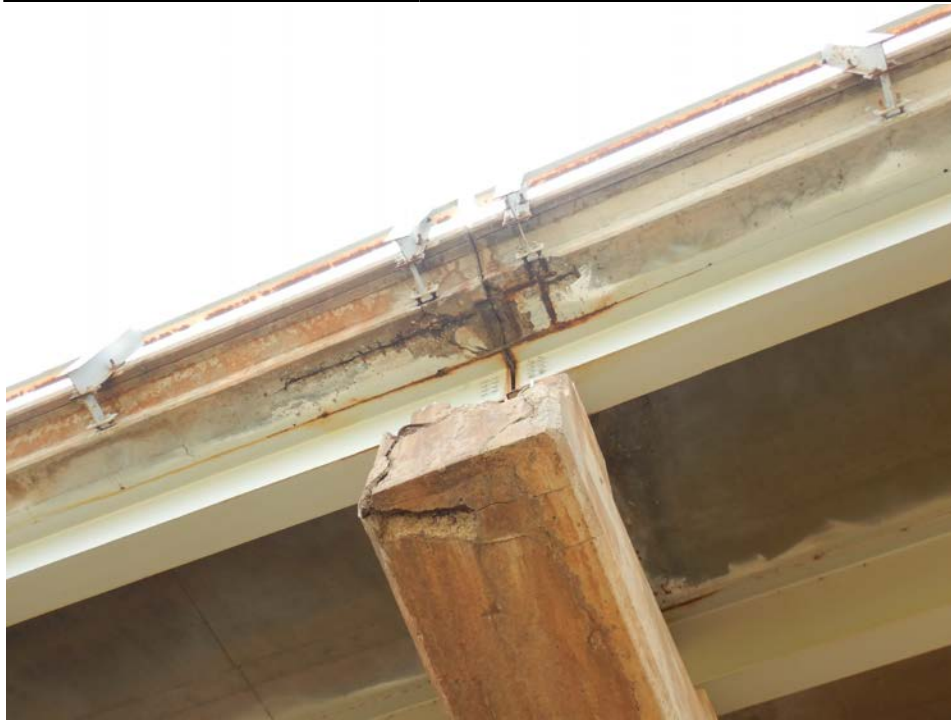
Photograph 41 - Looking up at the west end of the pier 5 cap. Note: spall in the west end of the cap adjacent to the beam 1 bearing.

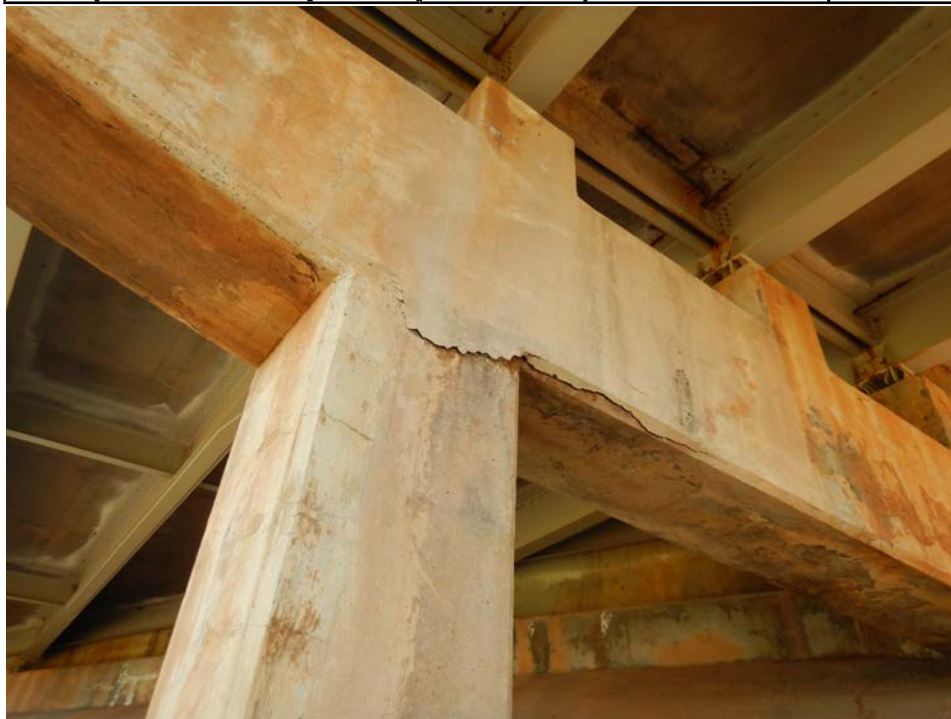
Photograph 42 - Looking northeast at pier 5 . Note: horizontal crack along bottom steel of cap with adjacent 2-foot by 5-foot delamination near column 1.

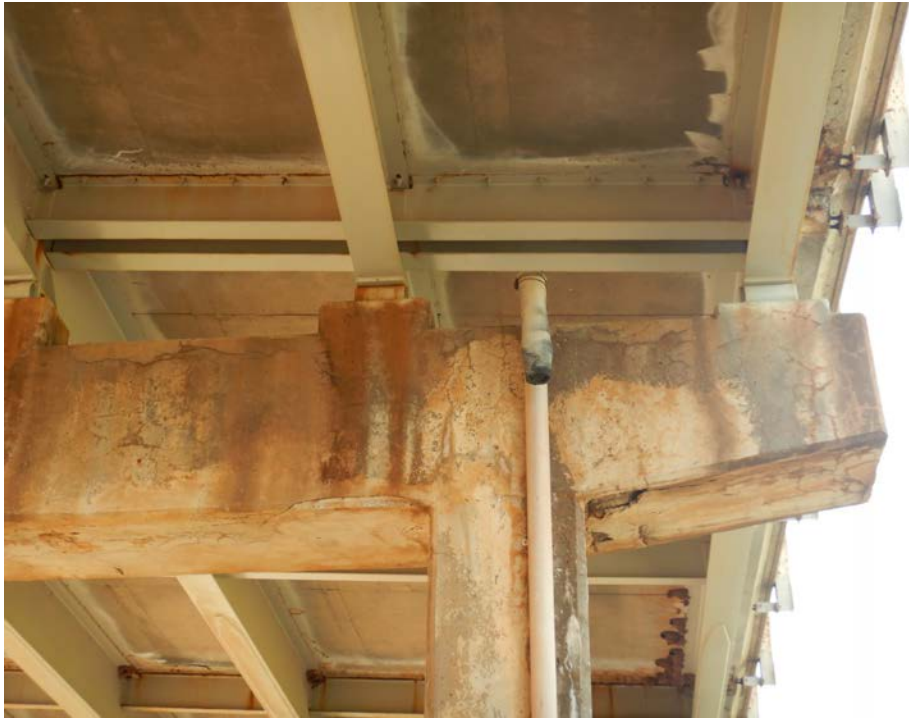
Photograph 43 - Looking south at the west end of the pier 4 cap. Note: cracks with corrosion stains and delaminations exist in the vertical face and underside of the cap.

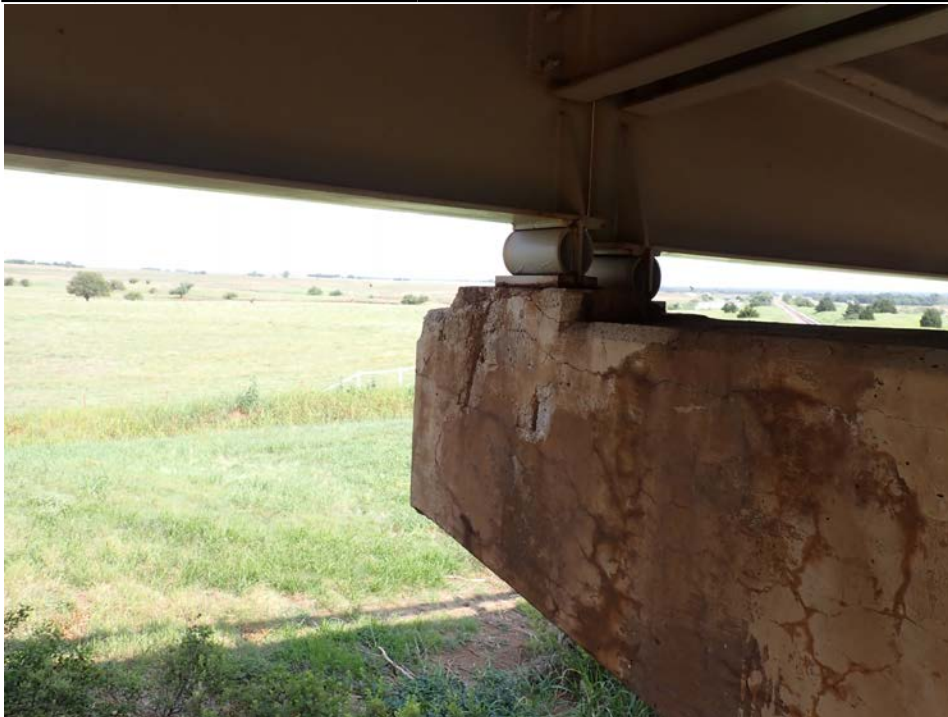
Photograph 44 - Looking northwest at the beam 1 bearing pedestal on pier 2. Note: spall encroaching on the masonry plate with exposed reinforcing steel. Discolored concrete exists in the cap.

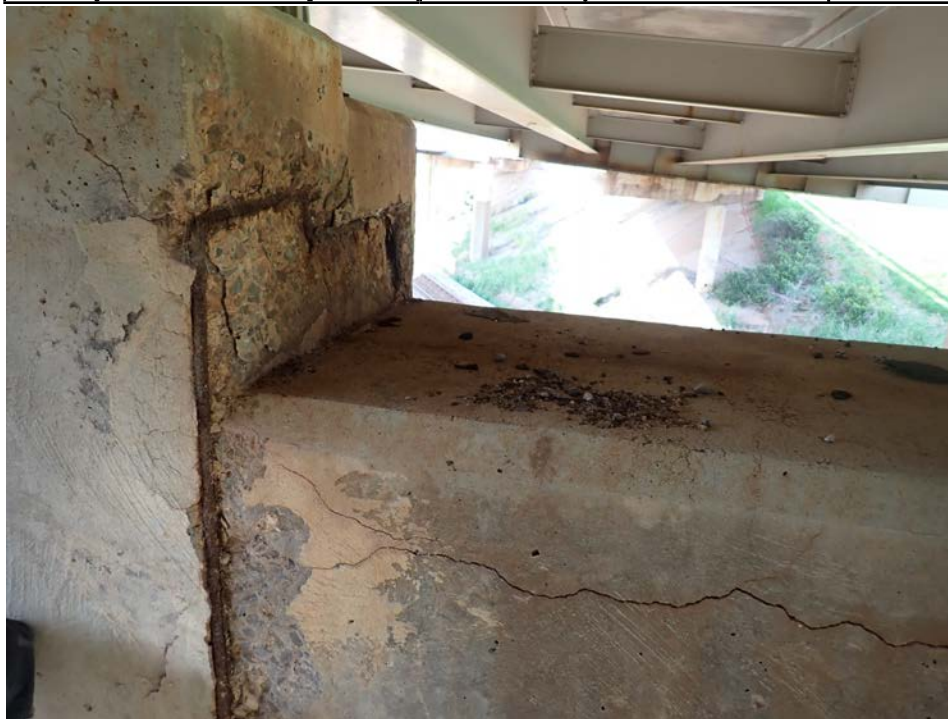
Photograph 45 - Looking south at the west face of the beam 4 bearing pedestal on pier 4. Note: spall with exposed reinforcing steel.

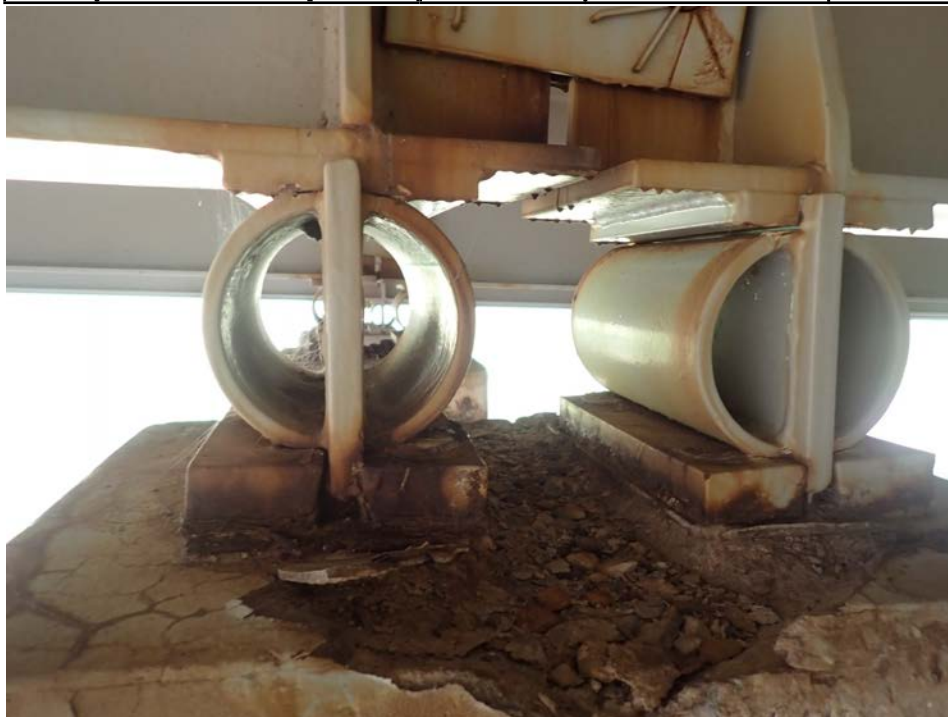
Photograph 46 - Looking west at the beam 4 canister bearings at pier 5. Note: scaling concrete in the bearing seat adjacent to the masonry plates. Beam 4, span 6 bearing is lifted from the canister.

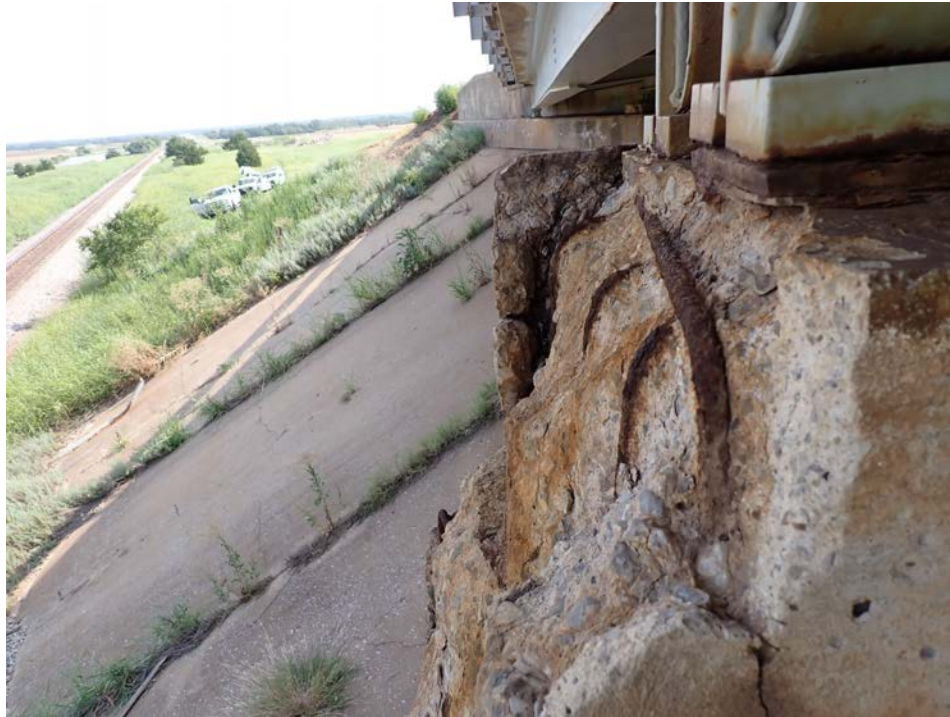
Photograph 47 - Looking north at the west end of pier 5. Note: scaling concrete has undermined the southwest corner of the beam 5, span 5 masonry plate 1 inch.

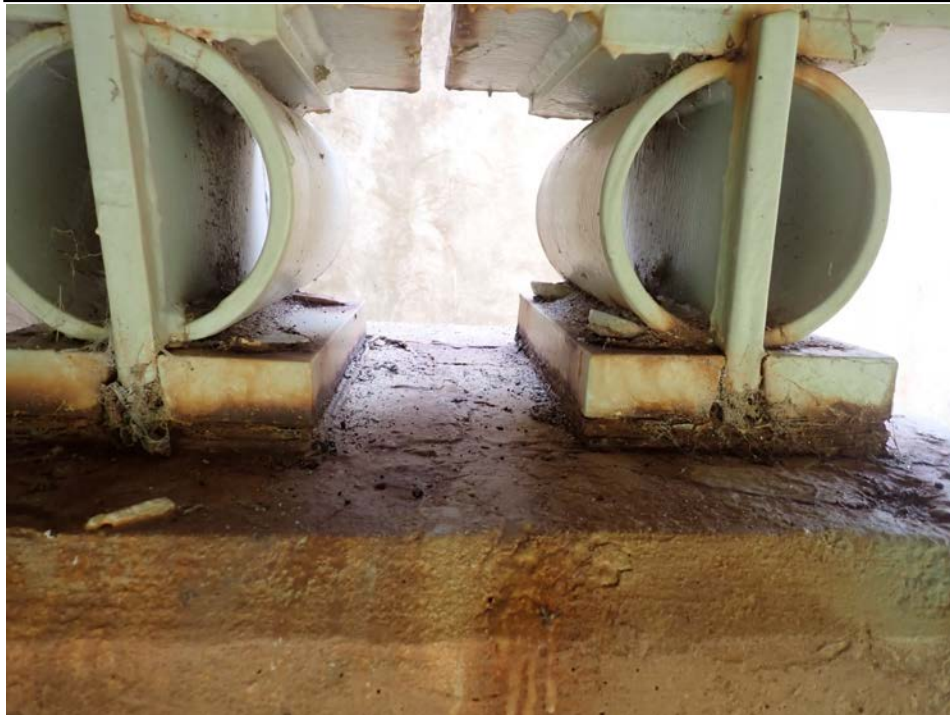
Photograph 48 - Looking east at the beam 5 canister bearing at pier 5. Note: lead plugs are extruded and inhibit expansion of the canisters. Pack rust exists between the masonry plate and the bearing seat.

- Remove lead plugs and portion of anchor studs extending above the masonry plate of the canister bearings to allow expansion of the bearings.
- Seal the cracks in the approach roadway.

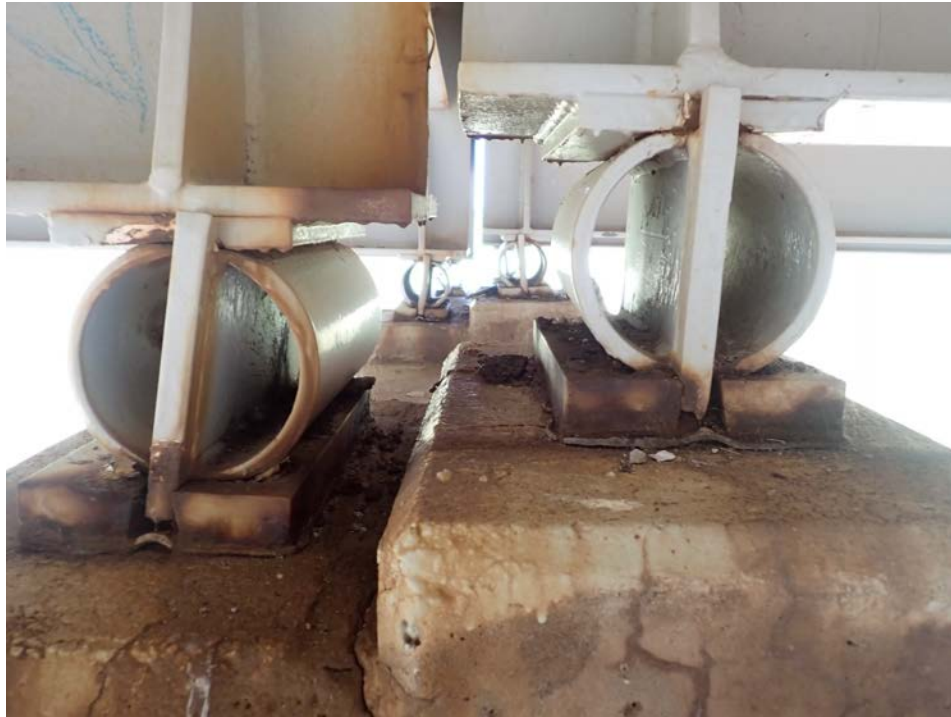
Photograph 49 - Looking west at the beam 3, canister bearings at pier 4. Note: the span 4 bearing is offset from the bearing stiffener and rotated in expansion. The span 5 bearing is aligned with the vertical stiffener and rotated in contraction. Canister thickness is worn at the point of contact with the

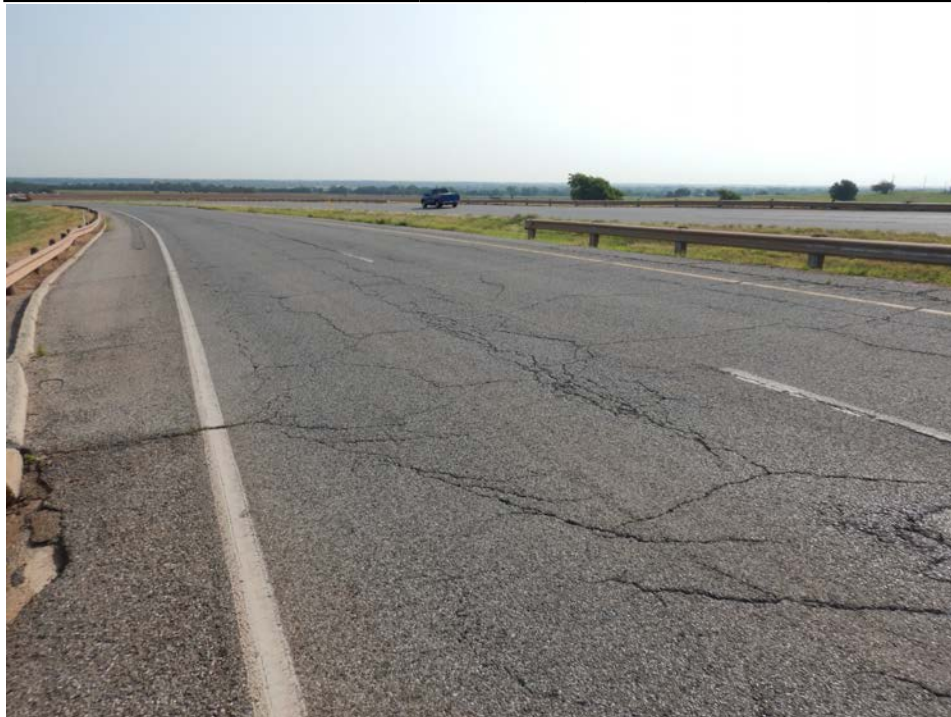
Photograph 50 - Looking northeast at north approach asphalt roadway. Note: longitudinal cracking in the wheel paths.

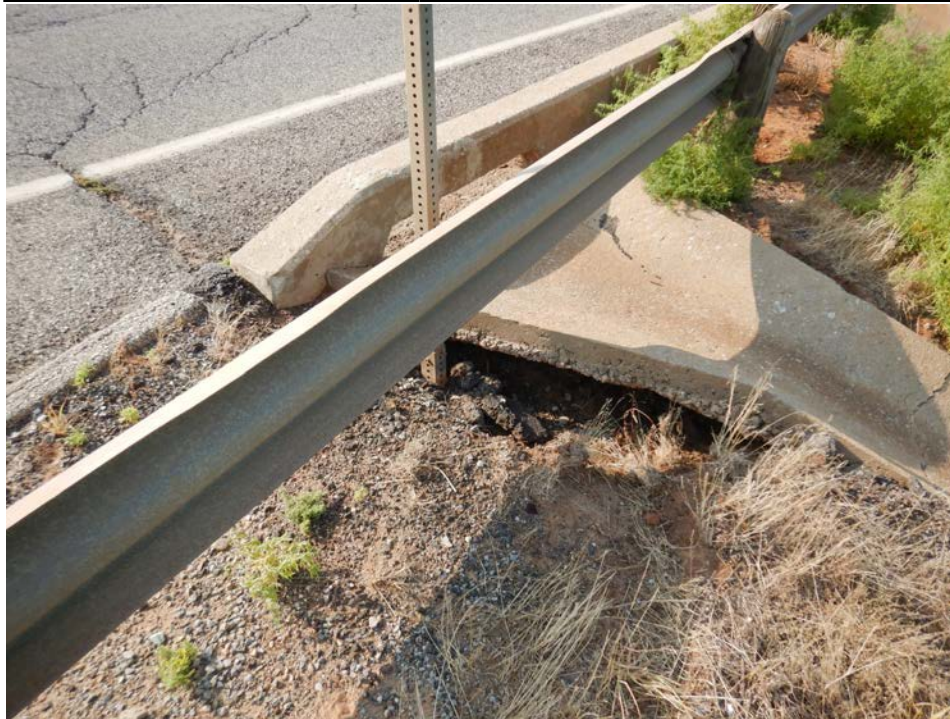
Photograph 51 - Looking south at the northwest corner of the north approach slab. Note: paved drainage flume undermined with approximately 1 foot of penetration.
