Oklahoma Dept. of Transportation - Bridge Inspection Report

NBI No.: 16167	Structure No.: 3704 0543WX	Local ID: 024A	Suff. Rating: 68.40	ND																														
Bridge Description: 32ft.,49ft.,2-57ft.,49ft.,39ft. I-BM. SPANS WITH 2-1.5ft. SAFETY CURBS SKEW VARIES		INSPECTION																																
		<table border="1" style="width:100%; border-collapse: collapse;"><thead><tr><th>Type</th><th>Insp. Req.</th><th>Insp. Done</th><th>Freq.</th><th>Insp. Date</th><th>Next Insp.</th></tr></thead><tbody><tr><td>NBI:</td><td></td><td>1</td><td>24 months</td><td>7/24/2024</td><td>07/24/2026</td></tr><tr><td>FC:</td><td>Y</td><td>1</td><td>24 months</td><td>7/24/2024</td><td>7/24/2026</td></tr><tr><td>UW:</td><td>N</td><td>0</td><td></td><td>NA</td><td>NA</td></tr><tr><td>OS:</td><td>N</td><td>0</td><td></td><td>NA</td><td>NA</td></tr></tbody></table>			Type	Insp. Req.	Insp. Done	Freq.	Insp. Date	Next Insp.	NBI:		1	24 months	7/24/2024	07/24/2026	FC:	Y	1	24 months	7/24/2024	7/24/2026	UW:	N	0		NA	NA	OS:	N	0		NA	NA

Inspection Date: 7/24/24

The bridge is a 6-span structure numbered from south-to-north:

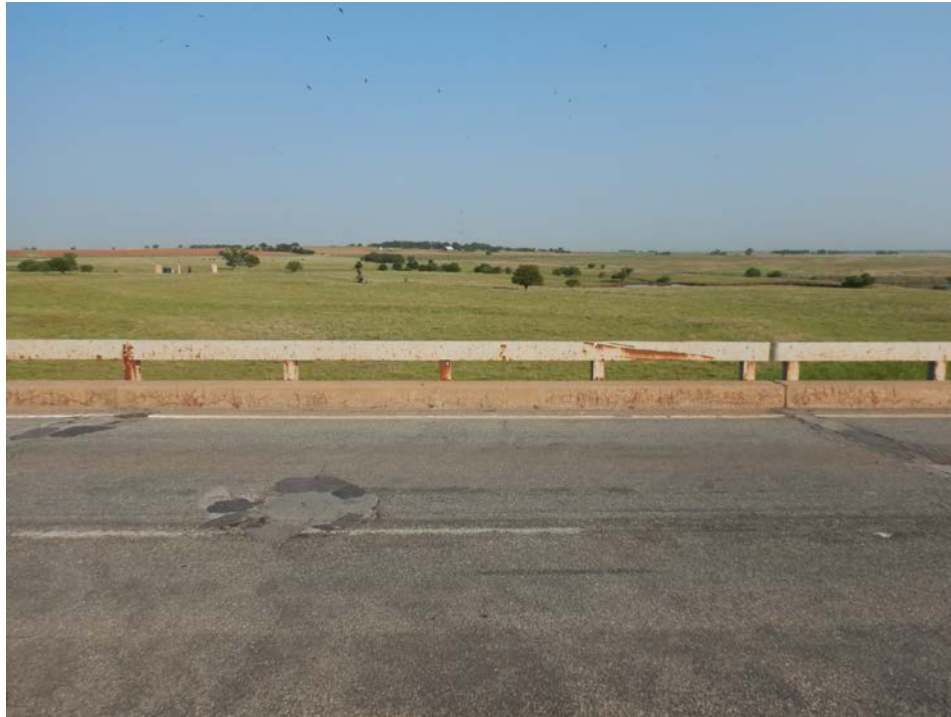
Photograph 3 - Looking west at the west bridge railing in span 4. Note: the railing is obsolete. Cracks with corrosion stains exists in the face of the curb and impact damage exists to the rail.

- Upgrade bridge and approach rail, transitions, and terminations to meet current standards.
- Repair damaged areas and abrasively clean and paint steel bridge rail. (disregard if bridge railing is upgraded)

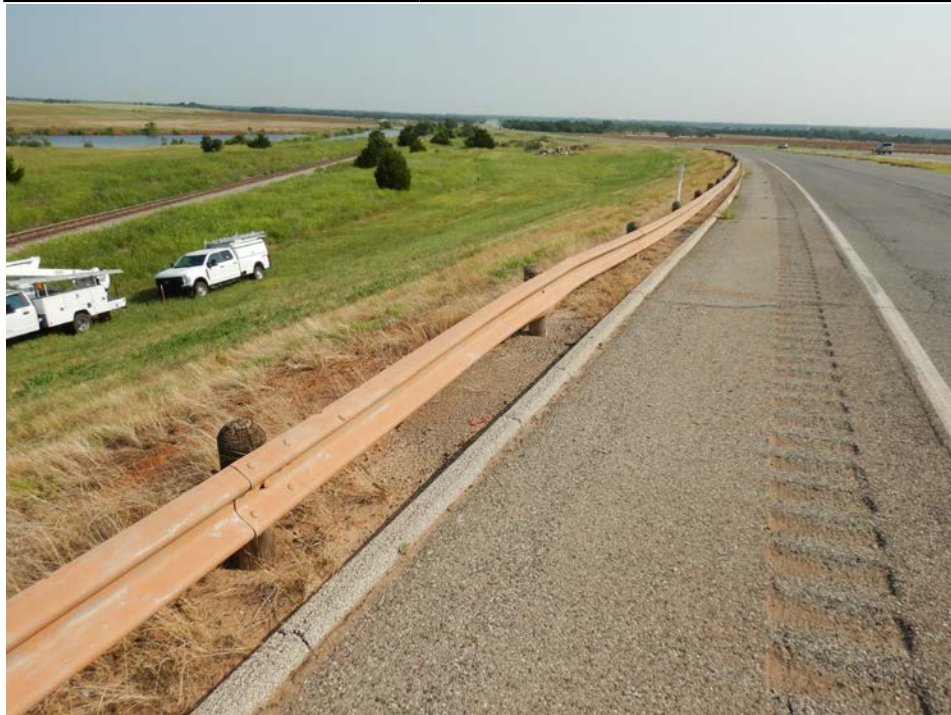
Photograph 4 - Looking north along the northwest approach railing. Note: approach railing is low and blockouts were not used.

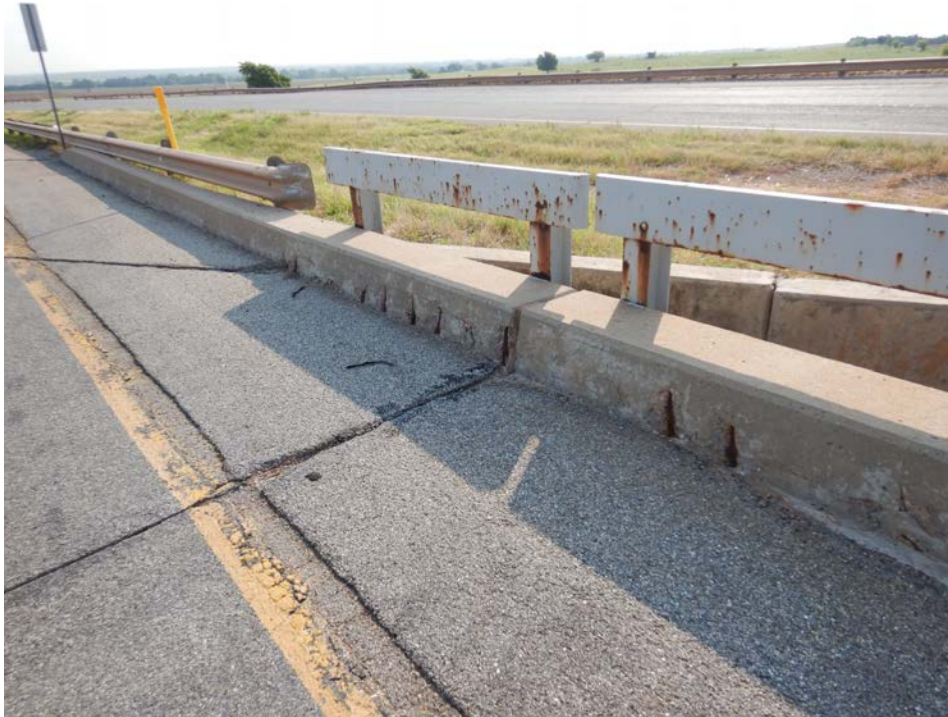
Photograph 5 - Looking northeast at the northeast approach railing and east bridge railing in spans 5 and 6. Note: approach railing transition is insufficient with flared end approach rail termination at the bridge. Curb is spalled with exposed reinforcing steel due to insufficient cover.

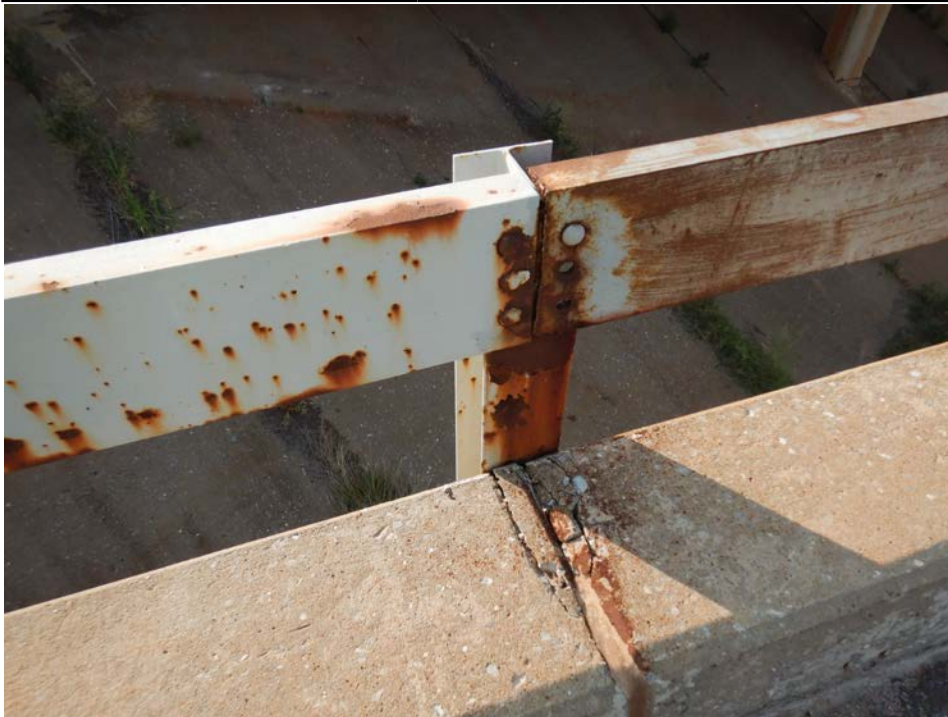
Photograph 6 - Looking east at the east bridge railing at the 5th post in span 3. Note: typical surface corrosion to the rail and post, and missing connection bolts

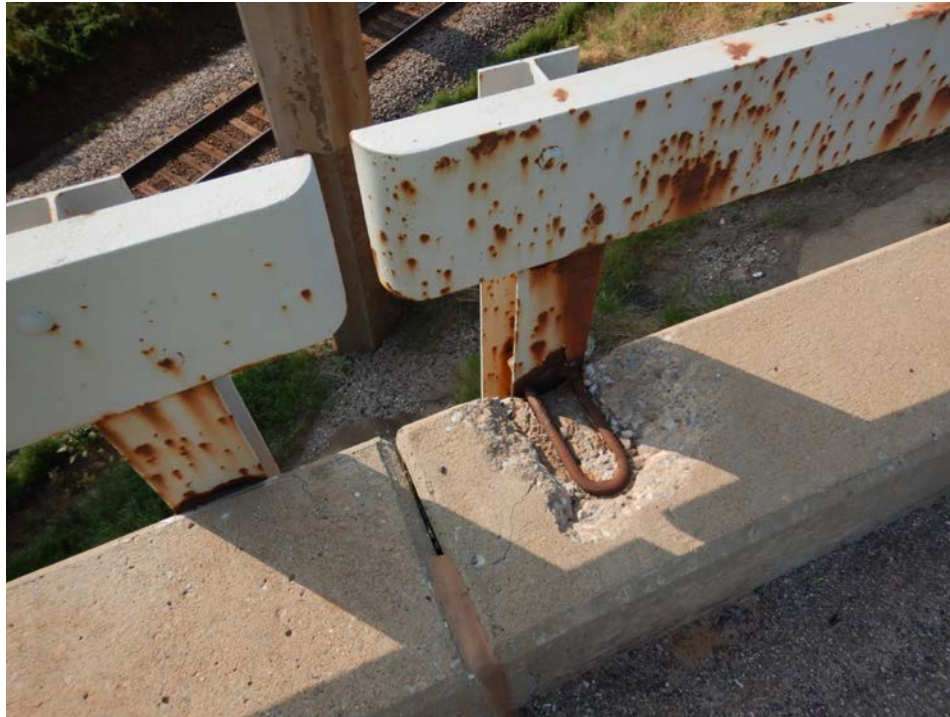
Photograph 7 - Looking east at the east curb in span 1 at pier 1. Note: spall in the top face of the curb exposing the U-bolt anchorage for the bridge railing post.

- Patch spalls in curb and soffit where bridge railing posts are exposed .
- Patch wearing surface on bridge as necessary to provide a smooth riding surface.

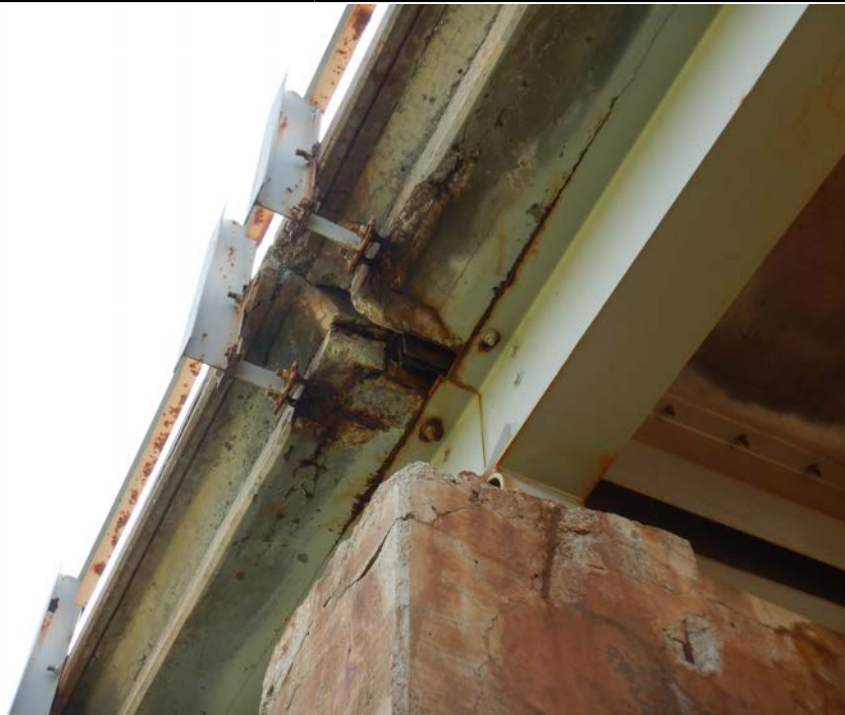
Photograph 8 - Looking northeast at the west overhang at pier 2. Note: spall in soffit exposing the U-bolt anchorage for the bridge railing post.

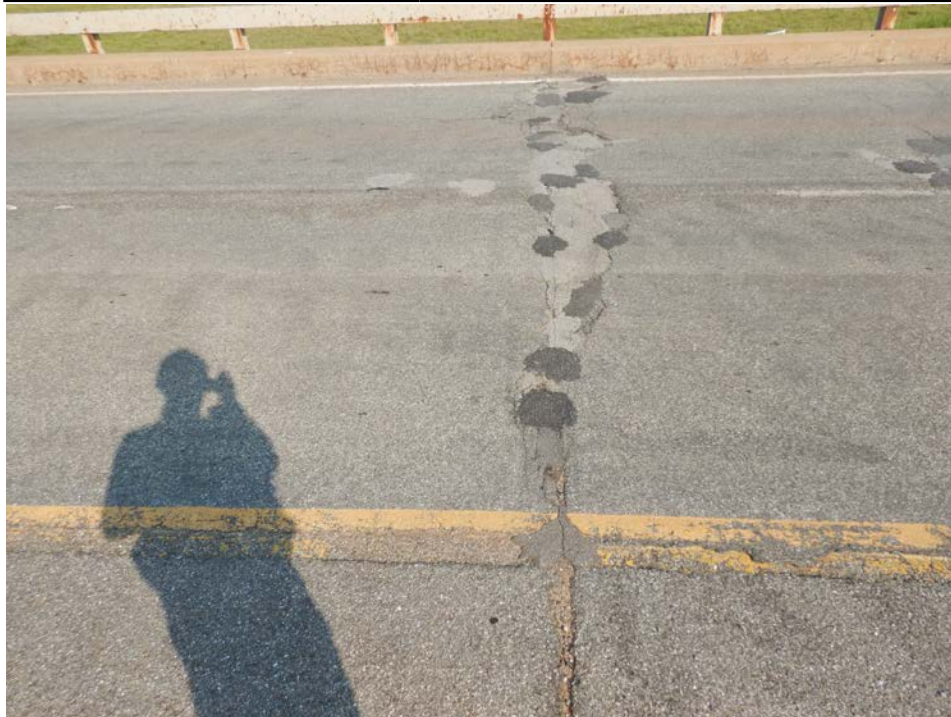
Photograph 10 - Looking west along the north deck control joint in span 3. Note: asphalt patches along the control joint.

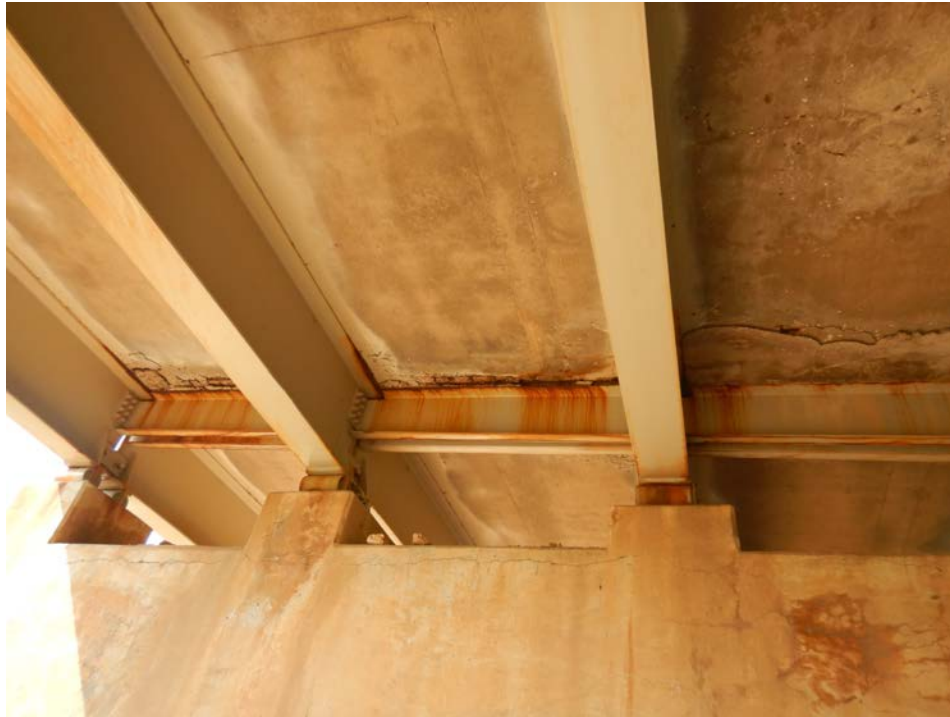
Photograph 11 - Looking south at the underside of span 2 at pier 1 between beams 1 and 4. Note: spalling with exposed reinforcing steel along the end diaphragm. Full-depth patch exists between beams 3 and 4.

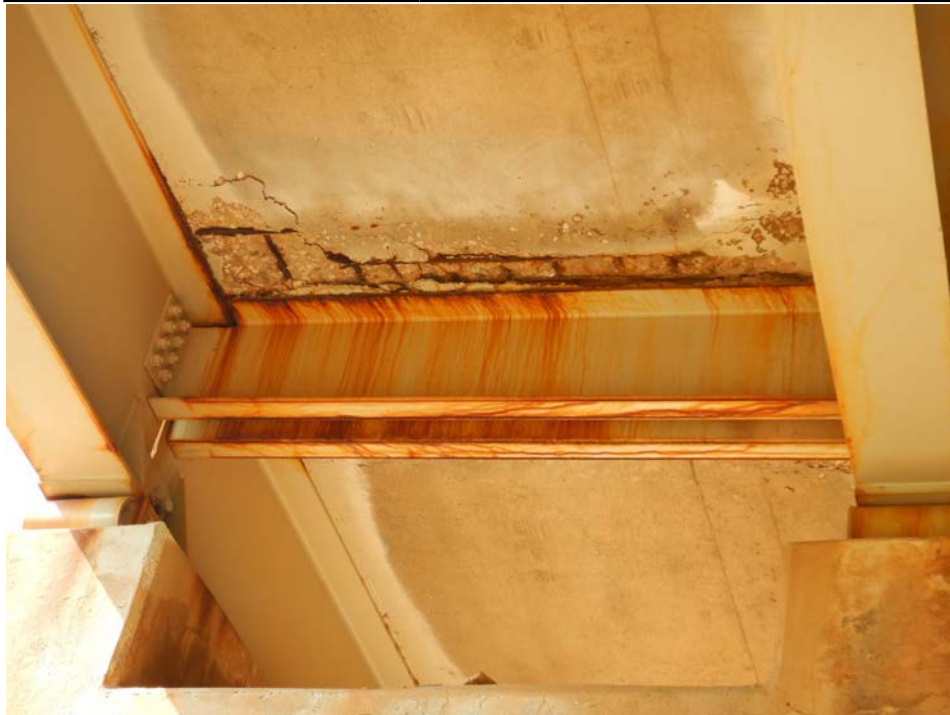
Photograph 12 - Looking south at the underside of span 2 at pier 1 between beams 1 and 2. Note: spall extending above the bottom reinforcing steel.

- Repair spill in soffit between beams 1 and 2 above pier 1 with a full depth patch.
- Reseal fixed and expansion joints.
- Place crushed aggregate slope protection in eroded areas around SW wingwall.

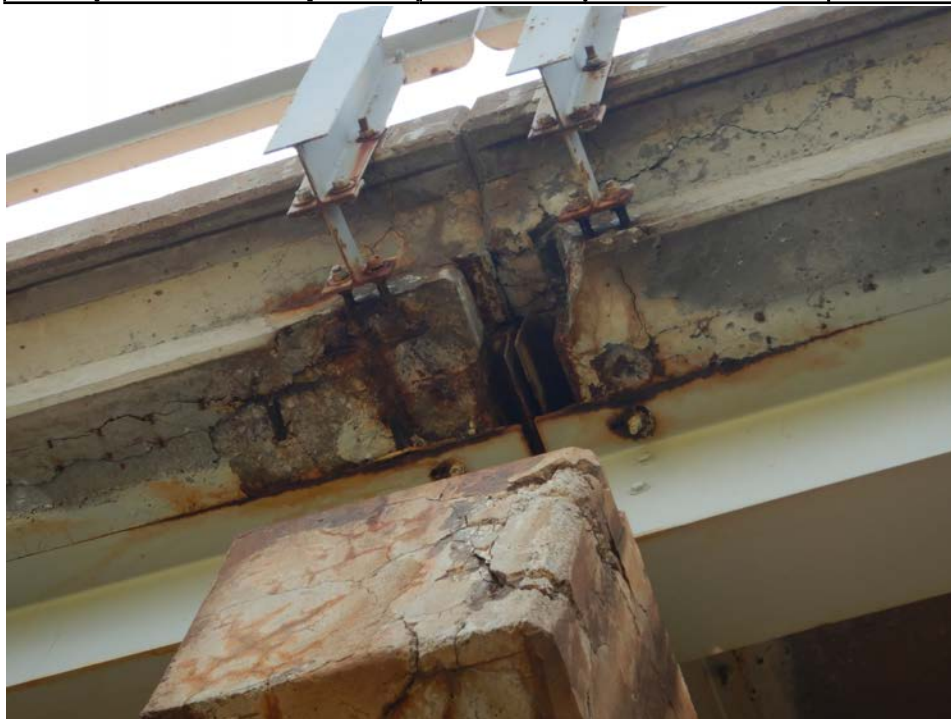
Photograph 14 - Looking east at Underside of deck overhang at Pier 4. Note: spalling and cracking at u bolts for bridge railing.

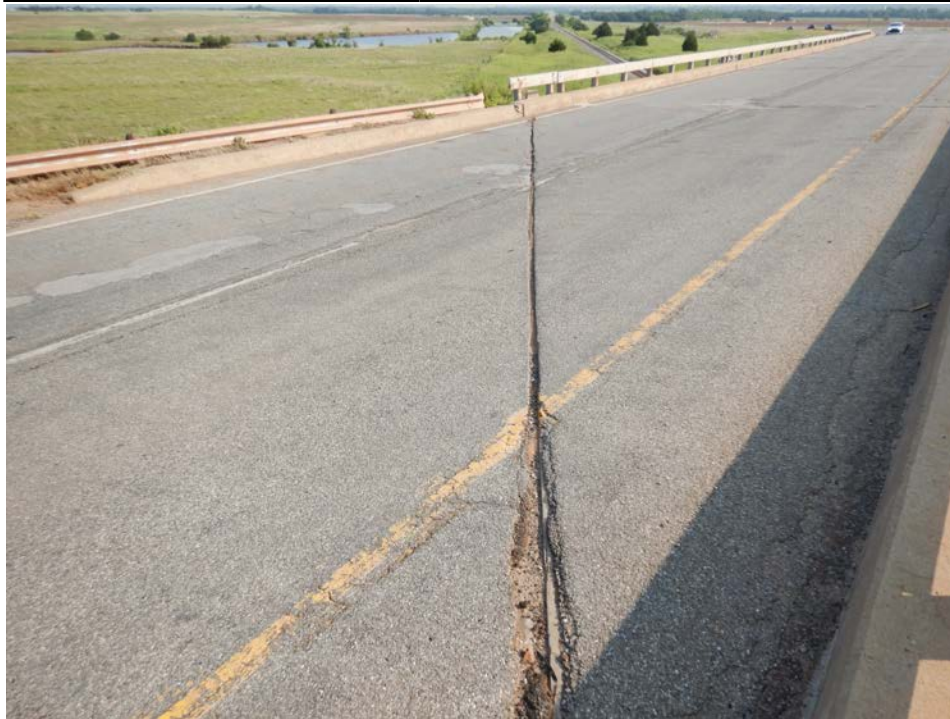
Photograph 17 - Looking northwest along the poured seal fixed joint over the south abutment. Note: minor spalling and patching of the asphalt exists along the joint.

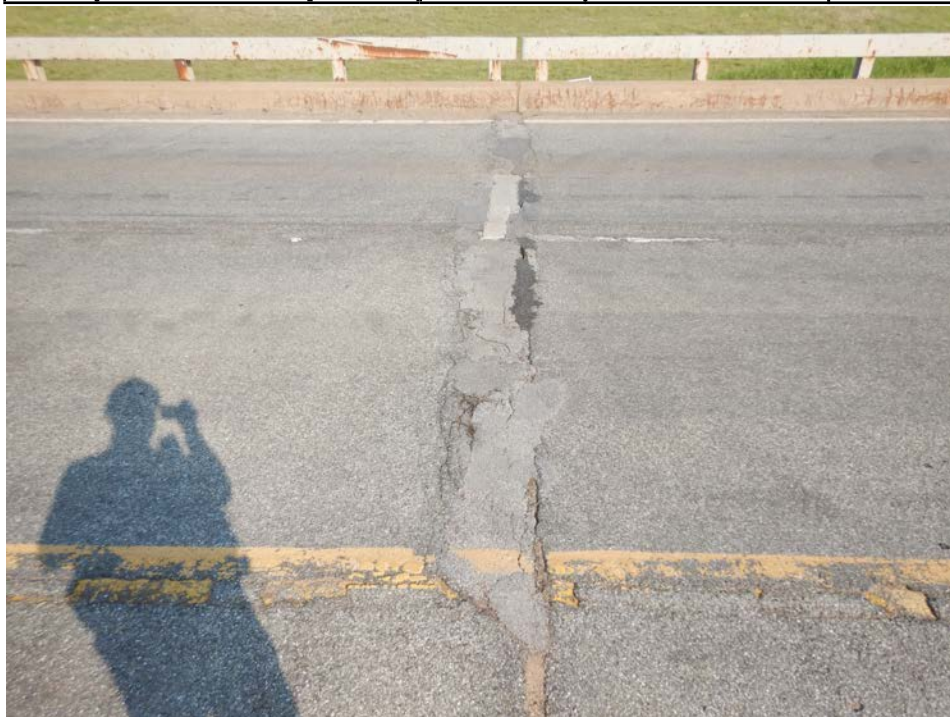
Photograph 18 - Looking west along the poured seal fixed joint over pier 3. Note: asphalt and concrete patches exist along the joint.

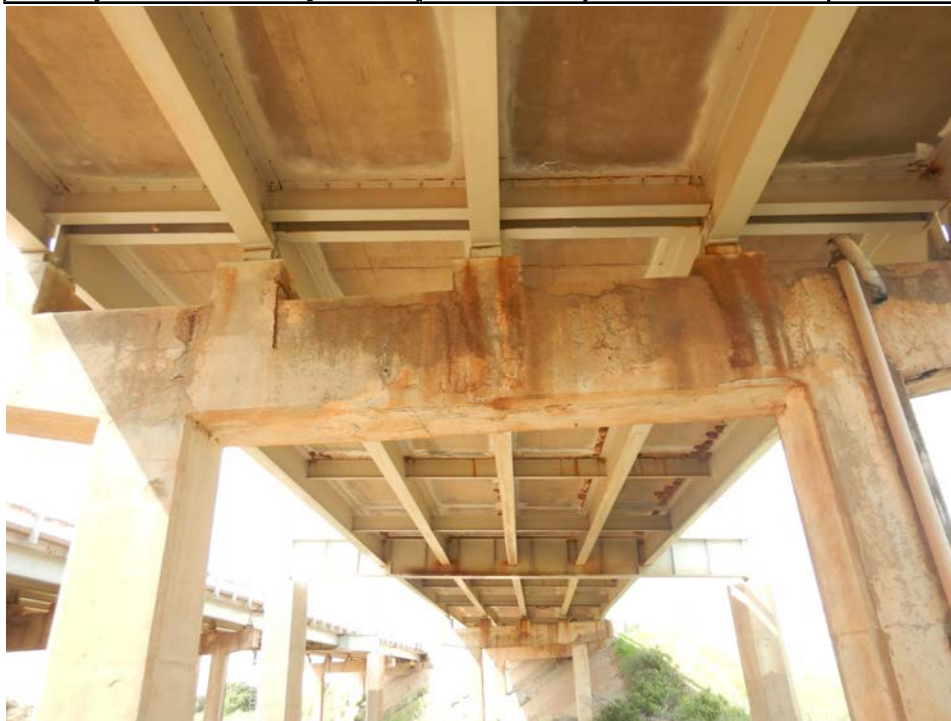
Photograph 39 - Looking south at pier 4. Note: cracking and spalling with exposed reinforcing steel in the beam 2 pedestal.

- Remove deteriorated concrete in abutments and piers, patch, and install RFP over patches at pier caps and columns .
- Install CIM 1000 on bearing seats at abutments and piers.

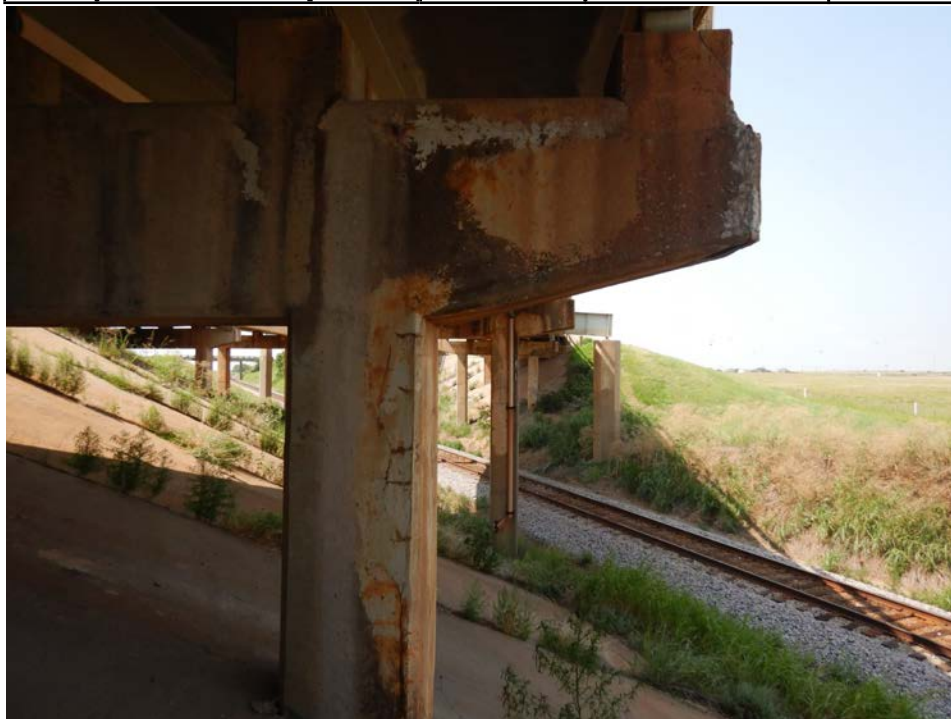
Photograph 40 - Looking south at the west end of the pier 5 cap. Note: vertical cracking up to 1/8 inch wide in column 1 in the west and north faces of the column.

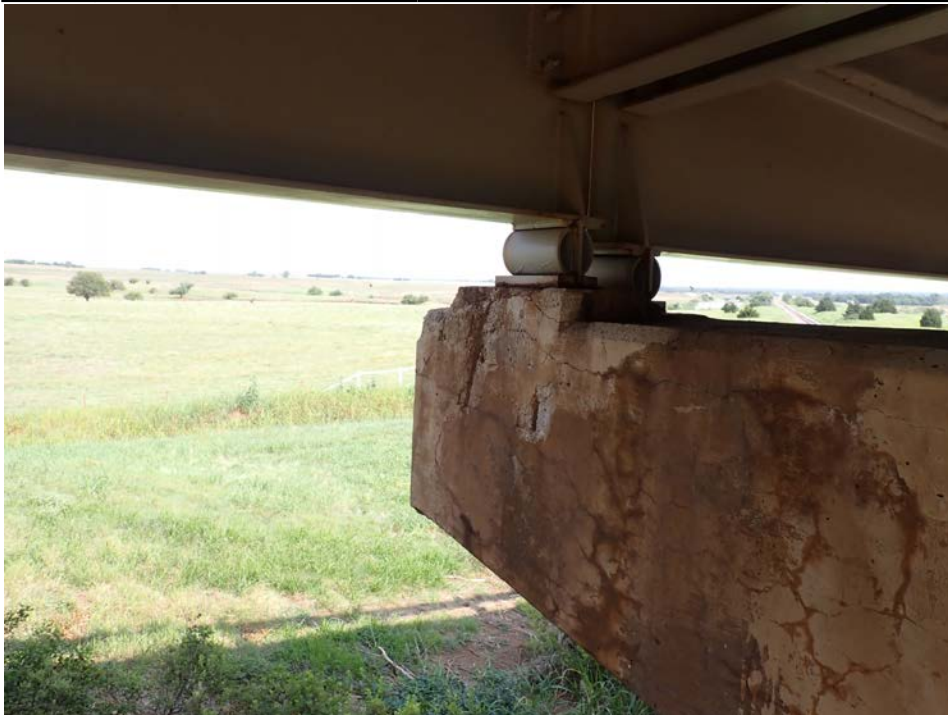
Photograph 44 - Looking northwest at the beam 1 bearing pedestal on pier 2. Note: spall encroaching on the masonry plate with exposed reinforcing steel. Discolored concrete exists in the cap.

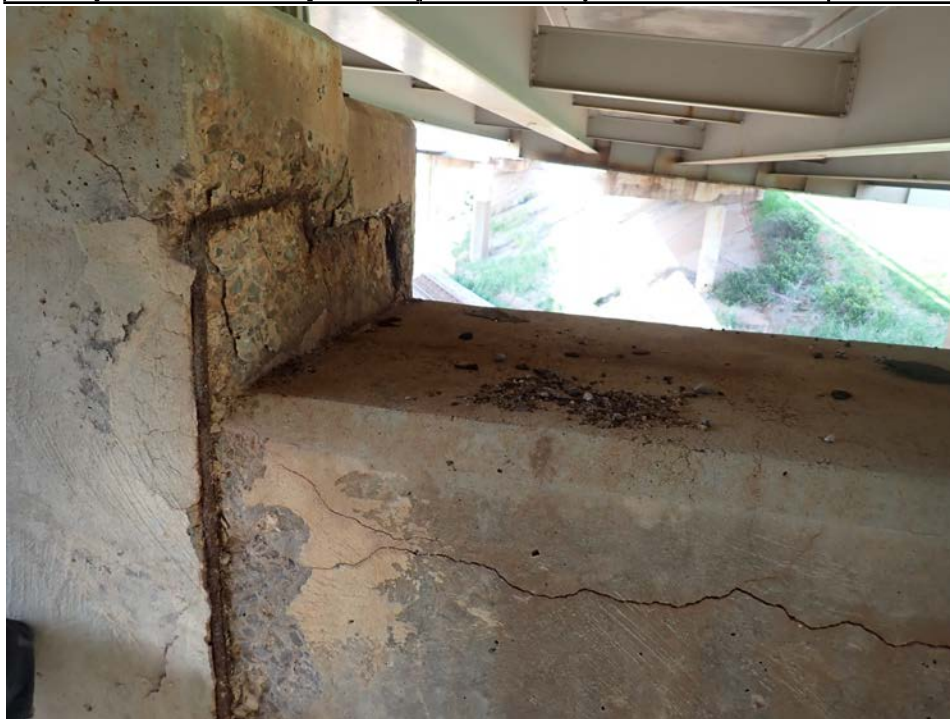
Photograph 45 - Looking south at the west face of the beam 4 bearing pedestal on pier 4. Note: spall with exposed reinforcing steel.

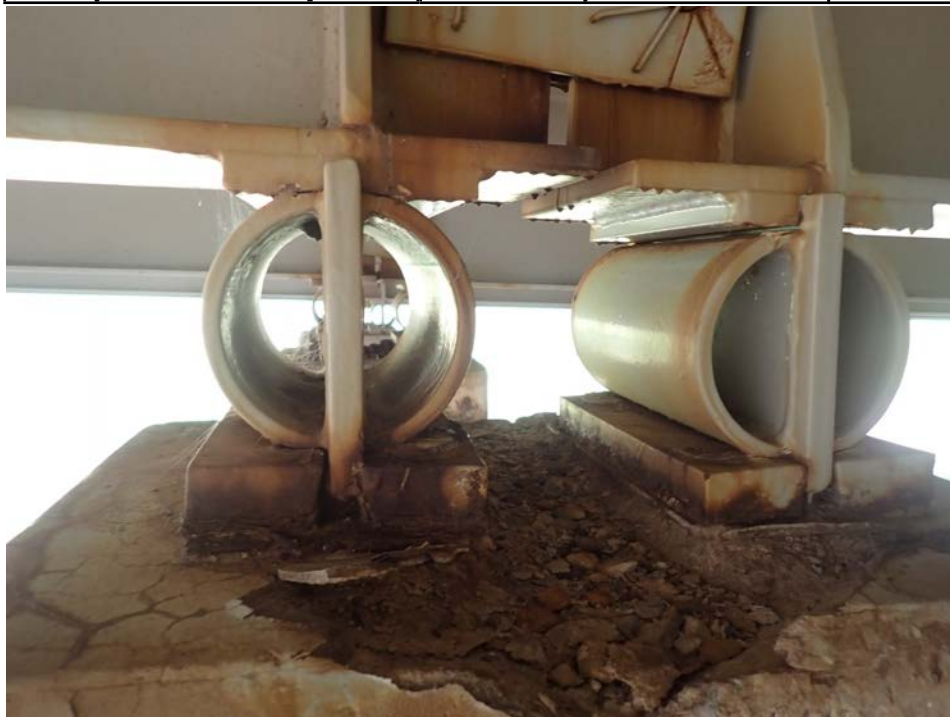
Photograph 46 - Looking west at the beam 4 canister bearings at pier 5. Note: scaling concrete in the bearing seat adjacent to the masonry plates. Beam 4, span 6 bearing is lifted from the canister.

- Install shim plates where beams are lifted from canister bearing at:
 - o Beam 3, span 4 at pier 4
 - o Beam 2, span 5 at pier 4
 - o Beam 4, span 6 at pier 5.

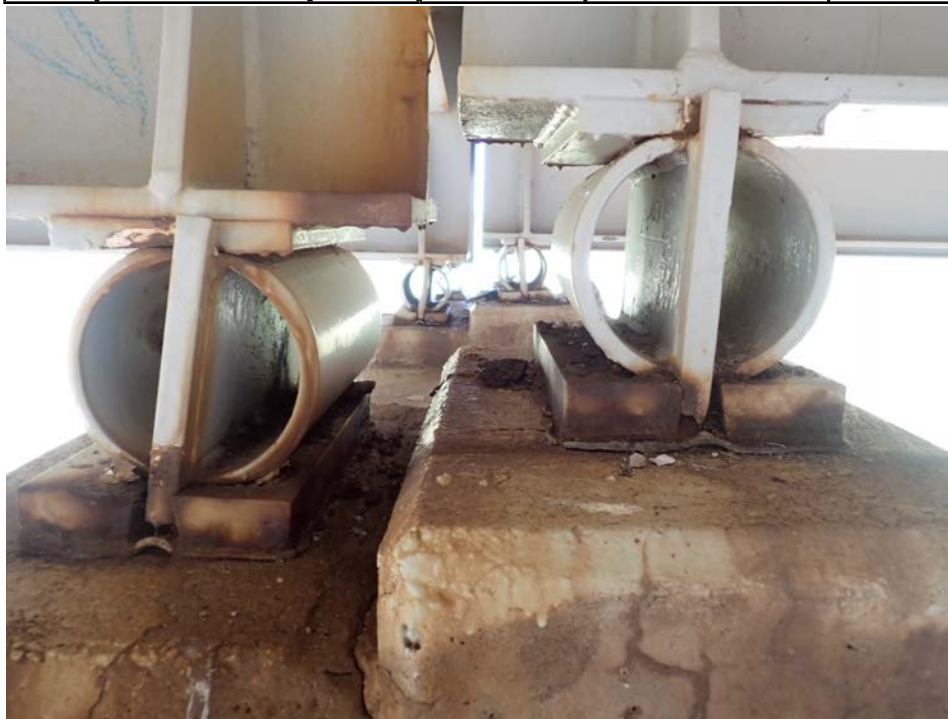
Photograph 49 - Looking west at the beam 3, canister bearings at pier 4. Note: the span 4 bearing is offset from the bearing stiffener and rotated in expansion. The span 5 bearing is aligned with the vertical stiffener and rotated in contraction. Canister thickness is worn at the point of contact with the

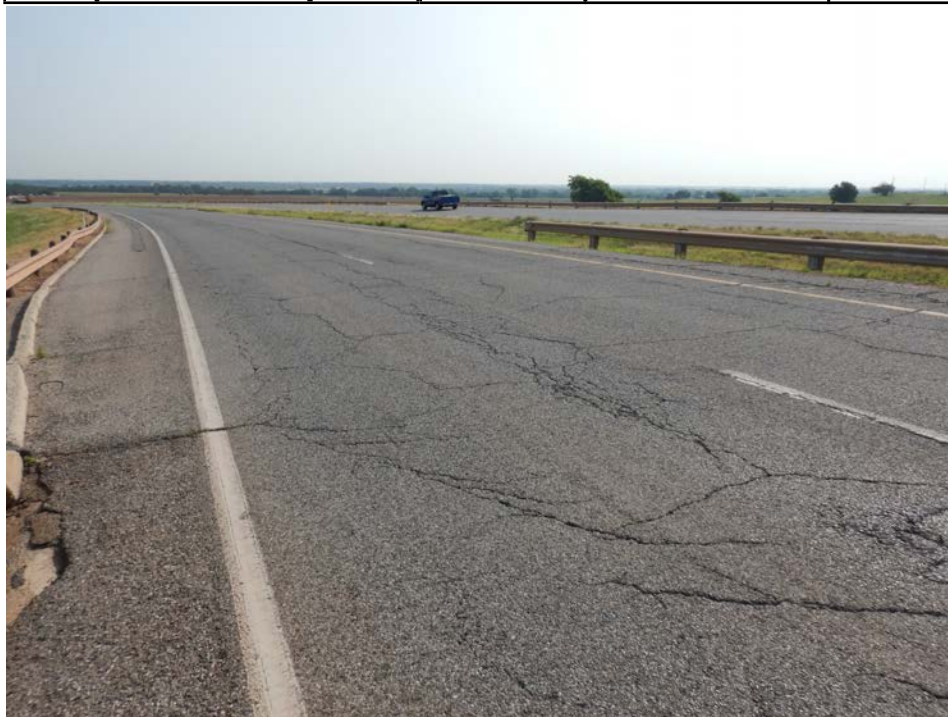
Photograph 50 - Looking northeast at north approach asphalt roadway. Note: longitudinal cracking in the wheel paths.

- Remove lead plugs and portion of anchor studs extending above masonry plate of canister bearings to allow expansion of bearings.
- Seal cracks in approach roadway.

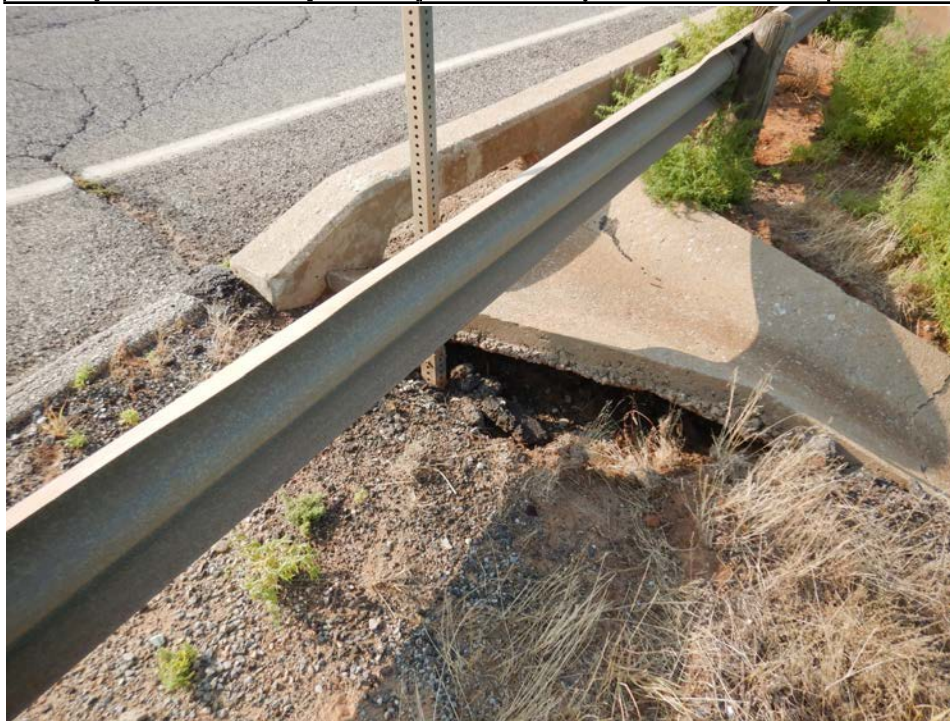
Photograph 51 - Looking south at the northwest corner of the north approach slab. Note: paved drainage flume undermined with approximately 1 foot of penetration.
