Other Special Inspection of **SH 99 over Cimarron River** Creek County, OK

1935-0635-X

NBI No. 15863

To: Leslie Lewis, P.E.
From: CONSOR Engineers, LLC
Date: September 4, 2019
Subject: Other Special Inspection
NBI 15863, Structure 1935-0635-X, SH 99 over Cimarron River

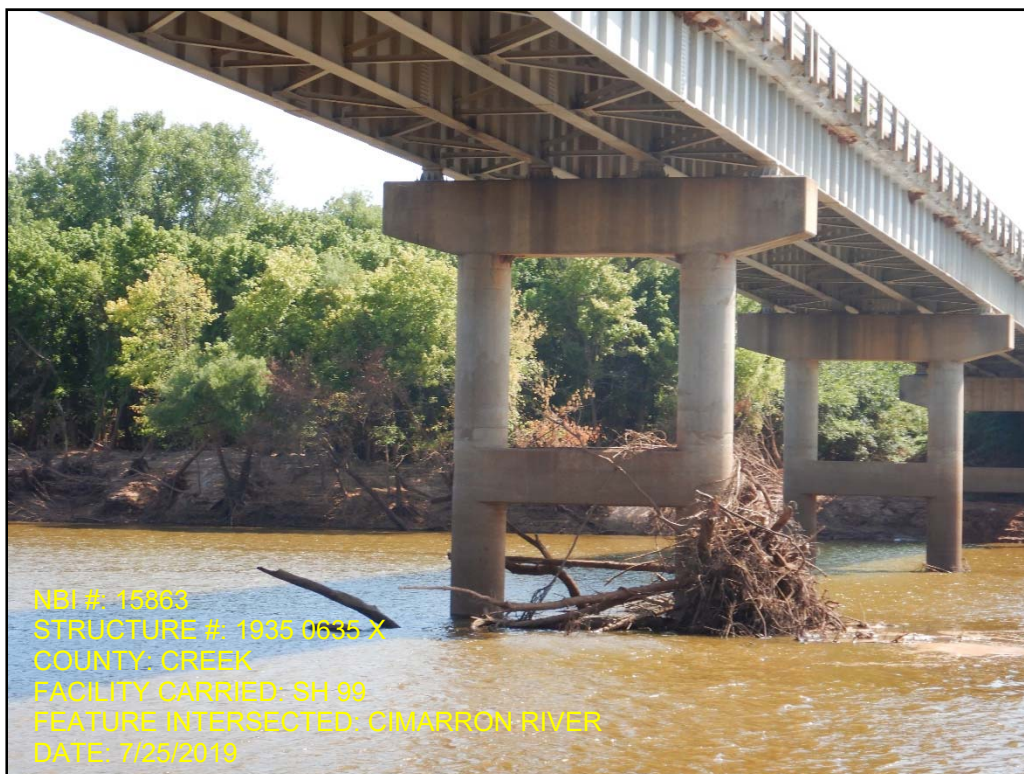
Photo 2 Pier 3, north face

There is timber debris lodged on the upstream portions of Piers 2-4 (Photo 2). Both embankments appeared stable and are well vegetated (Photos 3 and 4).

- Remove the timber debris from Piers 2, 3, and 4.
