Oklahoma Department of Transportation

Programmatic/Individual Categorical Exclusion

An alignment study was completed in 2012. Total offset reconstruction to the north 40 ft was evaluated and rejected due to new right-of-way requirements, wetland impacts and relocations. An option of using the existing alignment and providing offset reconstruction at the curves was rejected due to new right-of-way requirements and construction costs. Adding shoulders and resurfacing the existing roadway minimized new right-of-way and cost; thus was selected as the preferred option.

SUBJECT: Atoka County Project: J/P 24066(04). Proposed roadway improvements and bridge replacement on SH-7 over an unnamed creek.

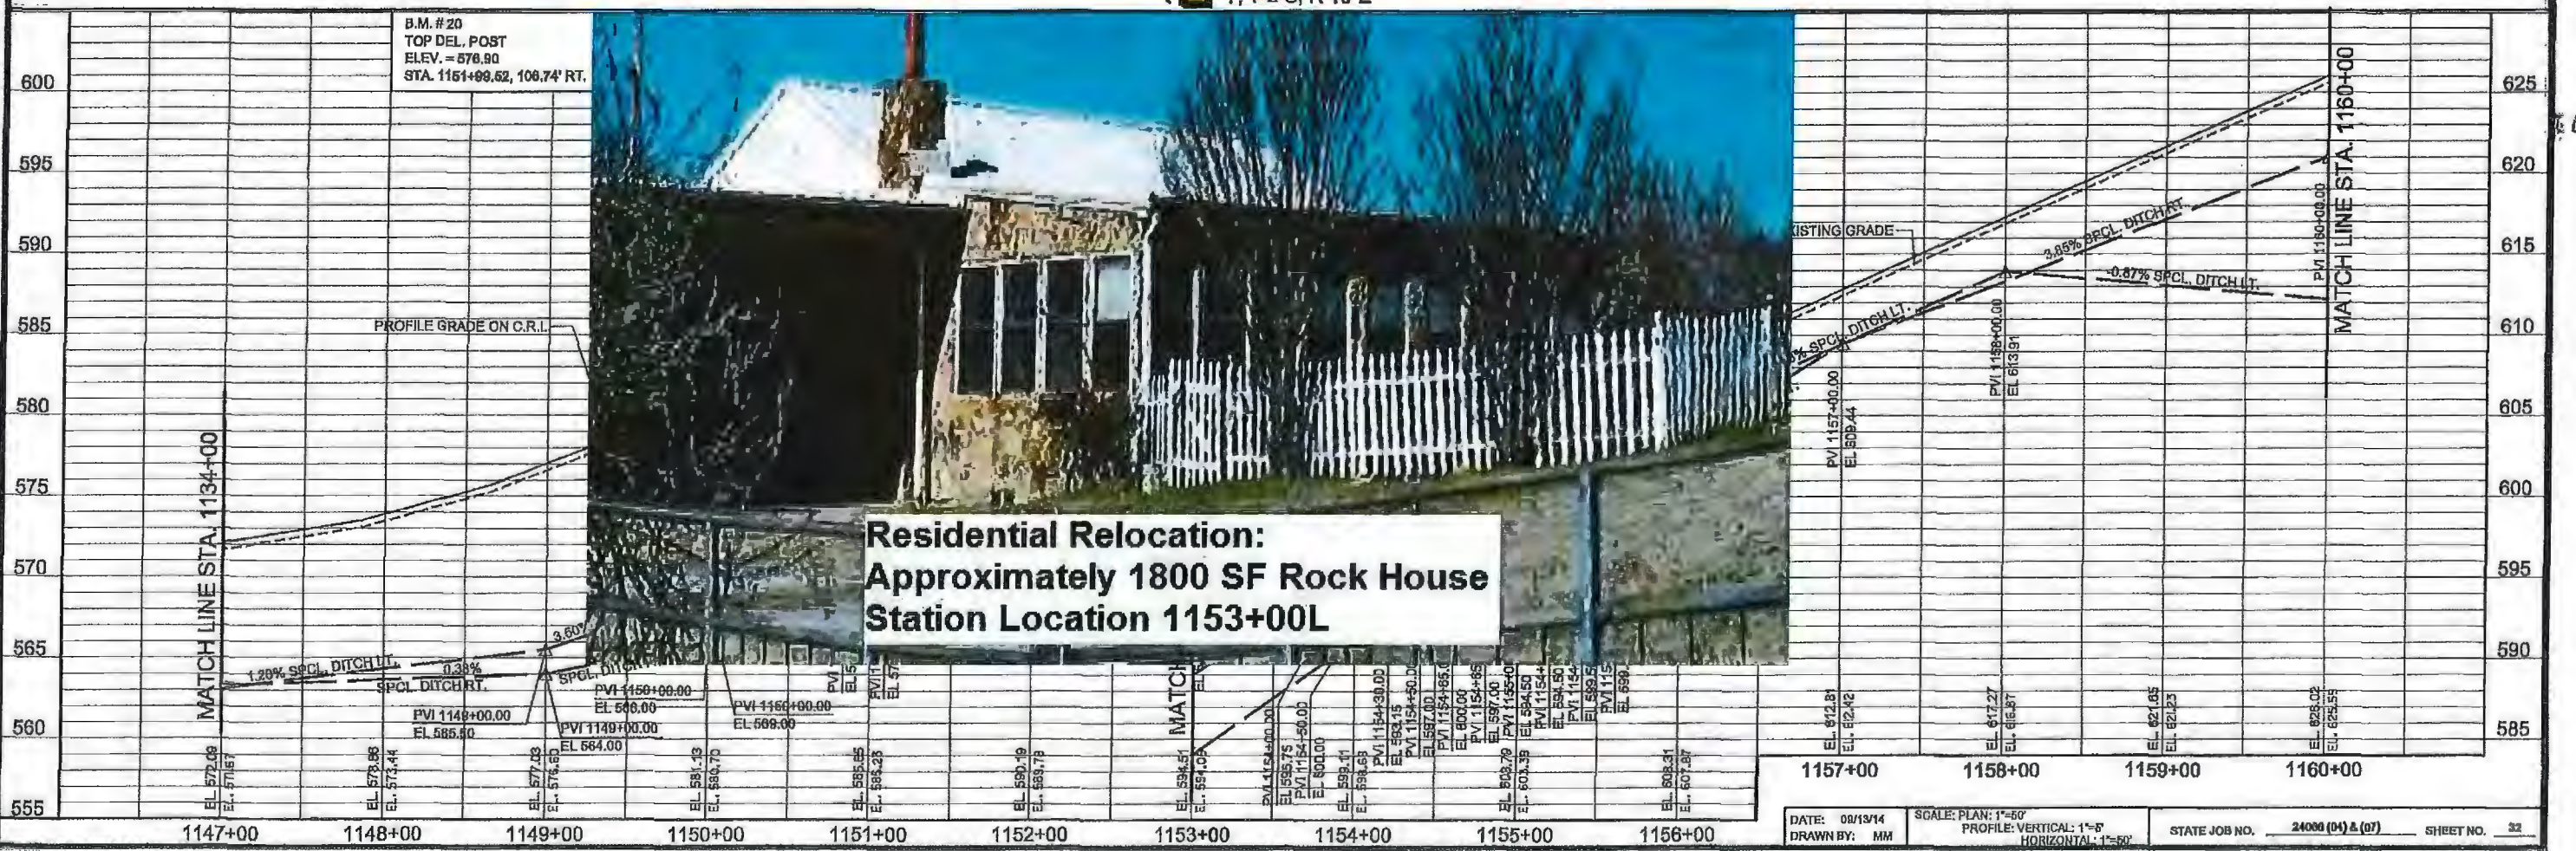
**Residential Relocation:
Approximately 1800 SF Rock House
Station Location 1153+00L**

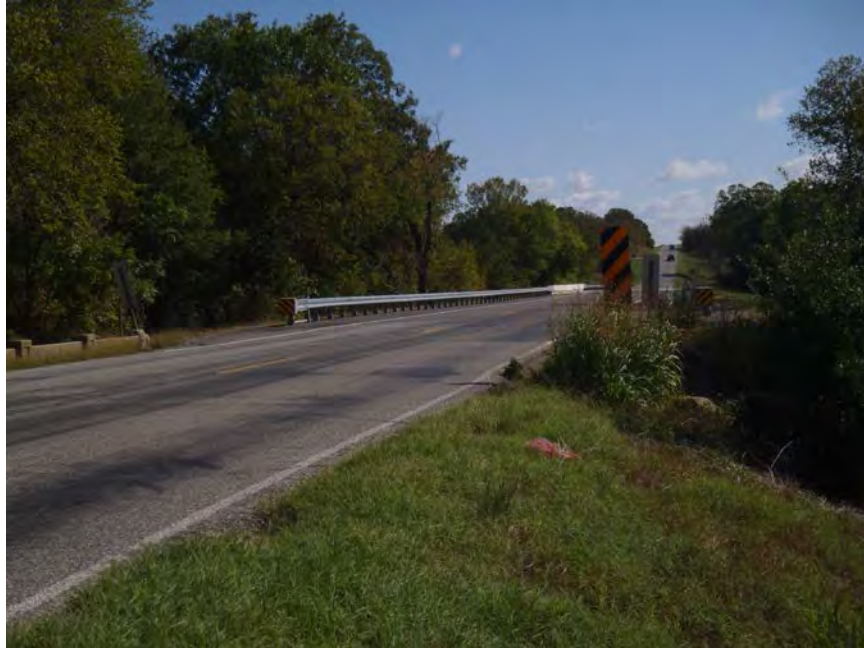
The only bridge in JP 24066(04) is a triple cell 10' x 7' RCB (NBI # 06295) which serves as an overflow structure for the newly constructed Watson Creek bridge. This RCB was constructed in 1938, has a sufficiency rating of 81.4, is not deficient, and has adequate capacity for the design storm. A hydraulic conference was held on 3/18/11 discussing its capacity and any required replacement to be included in this construction contract. It was decided that the existing structure can remain and be extended to the clear zone at 0.3% slope. Hydraulic modeling for this structure was prepared by SAIC under separate contract with the Oklahoma Department of Transportation. Copies of the hydraulic findings are included in Appendix D of this report. An email dated 3/31/11 from Leslie Lewis, P.E. detailing the conference results is included in Appendix D of this report.

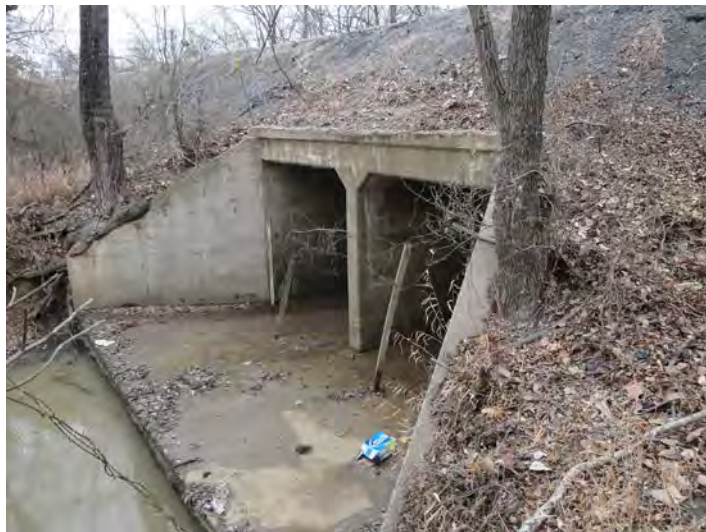
PROPOSED R/W

The remaining three (3) structures are located within the limits of JP 24066(07). All are multi-cell reinforced concrete boxes. A double cell 10' x 10' RCB (NBI # 06055) is located at station 1353+41 and conveys drainage from an unnamed tributary of Sand Creek. This RCB was constructed in 1938, has a sufficiency rating of 87.8, is not deficient, and has adequate capacity for the design storm. A hydraulic conference was held discussing this bridge, and it was decided to replace the existing double cell 10' x 10' RCB with a single cell 20' x 10' RCB due to constant debris issues with the existing structure. Hydraulic modeling for this structure was prepared by Meshek & Associates under separate contract with the Oklahoma Department of Transportation. Copies of the hydraulic findings are included in Appendix D of this report. An email dated 4/05/11 from Leslie Lewis, P.E. detailing the conference results is included in Appendix D of this report.

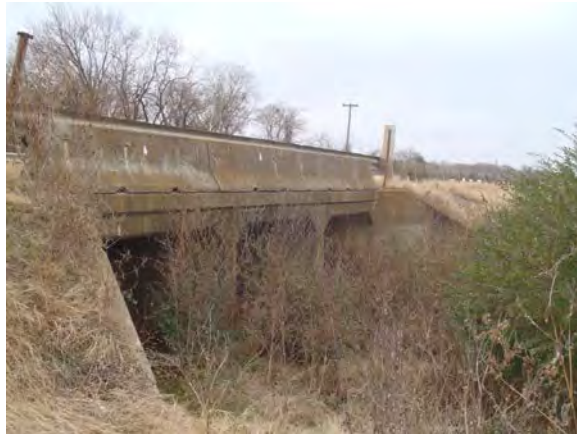
A triple cell 10' x 7' RCB (NBI #06303) is located at station 1444+45 which conveys drainage from an unnamed tributary of Sand Creek. This RCB was constructed in 1938, has a sufficiency rating of 81.4, is not deficient, and has adequate capacity for the design storm. A hydraulic conference was held discussing this bridge, and it was decided to replace the existing triple cell 10' x 7' RCB with a single cell 20' x 10' RCB due to constant debris issues with the existing structure. Hydraulic modeling for this structure was prepared by Meshek & Associates under separate contract with the Oklahoma Department of Transportation. Copies of the hydraulic findings are included in Appendix D of this report. An email dated 4/05/11 from Leslie Lewis, P.E. detailing the conference results is included in Appendix D of this report.

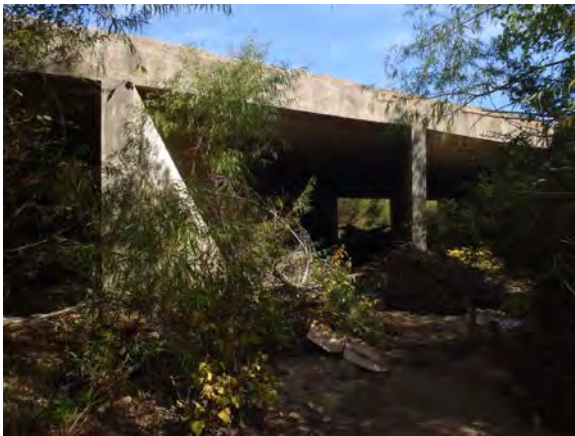
A triple cell 13' x 11' skewed RCB (NBI # 24302) is located at station 1514+95 which conveys drainage from an unnamed tributary of Sand Creek. This RCB was constructed in 1999, has a sufficiency rating of 93.1, is not deficient, and has adequate capacity for the design storm. The wingwalls on this RCB fall within the 65 mph clear zone by approximately three feet on each side. Removing the wingwalls, extending the RCB to

the clear zone and constructing new wingwalls on this recently constructed skewed RCB would be impractical and costly for the actual amount of box extension achieved. The existing RCB is quite shallow and the installation of guardrail above the RCB is not possible without profile revisions. We propose constructing a longitudinal concrete barrier above this RCB with guardrail to the length of need and G.E.T. end sections as required.
