## Re-evaluation Memo

DATE	<b>June 26, 2018</b>	Project No.	<b>J3-0374(004)</b>
County	<b>Tulsa</b>	State Job Piece No:	<b>30374(04)</b>
NEPA PROJECT MANAGER	<b>Greg Worrell</b>	PHONE NUMBER	<b>(405) 522-8014</b>
ODOT Field Division	<b>8</b>	Bridge NBI No. (For County & State Projects) & Location No. (County Projects Only)	<b>16492 (NB) and 16493 (SB)</b>
Project Description from JPINFO	<b>Bridge and approaches for US-75 over 81<sup>st</sup> Street South, Northbound and Southbound, 7 miles north of junction US-75/SH-67.</b>		
<b>Description of the Proposed Action</b> (eg. <i>Bridge Replacement on existing alignment or offset alignment to south/north/east/west, Resurfacing, Adding Shoulders, etc.</i> )	<p><b>The ultimate facility on US-75 from SH-67 north 10 miles to I-44 interchange in Tulsa County will upgrade US-75, on existing alignment, to a four/eight lane fully controlled access facility with improved or new interchanges and will provide improved or new frontage roads.</b></p> <p><b>The proposed interim project, constructed on existing alignment, will correct two functionally obsolete bridges over 81<sup>st</sup> Street. The project is located within the City limits. The bri

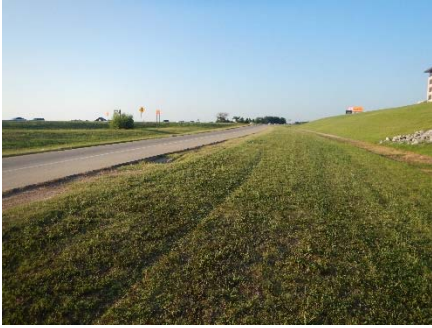
**Photograph 1:**

Maintained Road ROW Community Type

Maintained Road ROW: Dominant vegetation in this community type included bermudagrass (*Cynodon dactylon*), tall fescue (*Festuca arundinacea*), and Floridia paspalum (*Paspalum floridanum*) (Photograph 1).

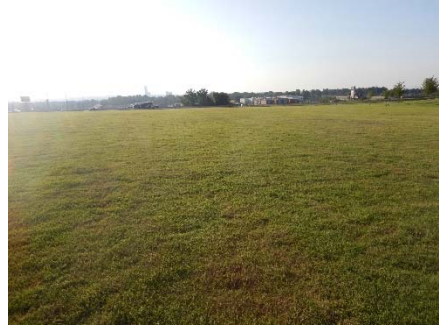
**Photograph 2:**

Maintained Lawn Community Type

Maintained Lawn: Dominant vegetation in this community type included bermudagrass (Photograph 2).

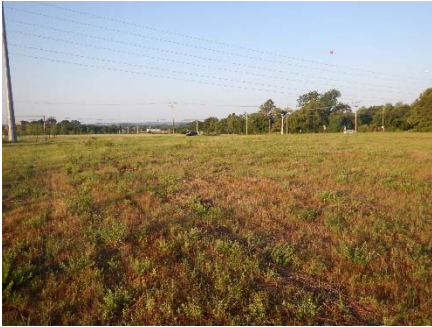
**Photograph 3:**

Improved Grass Field Community Type

Improved Grass Field: Dominant vegetation in this community type included bermudagrass, Johnsongrass (*Sorghum halepense*), and sericea (*Lespedeza cuneata*) (Photograph 3).

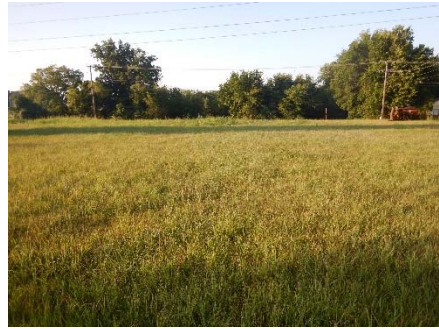
**Photograph 4:**

Mixed Grass Field Community Type

Mixed Grass Field: Dominant vegetation in this community type included foxtail (*Setaria parviflora*), yellow bluestem (*Bothriochloa ischaemum*), and prairie sedge (*Carex festucacea*) (Photograph 4).

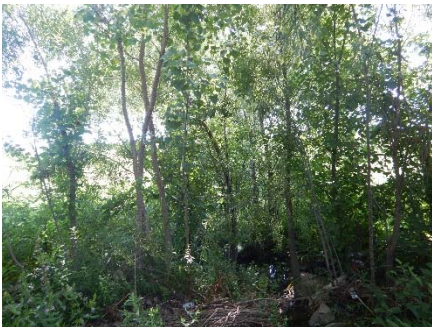
**Photograph 5:**

Isolated Upland Trees

Isolated Upland Trees: Dominant vegetation in this community type included pecan (*Carya illinoensis*), hackberry (*Celtis occidentalis*), and American elm (*Ulmus americana*) (Photograph 5).

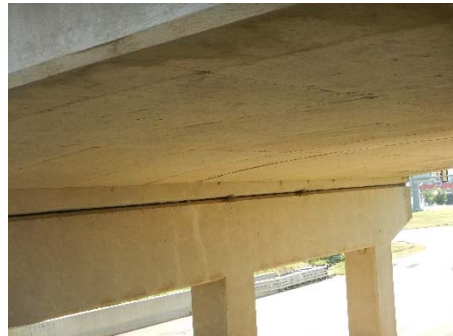
**Photograph 6:**

Swallow Nests, NBI 16492

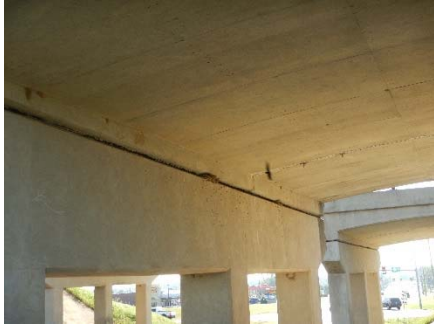
**Photograph 7:**

Swallow Nests, NBI 16493

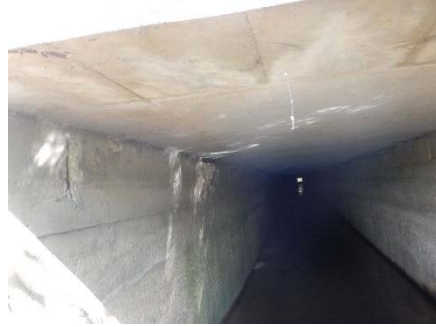
**Photograph 8:**

Swallow Nest, RCB 3

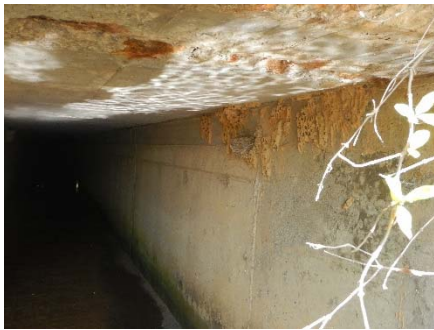
**Photograph 9:**

Swallow Nests, RCB 4

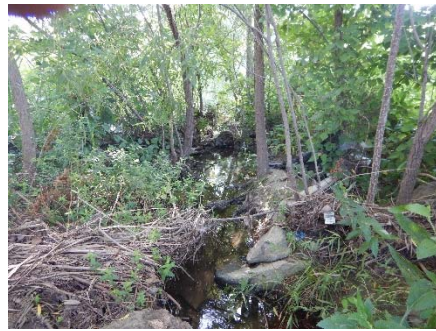
**Photograph 10:**

Intermittent Stream, S1, Isolated Riparian  
Trees

Isolated Riparian Trees: Dominant vegetation in this community type included black willow (*Salix nigra*) and cottonwood (*Populus deltoides*) (Photograph 10).

**S1** is mapped on the USGS topographic quadrangle as intermittent. This stream is characterized by clay/cobble substrate and flows from west to east, the majority of the stream flows through an RCB under US-75. Approximately 389 linear feet (0.04 acres) of this channel was located within the study area. The stream has an observable average ordinary high water mark (OHWM) prior to the RCB of 4 feet. The stream had clear flowing water at the time of field reconnaissance. The stream supports intermittent flow. The stream banks were vegetated with trees, including black willow and cottonwood. S1 will likely be regulated by the US Army Corps of Engineers (Corps) under Section 404 of the Clean Water Act (CWA) (Photograph 10).

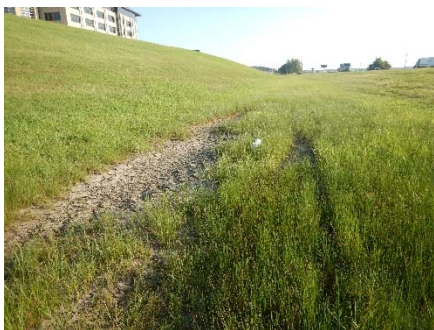
**Photograph 11:**

Emergent Wetland, W1

**W1** is an emergent wetland with a Cowardin classification of PEM1A; Palustrine, Emergent, Persistent, Temporarily Flooded. The feature is approximately 0.03 acres and is not illustrated on the NWI map. Dominant vegetation consisted of spikerush (*Eleocharis palustris*). This wetland exhibited a loamy gleyed matrix. This feature is isolated in a small depression and will likely not be regulated by the Corps under Section 404 of the CWA (Photograph 11).

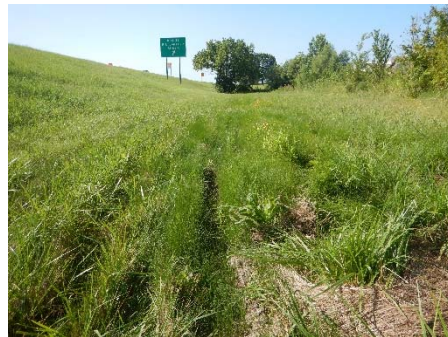
**Photograph 12:**

Emergent Wetland, W2

**W2** is an emergent wetland with a Cowardin classification of PEM1A; Palustrine, Emergent, Persistent, Temporarily Flooded. The feature is approximately 0.21 acres and is not illustrated on the NWI map. Dominant vegetation consisted of spikerush. This wetland exhibited a redox dark surface soil matrix. This feature is adjacent and flows into S1 and will likely be regulated by the Corps under Section 404 of the CWA (Photograph 12).

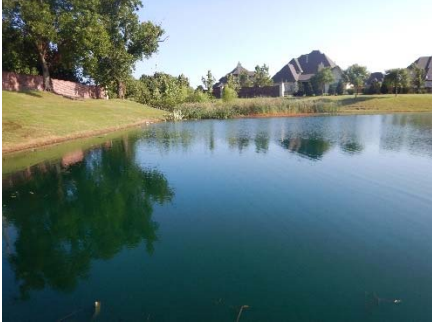
**Photograph 13:**

Pond, P1

**P1** has a Cowardin classification of PUB3; Palustrine, Unconsolidated Bottom, Mud. The feature is not illustrated on the NWI map. The feature is a storm water retention pond (0.07 acres) and will likely not be regulated by the Corps under Section 404 of the CWA (Photograph 13).
