**NBI # 10053
STRUCTURE NUMBER 6702-04.19X
COUNTY SEMINOLE
FACILITY CARRIED U.S. 270
FEATURE INTERSECTED CARTER CREEK
11/30/2017**

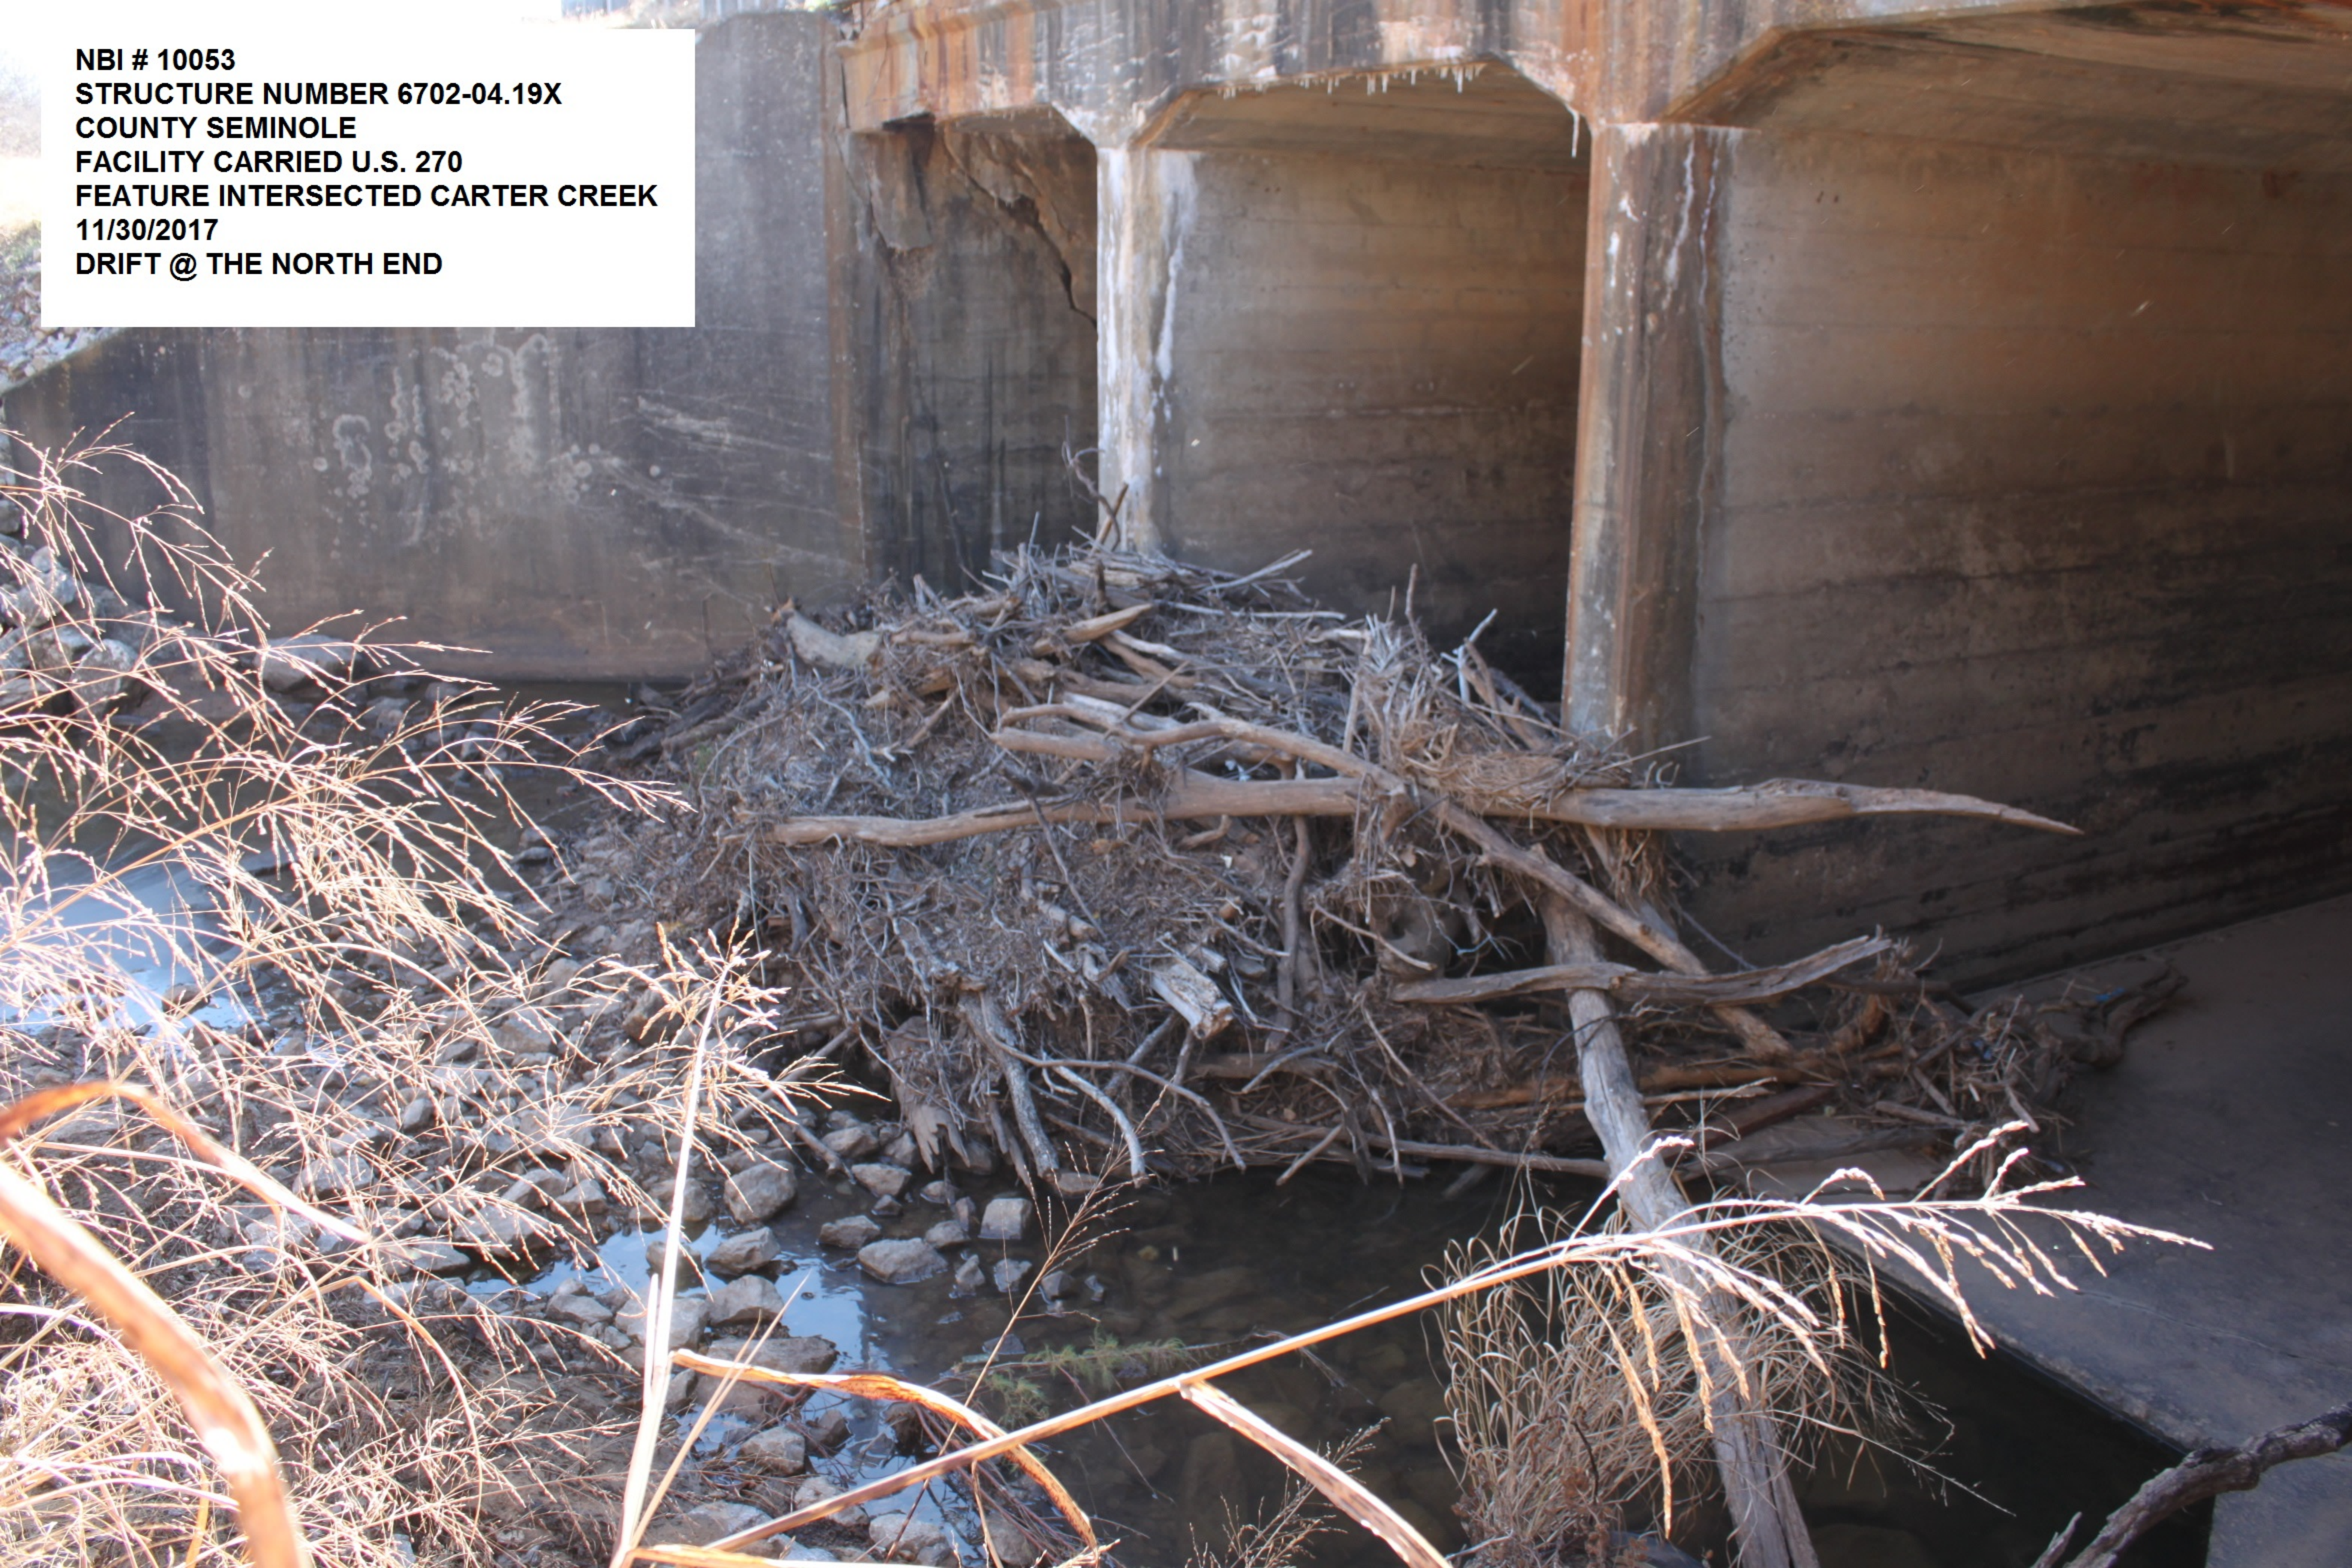
NBI # 10053
STRUCTURE NUMBER 6702-04.19X
COUNTY SEMINOLE
FACILITY CARRIED U.S. 270
FEATURE INTERSECTED CARTER CREEK
11/30/2017
DRIFT @ THE NORTH END

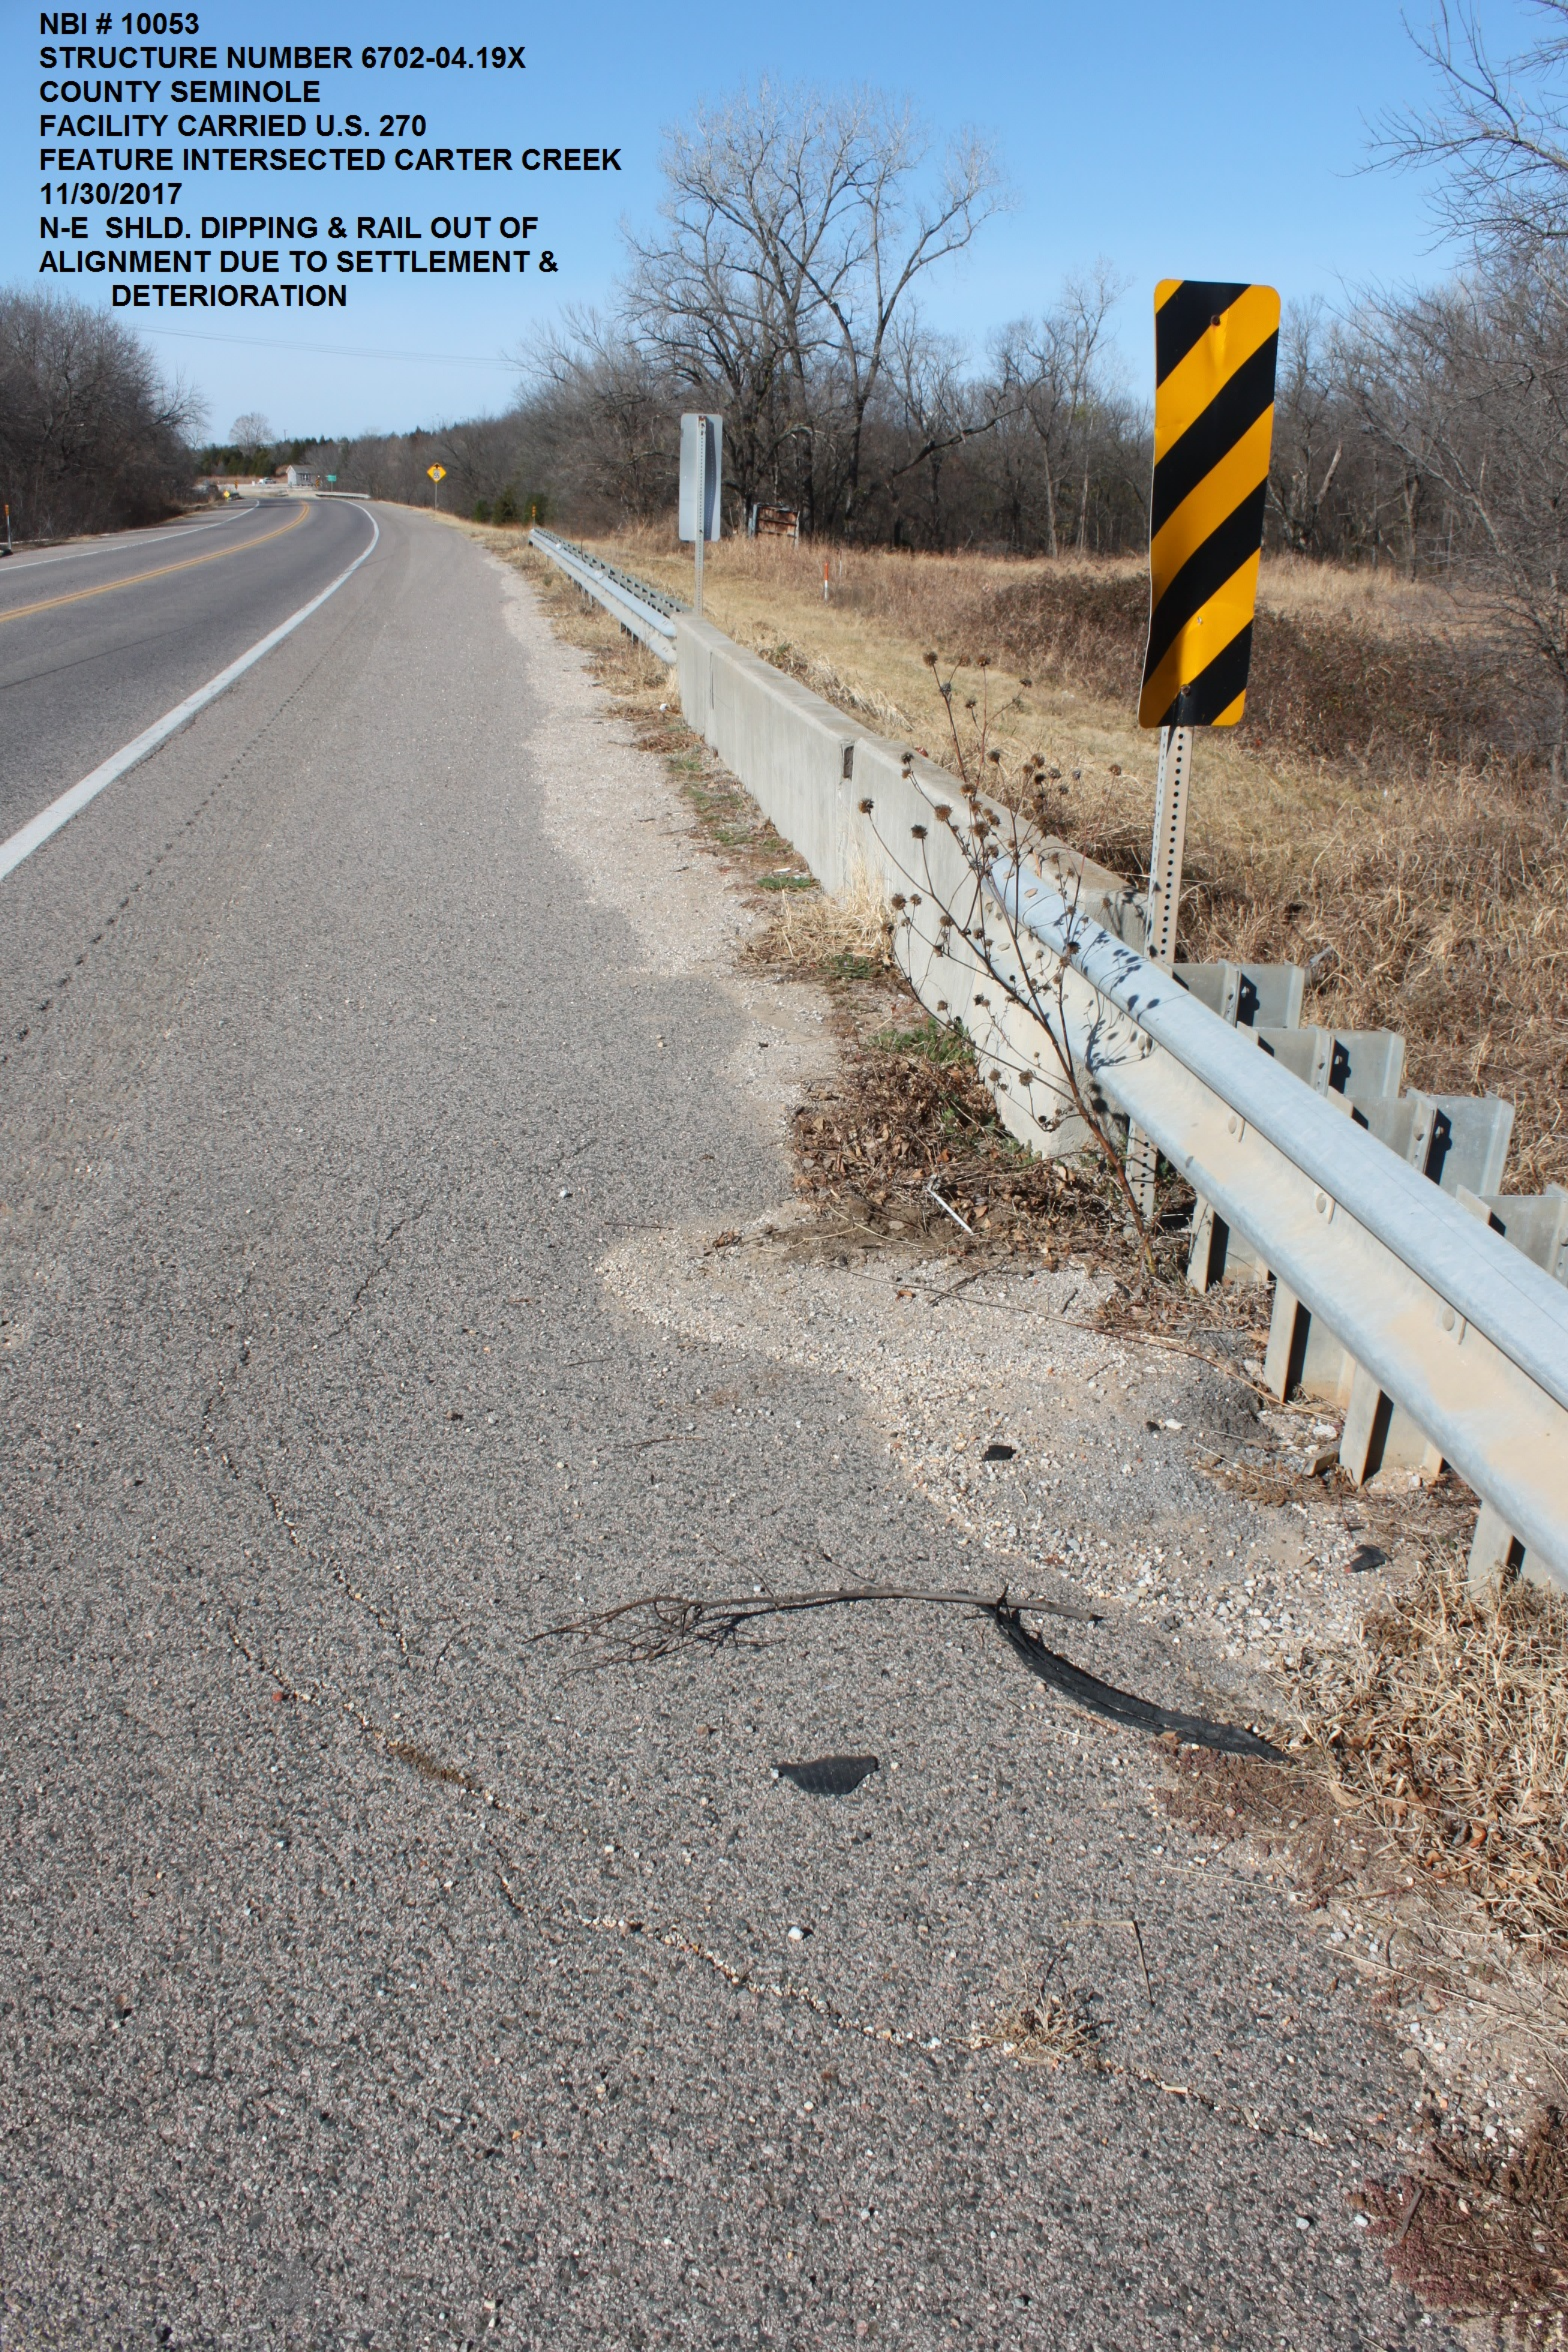
**NBI # 10053
STRUCTURE NUMBER 6702-04.19X
COUNTY SEMINOLE
FACILITY CARRIED U.S. 270
FEATURE INTERSECTED CARTER CREEK
11/30/2017
N-E SHLD. DIPPING & RAIL OUT OF
ALIGNMENT DUE TO SETTLEMENT &
DETERIORATION**

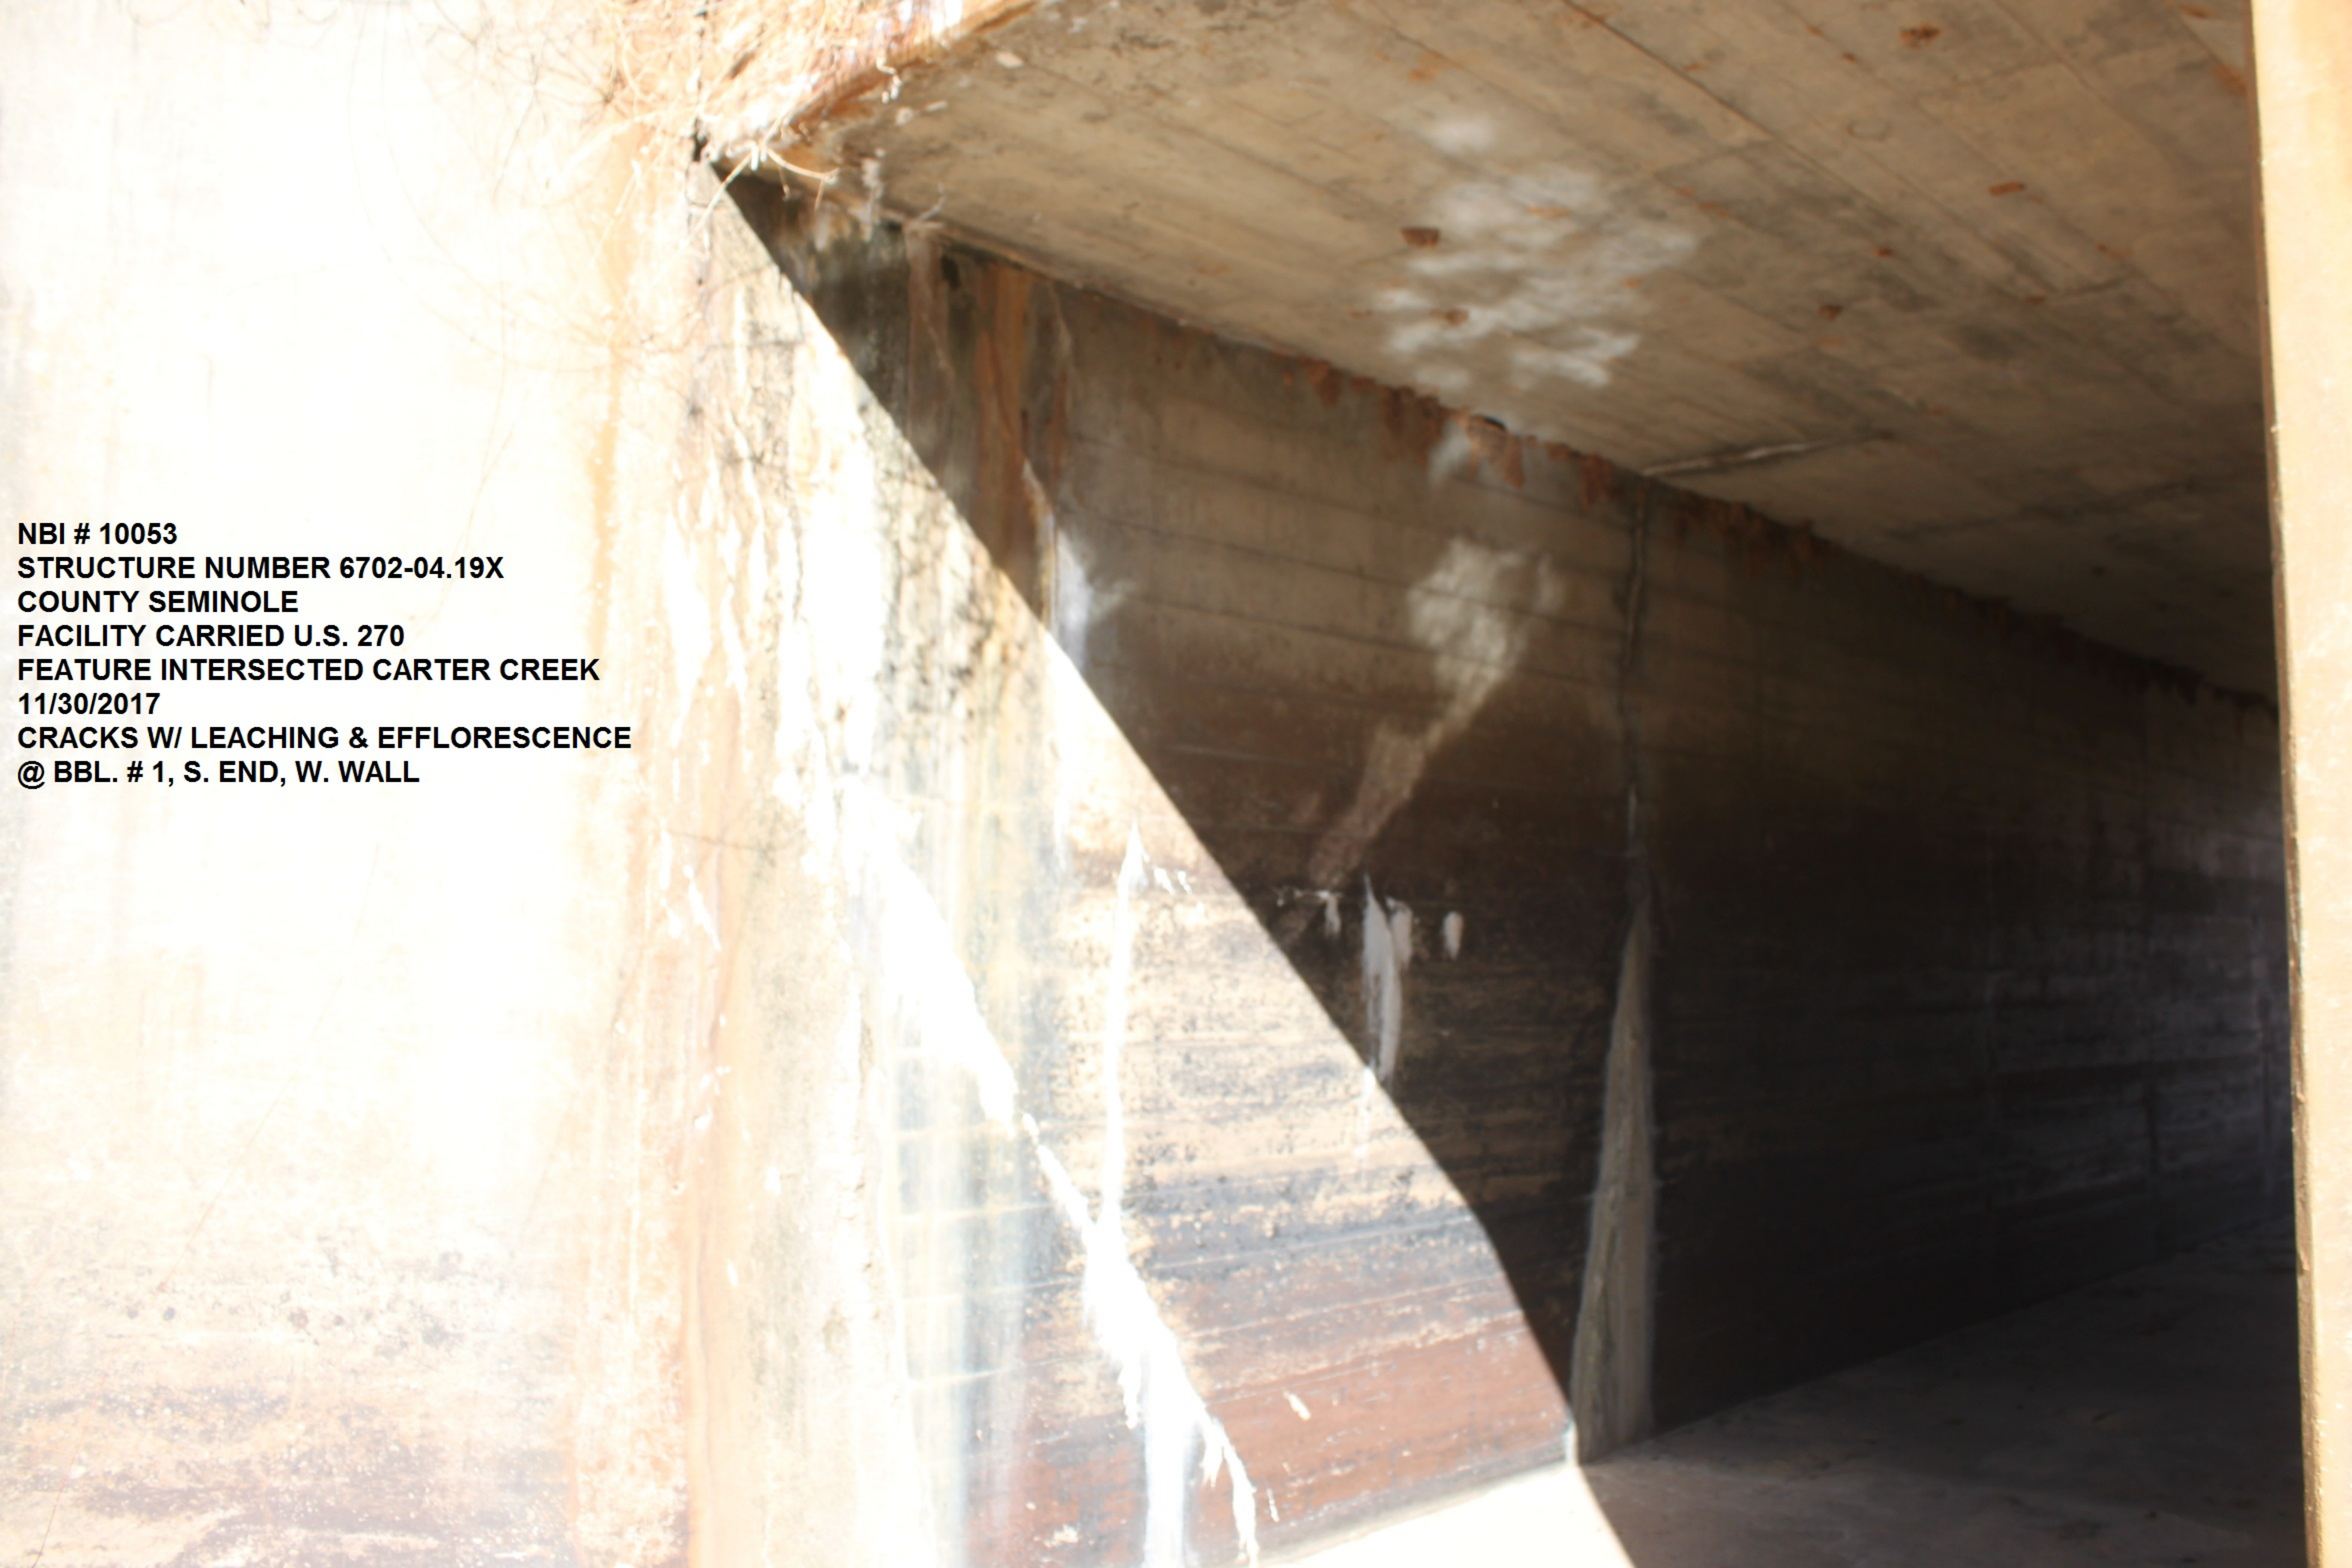
**NBI # 10053
STRUCTURE NUMBER 6702-04.19X
COUNTY SEMINOLE
FACILITY CARRIED U.S. 270
FEATURE INTERSECTED CARTER CREEK
11/30/2017
CRACKS W/ LEACHING & EFFLORESCENCE
@ BBL. # 1, S. END, W. WALL**

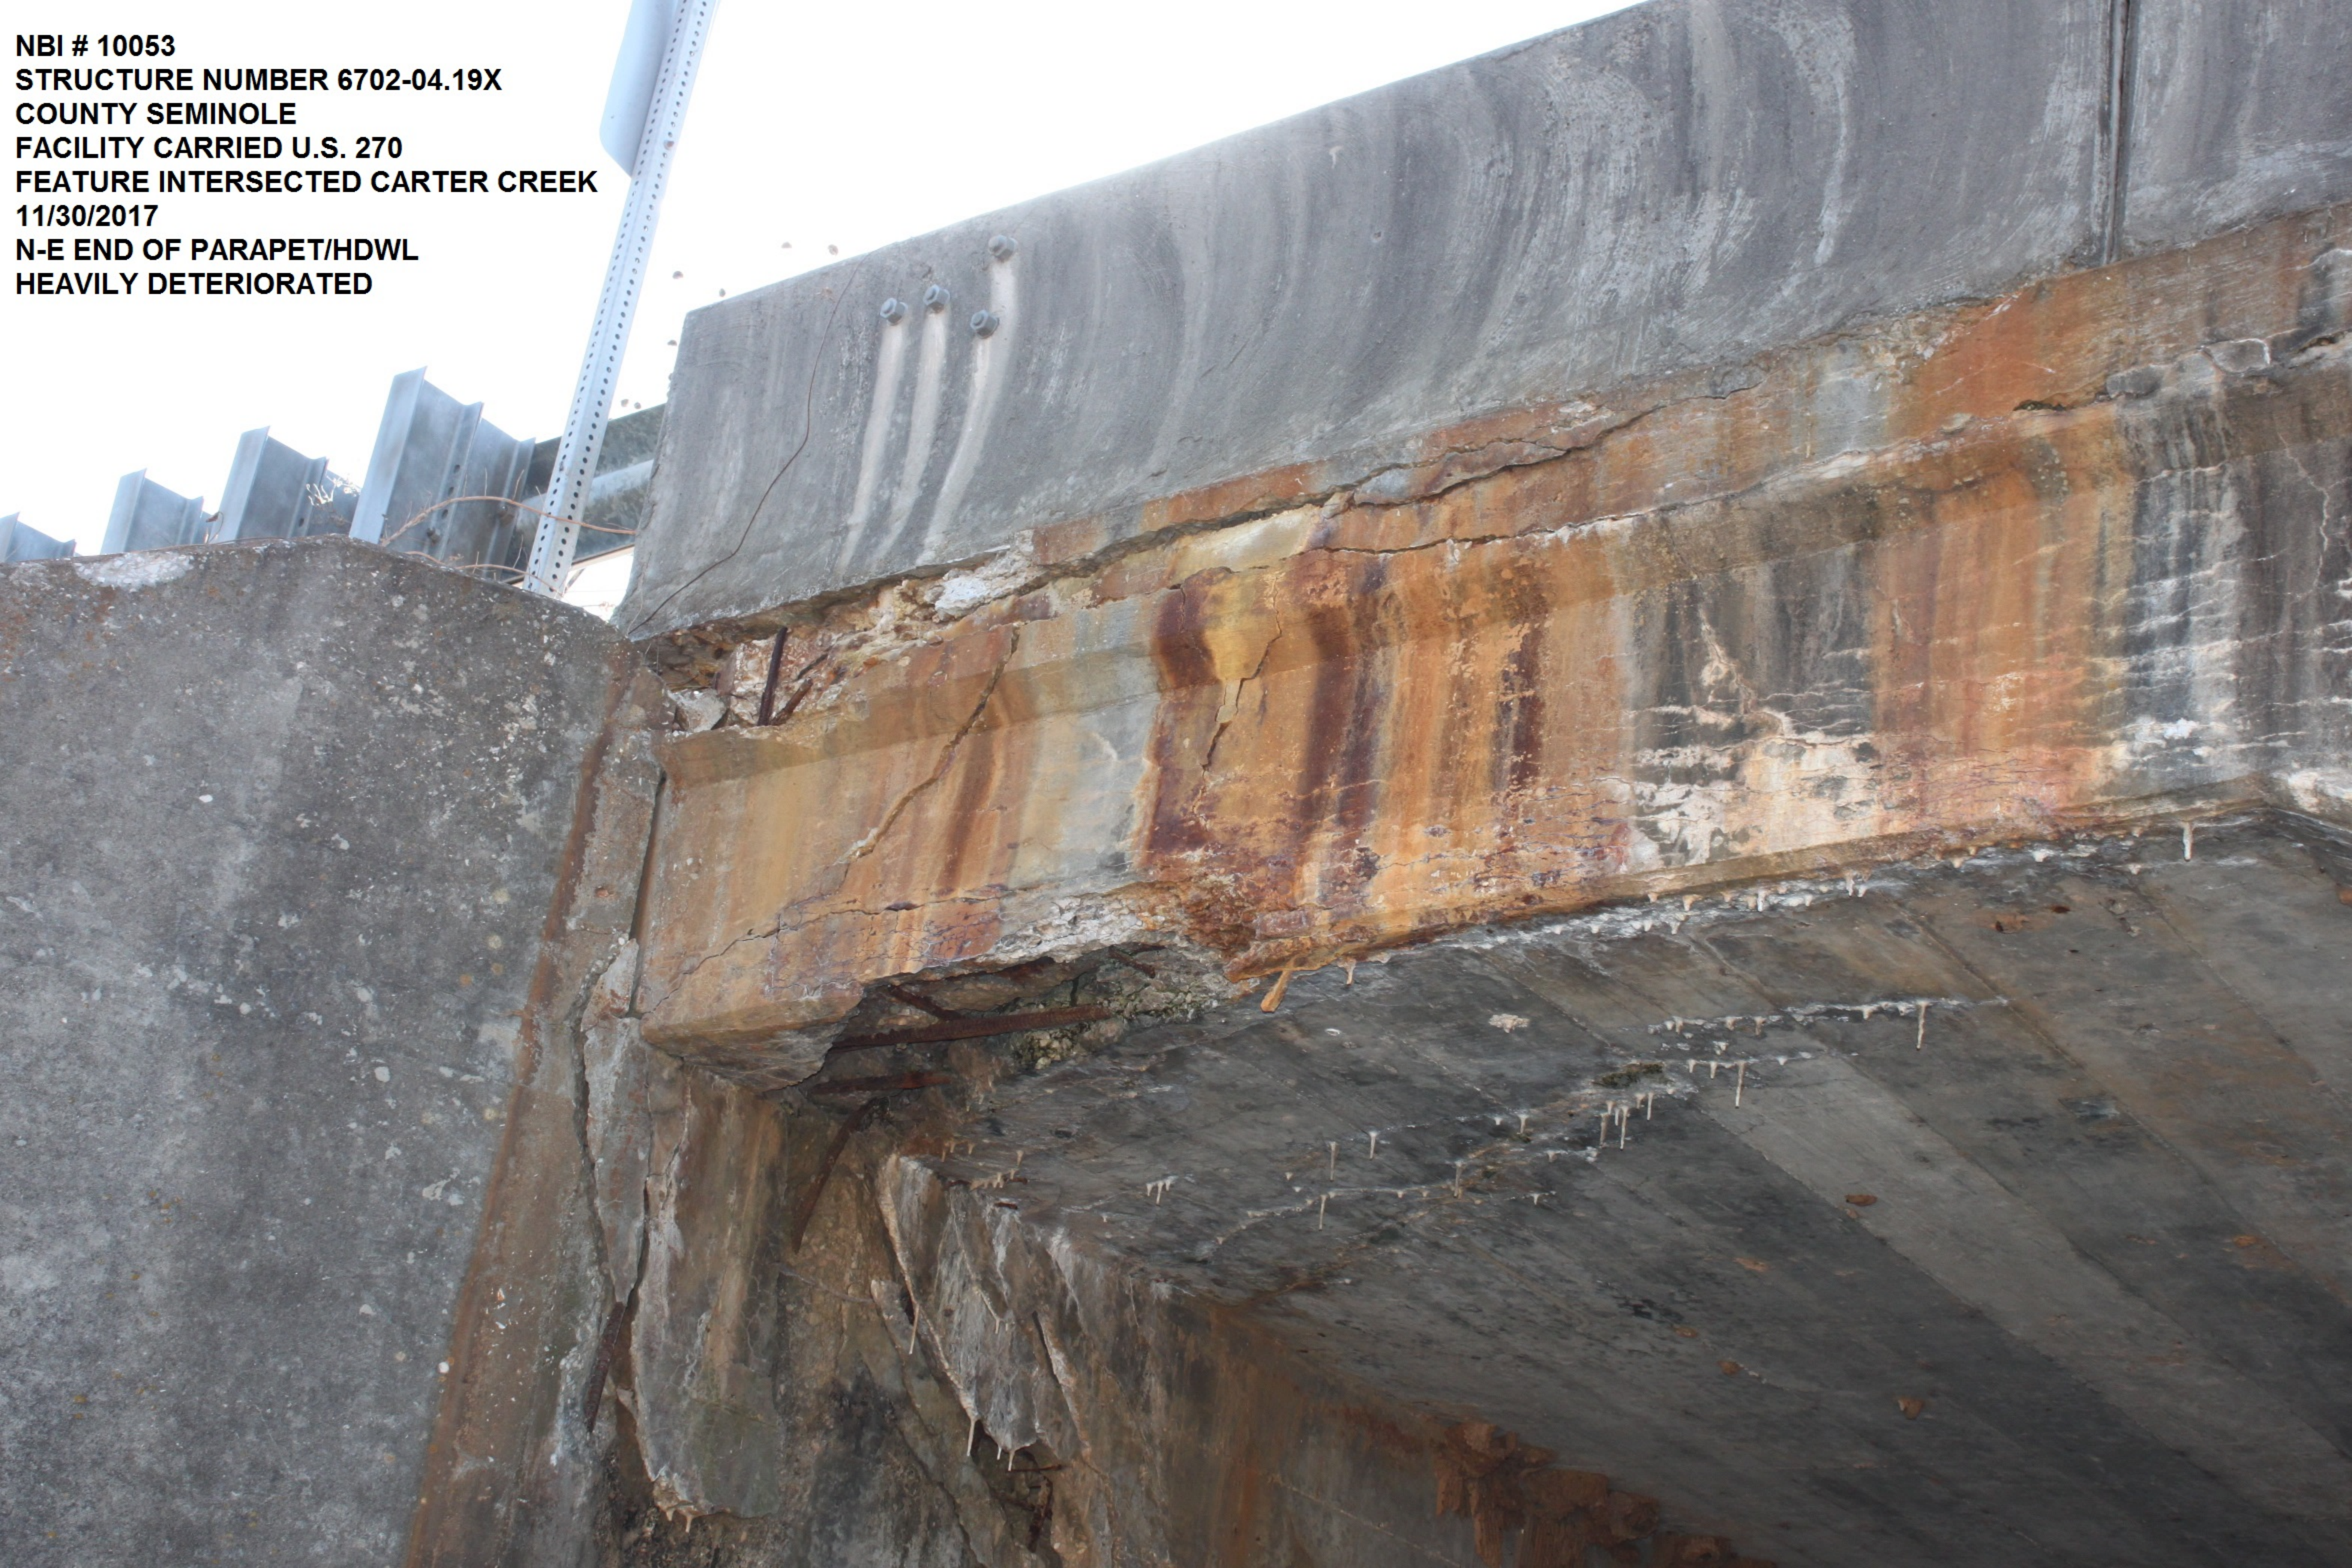
NBI # 10053
STRUCTURE NUMBER 6702-04.19X
COUNTY SEMINOLE
FACILITY CARRIED U.S. 270
FEATURE INTERSECTED CARTER CREEK
11/30/2017
N-E END OF PARAPET/HDWL
HEAVILY DETERIORATED

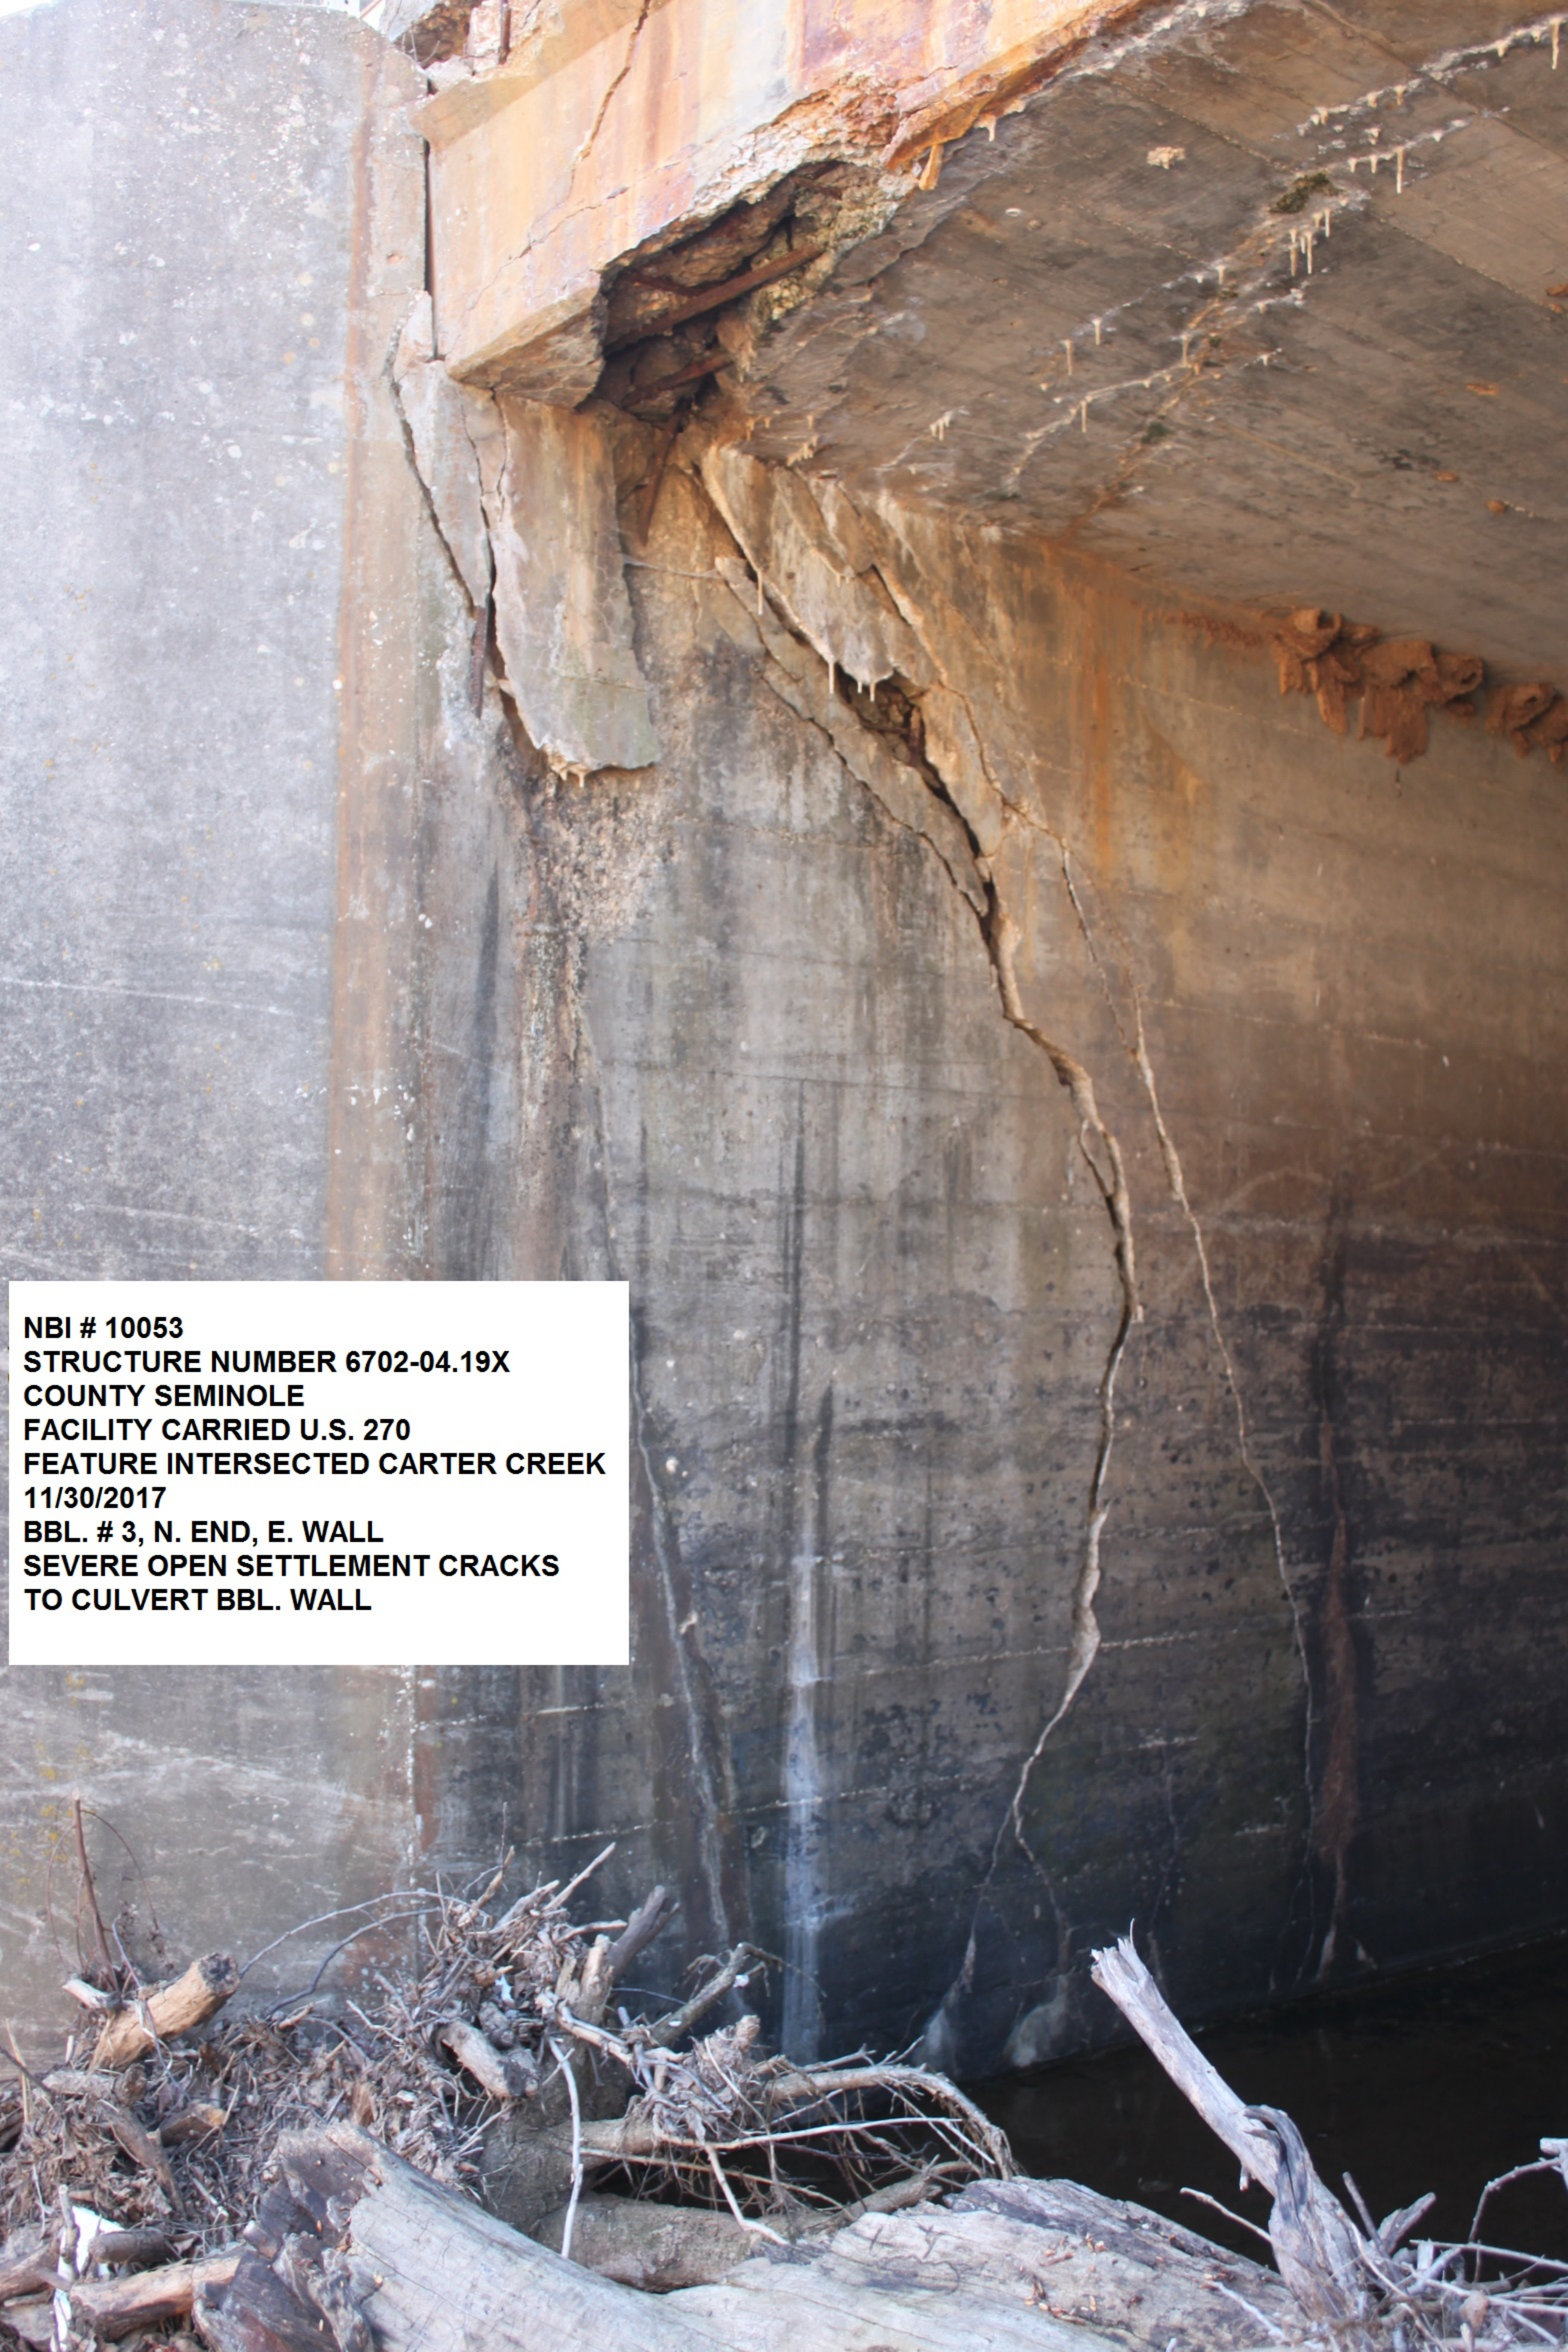
**NBI # 10053
STRUCTURE NUMBER 6702-04.19X
COUNTY SEMINOLE
FACILITY CARRIED U.S. 270
FEATURE INTERSECTED CARTER CREEK
11/30/2017
BBL. # 3, N. END, E. WALL
SEVERE OPEN SETTLEMENT CRACKS
TO CULVERT BBL. WALL**
