Fracture Critical Bridge Inspection Report

NBI Bridge No.: 17611

Route S.H. 100 over ARKANSAS RIVER
Muskogee County

7/14/2023

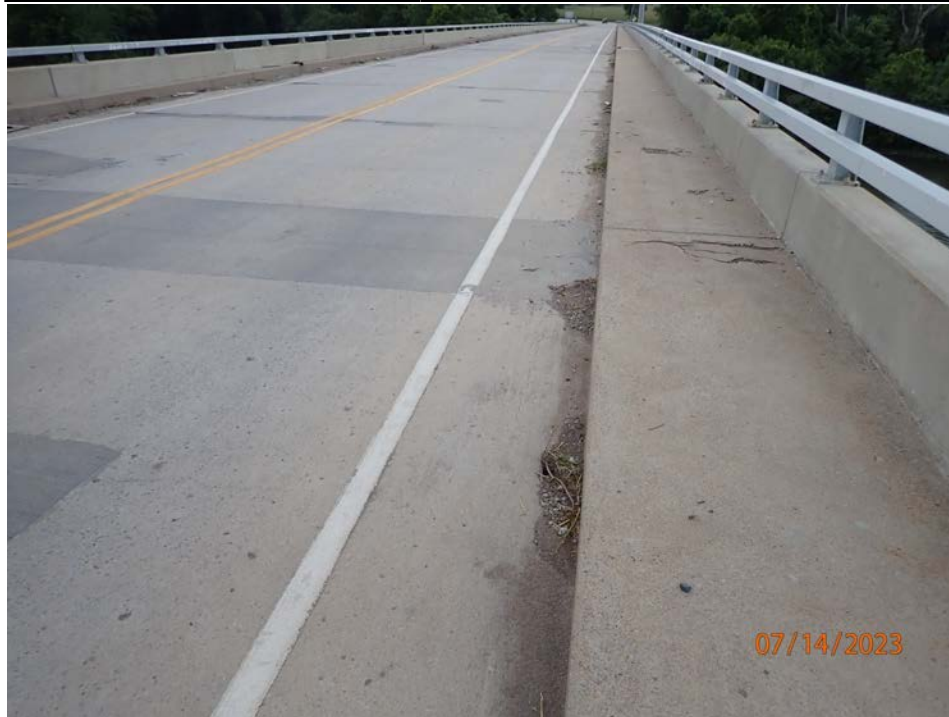
- **PX** – Minor to moderate debris accumulation exists along the curbs. Several scuppers are clogged or partially clogged with vegetation **(photo 9)**.
- The 2014 epoxy grit overlay is failing in patches throughout the deck, mostly along the wheel lines.
- Isolated shallow spalls exist in the deck, a few of which exhibit exposed and corroded reinforcing steel **(photo 10)**.
- Transverse cracks spaced at 1 to 3 feet exist on the surface randomly along the full length of the bridge. Cracks are widest and most prominent in the twin girder spans **(photo 11)**.
- Concrete deck patches exist throughout the driving surface from a prior rehabilitation **(photo 12)**. Isolated spalls have been patched with asphalt **(photo 13)**. The concrete patches are functioning as intended and the asphalt patches exhibit some deterioration.

Photograph 9 - Looking east along the south curb in span 10. Note: isolated scuppers clogged with debris. Moderate debris exists along edge of deck full length.

- Replace north railing post anchor bolts missing from the eastern most railing post.
- Unclog the deck scuppers.
- Reseal the fixed poured joint seal at both abutments.

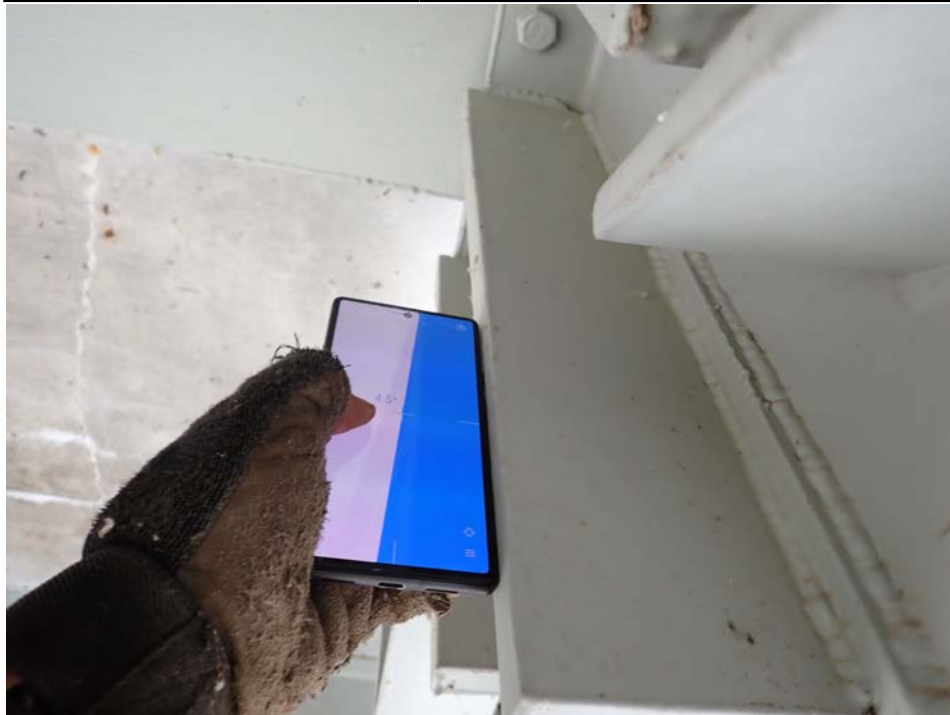
- Span 7, floor beam 5 – upper chord is rotated 4.5° to the east (**photo 50**).
 - Span 7, floor beams 2, 5, and 8 at stringer 3 – bottom horizontal face of gusset plate kinked 1/4-inch and rotated up to 1/2-inch to the west. Floor beam 2 exhibits a poor-quality weld between the north vertical stiffener under stringer 3 and the floor beam bottom flange that appears to have never properly been attached at this location.

Photograph 50 - Looking northwest at floor beam 5, span 7 under stringer 3. Note: top chord/strut is rotated 4.5 degrees east.

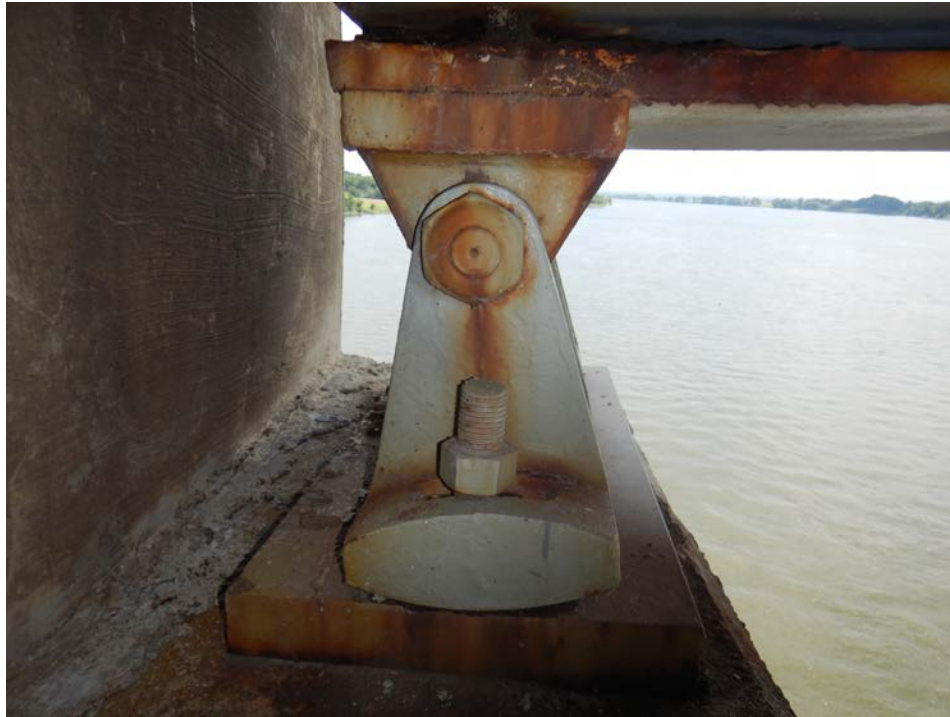
- Bearing measurements are listed in the table below (**photos 71 and 72**).

Photograph 71 - Looking south at the girder 1, span 7 expansion bearing at pier 7. Note: bearing in expansion 3 degrees at 96F.

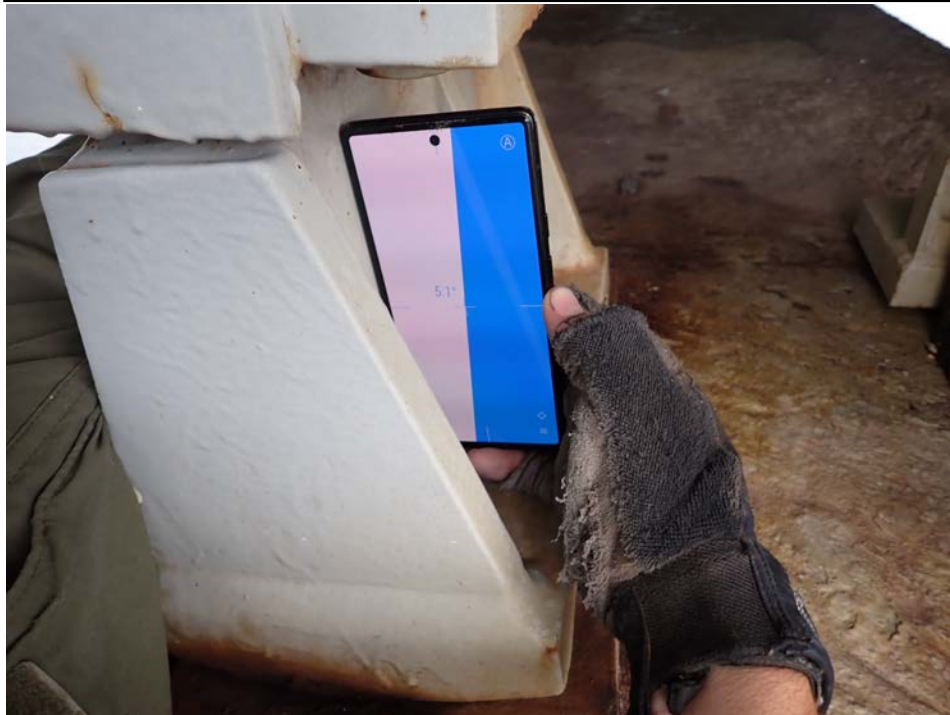
Photograph 72 - Looking north at the girder 1, span 10 expansion bearing at pier 10. Note: bearing is rocked 5 degrees in contraction at 77 F.

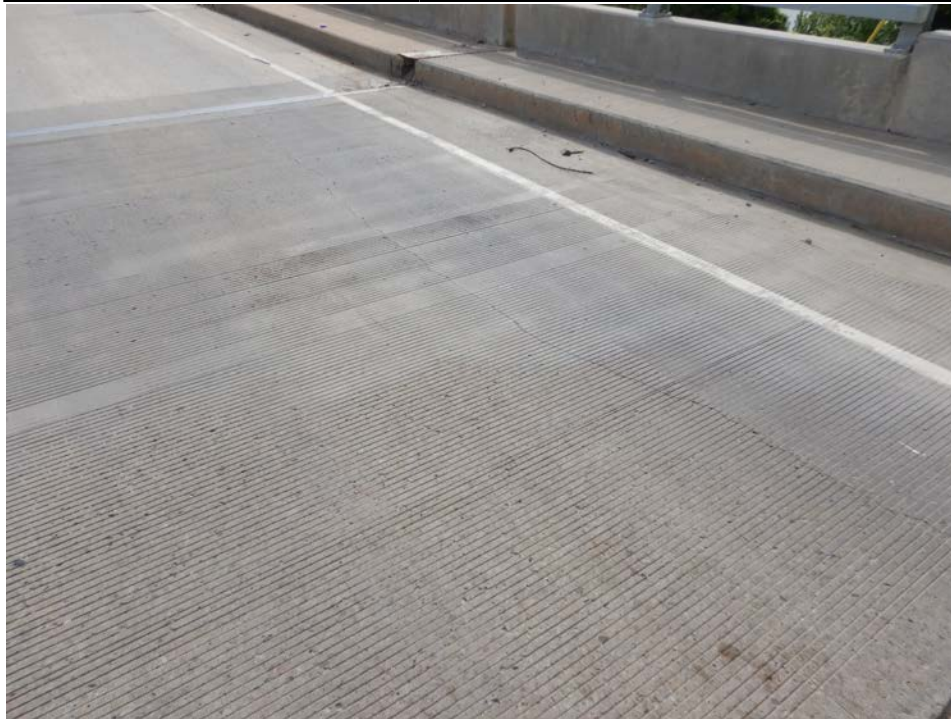
- Both approach slabs have been recently replaced. The east and west approach slabs exhibit up to 0.020-inch-wide longitudinal cracking in the wheel lines with intersecting transverse cracks (**photo 73**).
- The west approach slab approximately 40 feet from the west abutment exhibits a 7 1/2-inch diameter infilled core hole in the west travel lane (**photo 74**).
- A spall measuring 2 feet by 6 inches exists along the east abutment joint.
- Pavement relief joints at the ends of both approach slabs exhibit adhesion failures and minor debris impaction.

Photograph 73 - Looking southeast at the west approach slab in the eastbound lane. Note: longitudinal crack running the full length of the slab with intersecting transverse cracks.

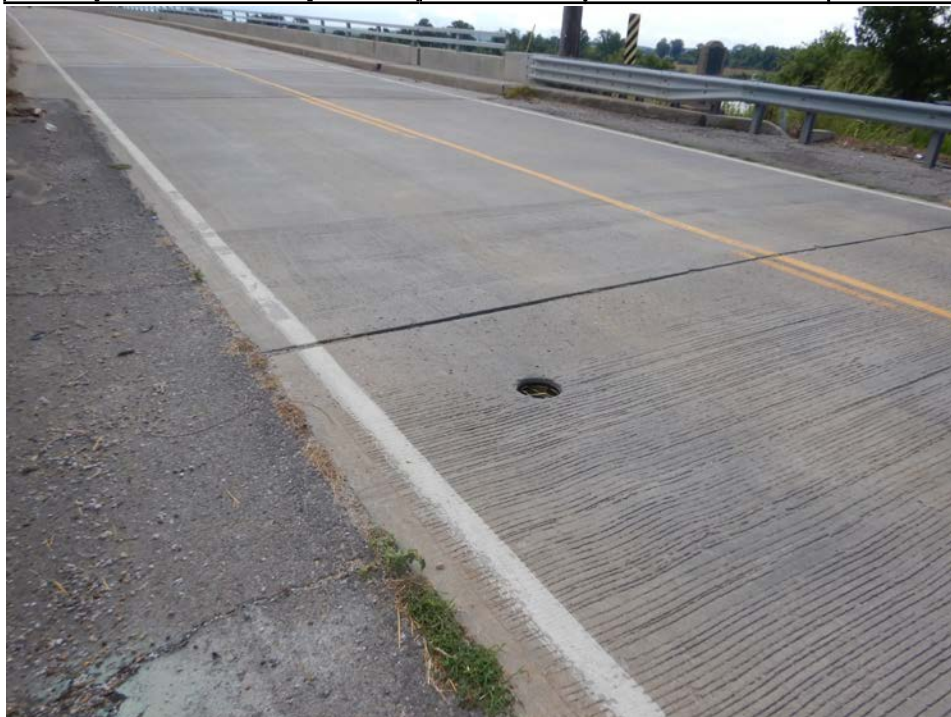
Photograph 74 - Looking southeast at the west approach roadway. Note: 7 1/2-inch diameter filled core hole exists in the westbound lane approximately 40 feet from the west abutment.
