**Underwater Inspection of
SH 100 over the
Arkansas River**
Muskogee County, Oklahoma
October 14, 2022

Structure No. 5159-0300-X
NBI No. 17611

Subject: Underwater Bridge Inspection
NBI 17611, Structure 5159-0300-X, SH 100 over the Arkansas River

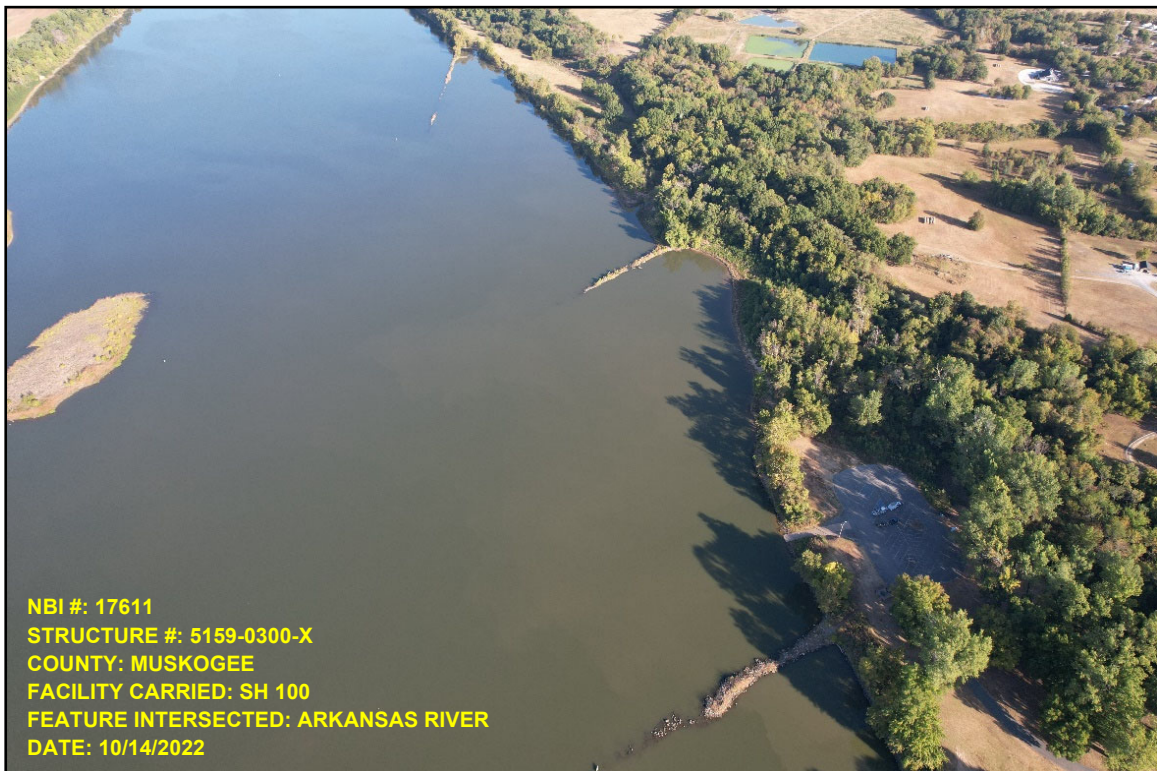
The channel in the vicinity of the bridge has a slight bend and is well aligned with the piers. There are spur dikes on the east bank (outside of the bend), approximately 450-ft, 1400-ft, and 2700-ft upstream of the bridge. Refer to Photo 10. Both embankments are protected with dense vegetation. The embankments appear stable. There is light to moderate timber debris on the channel bottom at Piers 3, 4, 7, 8, 9, and 10; however, there are no significant restrictions to flow at the bridge. The channel bottom material at the piers consists of sand, gravel, and rock. Refer to Photos 4 through 10 for views of the channel alignment and embankments.

Photo 10 – Spur Dikes Along East Embankment Upstream of Bridge
