Countermeasures

Countermeasures are an important and necessary part of bridge maintenance. Not only must the countermeasure restore the safety of the structure, but guard against future assaults. This often has to be completed in a short time and on a shoe string budget.

This document will display some of the different types of countermeasures that have been used both successfully and unsuccessfully in Oklahoma.

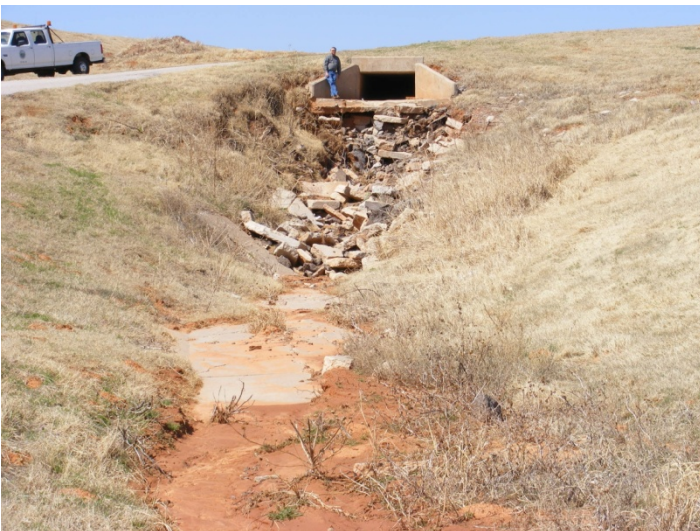
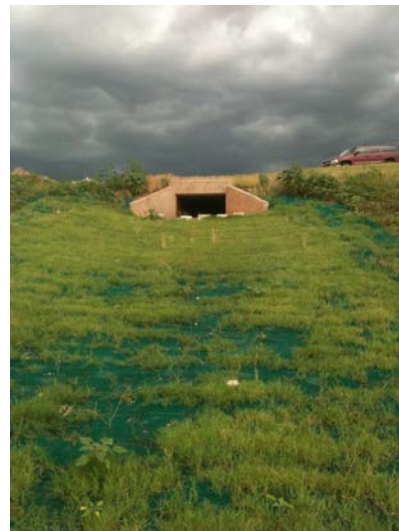
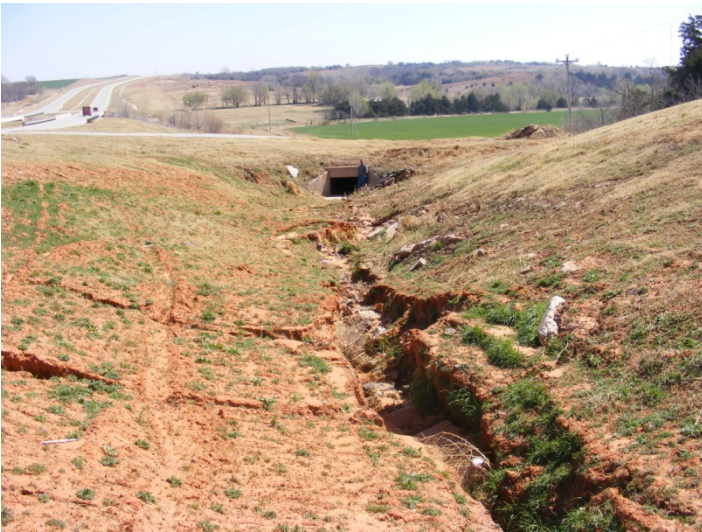
Problem Type: Channel Degradation with channel slope greater than 8.8%.

Location: Both upstream and downstream of side drain was degrading

Notes: The cross drain is located 2 miles north of I-40. Completed in 2009. This solution has performed well.

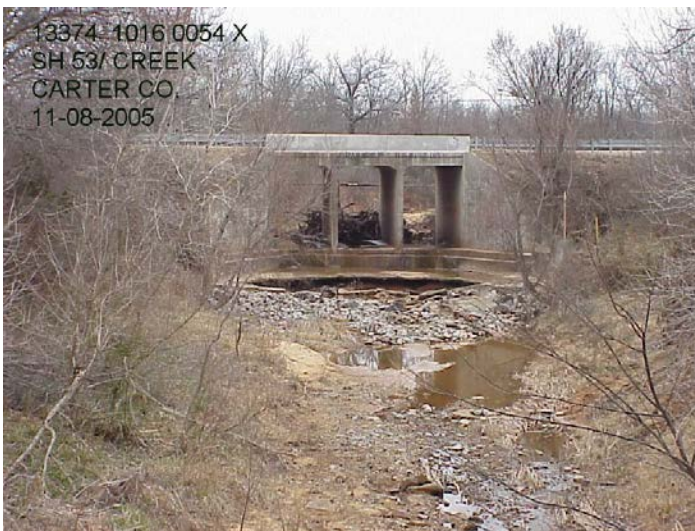
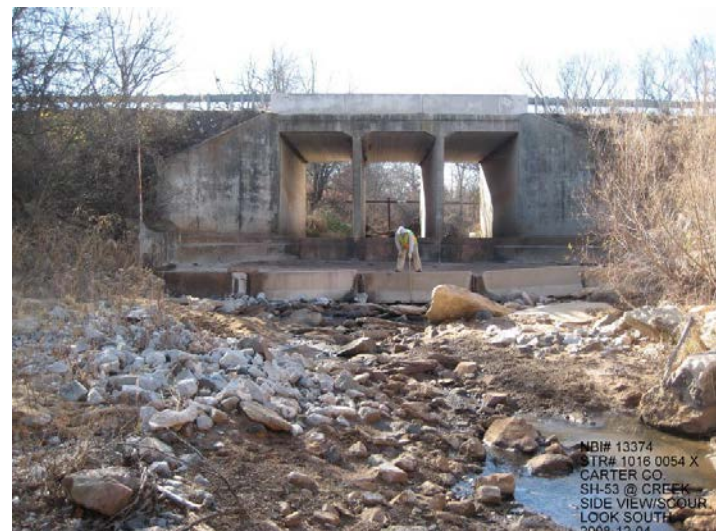
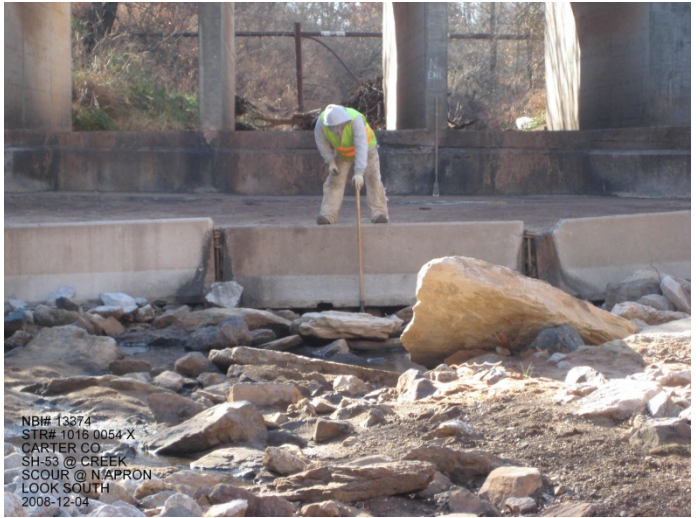
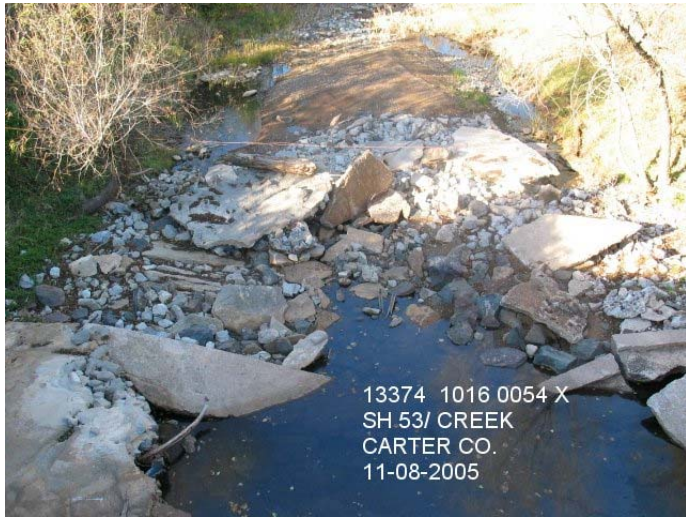
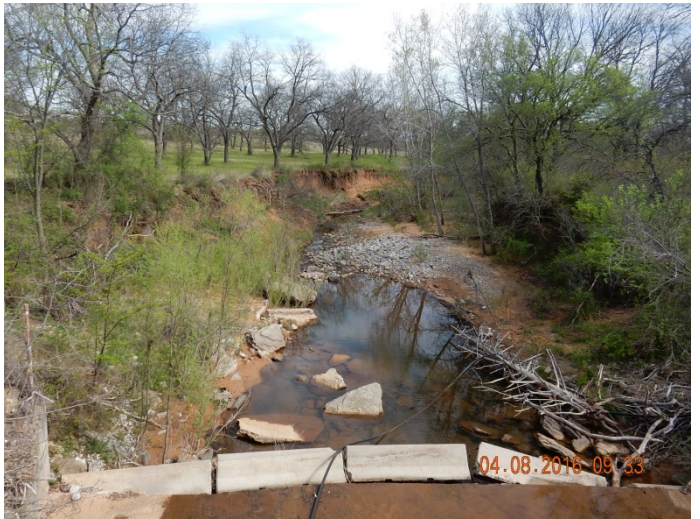
Problem Type: Downstream Degradation

Cost/Outcome: \$ 15,000; Repair is working.

Notes: Completed in 2008.

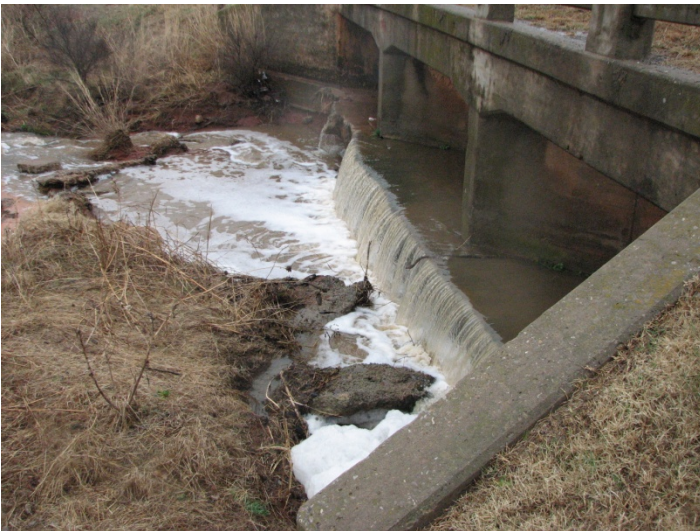
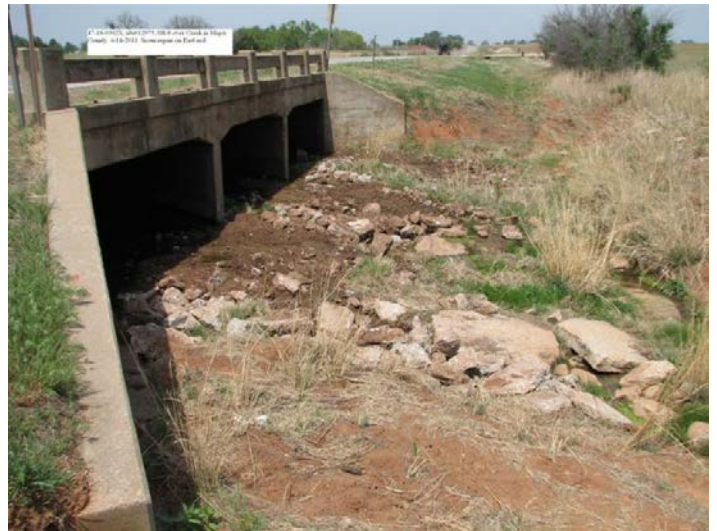
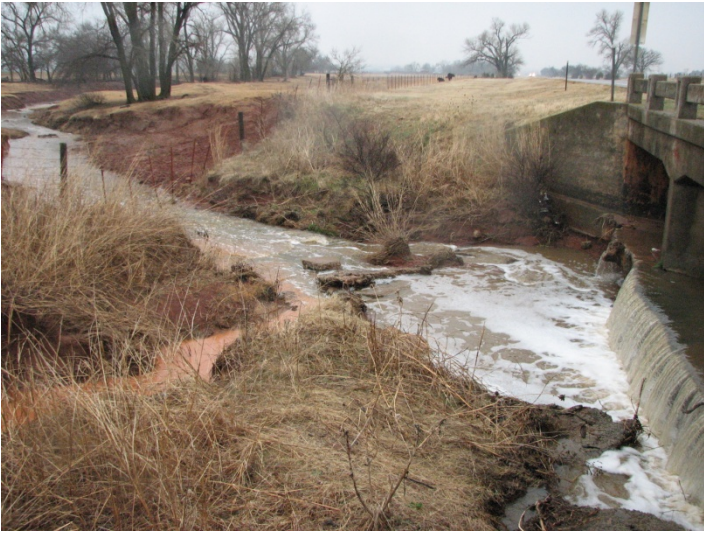
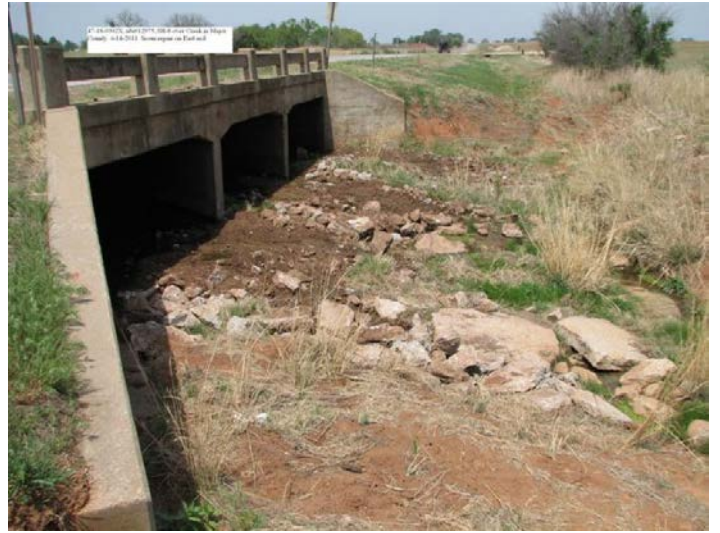
NBI 12975 S.H. 8 over Unnamed Creek

Structure #: 4718 0302X Size: 3-10'x5'x56.8' SK 45°

Problem Type: Degrading Channel

Notes: Completed in 2011.

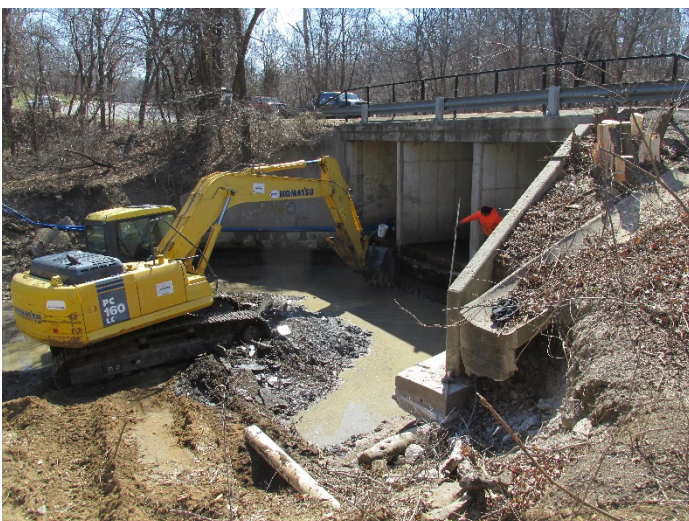
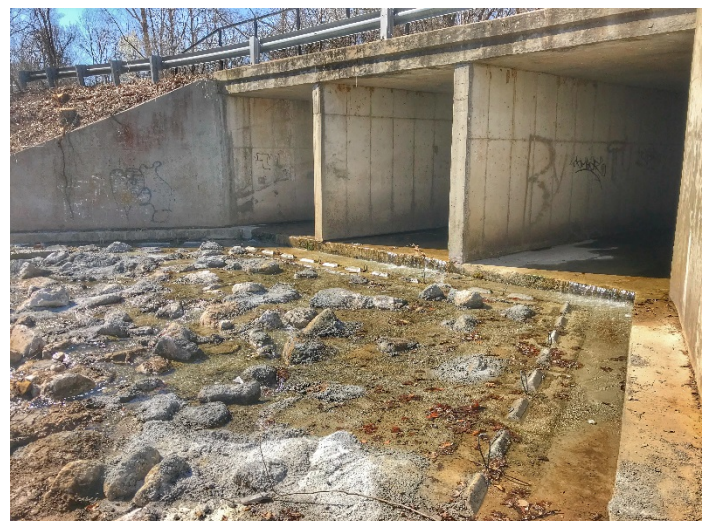
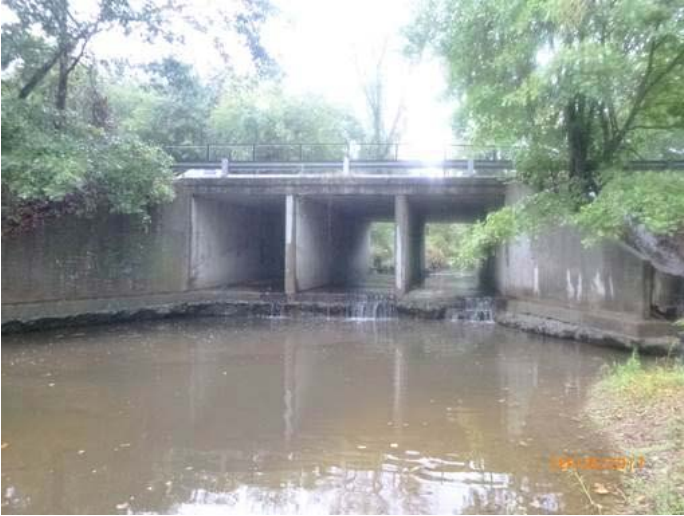
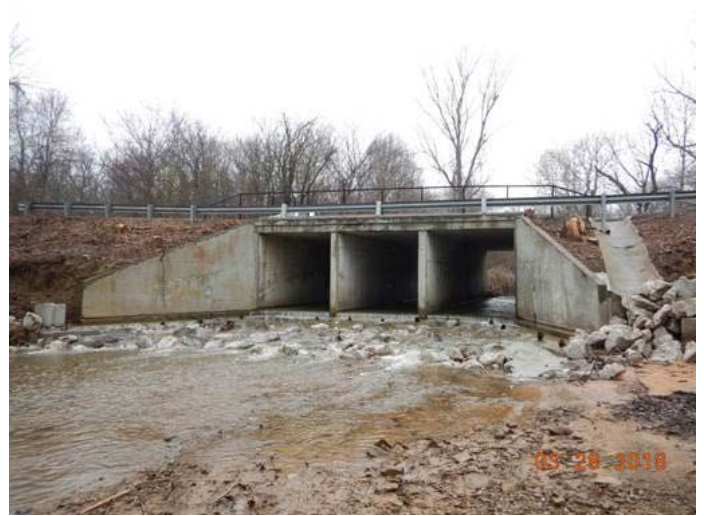
NBI 14748 over Whispering Creek

Problem Type: Downstream Degradation

Notes: Ecology Blocks, Rip Rap, and Flow Fill Placement Used

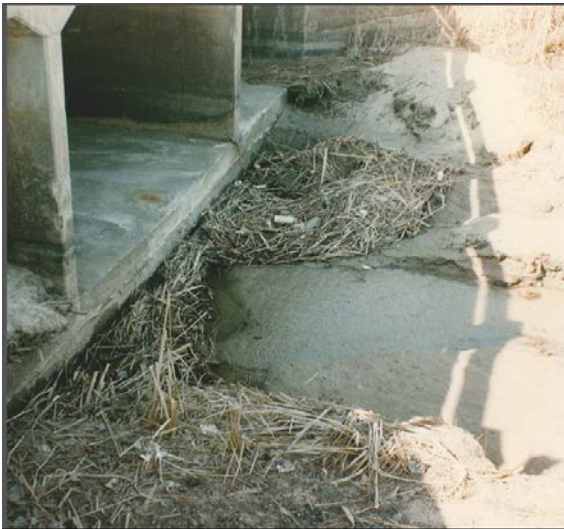
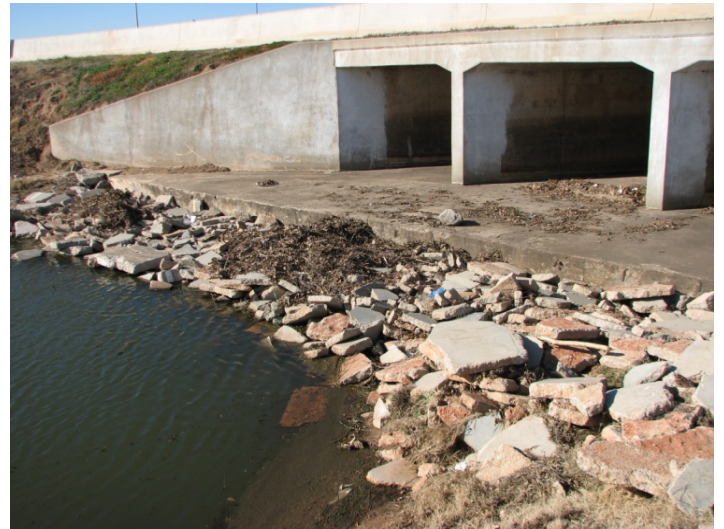
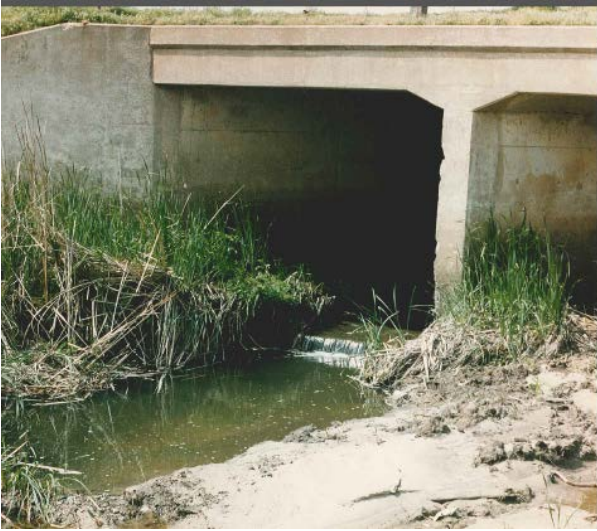
NBI 16393 I-40 over Unnamed Creek

Structure #: 5569 0212X Size: (12'-14'-12')x10'x183' SK 60°

Problem Type: Degradation of Channel

Notes: Completed in 1996 along with the fix of the Rockwell RCB.

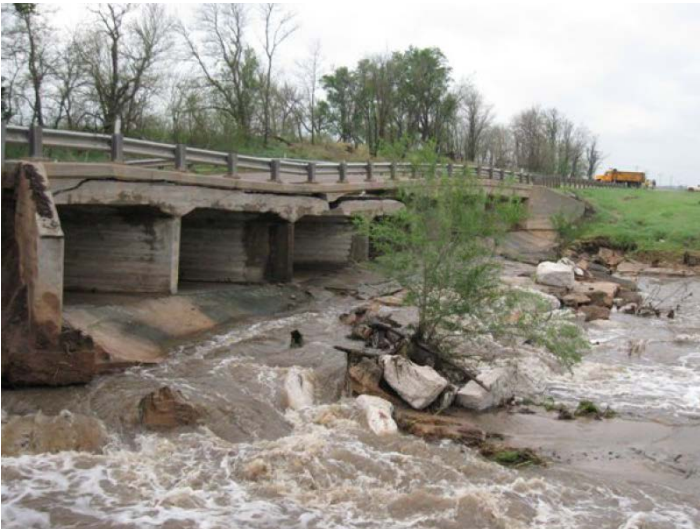
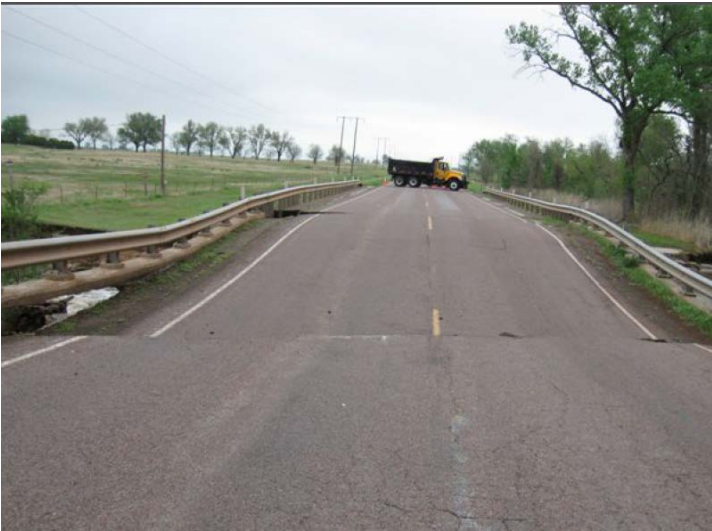
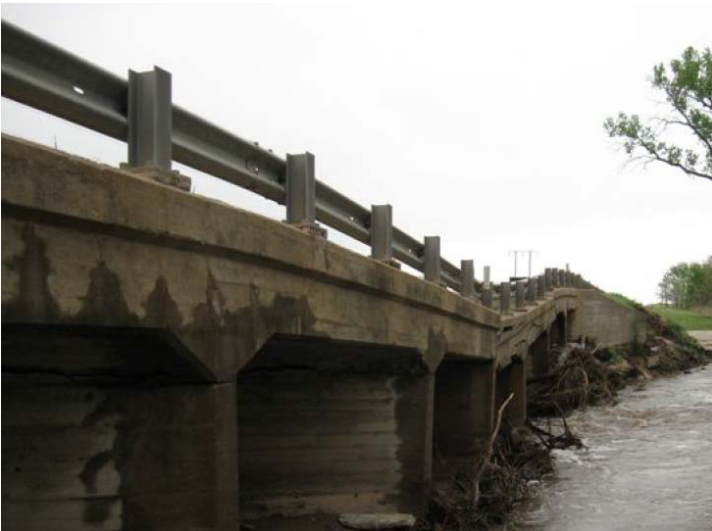
Problem Type: Degrading Channel

Solution: Replace failed RCB.

Notes: Completed in 2009.

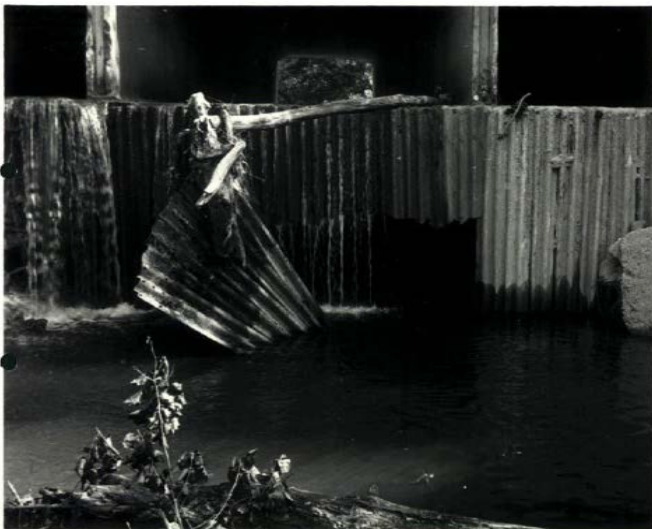
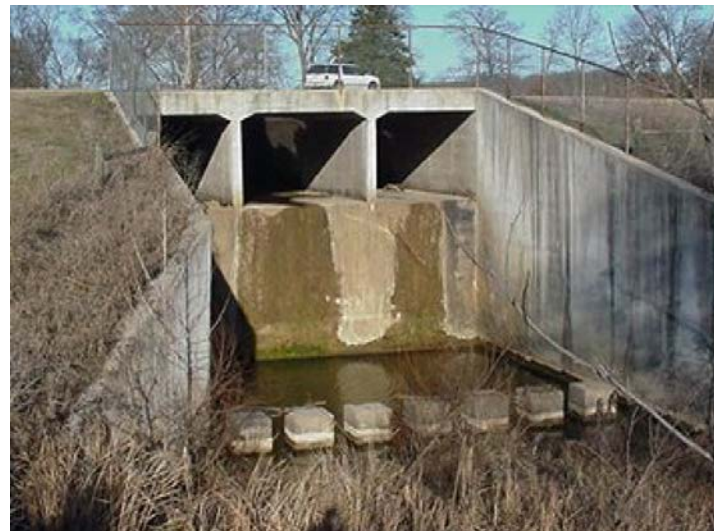
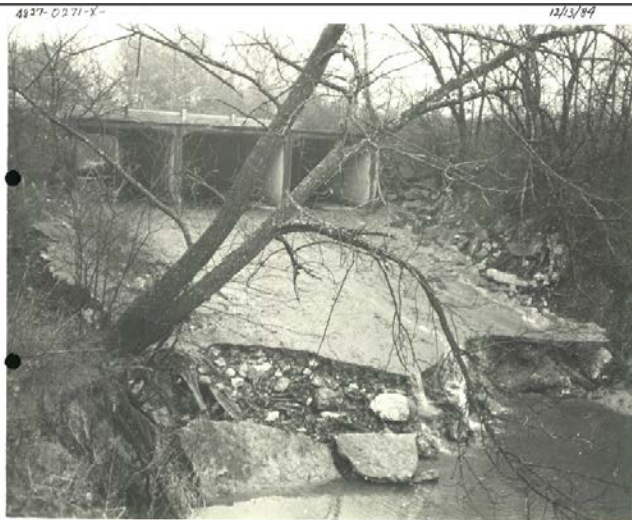
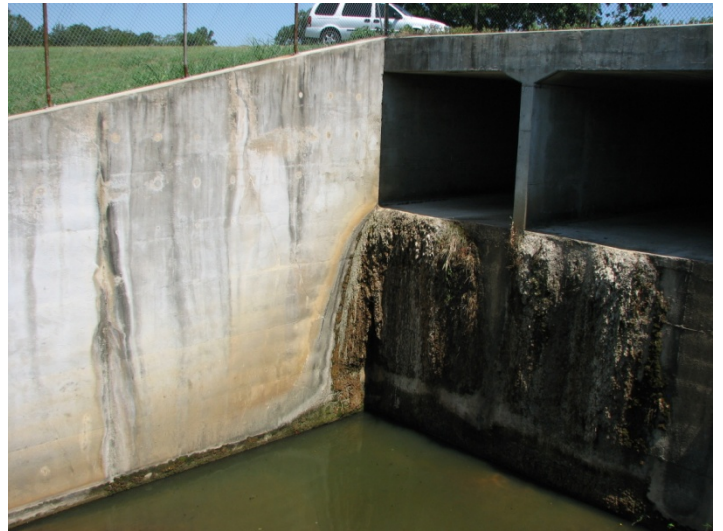
NBI 14956 U.S. 70 over Little Hauani Creek

Structure #: 4827 0271X Size: (12' - 14' - 12') x 10' x 91' RCB SK 30°

Problem Type: Degrading Channel

Location: Degradation of the channel on the downstream side of the RCB.

Notes: Completed in 1992.

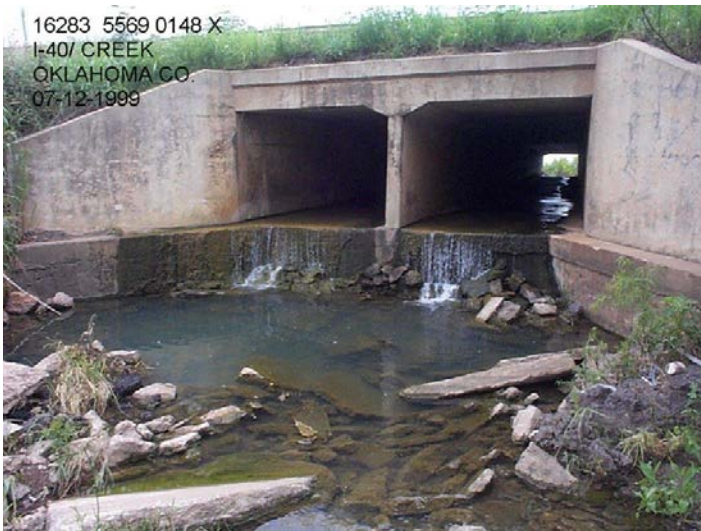
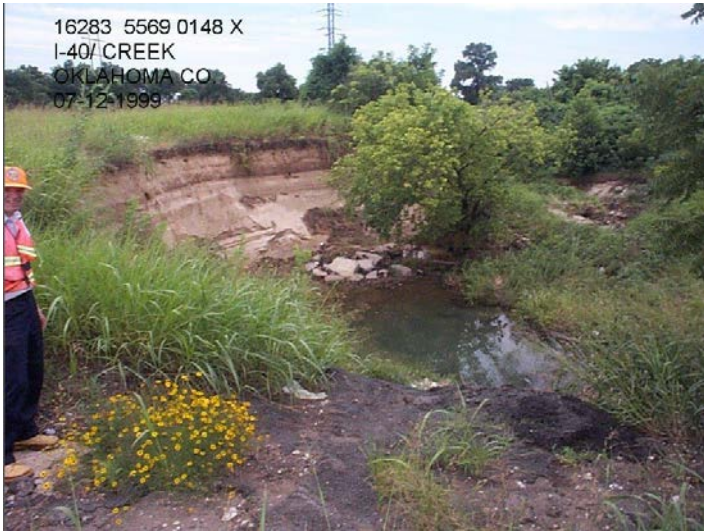
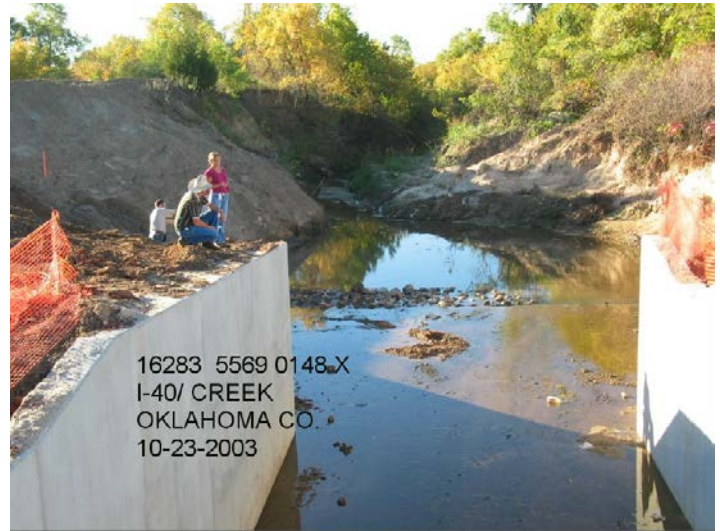
NBI 16283 I-40 over Unnamed Creek

Structure #: 5569 0148X Size: 2-10' X 7' X 182' R.C. BOX

Problem Type: Degradation of downstream channel

Notes: Completed in 2003.

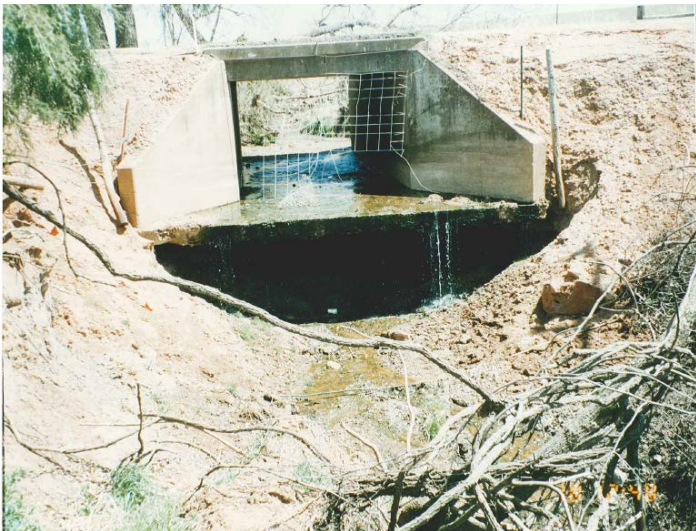
NBI 25082 S.H. 146 over Tributary to Punjo Creek

Structure #: 0851 0381X Size: BROKENBACK RCB US-2-13'X10'X60' DS-2-13'X27'X60' RCB

Problem Type: Degrading Channel

Notes: Completed in 1997. The new structure withstood Tropical Storm Erin which deposited an enormous amount of debris on the upstream side. A well vegetative channel can be seen looking through the 2010 inspection picture.

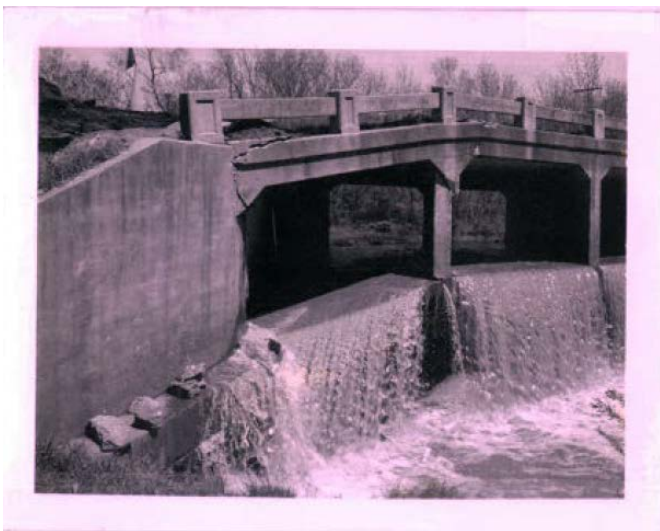
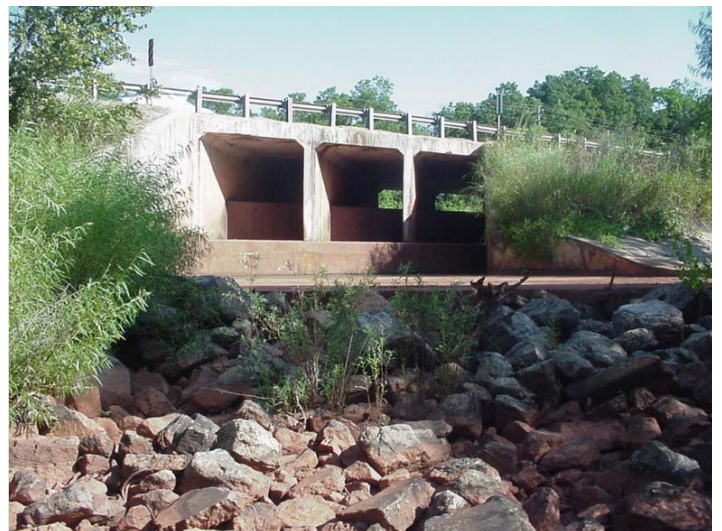
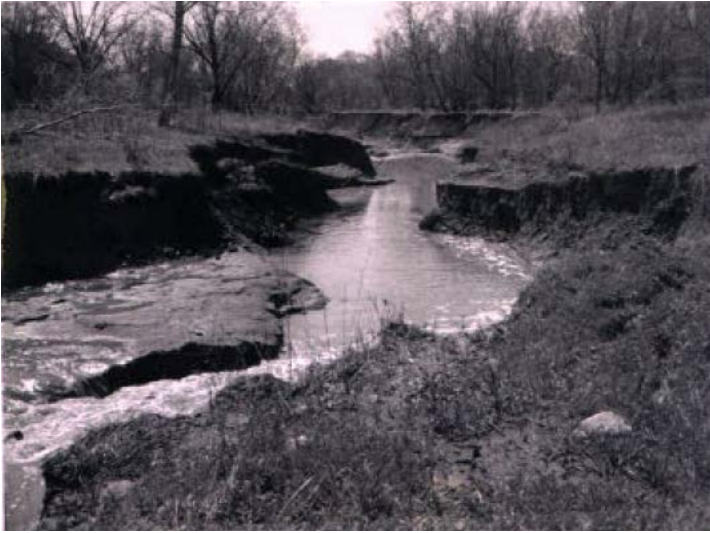
Problem Type: Downstream Degradation

Solution: Replace RCB

Notes: Major work including a drop outlet was completed on the downstream side in 1973. A curtain wall was added on the downstream side of the RCB in 1984.

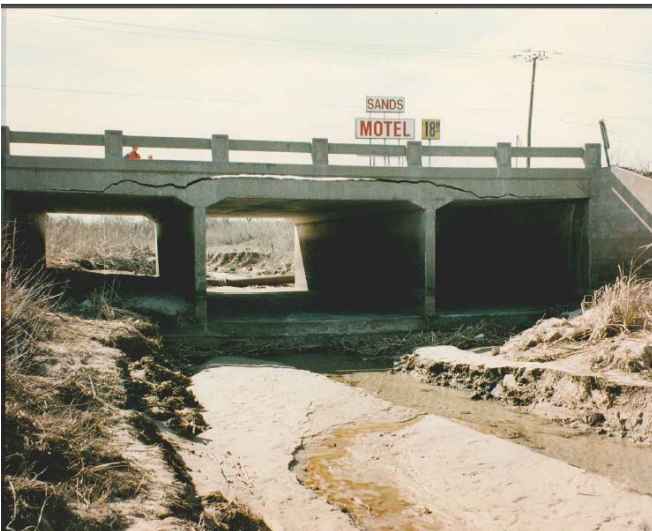
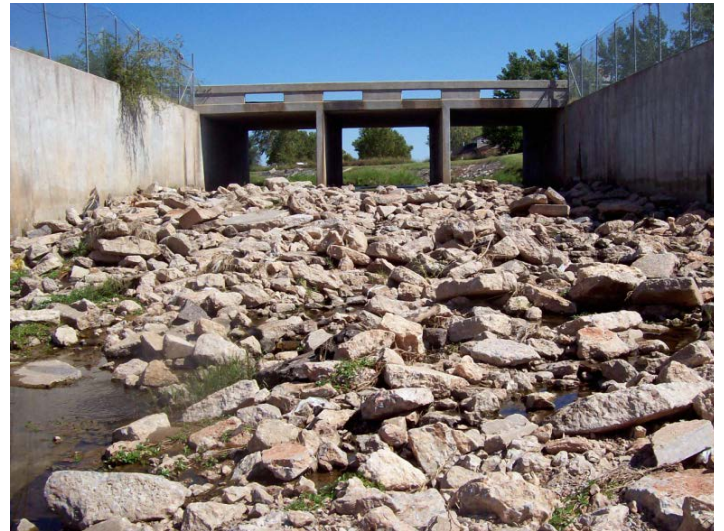
NBI 16373 Rockwell Ave over Unnamed Creek

Problem Type: Downstream Degradation

Location: Degradation through the RCB

Solution: Replace RCB

Notes: Completed in 1996.

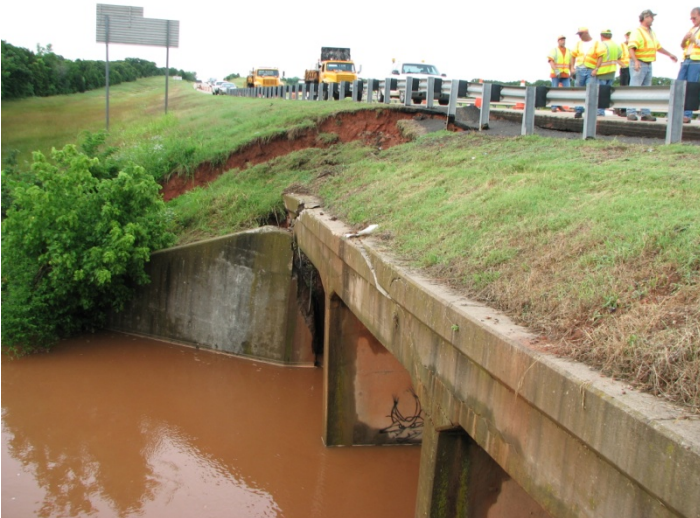
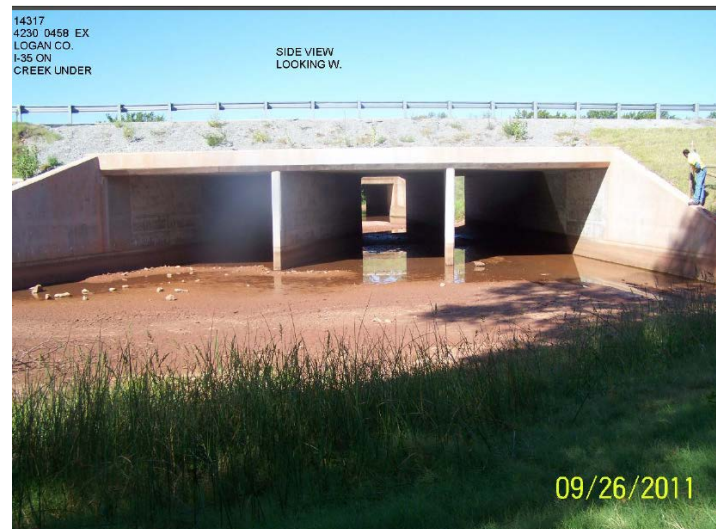
NBI 14317 I-35 over Tributary to Cottonwood Creek

Problem Type: Degradation at the inlet

Solution: Replace Inlet

Notes: Completed in 2010.

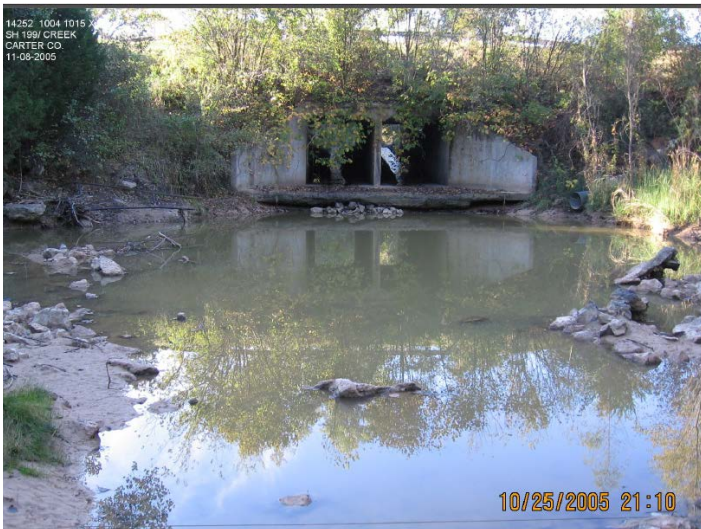
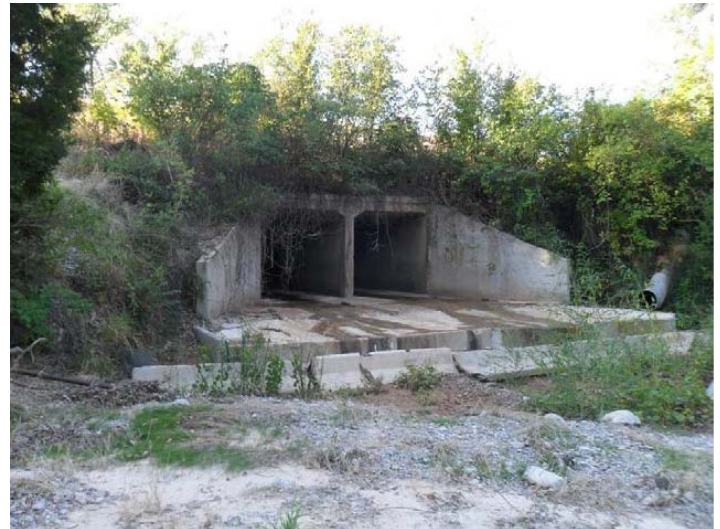
NBI 14252 S.H. 199 over Unnamed Creek

Problem Type: Downstream Degradation

Notes: Completed in 2009.

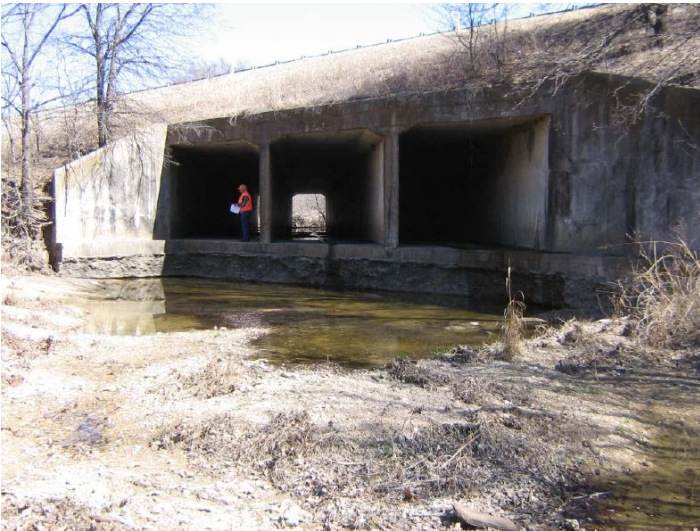
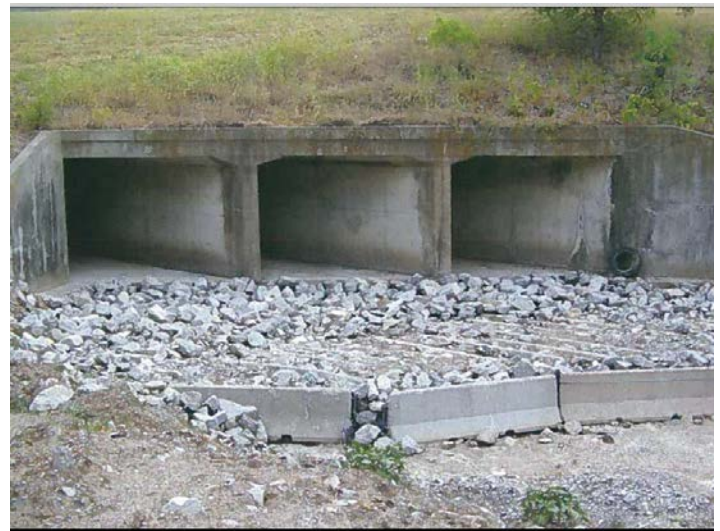
NBI 15702 I-35 over Bills Creek

Problem Type: Downstream Degradation

Notes: Completed in 2011.

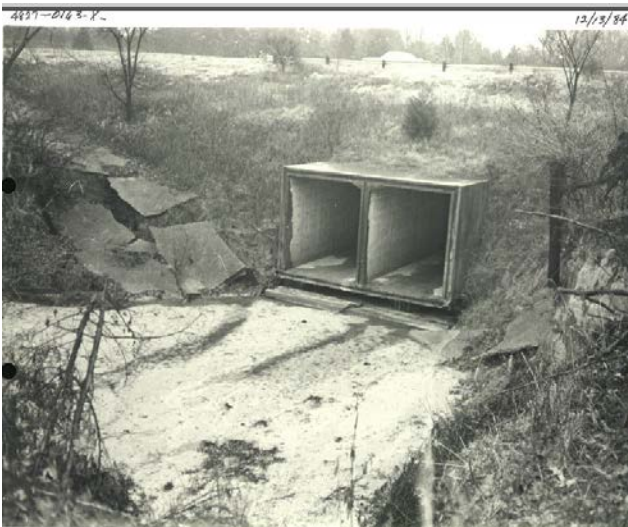
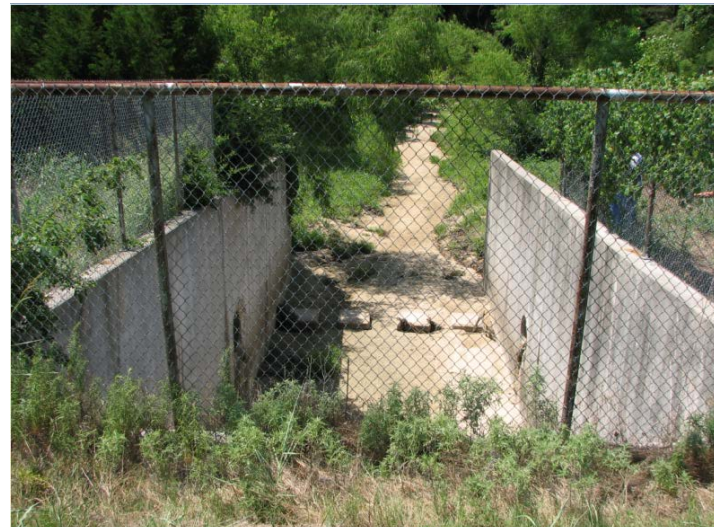
NBI 14726 U.S. 70 over Unnamed Creek

Problem Type: Downstream Degradation

Notes: Completed in 1990.

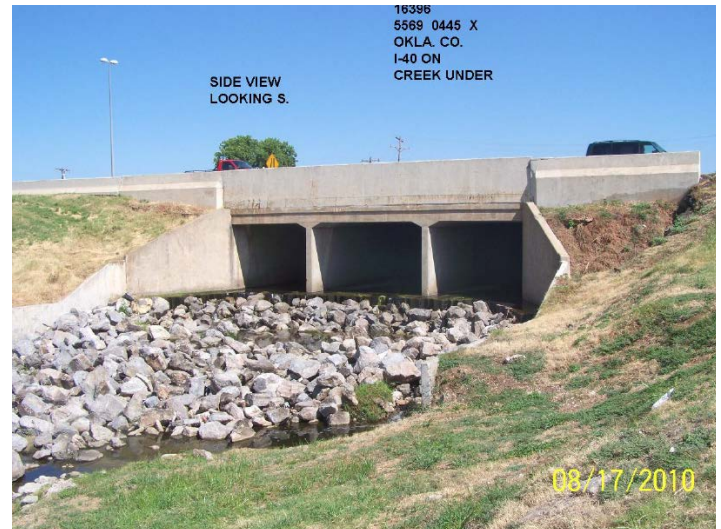
Problem Type: Degradation

Notes: Completed in 1999.

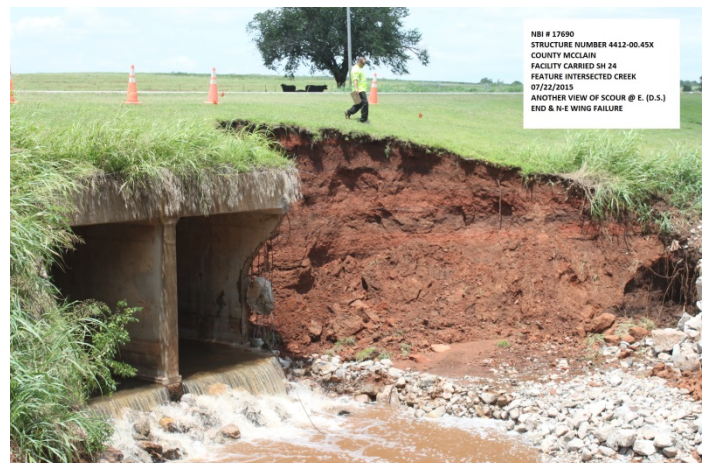
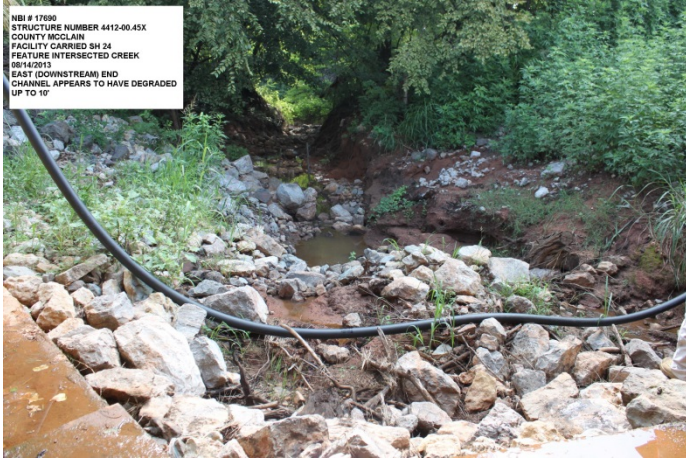
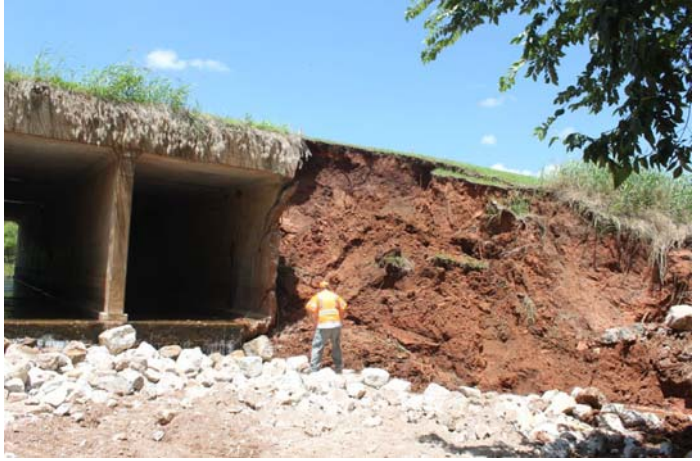
NBI 17690 S.H. 24 over Unnamed Creek

Problem Type: Downstream Degradation

Notes: After the wing was replaced, grouted riprap was also placed in the channel.

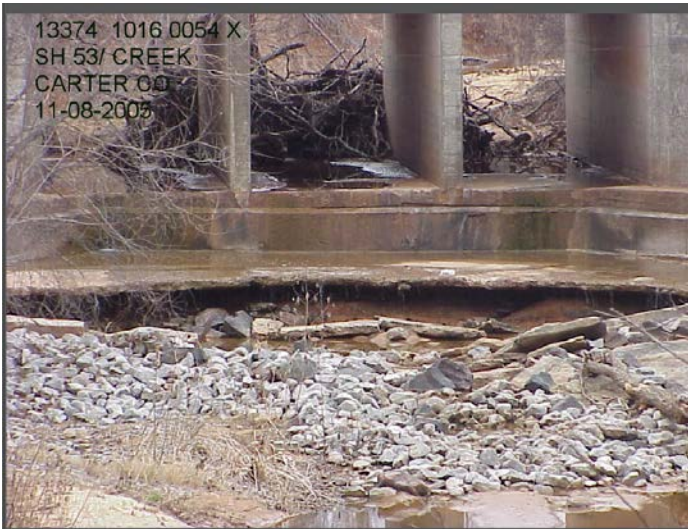
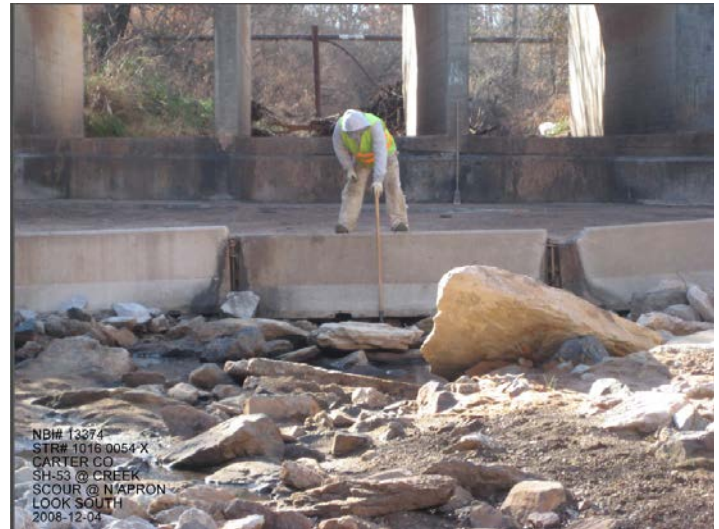
NBI 13374 S.H. 53 over Whiskey Creek

Problem Type: Degradation with undermining

Notes: Completed in 2008.

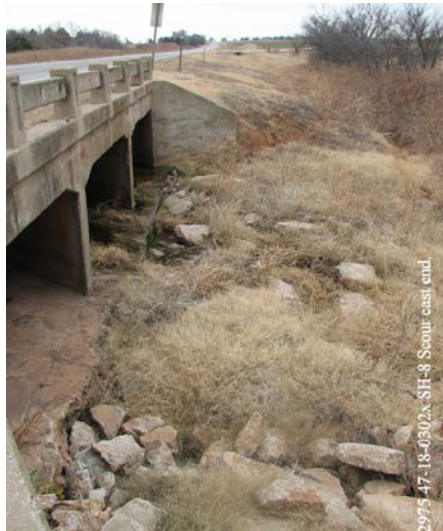
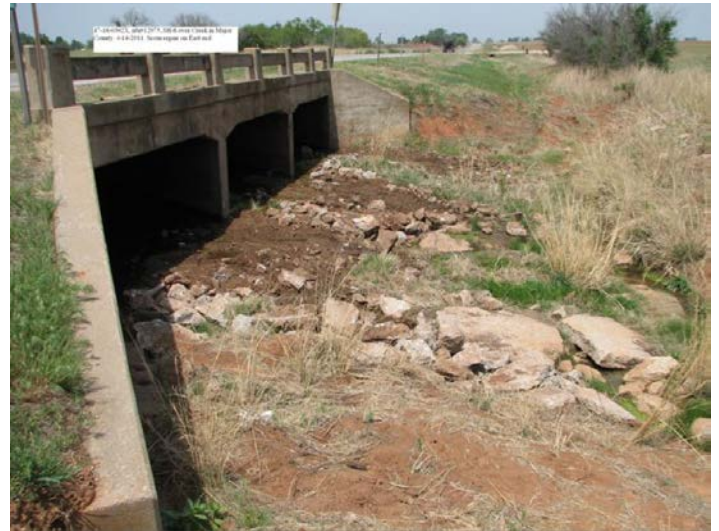
Problem Type: Degradation and undermining

Notes: Completed in 2010.

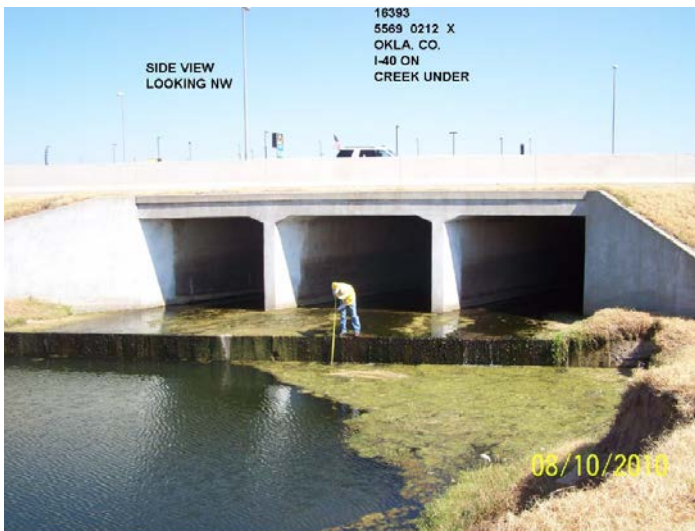
NBI 16393 I-40 over Unnamed Creek

DEG. Problem Type: Degradation and undermining

Notes: Completed in 1996 along with the fix of the Rockwell RCB.

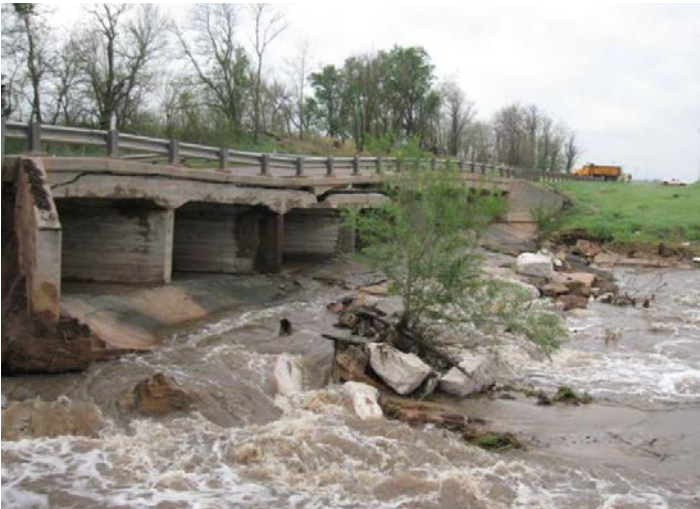
BEFORE

NBI 12611 S.H. 8 over Unnamed Creek

Problem Type: Degradation and undermining

Solution: Replace failed RCB.

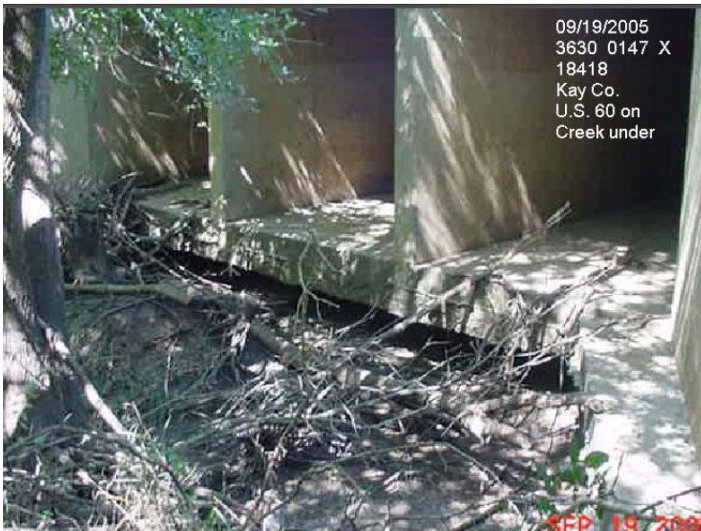
BEFORE

NBI 18418 U.S. 60 over Unnamed Cr (Near Chikaskia River)

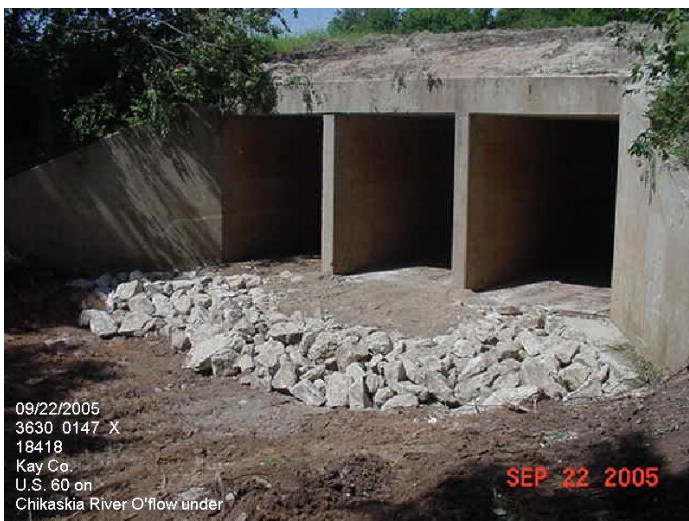
BEFORE

NBI 18418 U.S. 60 over Unnamed Cr (Near Chikaskia River)

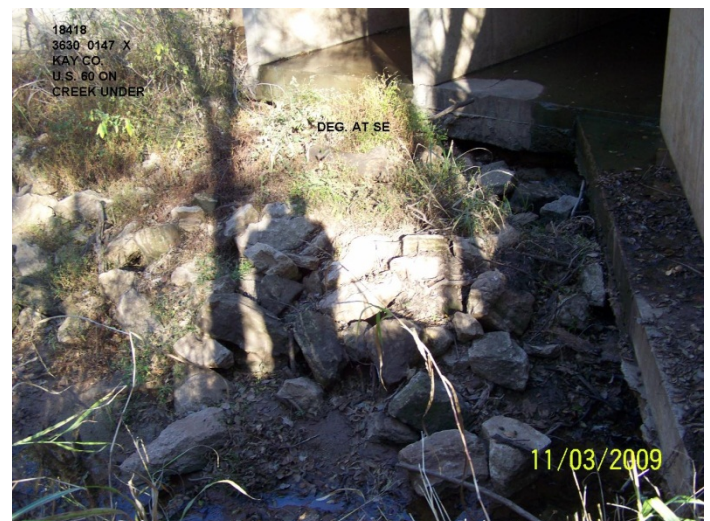
AFTER

Cost/Outcome: This countermeasure failed.

Notes: Completed in 2005

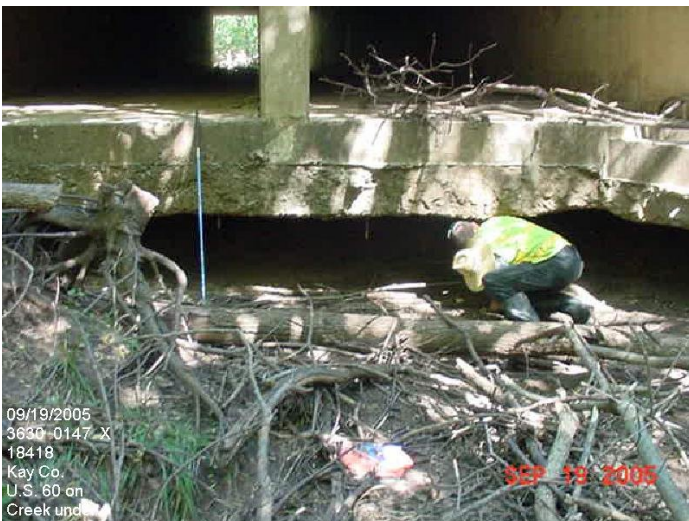
BEFORE

NBI 18418 U.S. 60 over Unnamed Cr (Near Chikaskia River)

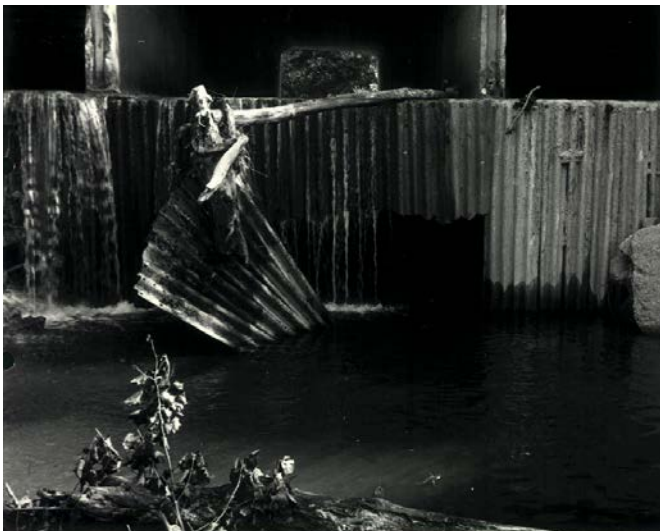
BEFORE

NBI 14956 US 70 over Little Hauani Creek

Problem Type: Degradation and undermining

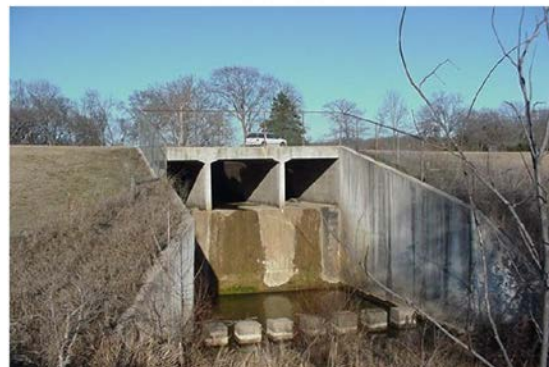
AFTER

4827 0271X
NBI# 14956
MARSHALL COUNTY
U.S. 70
LITTLE HAVANI CREEK
01/09/2007

Notes: Completed in 1993.

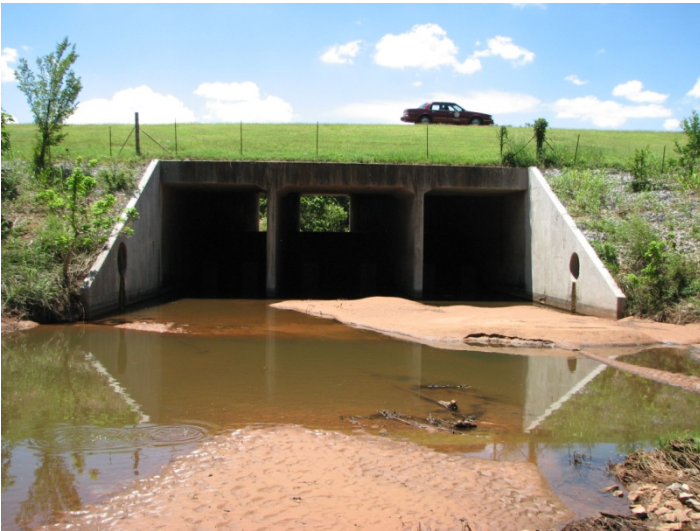
AFTER

NBI 14072 I-35 over Coffee Creek

Problem Type: Channel Degradation with Undermining of RCB.

Location: Channel degradation on the downstream side

Notes: Completed in 1993. Most of the gabions have washed away.

Solution: Build a broken back drop outlet with chute blocks and place gabions at the outlet.

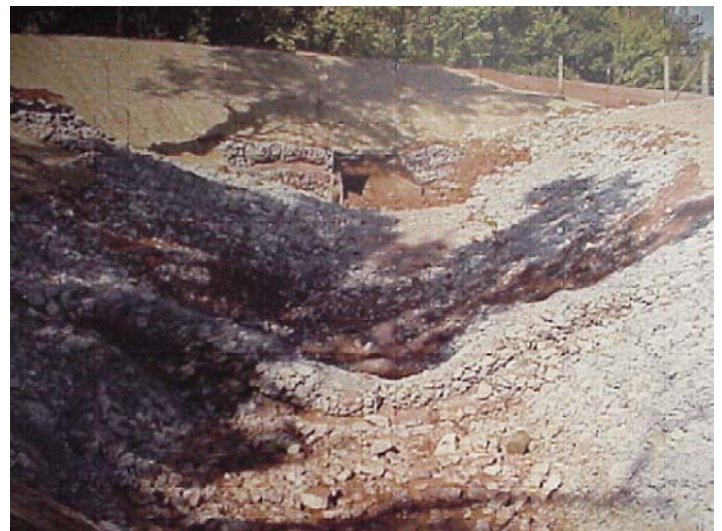
AFTER

S.H. 39 over Unnamed Creek

Problem Type: Degradation of the downstream channel with undermining of the RCB.

Notes: The RCB is 4.5 miles east of US 177 in Pottawatomie county. The drainage channel had degraded 11 ft.
