Countermeasures

Countermeasures are an important and necessary part of bridge maintenance. Not only must the countermeasure restore the safety of the structure, but guard against future assaults. This often has to be completed in a short time and on a shoe string budget.

This document will display some of the different types of countermeasures that have been used both successfully and unsuccessfully in Oklahoma.

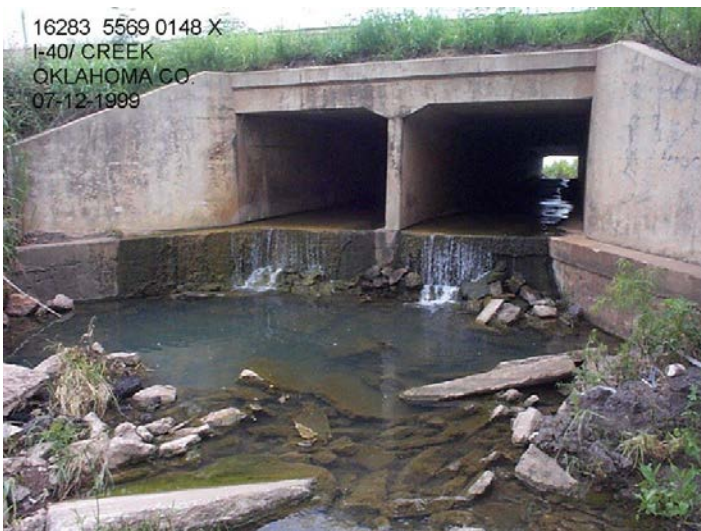
BEFORE

NBI 16283 I-40 over Unnamed Creek

Problem Type: Degradation and undermining

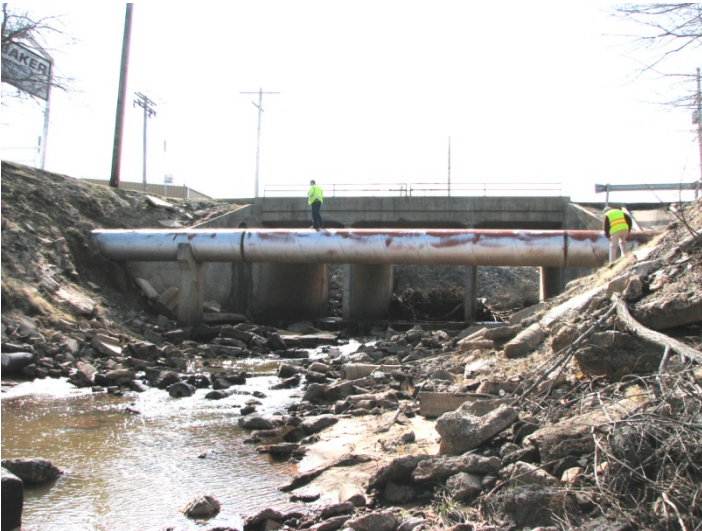
BEFORE

Problem Type: Degradation and Undermining

Location: Degradation of downstream channel

Solution: Replace RCB.

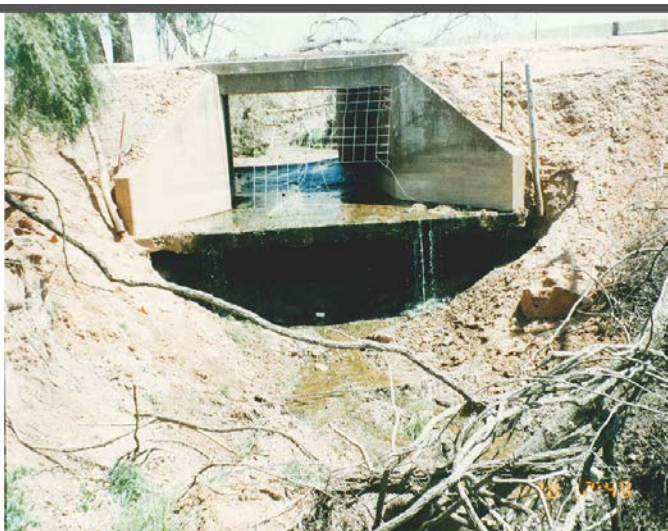
BEFORE

NBI 25082 S.H. 146 over Punjo Creek

Problem Type: Degradation and Undermining

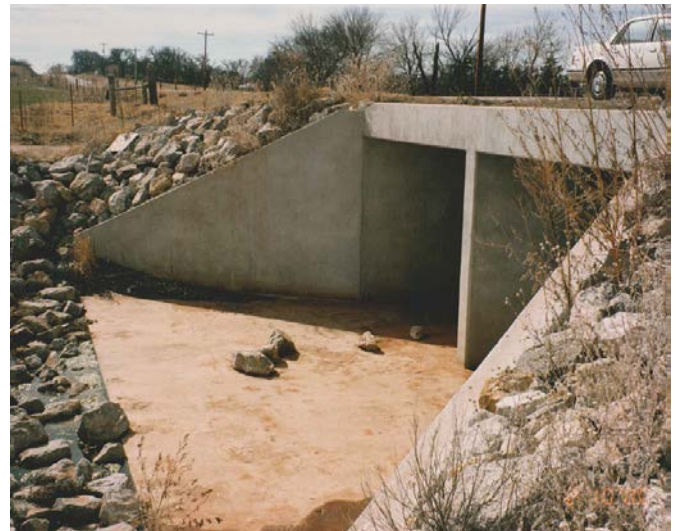
AFTER

Notes: Completed in 1997. The new structure withstood Tropical Storm Erin which deposited an enormous amount of debris on the upstream side.

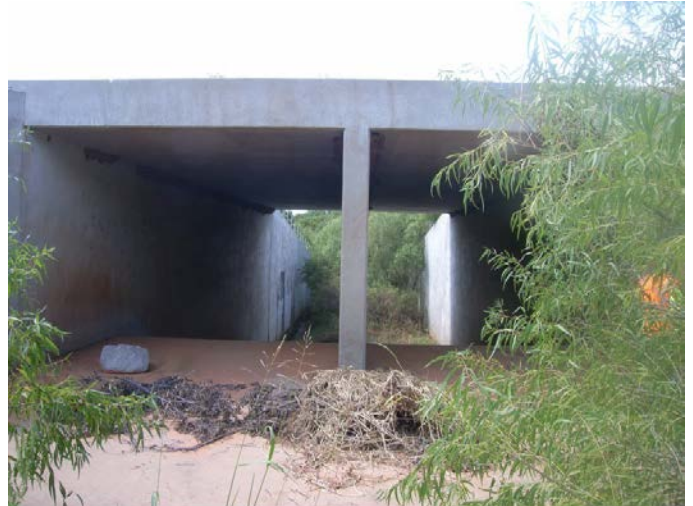
AFTER

NBI #: 22082 Str #: 0651 0381 X Caddo County
 Facility Carried: S.H. 148
 Feature Int.: PUNJO CREEK
 24 September, 2011
 Looking W

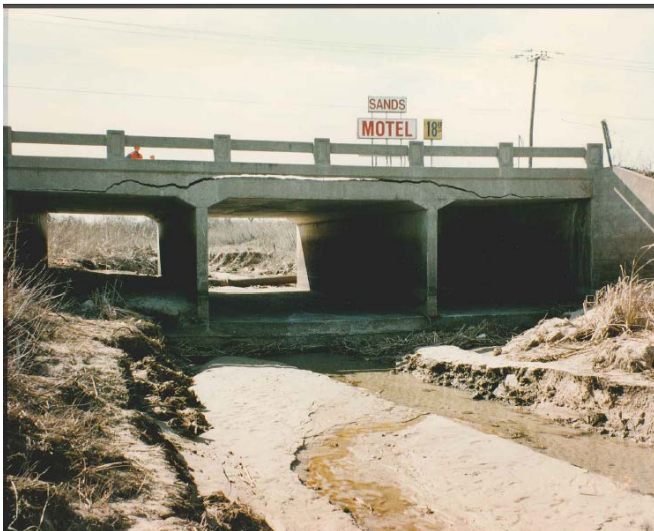
BEFORE

Problem Type: Degradation and Undermining

Location: Degradation through the RCB

Solution: Replace RCB

Notes: Completed in 1996.

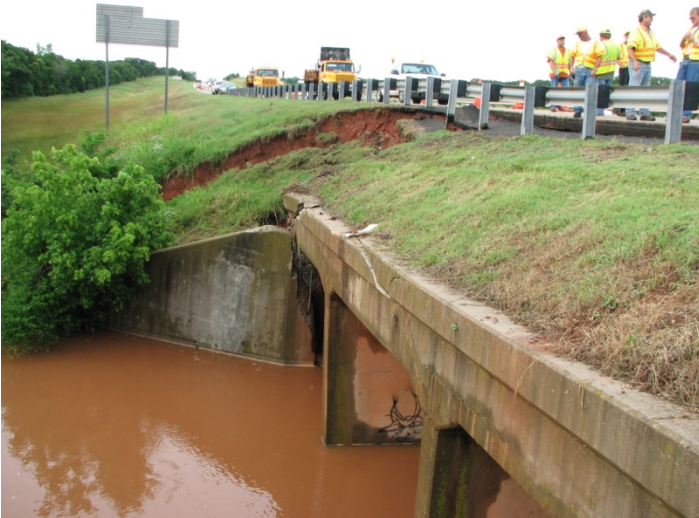
BEFORE

Problem Type: Degradation and Undermining

Solution: Replace Inlet

Notes: Completed in 2010.

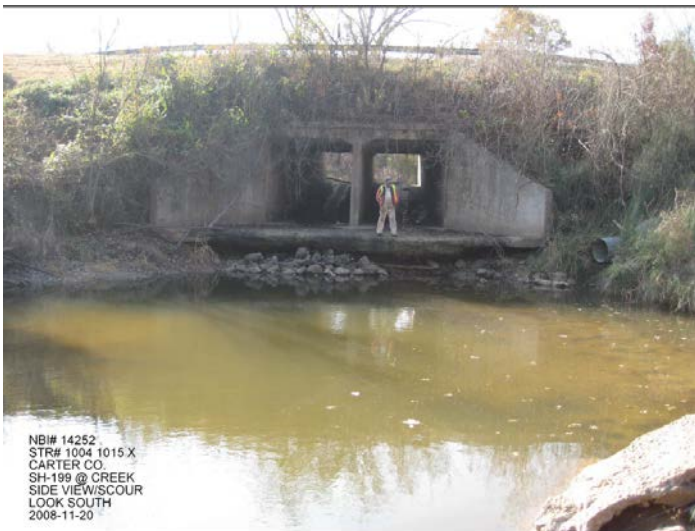
BEFORE

NBI 14252 S.H. 199 over Unnamed Creek

Structure #: 1004 1015X Size: 2-10'x10'x82' RCB

Problem Type: Degradation and Undermining

Notes: Completed in 2009.

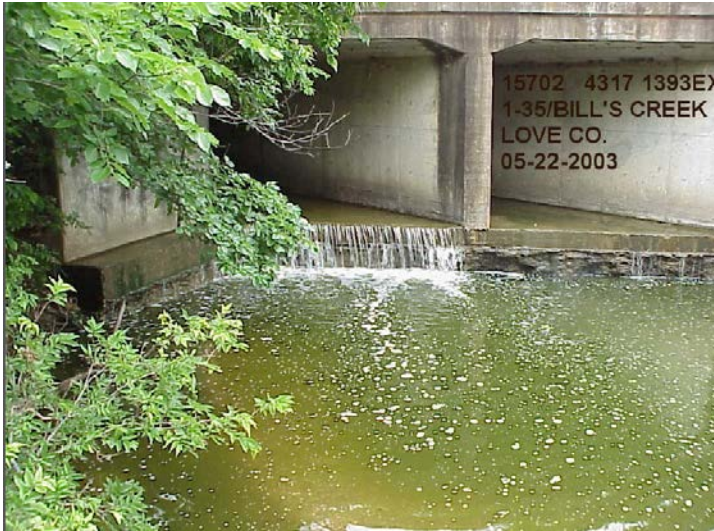
BEFORE

NBI 15702 I-35 over Bills Creek

Structure #: 4317 1393EX Size: 3-10'x10'x133' SK 45°

Problem Type: Degradation and Undermining

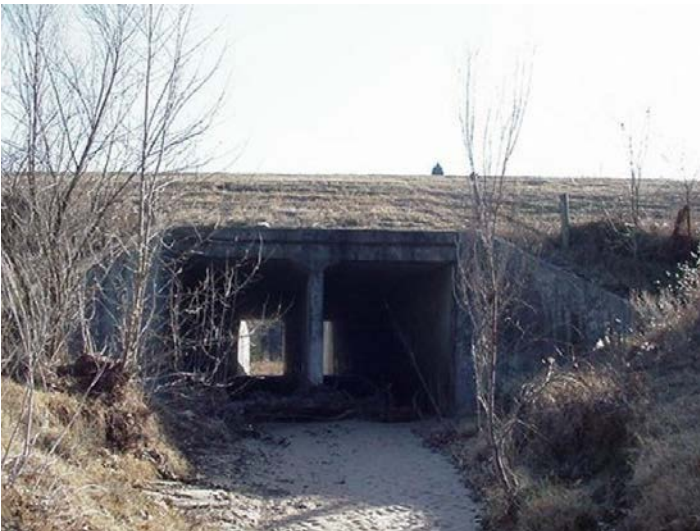
BEFORE

NBI 14726 U.S. 70 over Unnamed Creek

Structure #: 4827 0163X Size: 2-10'x12'x138' RCB

Problem Type: Degradation and Undermining

Notes: Completed in 1990.

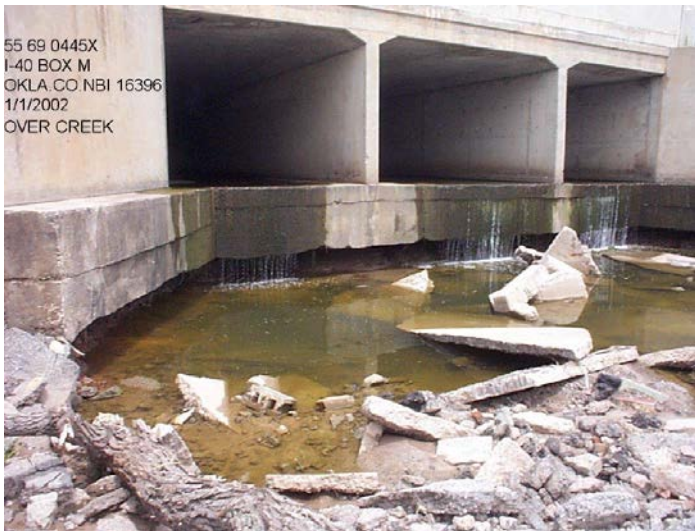
BEFORE

Problem Type: Degradation and Undermining

Notes: Completed in 1999.

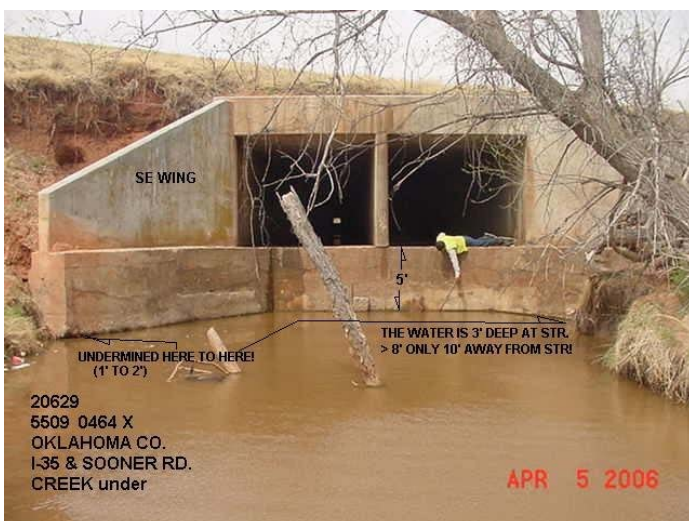
BEFORE

Problem Type: Degradation and Undermining

Cost/Outcome: Failed after 5 years.

Notes: The riprap was placed in 2006 and lasted until 2011.

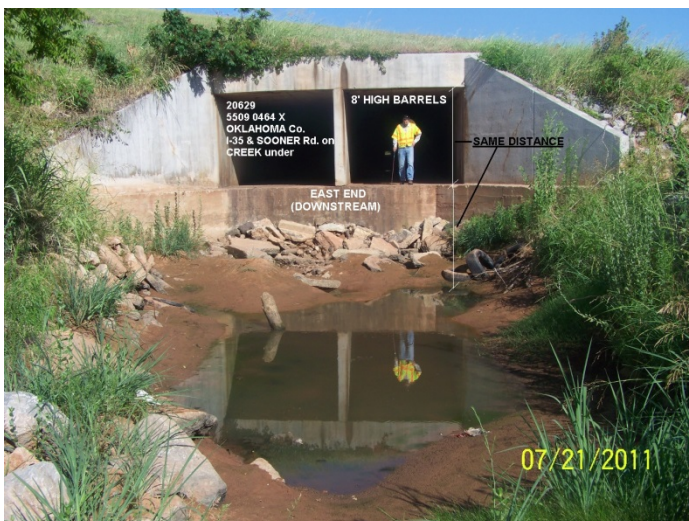
BEFORE

Problem Type: Degradation and Undermining

Notes: Out of spec Jersey Barrier Walls were placed at the outlet and then backfilled with riprap.

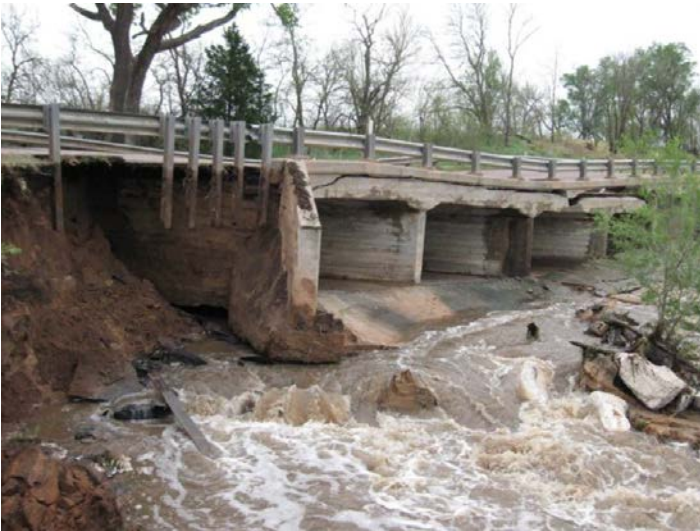
BEFORE

NBI 12611 S.H. 8 over Unnamed Creek

Structure #: 0208 0156X Size: 2(10.25',2-12.5,10.25)x6'x34' SK 60°

Solution: Replace failed RCB.

Notes: Completed in 2009.

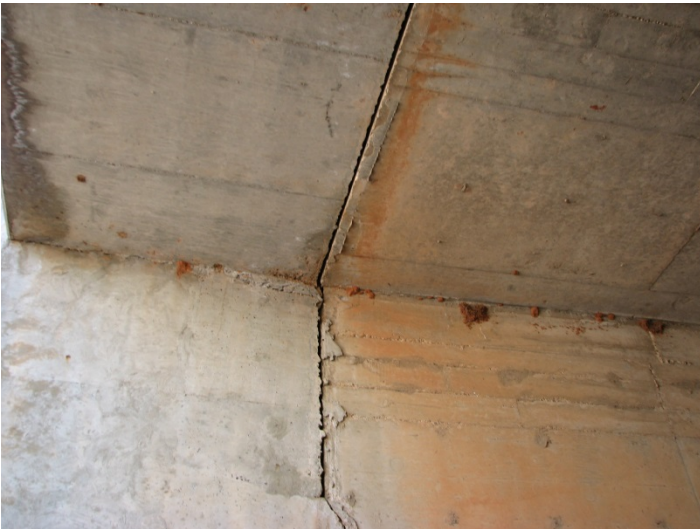
BEFORE

NBI 23278 Reno at Scott Street

Structure #: 55E1070N3100009 Size: (13'-17'-13')x15'x50' RCB

Solution: Replace RCB.

Notes: Completed in 2011.

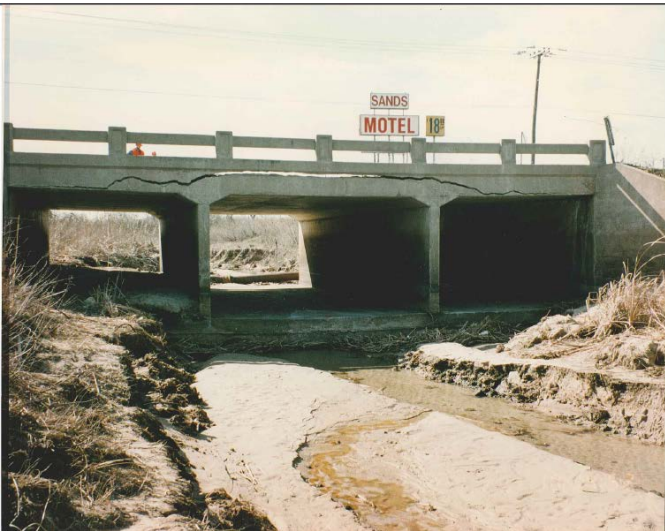
BEFORE

Location: Degradation through the RCB

Solution: Replace RCB

Notes: Completed in 1996.

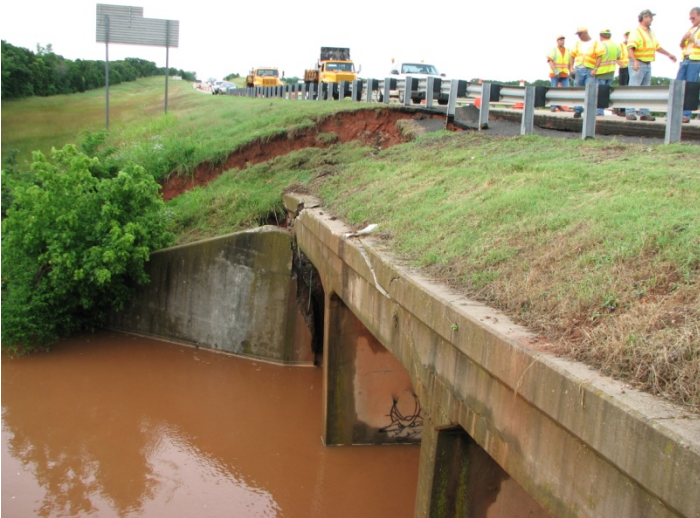
BEFORE

NBI 14317 I-35 over Tributary to Cottonwood Creek

Structure #: 1028 0276X Size: (12'-14'-12') X 12' X 78' R.C.BOX

Solution: Replace Inlet

Notes: Completed in 2010.

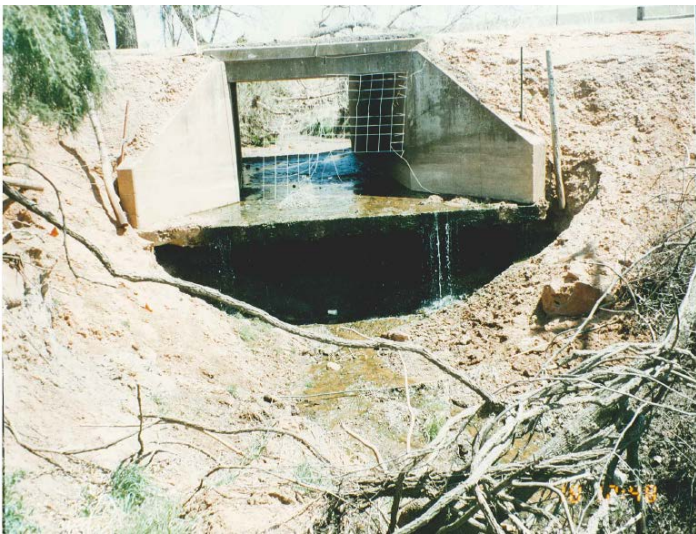
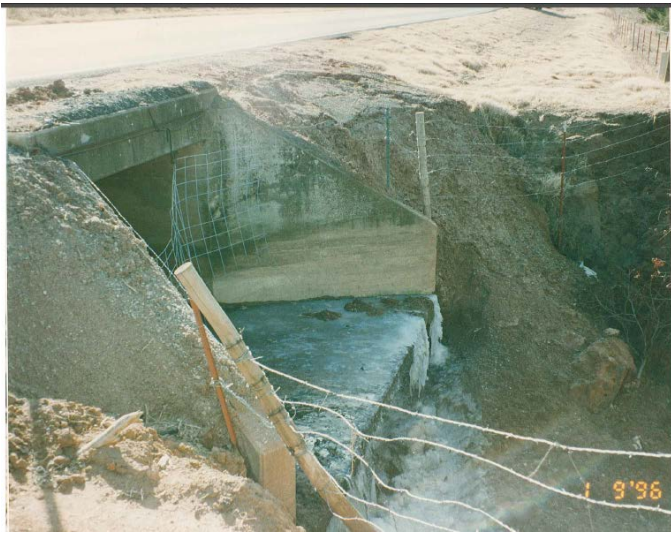
NBI 25082 S.H. 146 over Tributary to Punjo Creek

Notes: Completed in 1997. The new structure withstood Tropical Storm Erin which deposited an enormous amount of debris on the upstream side. A well vegetative channel can be seen looking through the 2010 inspection picture.

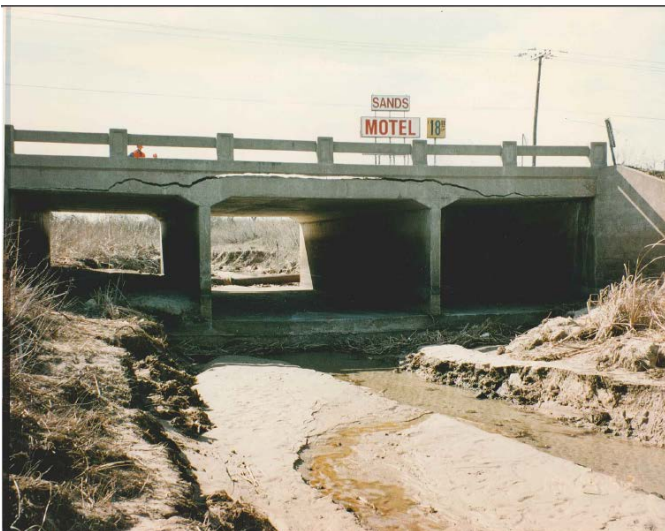
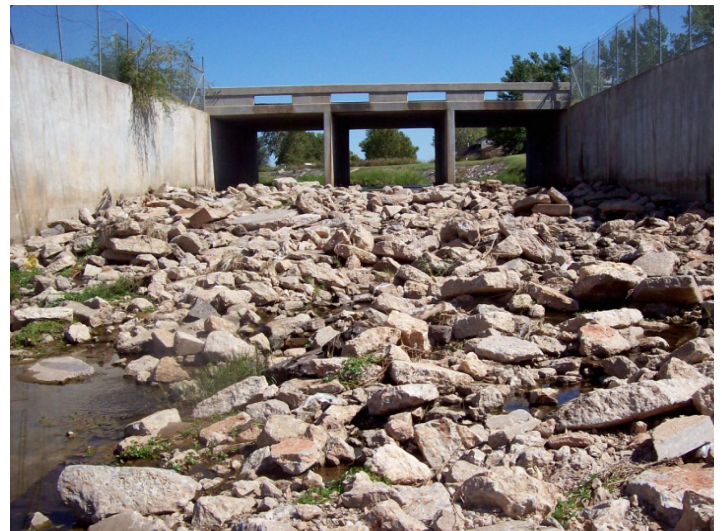
Location: Degradation through the RCB

Notes: Completed in 1996.

Solution: Replace RCB

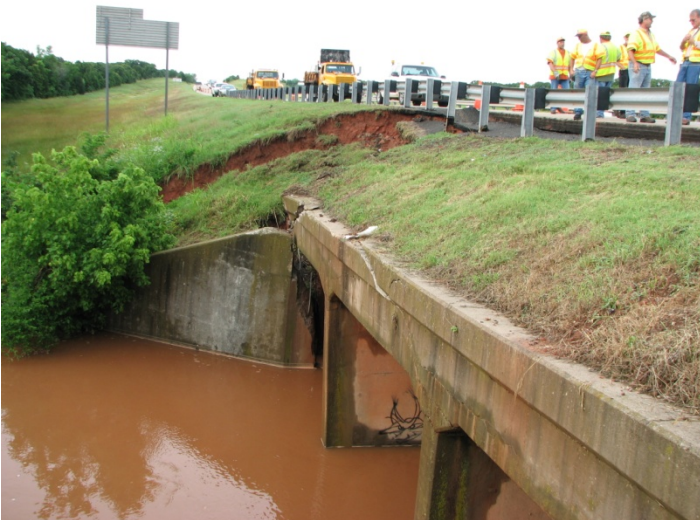
Notes: Completed in 2010.

Solution: Replace Inlet

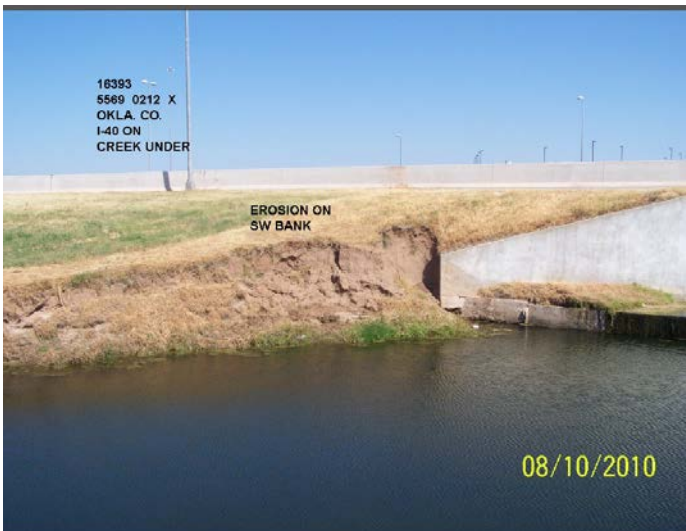
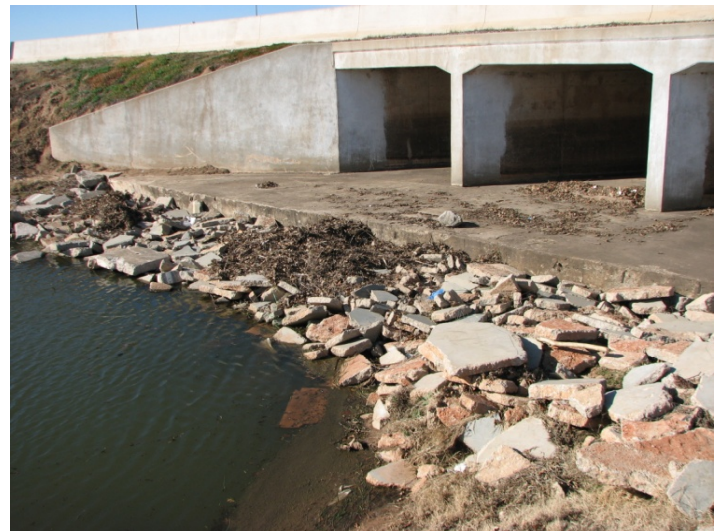
NBI 16393 I-40 over Unnamed Creek

Notes: Completed in 1996.

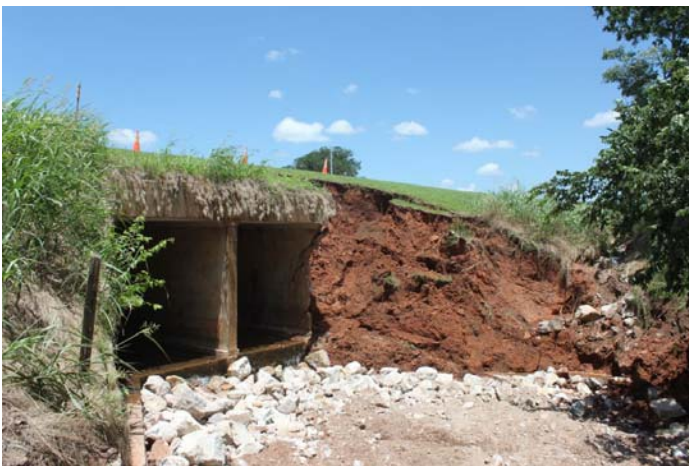
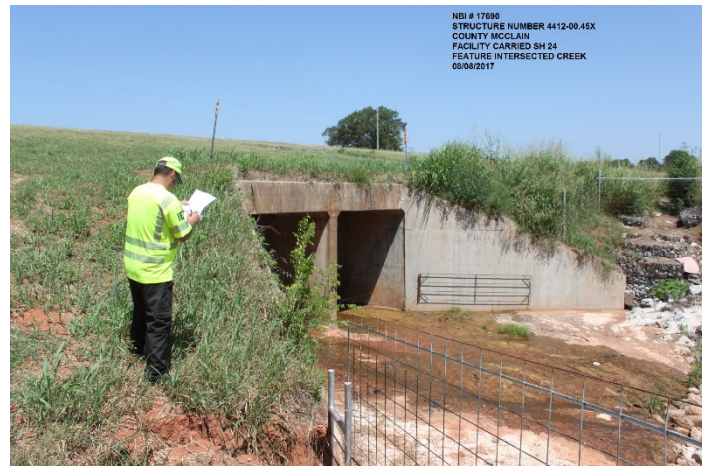
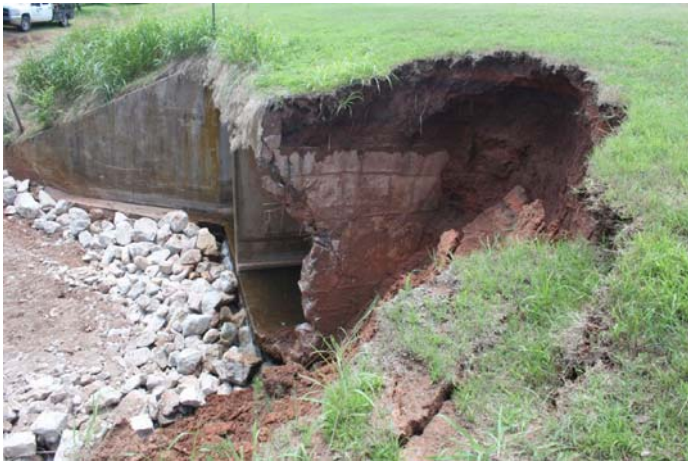
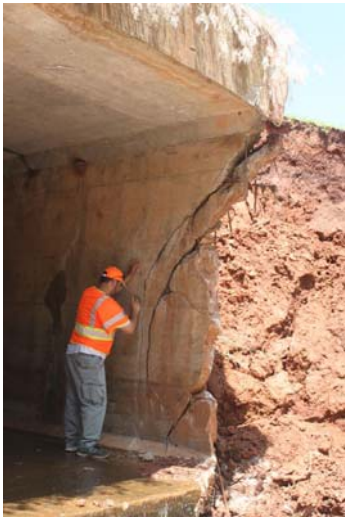
NBI 17690 S.H. 24 over Unnamed Creek

Problem Type: Wingwall - Cracks, Loss, Erosion, or Undermining

Cost/Outcome: \$18000

Solution: Re-poured the wingwall and the broken section of the barrel

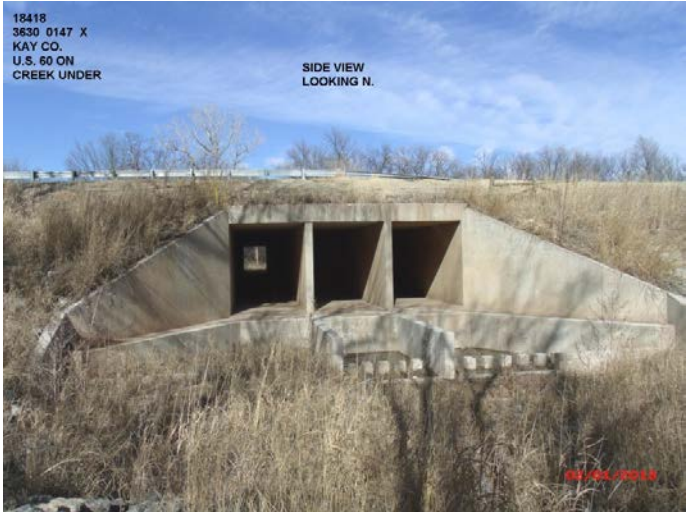
NBI 18418 U.S. 60 over Unnamed Creek

Notes: Completed in 2011.

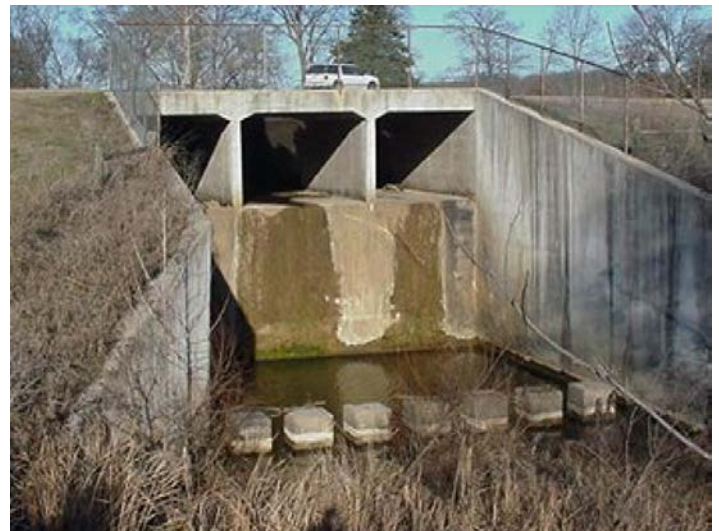
NBI 14956 US 70 over Little Havant Creek

Notes: Completed in 1993.

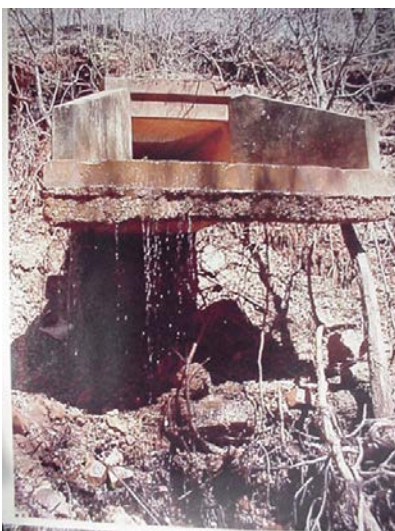
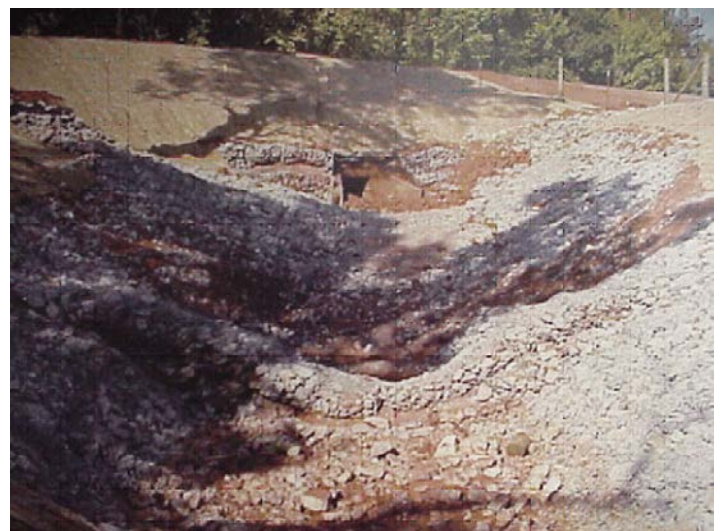
S.H. 39 over Unnamed Creek

Notes: The RCB is 4.5 miles east of US 177 in Pottawatomie county. The drainage channel had degraded 11 ft.

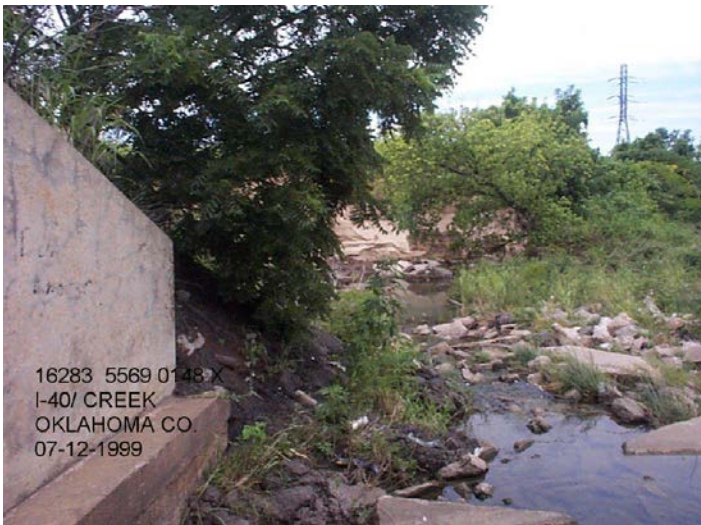
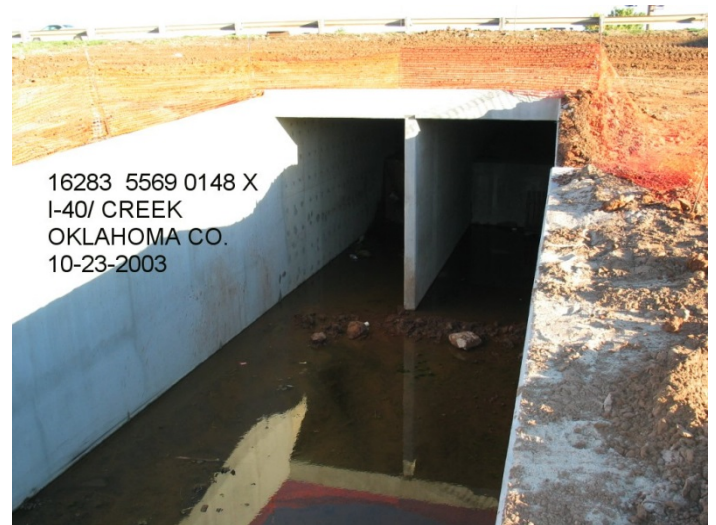
NBI 16283 I-40 over Unnamed Creek

Notes: Completed in 2003.

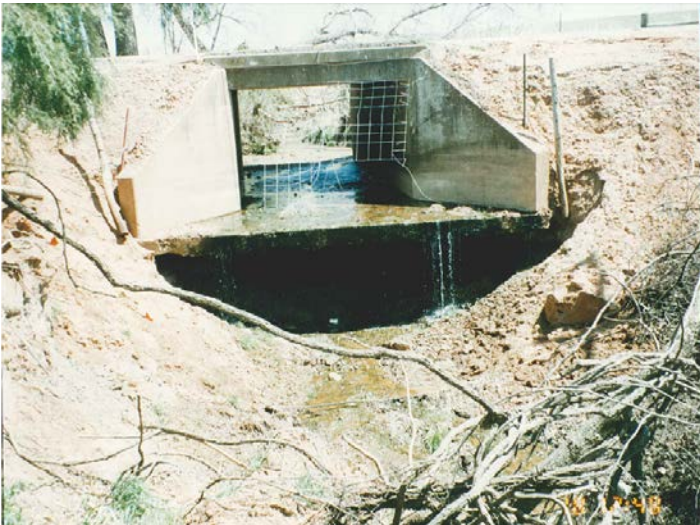
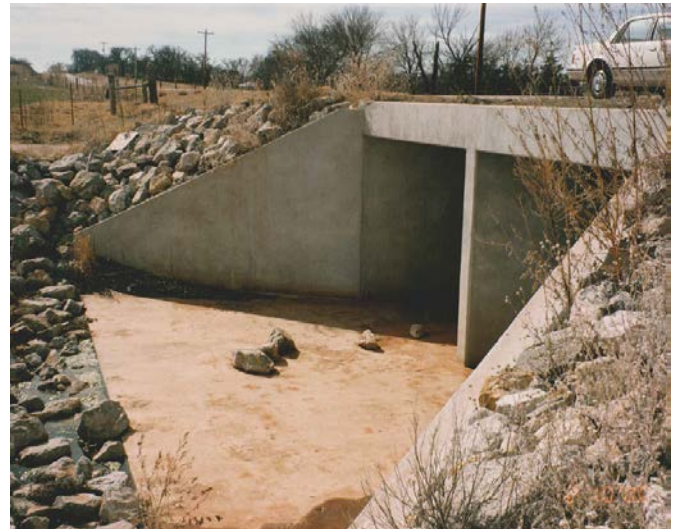
NBI 25082 S.H. 146 over Tributary to Punjo Creek

Notes: Completed 1997

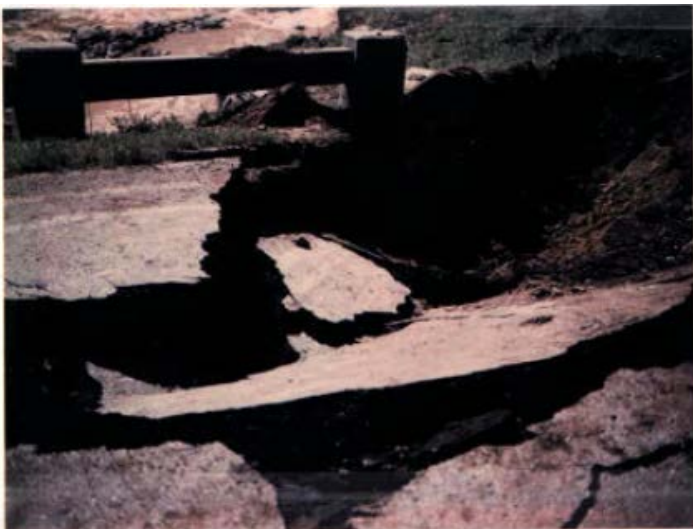
NBI 05418 S.H. 9 over Tributary to Pecan Creek

Notes: Major work including a drop outlet was completed on the downstream side in 1973. A curtain wall was added on the downstream side of the RCB in 1984.

Solution: Replace Outlet

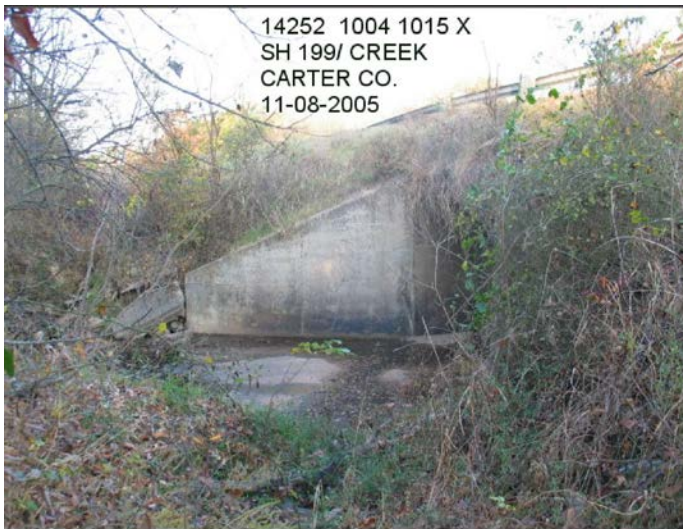
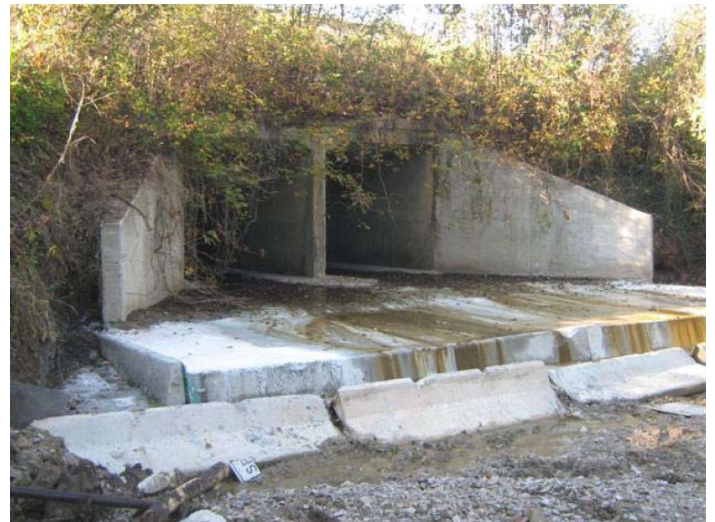
Problem Type: Wingwall Erosion and Cracks

Notes: Completed in 2009.

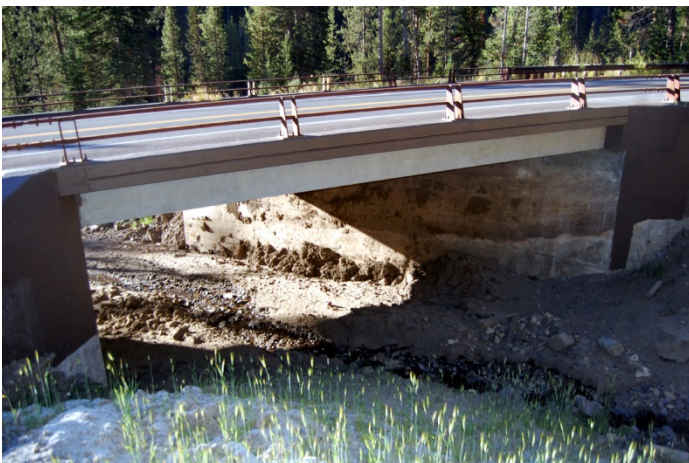
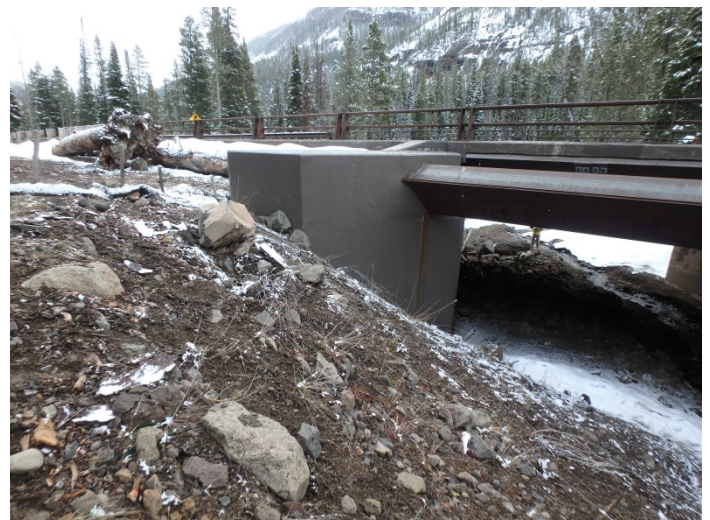
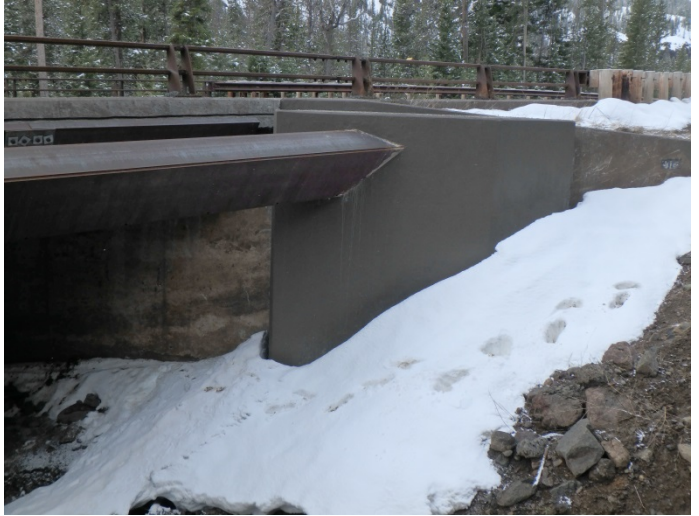
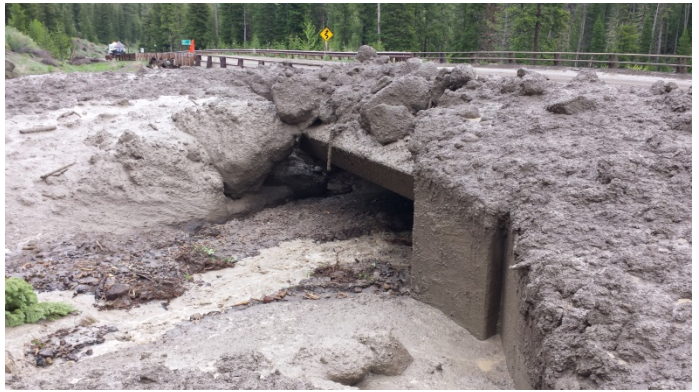
Deflector in Wyoming

Notes: This structure is in Wyoming. The boulders coming down from the mountain were damaging the upstream face of the RCB. The deflector protects the upstream face.

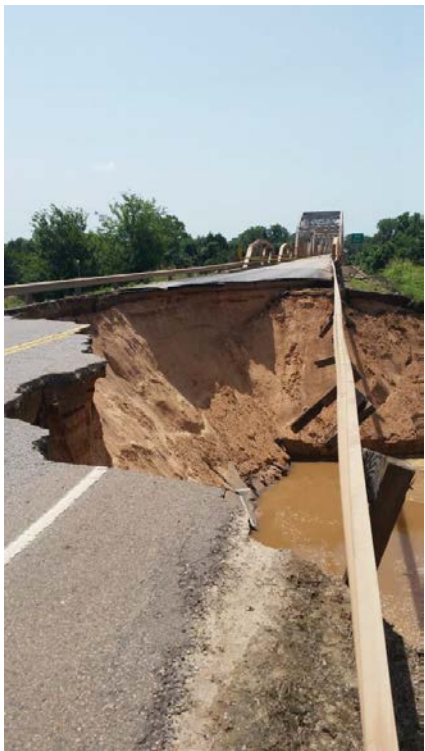
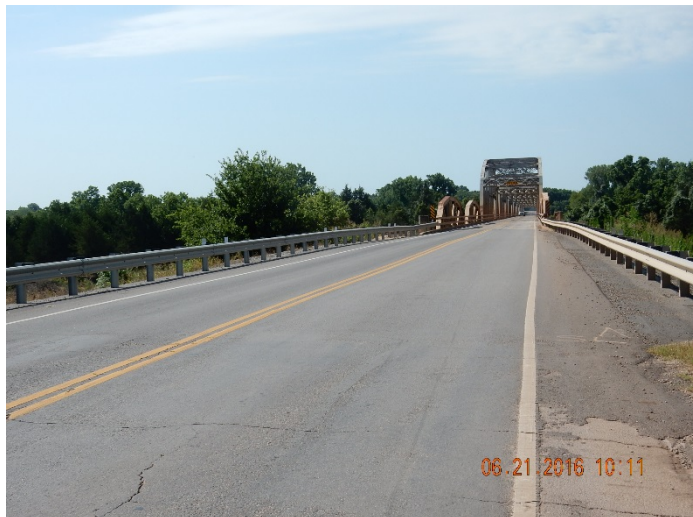
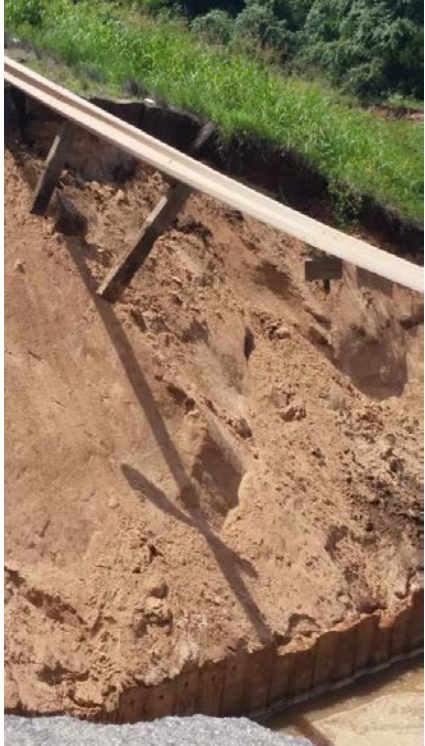
NBI 06591 S.H. 78 over Red River

Cost/Outcome: Rebuilt Road in 2015.

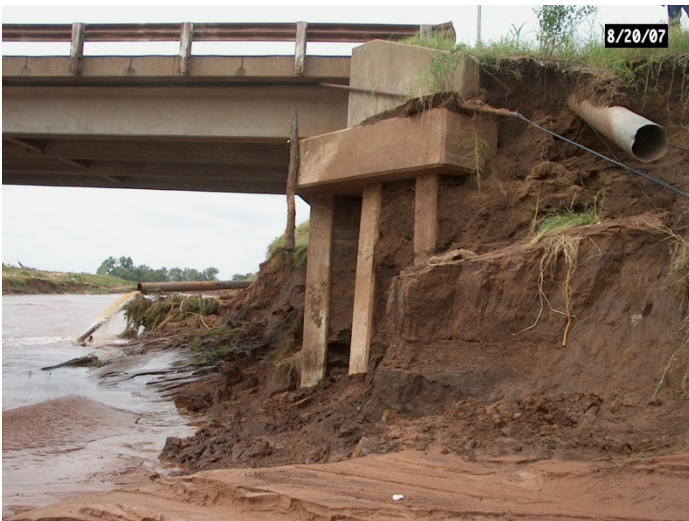
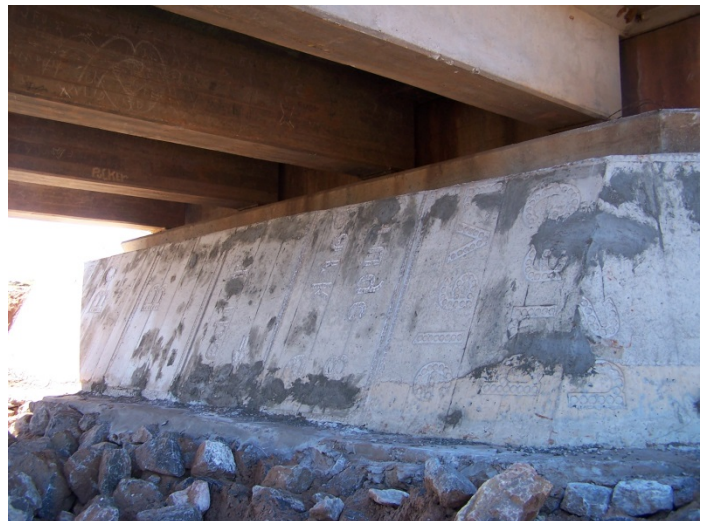
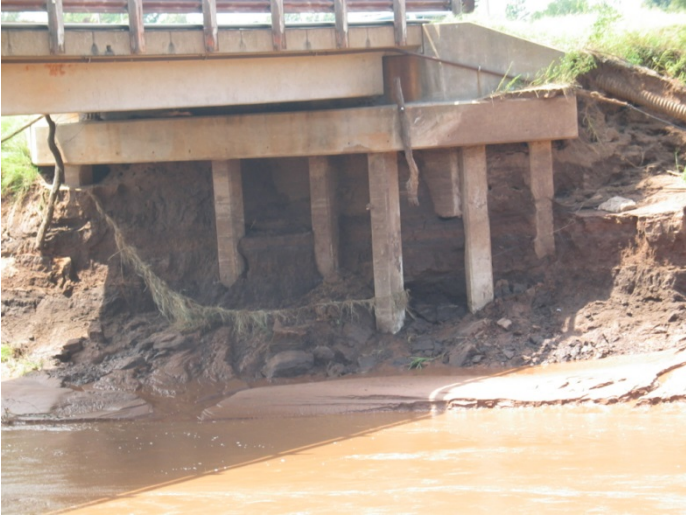
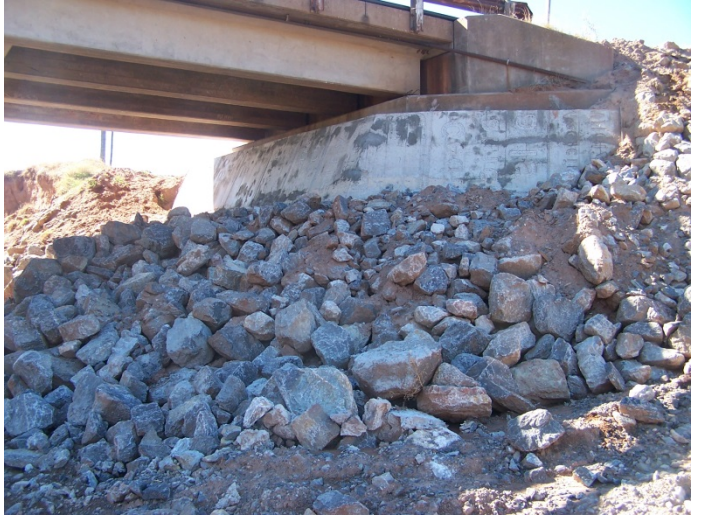
NBI 10742 S.H. 37 over Buggy Creek

Notes: Worked well until the bridge was replaced in 2012

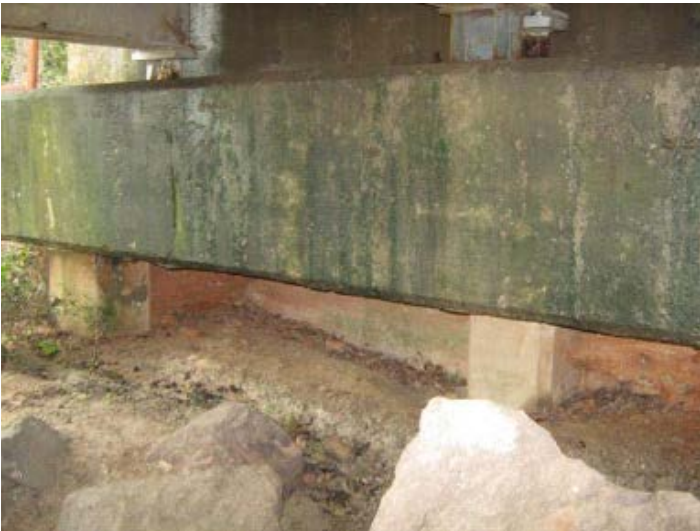
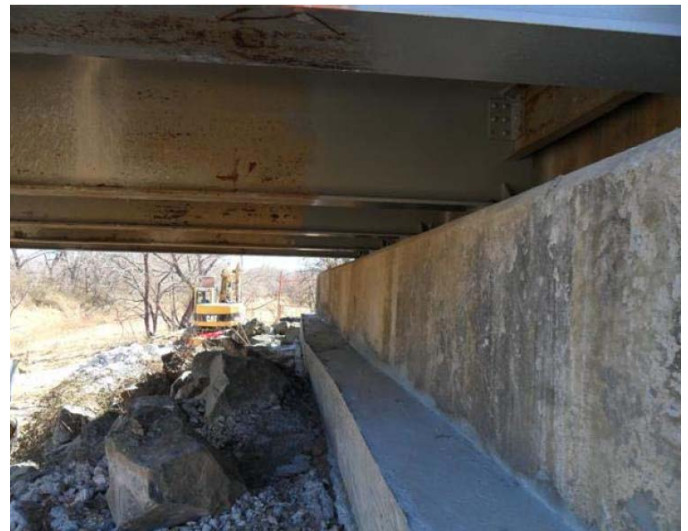
NBI 14114 S.H. 76 over Simon Creek

Notes: Completed in 2011

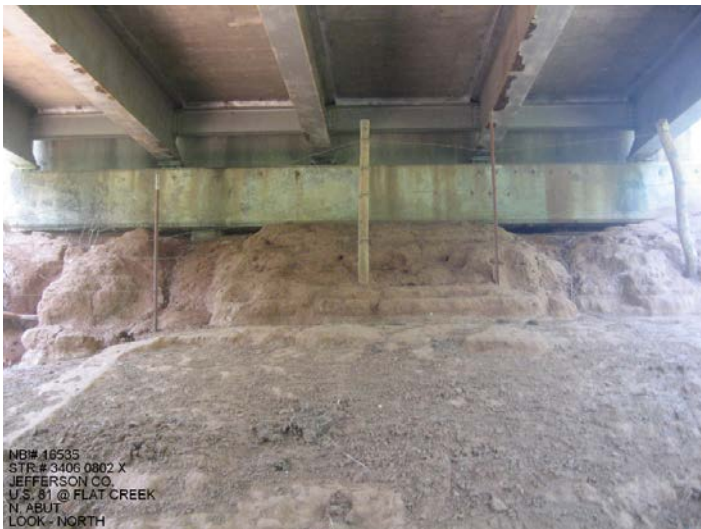
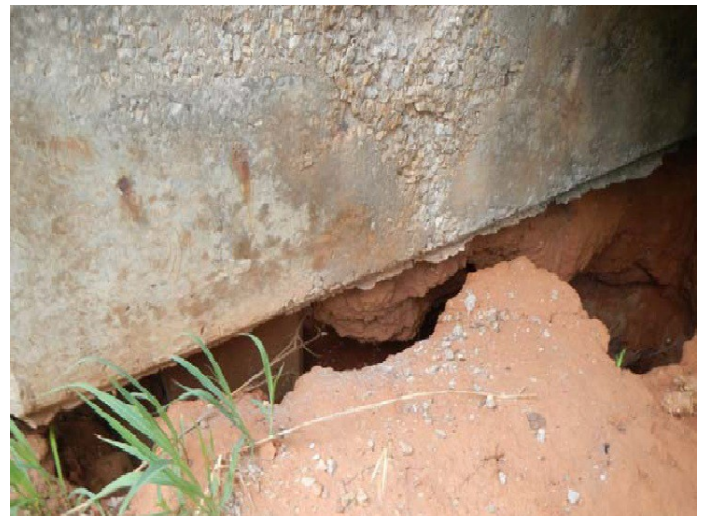
NBI 16535 S.H. 81 over Flat Creek

Notes: No repair as of 2015.

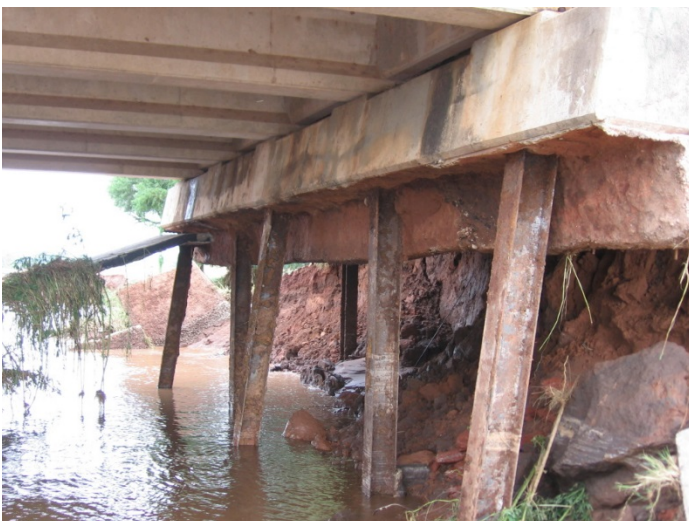
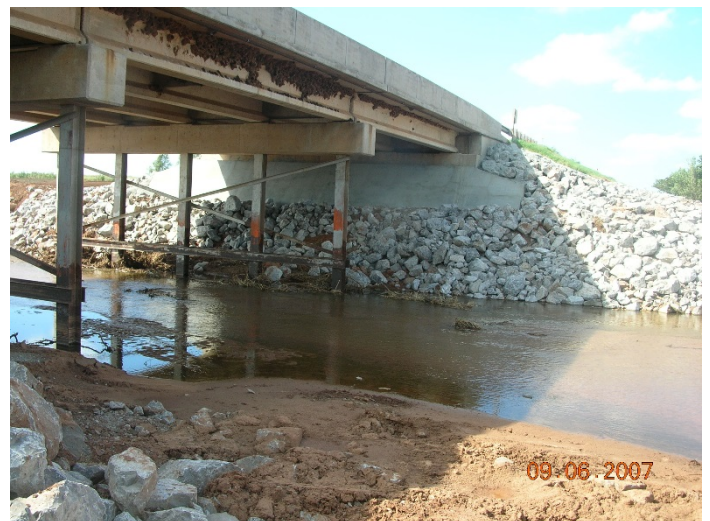
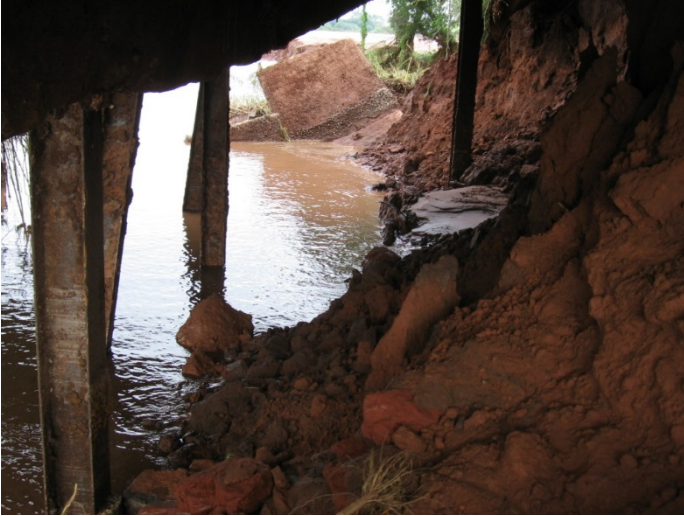
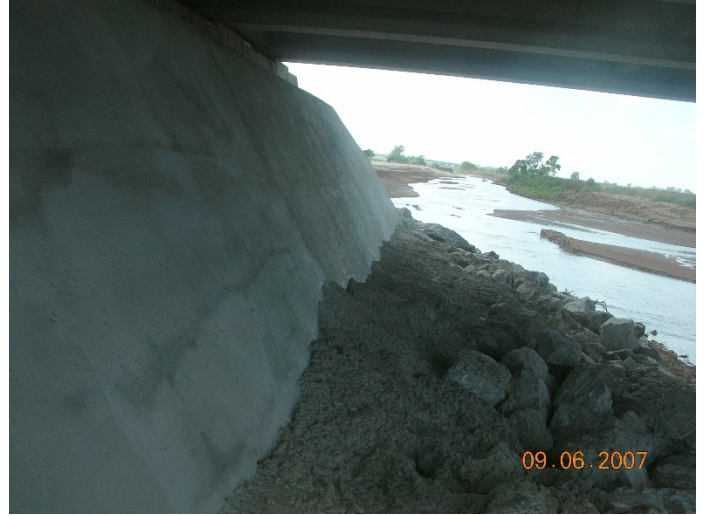
NBI 18273 US 81 over Buggy Creek

Cost/Outcome: Repairs were effective.

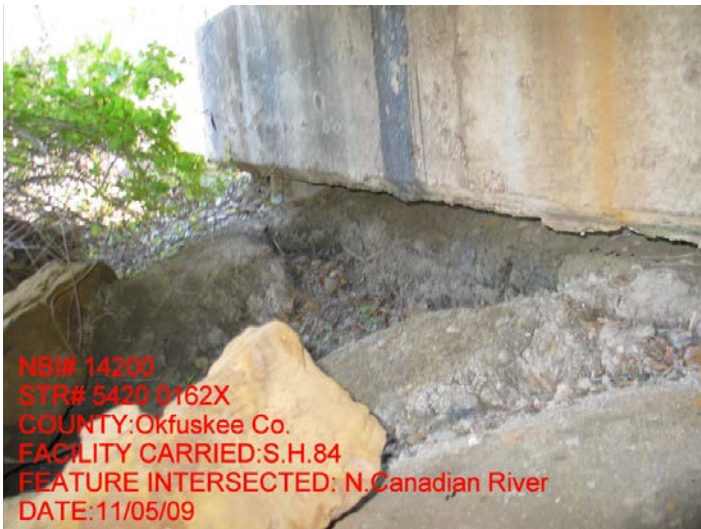
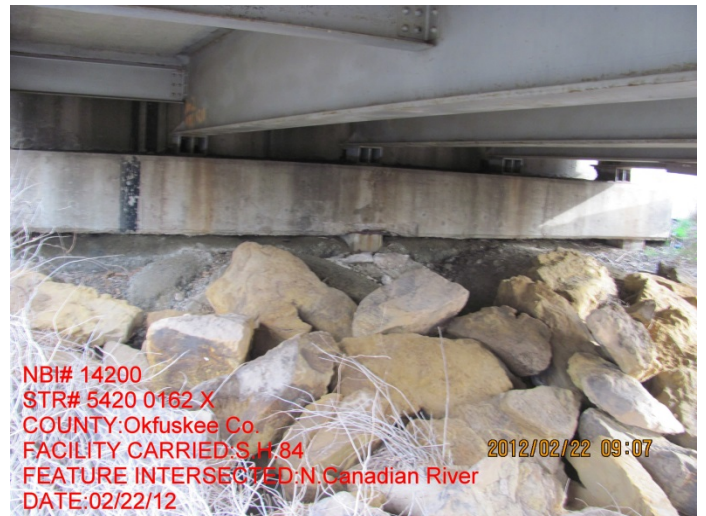
NBI 14200 S.H. 84 over North Canadian River

Notes: No Repair as of 2015.

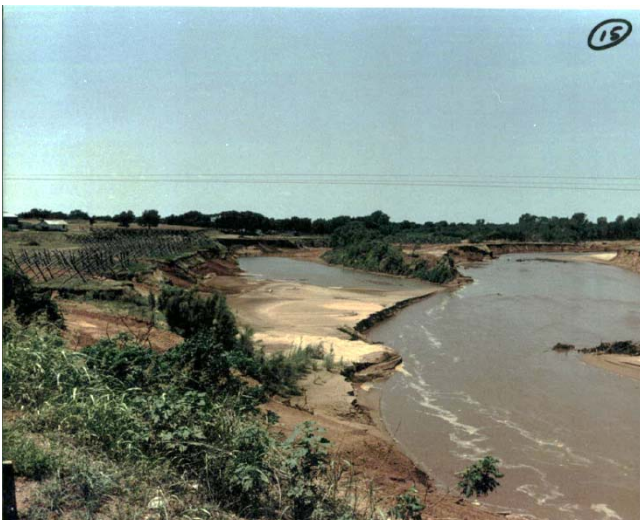
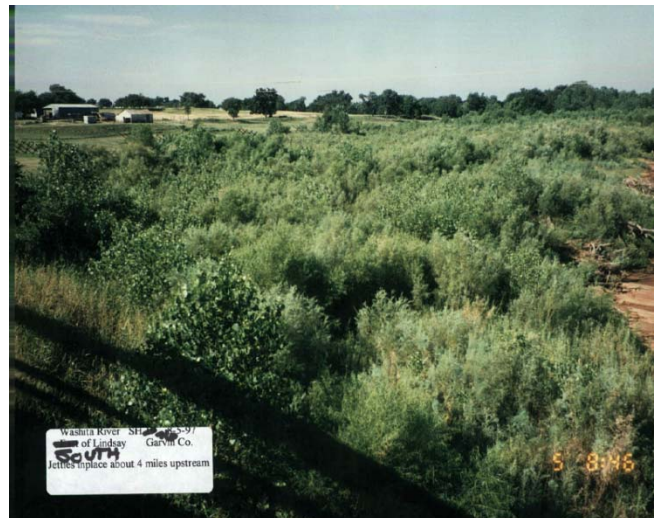
NBI 13121 S.H. 76 over Washita River

Notes: This has worked well until the bridge replacement in 2016.
