Countermeasures

Countermeasures are an important and necessary part of bridge maintenance. Not only must the countermeasure restore the safety of the structure, but guard against future assaults. This often has to be completed in a short time and on a shoe string budget.

This document will display some of the different types of countermeasures that have been used both successfully and unsuccessfully in Oklahoma.

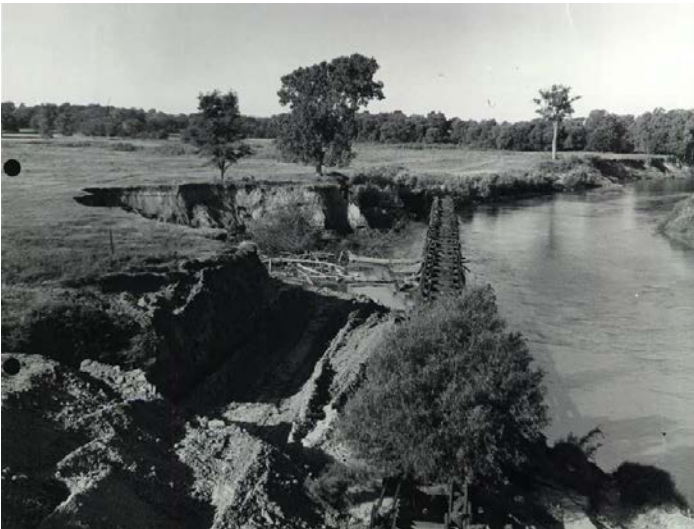
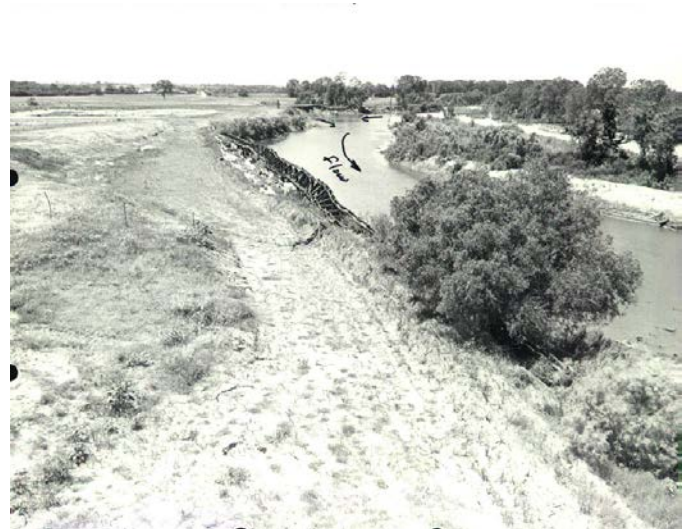
NBI 17598(WX) and 17599(EX) I-35 over Washita River

Notes: Completed in 1980.

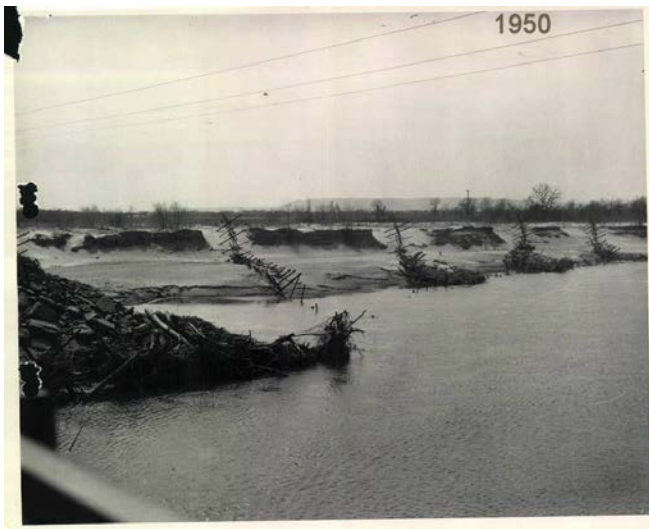
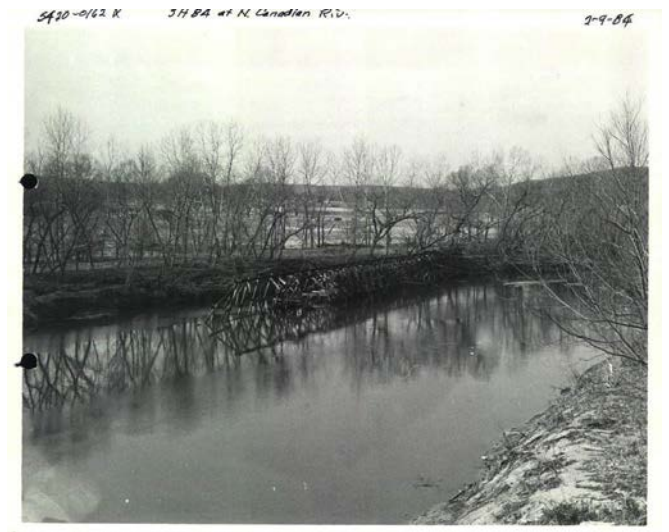
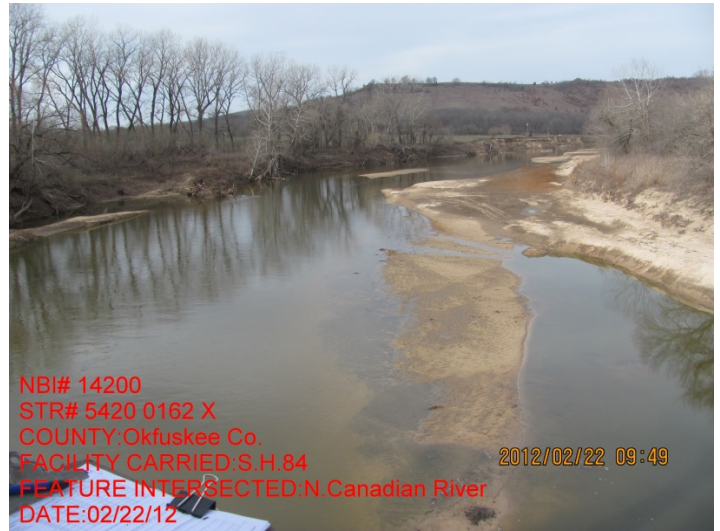
NBI 14200 S.H. 84 over North Canadian River

Notes: The jetties were placed and rebuilt several times. In 1996 the jetties were repaired and riprap placed at the bridge site.

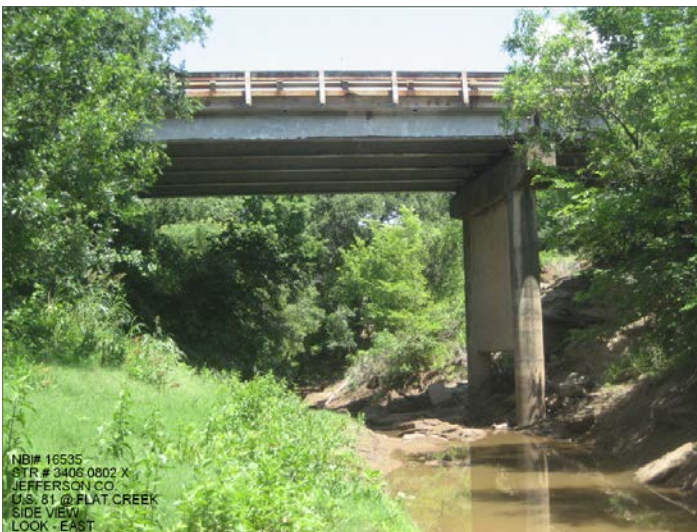
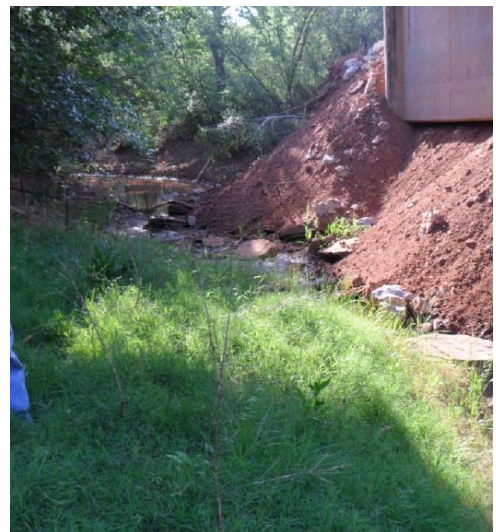
NBI 16535 S.H. 81 over Flat Creek

Notes: Completed in 2011.

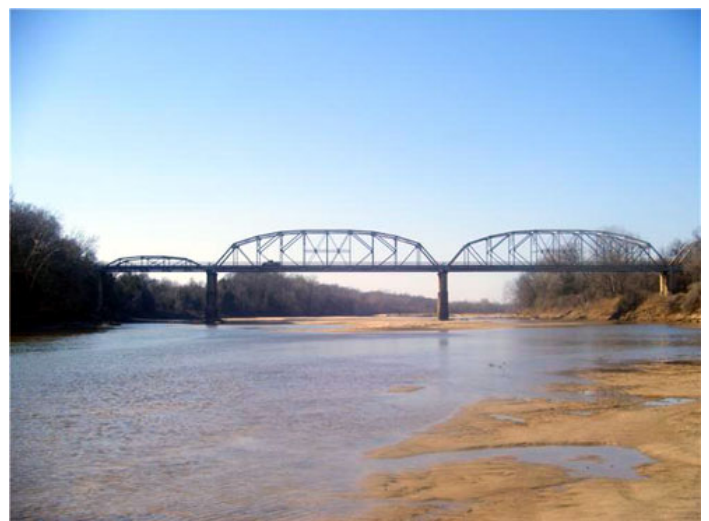
NBI 06591 S.H. 78 over Red River

Notes: Project Complete in 1946

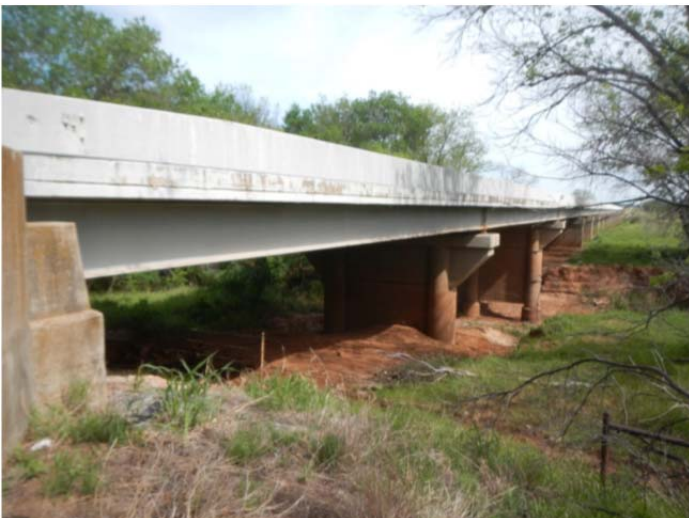
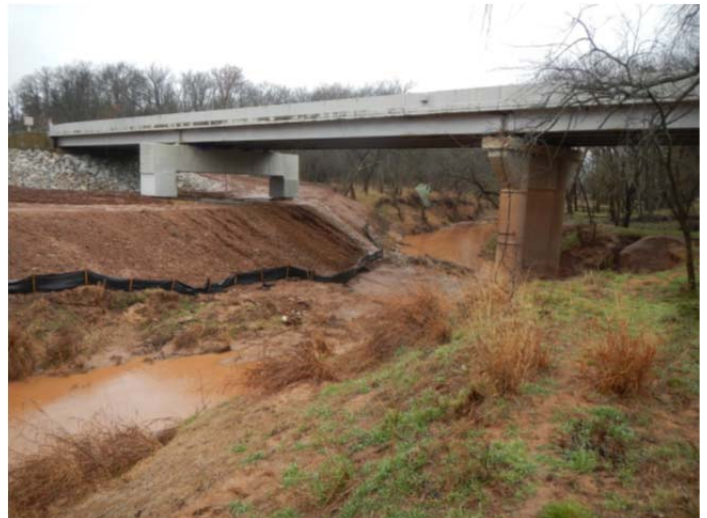
NBI 13936 S.H. 89 over Mud Creek

Notes: Completed in 2015.

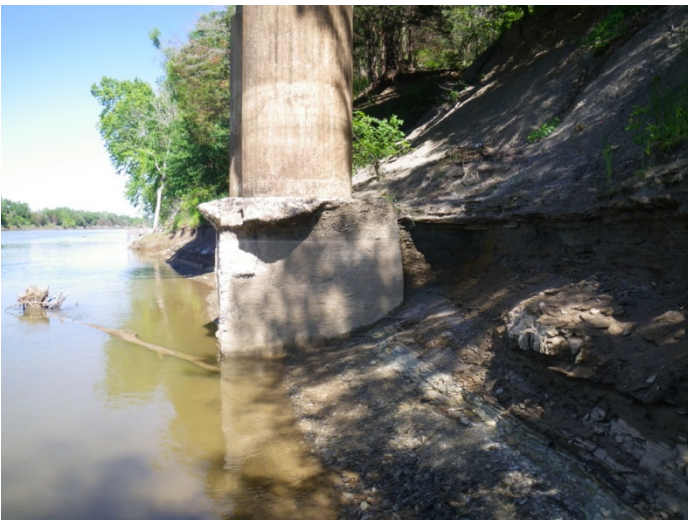
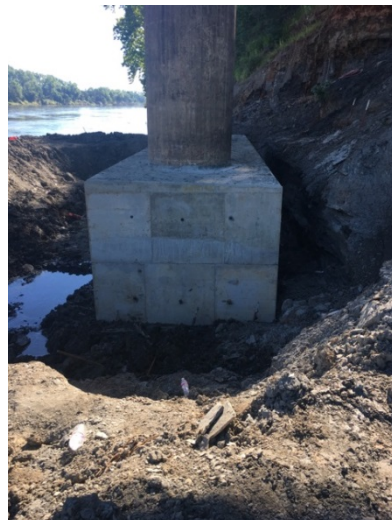
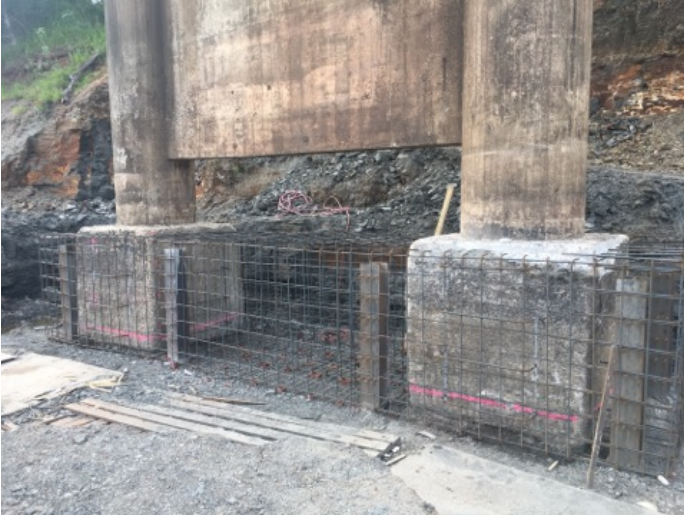
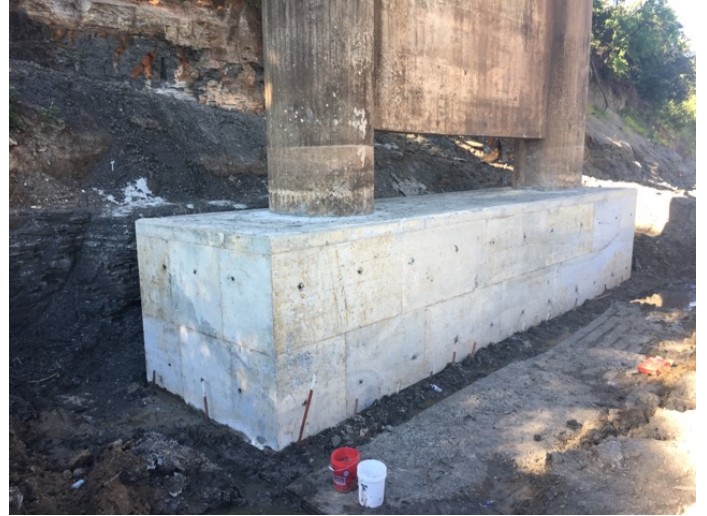
Notes: This was an emergency project that was completed in 2017

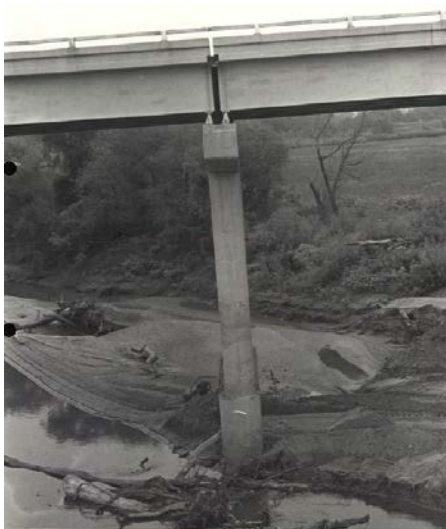
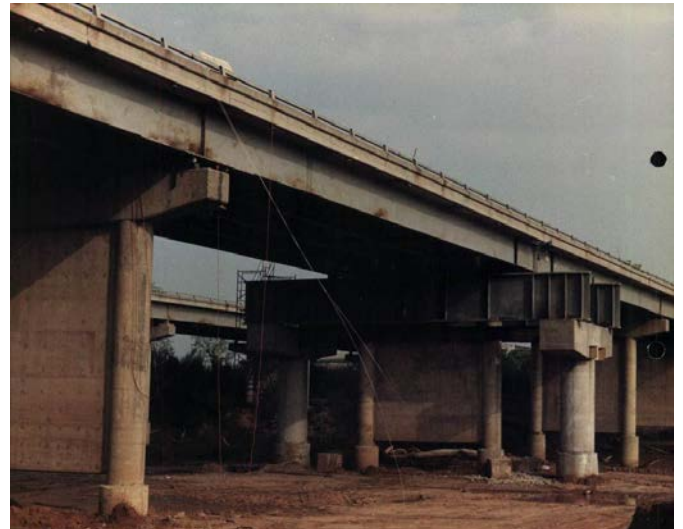
NBI 17598(WX) and 17599(EX) I-35 over Washita River

Notes: Completed in 1991.

Solution: Pier Replacement.

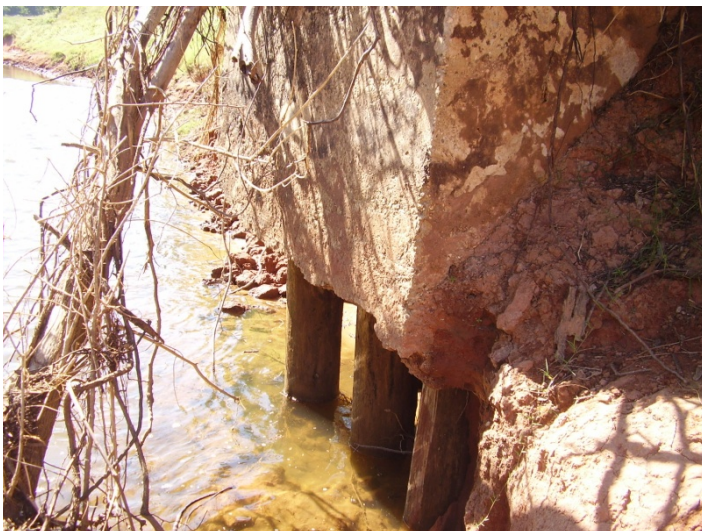
BEFORE

Notes: Completed in 2007. This was a temporary solution. The bridge is scheduled for replacement in 2012. The 2011 bridge inspection photos show the repairs are performing well.

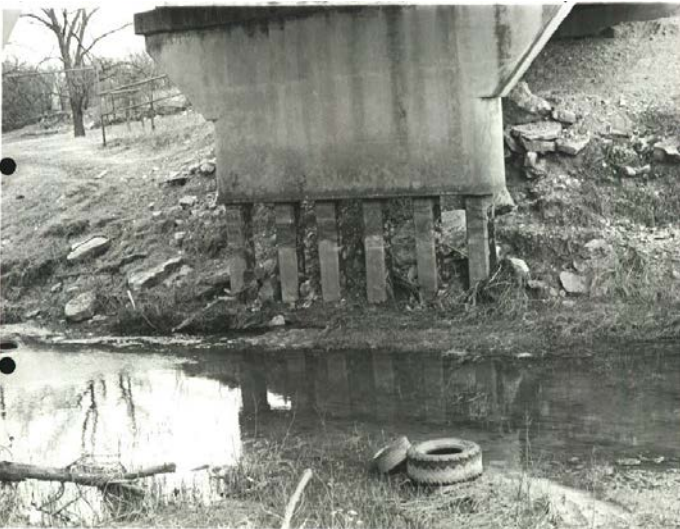
BEFORE

NBI 14114 S.H. 76 over Simon Creek

Structure #: 4316 0666X Size: 3-40' I BEAMS PILE BENT

Notes: Completed in 2011

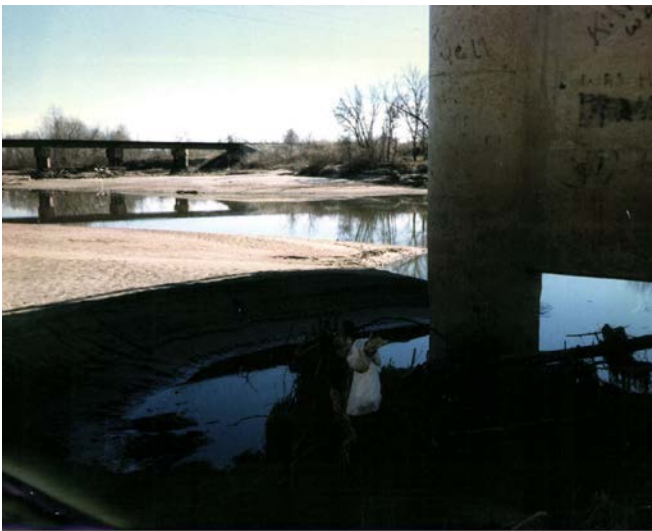
BEFORE

NBI 14200 S.H. 84 over North Canadian River

Problem Type: Channel Degradation

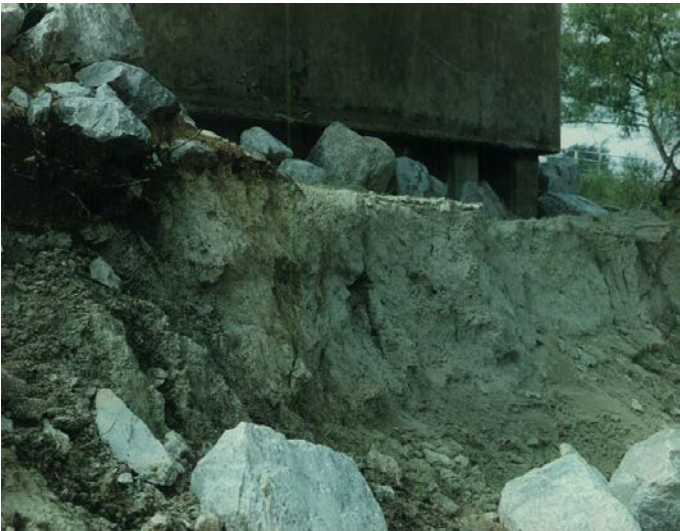
BEFORE

NBI 14114 S.H. 76 over Simon Creek

Problem Type: Channel Degradation

Notes: Completed in 2011

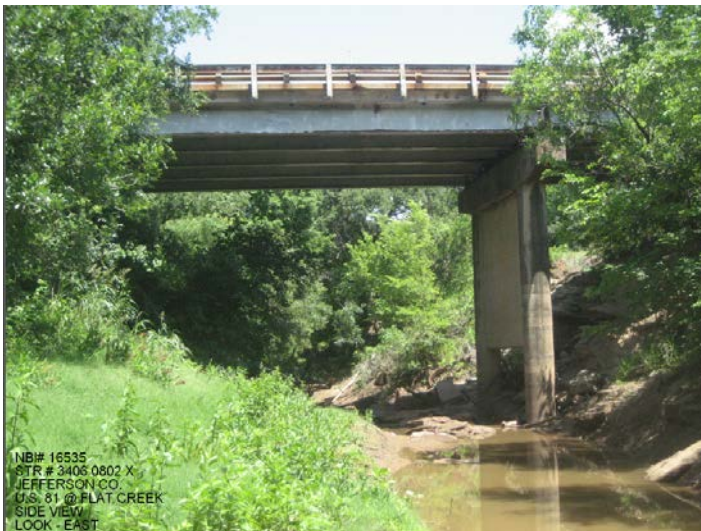
BEFORE

NBI 16535 S.H. 81 over Flat Creek

Problem Type: Channel Degradation

Notes: Completed in 2011.
